## Visual Inspection Checklist (Post-Closure) Site 7 Landfill

Name of Inspector:  Lisa Geist  Date:  August 7, 2013

## Visual Inspection Checklist (Post-Closure) Site 9 Landfill

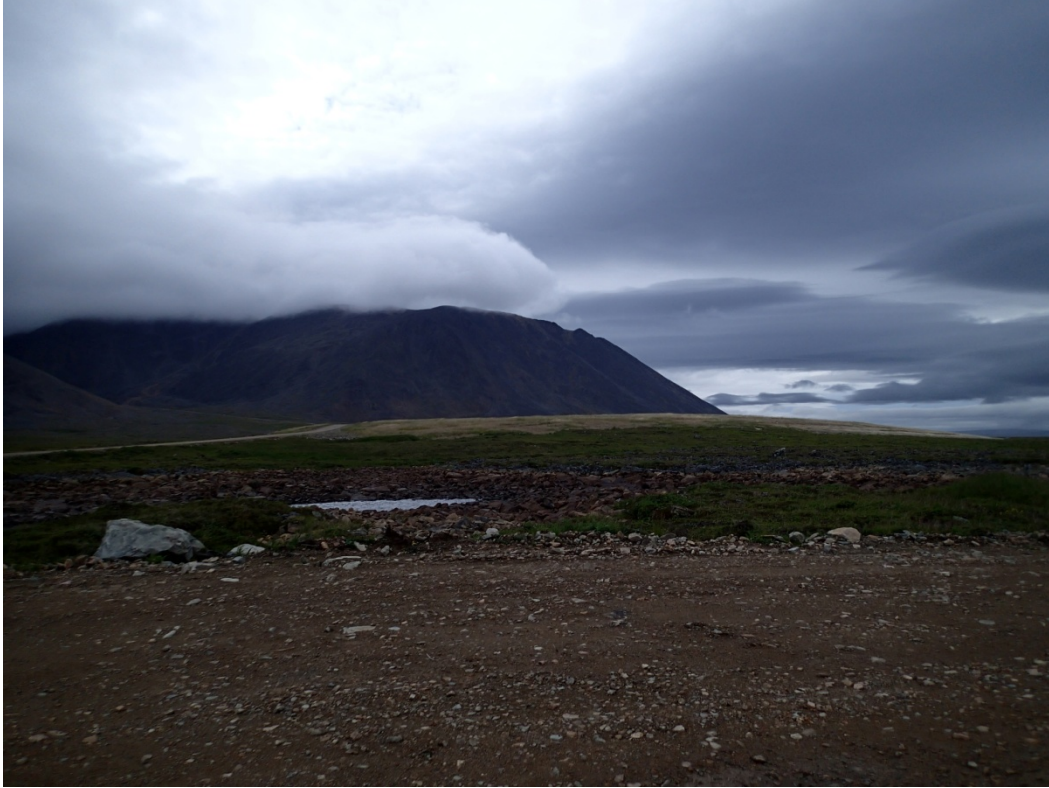
Photo 1: Site 7 Landfill - Overview of landfill area, facing SW.

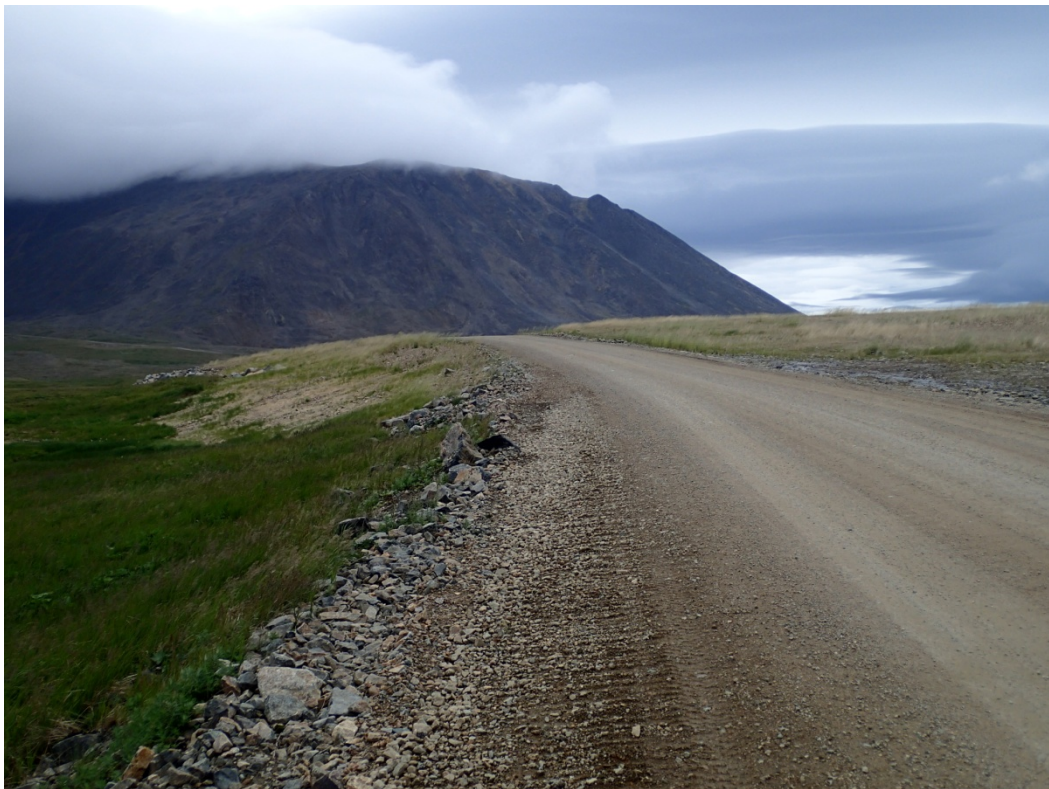
Photo 2: Site 7 Landfill - View of south side of landfill from Cargo Beach Road, facing SW.

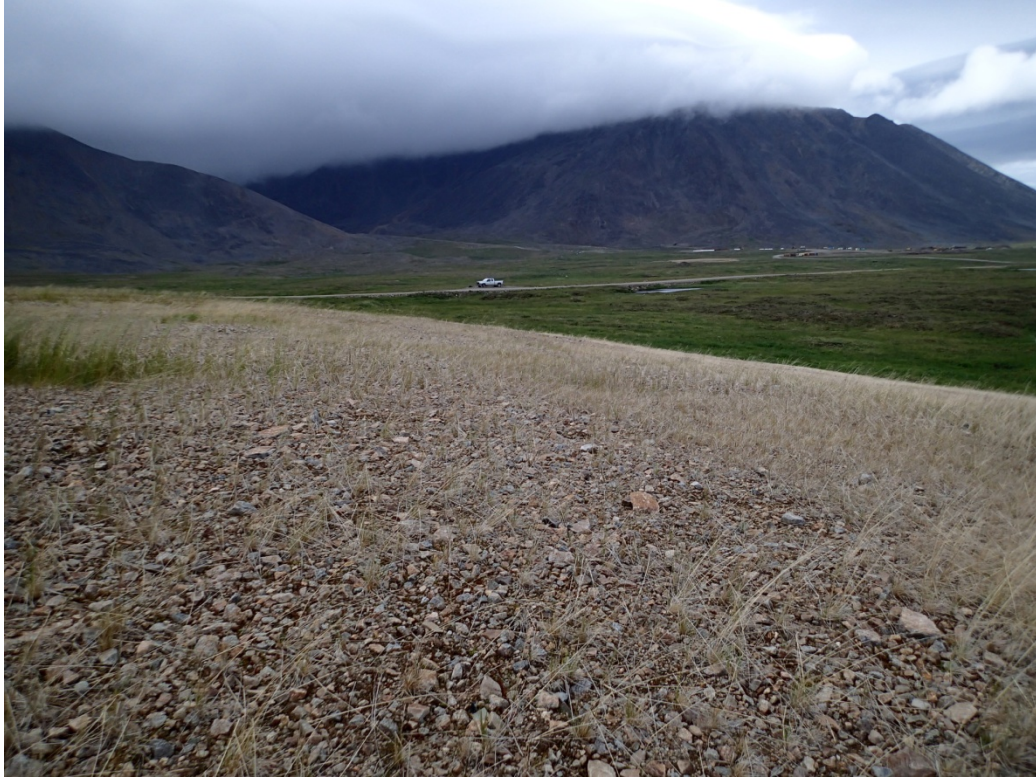
Landfill Post-Closure Monitoring Items	Y	N	COMMENTS
Evidence of settlement or frost jacking within or on surface of landfill?		X	
Ponded water within, against, or on surface of landfill?	X		Tundra ponds close to toe of landfill on west and north sides.
Evidence of surface erosion on disposal area walls or on exterior berms?		X	
Erosion of access roads?		X	
Discoloring of vegetation downslope?		X	
Any evidence of leakage or escape of waste from cells?		X	
Airborne ash or dust particles?		X	
Evidence of wildlife or birds present? Include number and type of birds on site.	X		One fox sighted on west side of landfill, animal droppings scattered around landfill. Three cranes in nearby tundra. Two Tundra voles on landfill cap.
Windblown litter in cells or along access roads or adjacent ponds?		X	
Landfill odors?		X	
Fire or combustion in the waste?		X	
Damage to the structural integrity of a dike wall, culvert, or erosion control feature, if present?		X	Culvert by gravel access road is clear.

Photo 3: Site 7 Landfill - View of west side of landfill area, facing south.

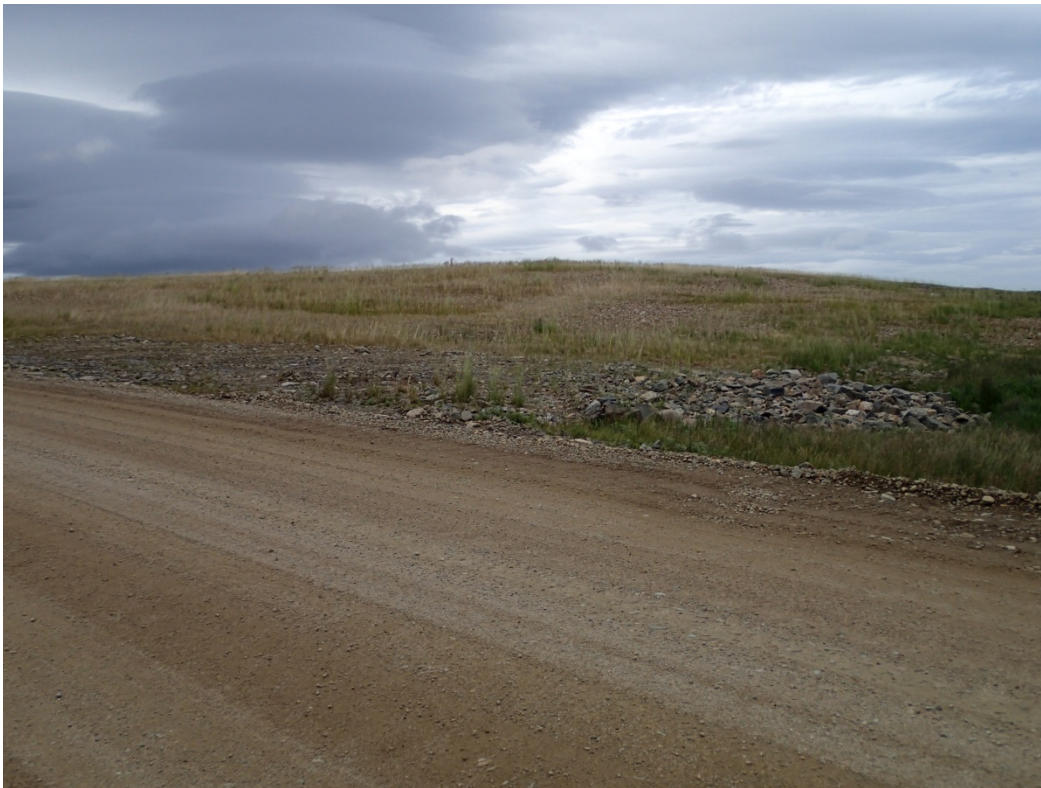
Photo 4: Site 7 Landfill – Southeast side of landfill from Cargo Beach Road, facing NW.

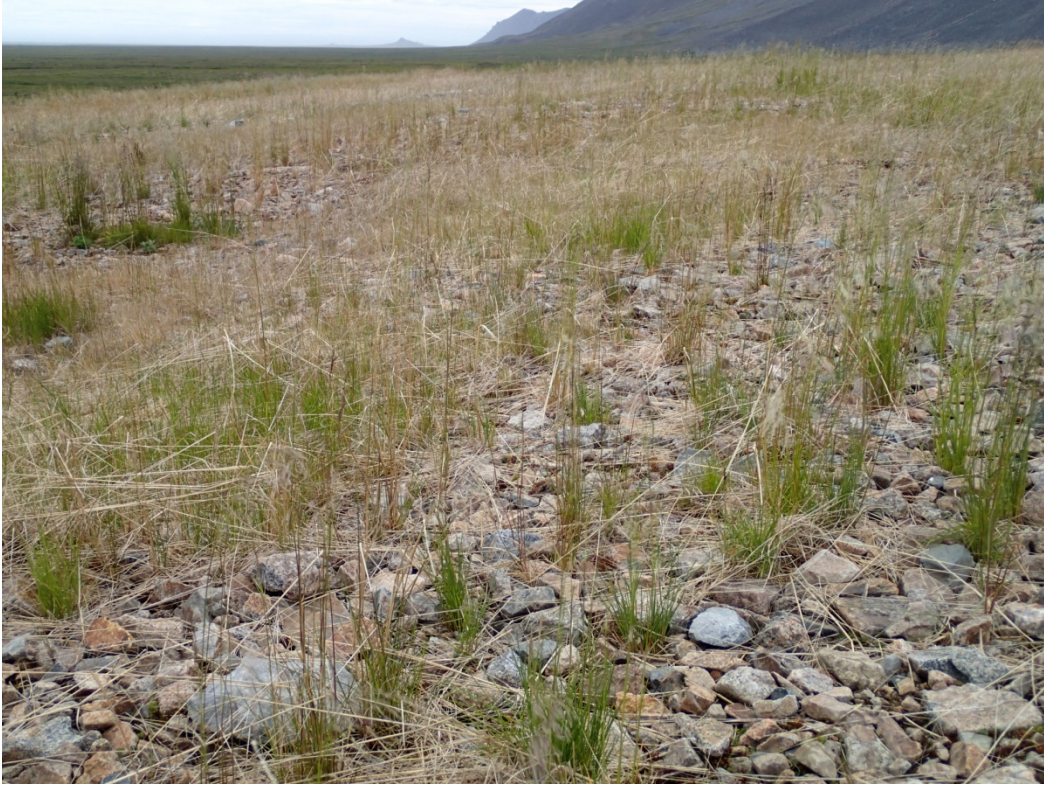
Is revegetation occurring?	X		Grass growing well, areas of moss beginning to appear, but landfill surface still very cobbly with rocks.
Estimated Percent Vegetative Cover: On Cap Surface <u> 70 </u> On Sideslopes: <u> 70 </u> Comments: Grasses growing well, but only moss is establishing itself on very rocky surfaces.

Photo 5: Site 7 Landfill – Surface of landfill, note both newer (green) and older (brown) grass tufts, facing east.

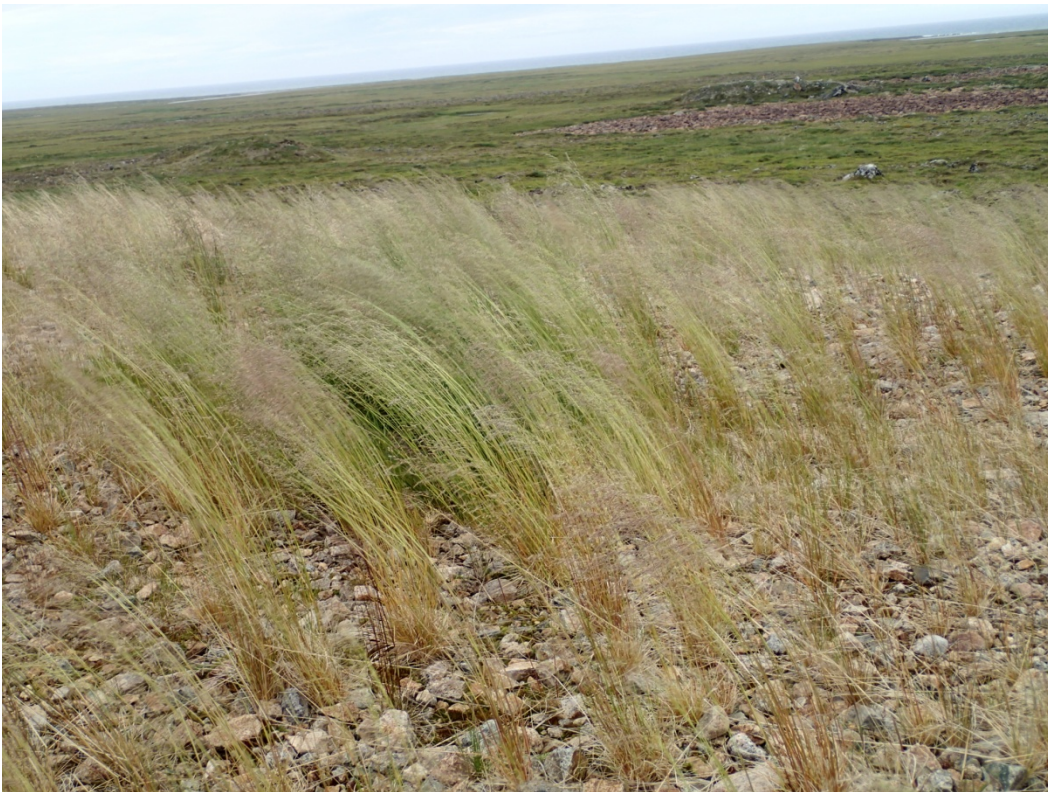
Photo 6: Site 7 Landfill – North slope of landfill, note tall grass tufts with seed, facing NW.

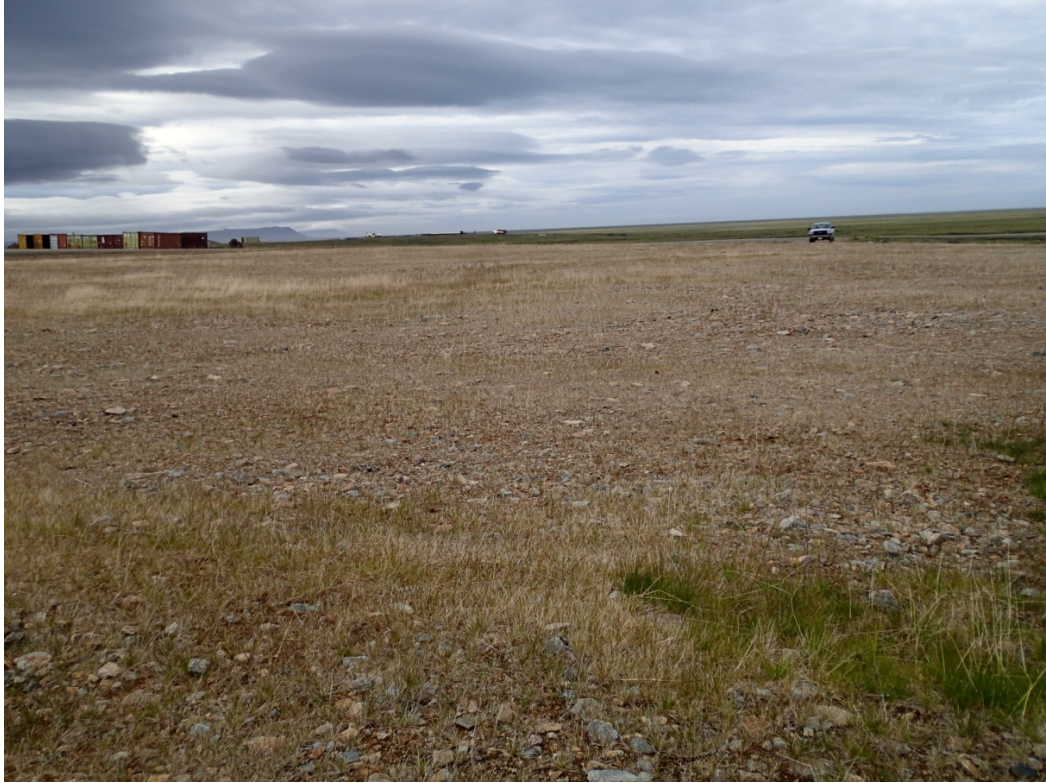
Photo 8: Site 9 Landfill – View of landfill facing west, MOC in background.

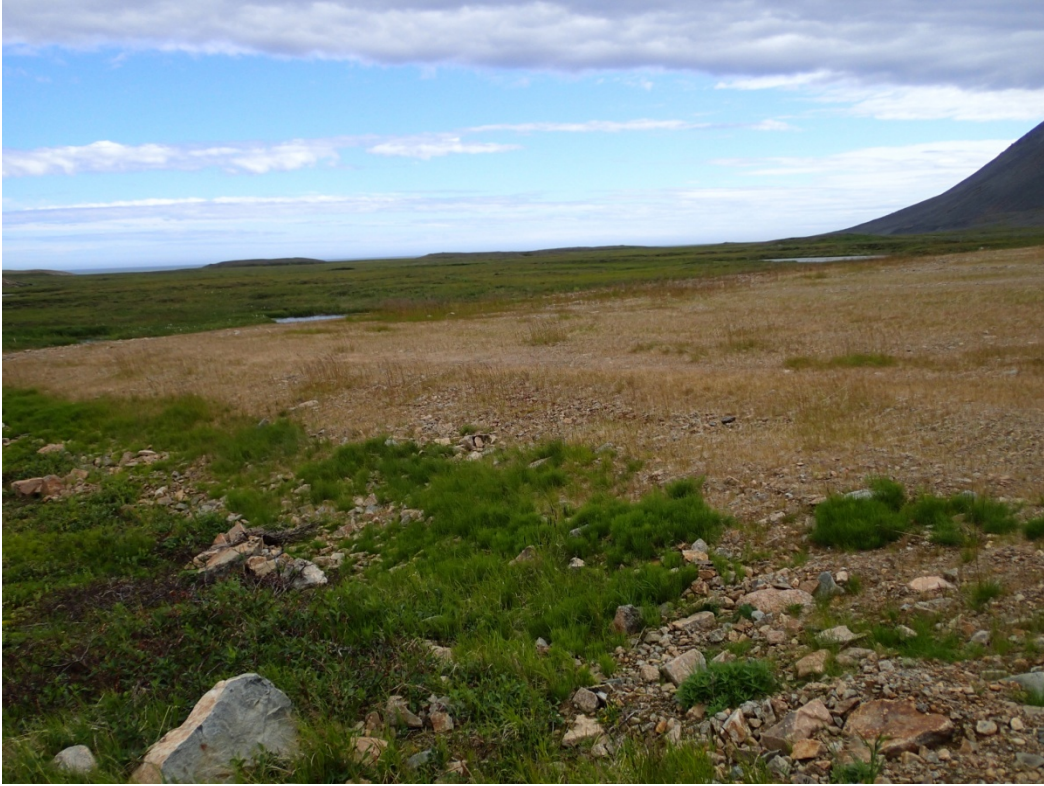
Photo 9: Site 9 Landfill – North end of landfill, facing NE.

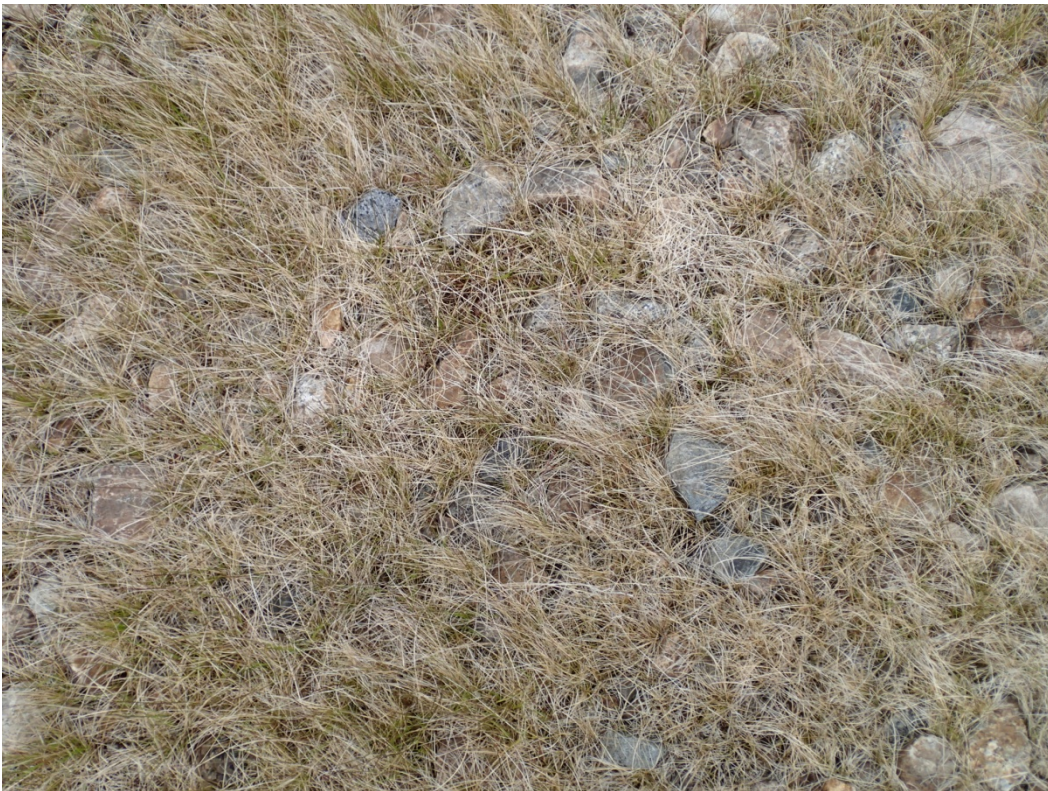
Photo 10: Site 9 Landfill – Close-up view of landfill vegetation.

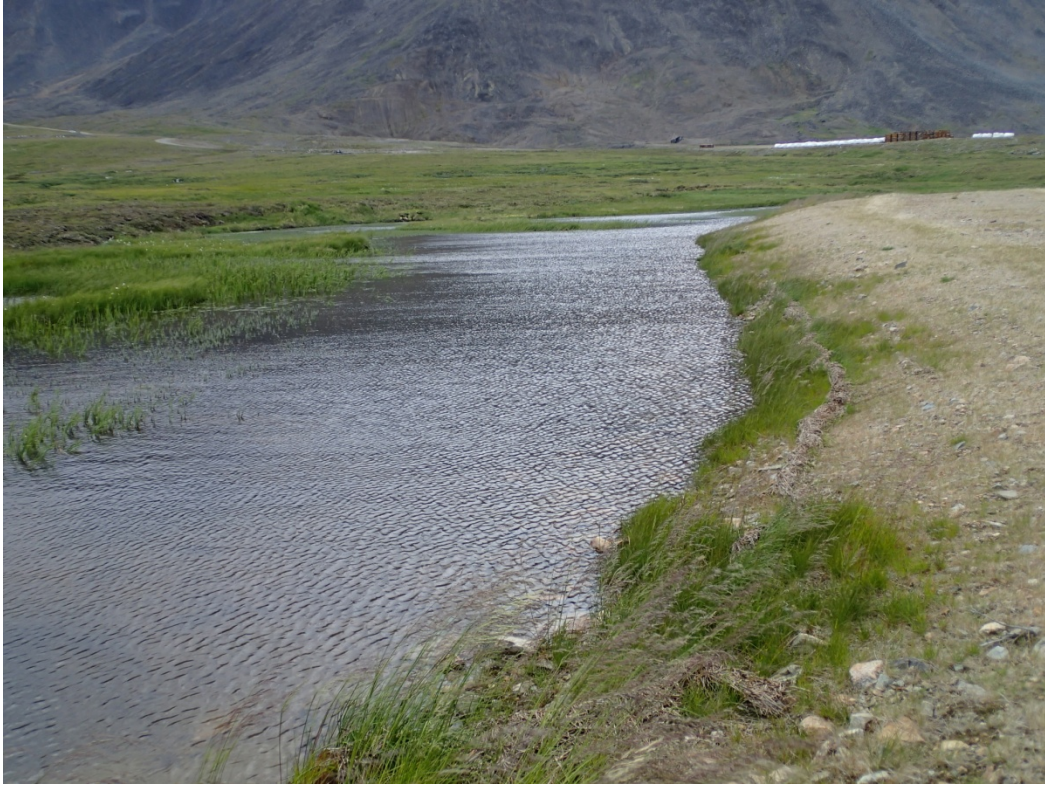
Landfill Post-Closure Monitoring Items	Y	N	COMMENTS
Evidence of settlement or frost jacking within or on surface of landfill?		X	
Ponded water within, against, or on surface of landfill?	X		Tundra ponds close to toe of landfill on east and north sides
Evidence of surface erosion on disposal area walls or on exterior berms?		X	
Erosion of access roads?		X	
Discoloring of vegetation downslope?		X	
Any evidence of leakage or escape of waste from cells?		X	
Airborne ash or dust particles?		X	
Evidence of wildlife or birds present? Include number and type of birds on site.	X		2 cranes in nearby tundra.
Windblown litter in cells or along access roads or adjacent ponds?		X	
Landfill odors?		X	
Fire or combustion in the waste?		X	
Damage to the structural integrity of a dike wall, culvert, or erosion control feature, if present?		X	
Is revegetation occurring?	X		
Estimated Percent Vegetative Cover: On Cap Surface ___80___ On Sideslopes: ___70___ Comments: Grasses growing well with moss establishing on more rocky areas.

Photo 11: Site 9 Landfill – Pond along SE side of landfill, facing SW.

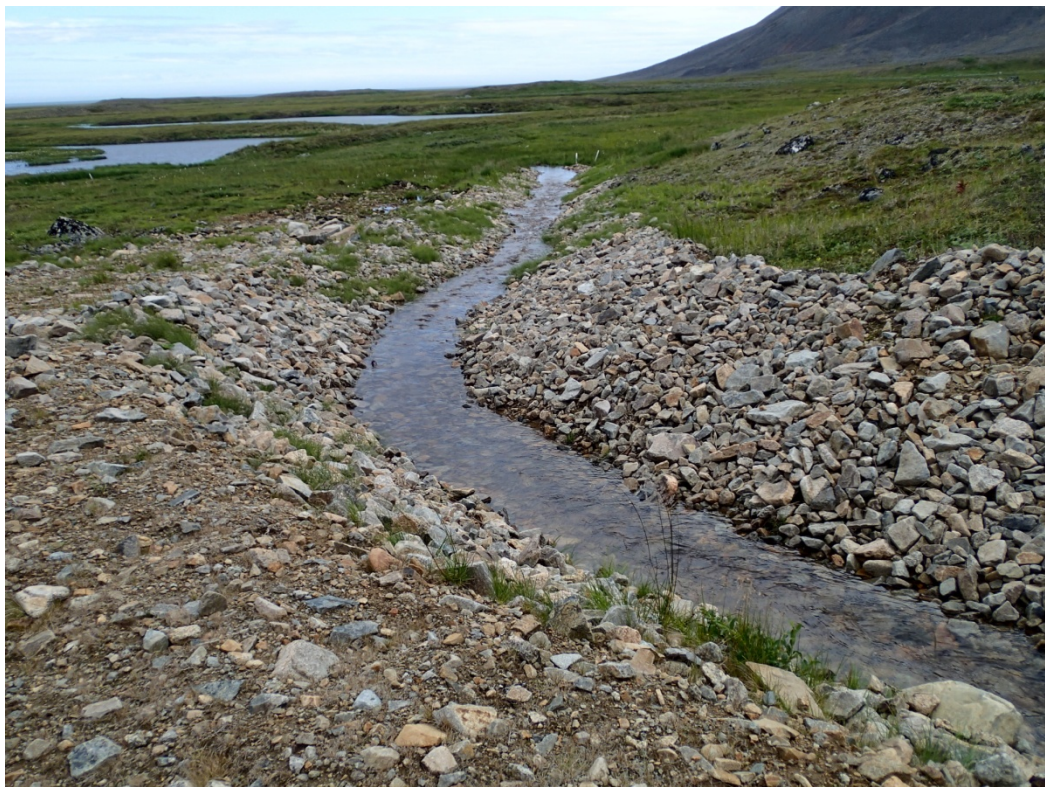
Photo 12: Site 9 Landfill – Diversion ditch that drain pond shown in Photo 11, operating sufficiently, facing NE.
