Visual Inspection Checklist (Post-Closure)

Site 7 Landfill

Site 9 Landfill

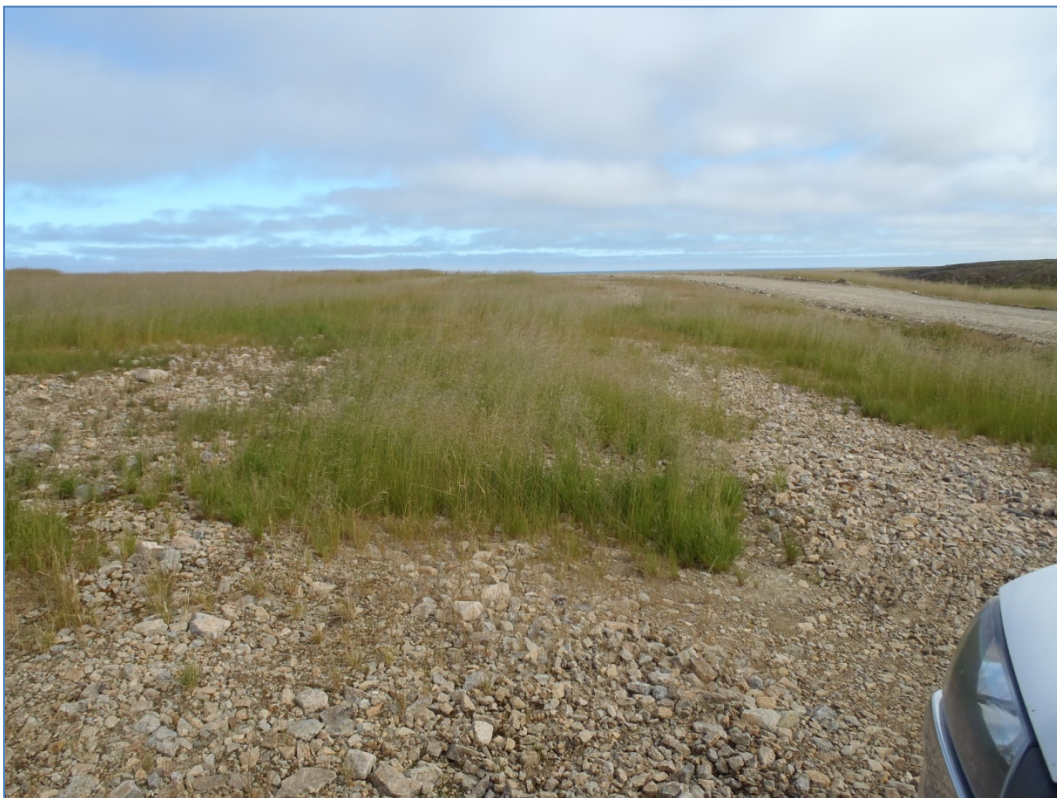
Photo 2: Site 7 Landfill – East slope of landfill, facing northeast.

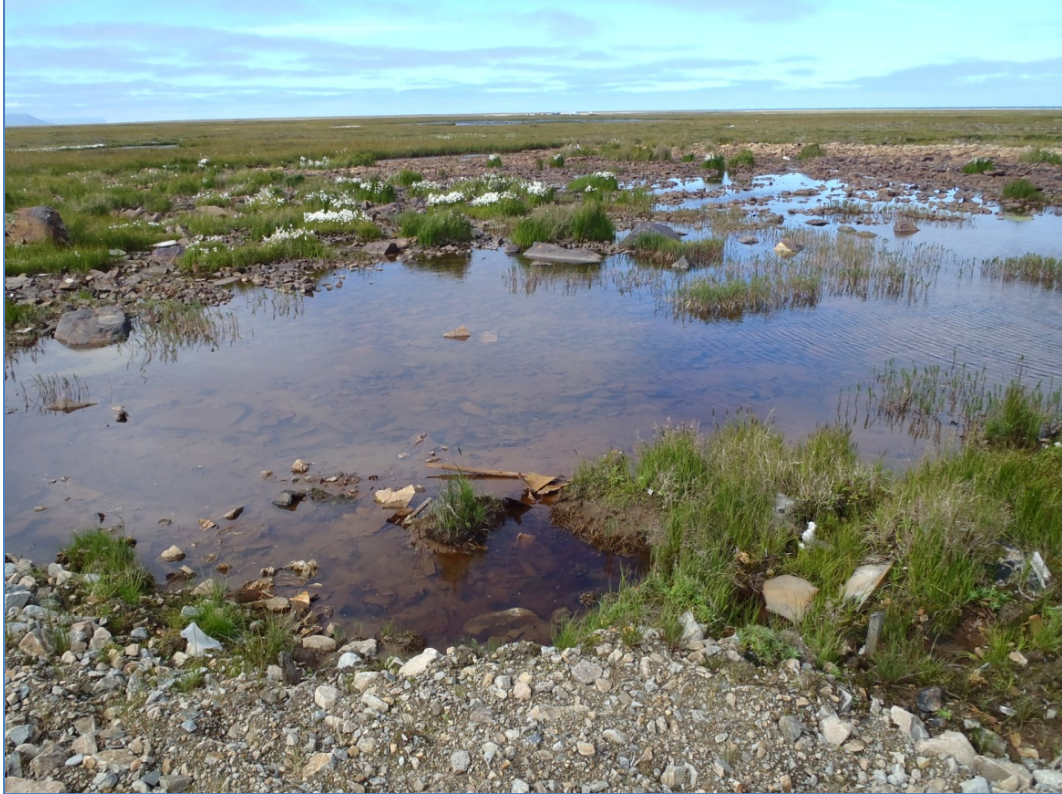
Landfill Post-Closure Monitoring Items	Y	N	COMMENTS
Evidence of settlement or frost jacking within or on surface of landfill?		X	Stable, level surface.
Ponded water within <u>(against)</u> or on surface of landfill?	X		Natural tundra ponds adjacent to landfill on S, W, N sides.
Evidence of surface erosion on disposal area walls or on exterior berms?		X	
Erosion of access roads?		X	
Discoloring of vegetation downslope?		X	
Any evidence of leakage or escape of waste from cells?		X	
Airborne ash or dust particles?		X	
Evidence of wildlife or birds present? Include number and type of birds on site.	X		Small white/black birds in corey of 15-20 eating bird seed.
Windblown litter in cells or along access roads or adjacent ponds?		X	No visible debris
Landfill odors?		X	
Fire or combustion in the waste?		X	
Damage to the structural integrity of a dike wall, culvert, or erosion control feature, if present?		X	N/A

Photo 11: Site 7 Landfill – Surface water pond on northwest side of landfill, facing northwest with camp in background.

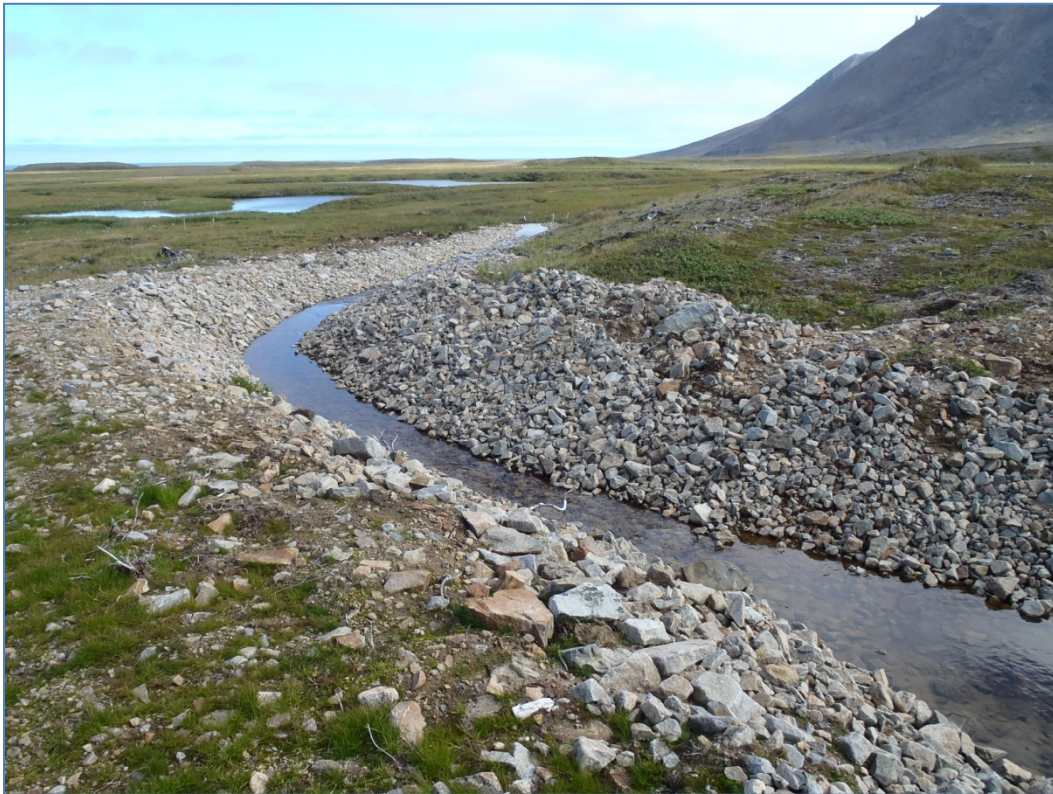
Landfill Post-Closure Monitoring Items	Y	N	COMMENTS
Evidence of settlement or frost jacking within or on surface of landfill?		X	Very stable in appearance
Ponded water within, <u>against</u> , or on surface of landfill?	X		Natural tundra ponds to north + east. Ditch drains to NE.
Evidence of surface erosion on disposal area walls or on exterior berms?		X	
Erosion of access roads?		X	
Discoloring of vegetation downslope?		X	
Any evidence of leakage or escape of waste from cells?		X	
Airborne ash or dust particles?		X	
Evidence of wildlife or birds present? Include number and type of birds on site.		X	
Windblown litter in cells or along access roads or adjacent ponds?		X	No visible debris.
Landfill odors?		X	
Fire or combustion in the waste?		X	
Damage to the structural integrity of a dike wall, culvert, or erosion control feature, if present?		X	Manmade ditch in excellent condition + functioning properly.

Photo 12: Site 9 Landfill – Drainage ditch operating well and in good condition, facing northeast.
