Visual Inspection Checklist (Post-Closure) Site 7 Landfill

Name of Inspector: Aaron Shewman Date: 26 July 2012

Visual Inspection Checklist (Post-Closure) Site 9 Landfill

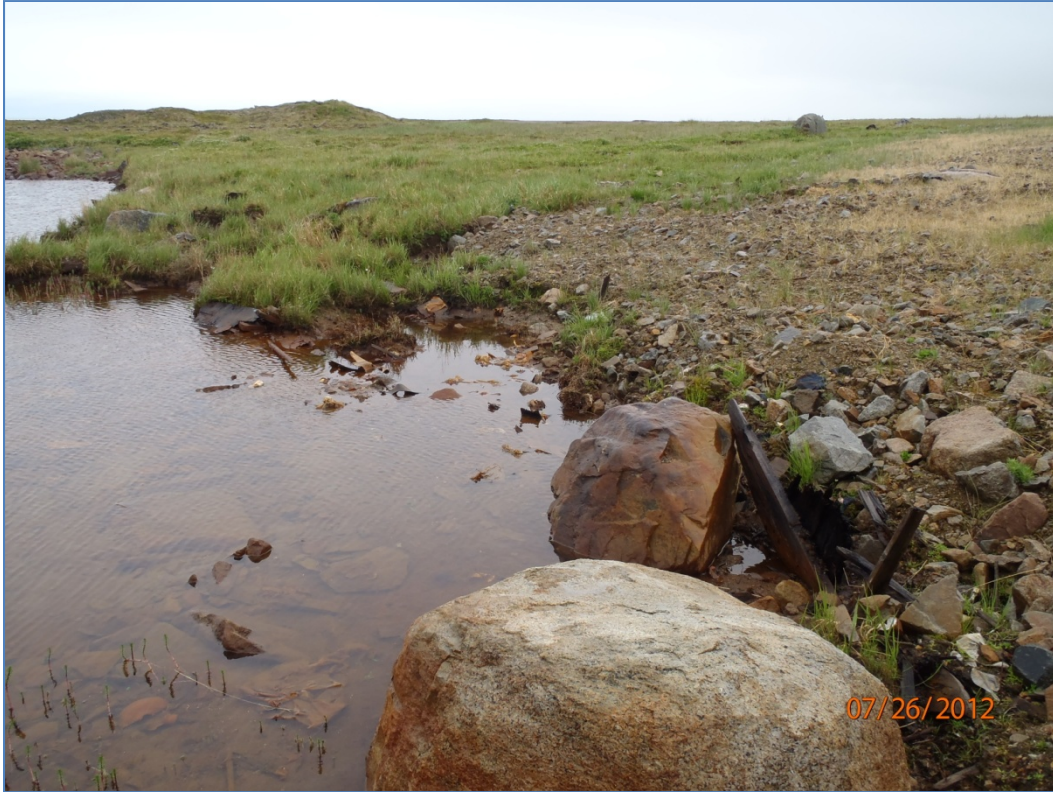
Photo 1: Site 7 Landfill – Pond on west side of landfill, facing north.

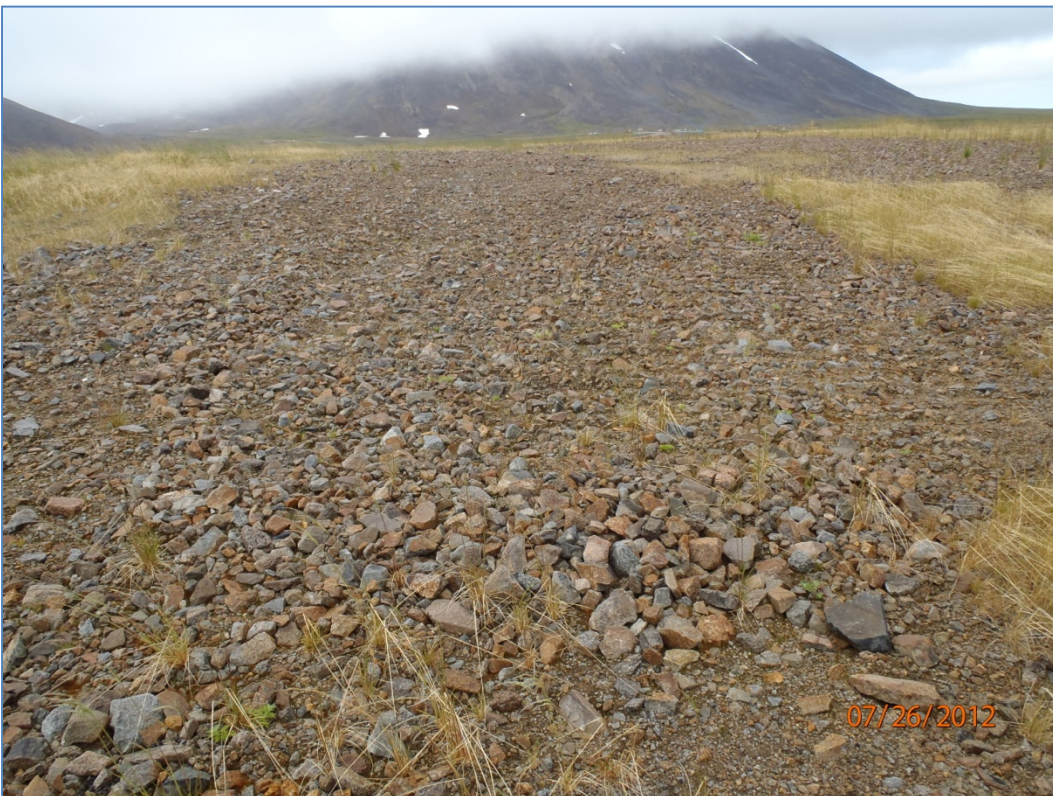
Photo 2: Site 7 Landfill – View of landfill cap from north side, facing southwest.

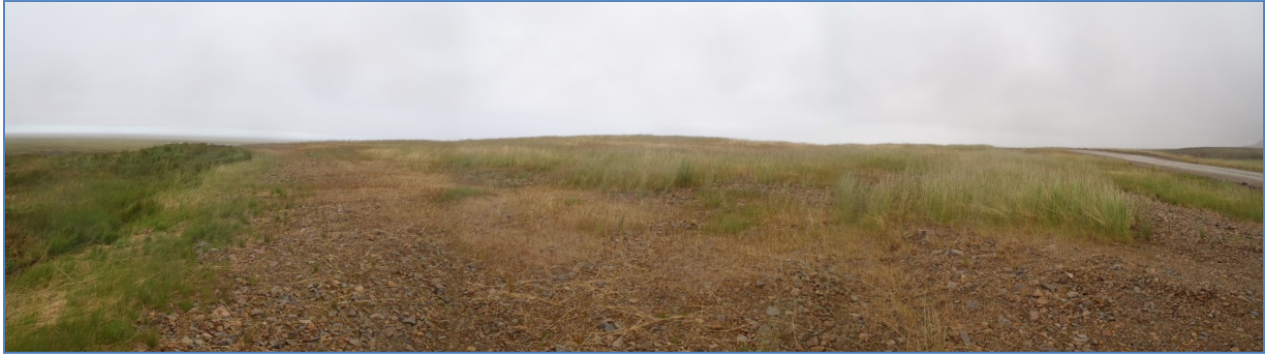
Photo 3: Site 7 Landfill – Panorama view from south side of landfill, facing north, road on right.

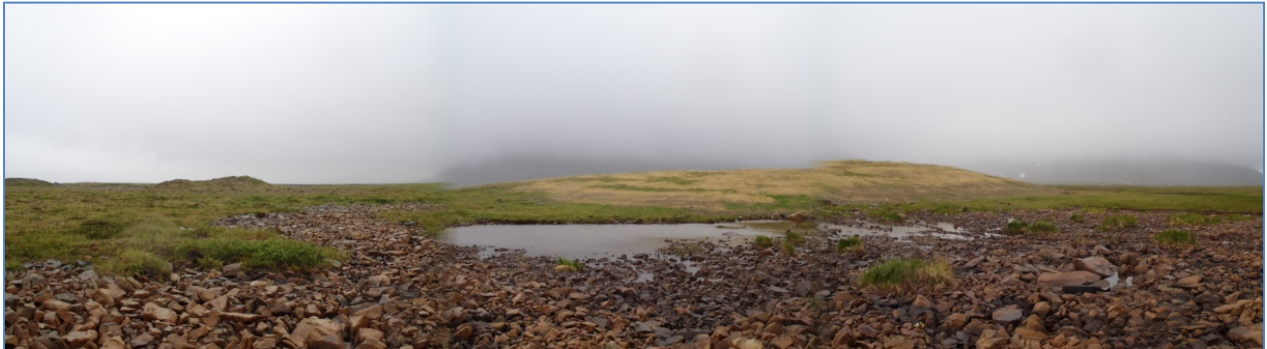
Photo 4: Site 7 Landfill – View of landfill cap, facing east.

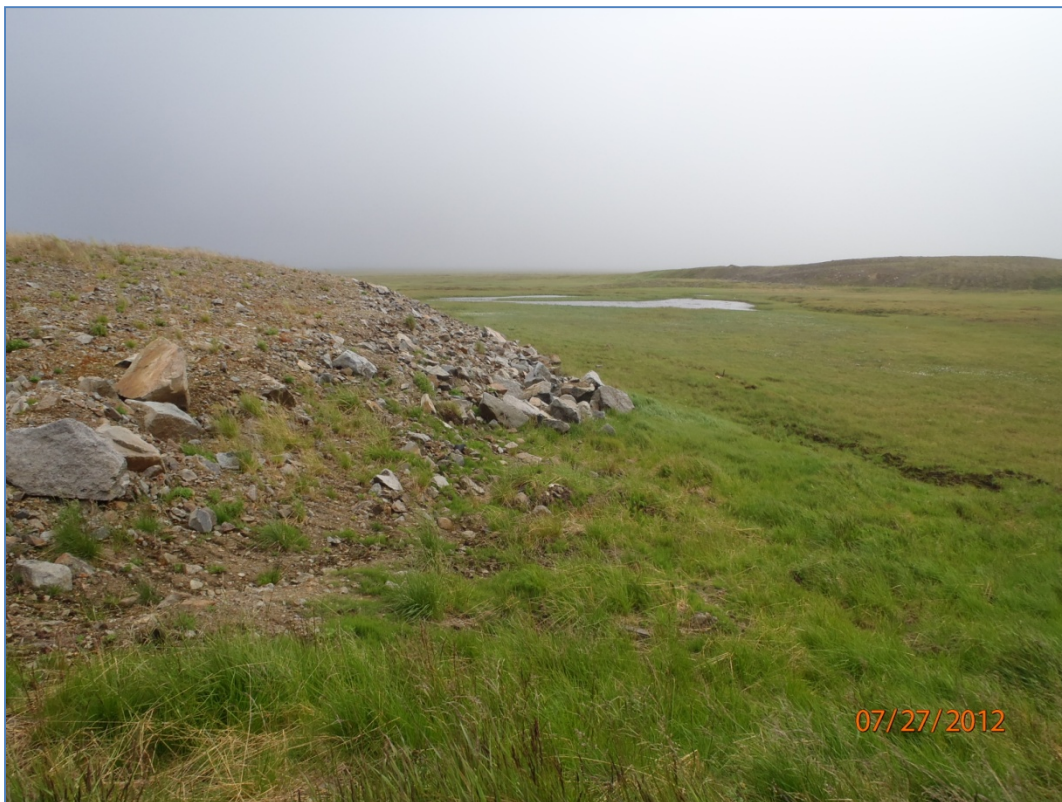
Photo 5: Site 7 Landfill – East side of landfill, facing northeast.

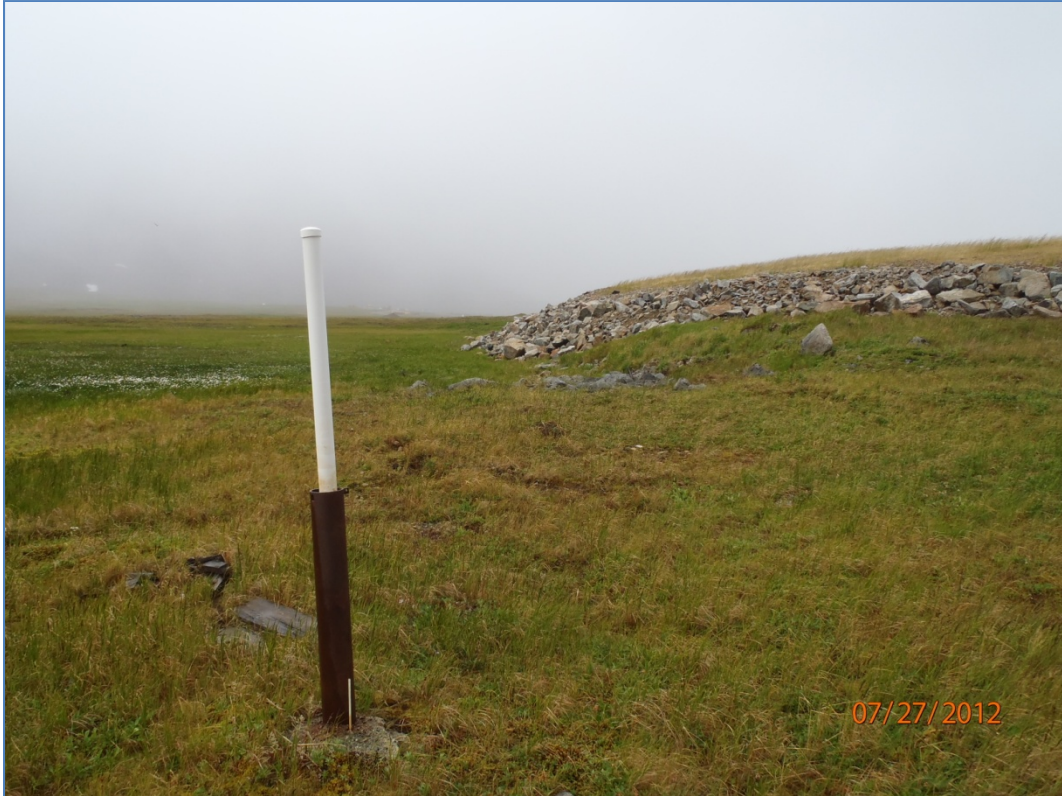
Photo 6: Site 7 Landfill – East side of landfill, facing south.

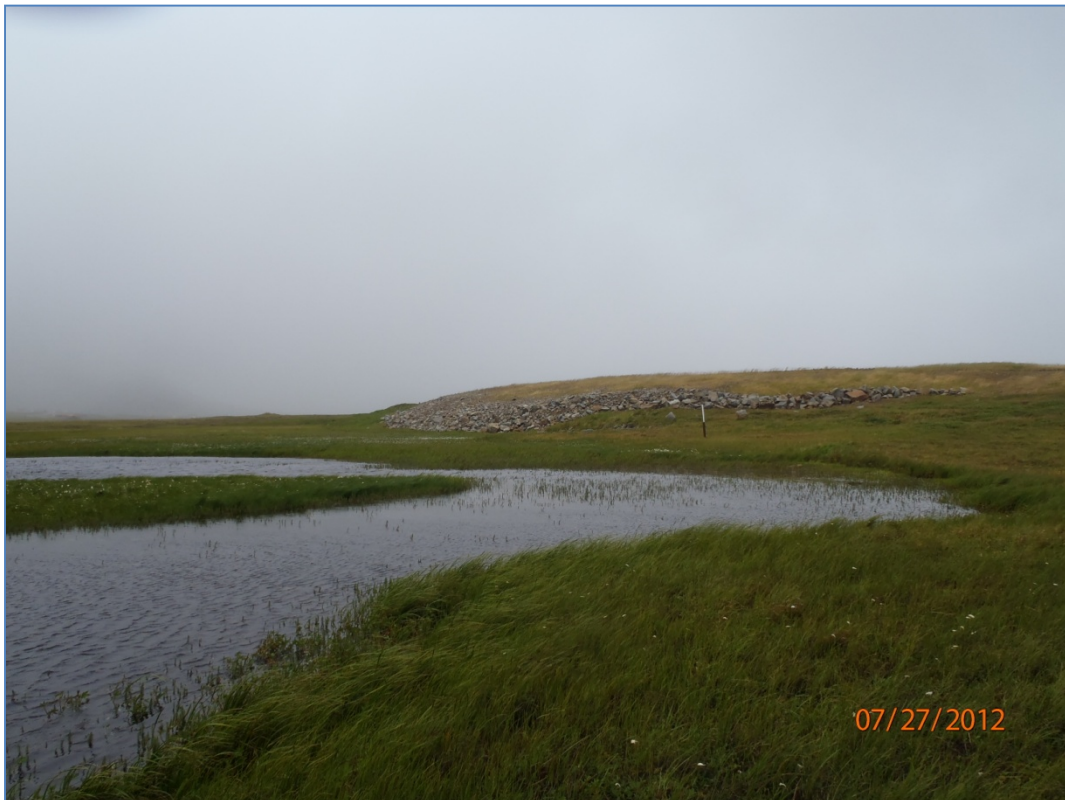
Photo 7: Site 7 Landfill – East side of landfill, facing southwest.

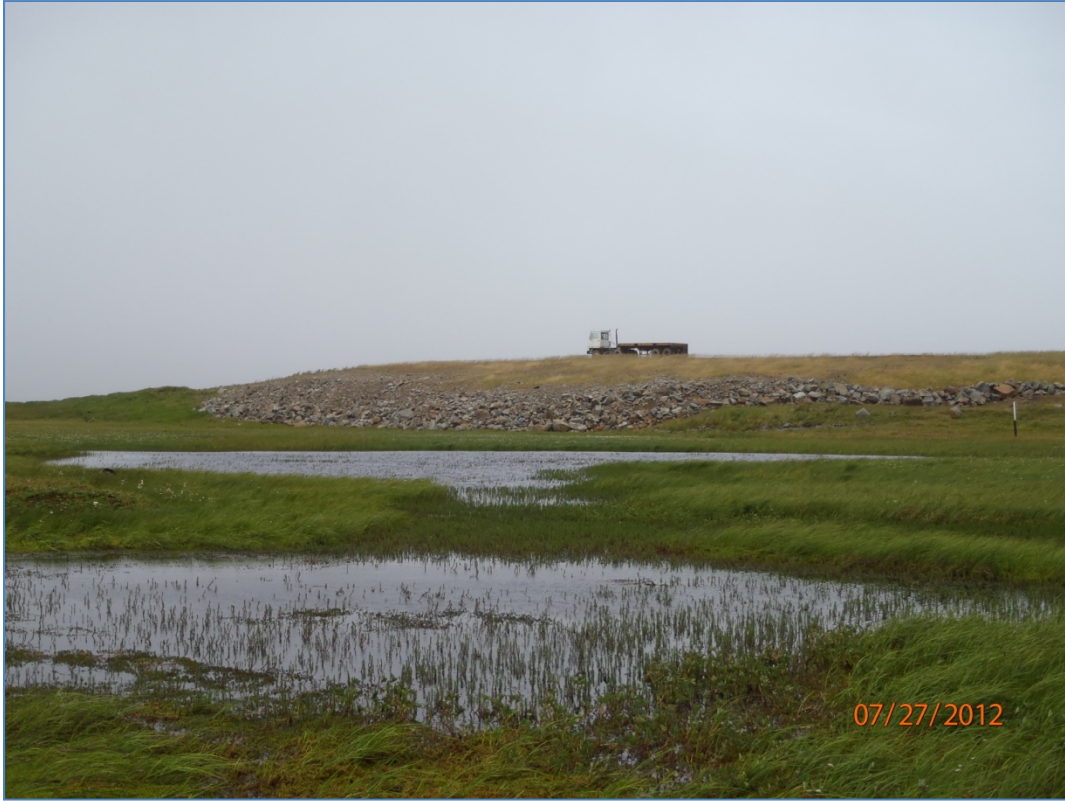
Photo 8: Site 7 Landfill – East side of landfill, facing west.

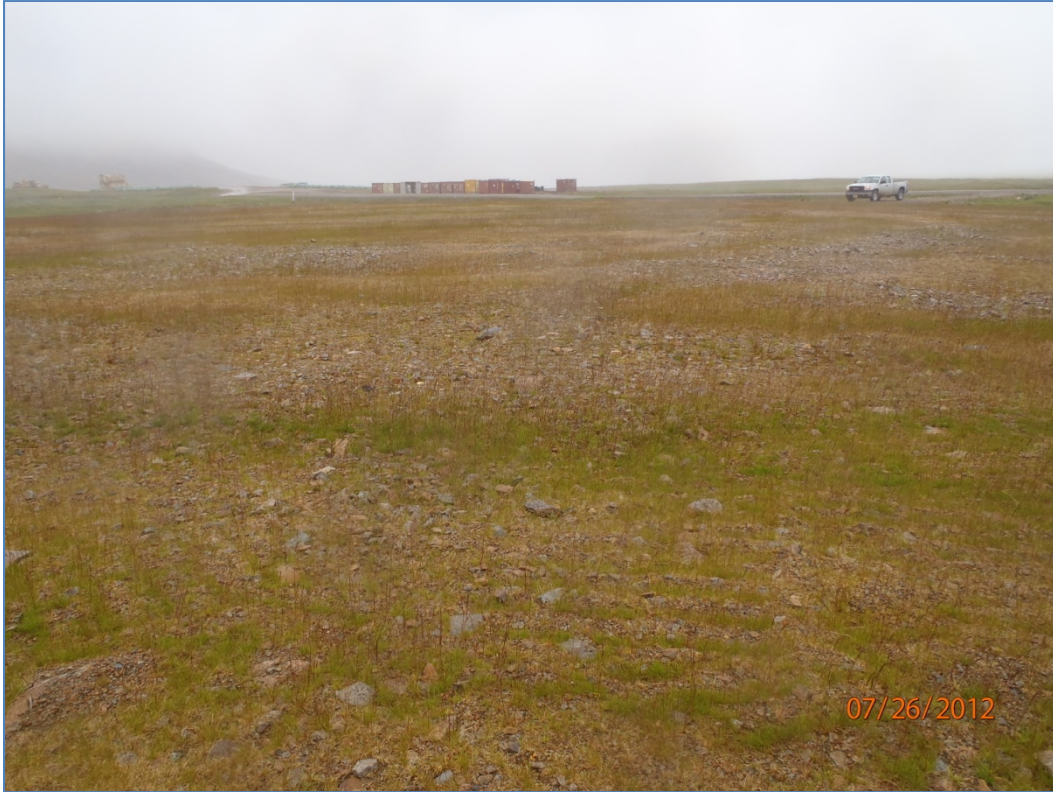
Photo 9: Site 9 Landfill – View of landfill cap surface, facing west with MOC in background.

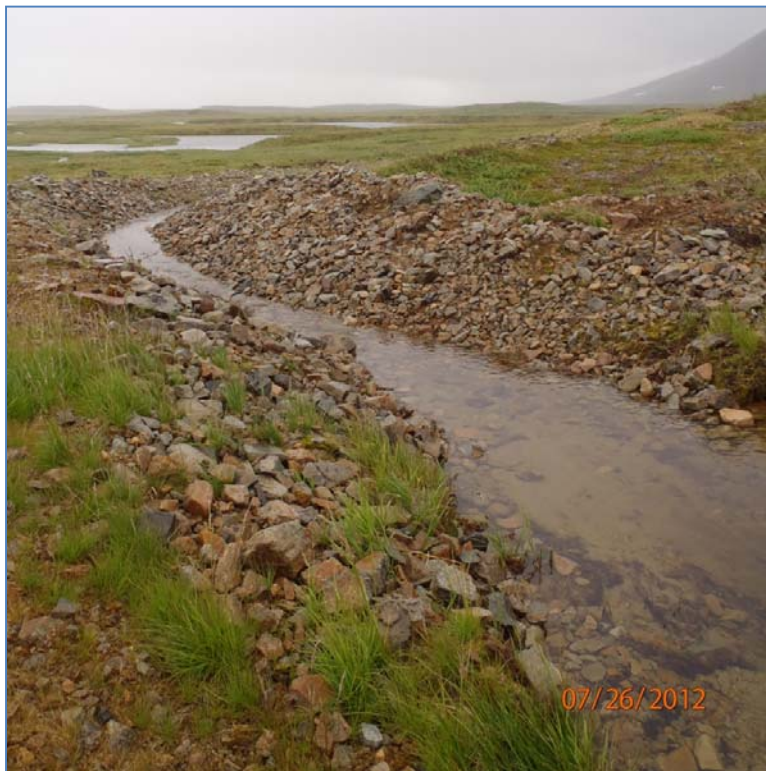
Photo 10: Site 9 Landfill – Pond outlet ditch in good condition and operating efficiently, facing northeast.

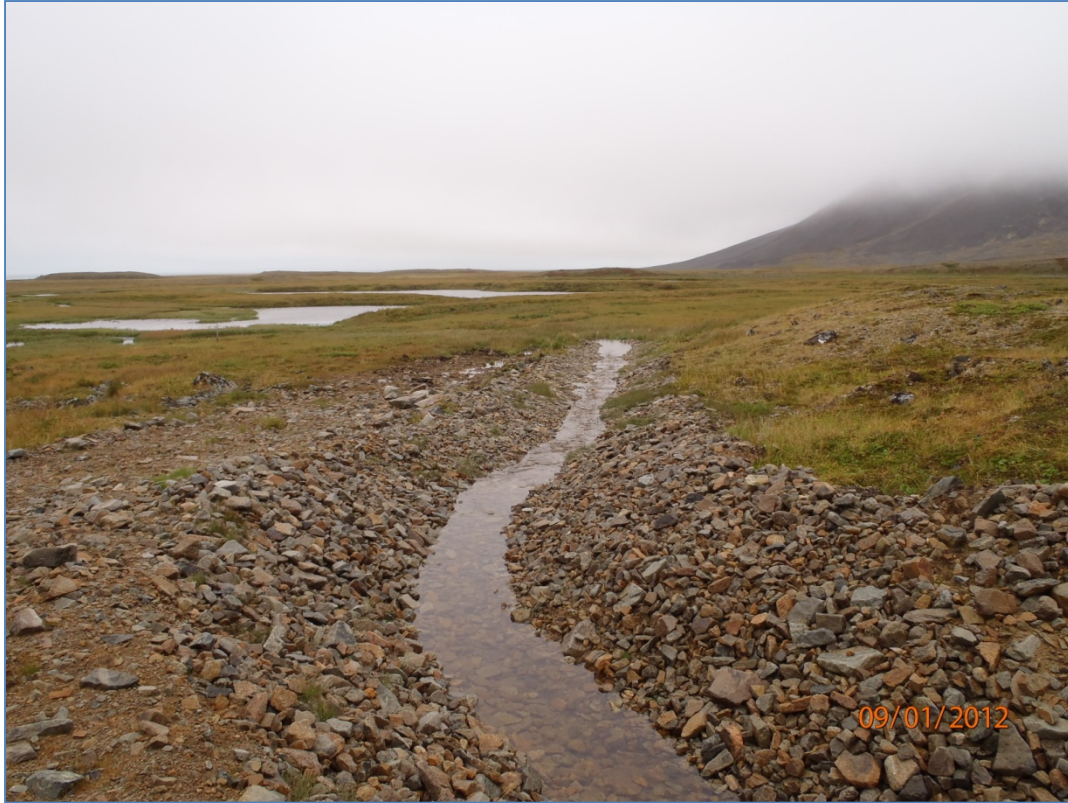
Photo 11: Site 9 Landfill – Diversion ditch in good condition, facing northeast.

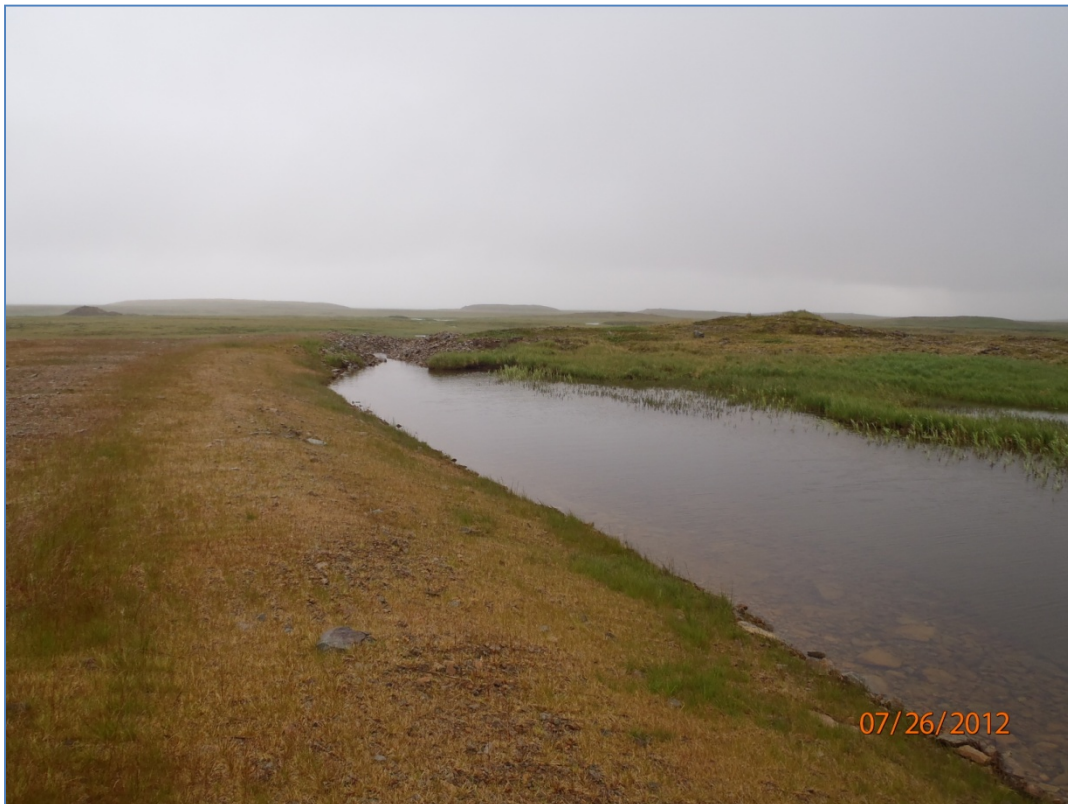
Photo 12: Site 9 Landfill – Northeast side of landfill and adjacent pond, facing northwest.

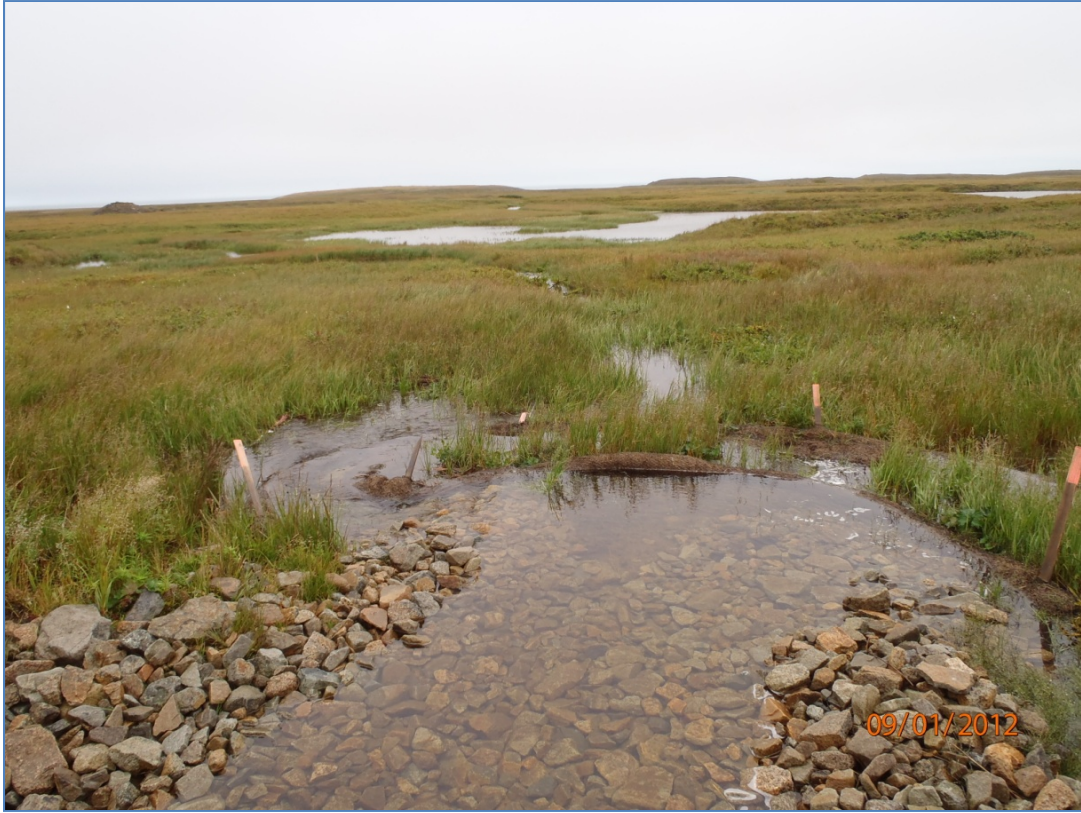
Photo 13: Site 9 Landfill – Diversion ditch outfall area into wetland, facing north.

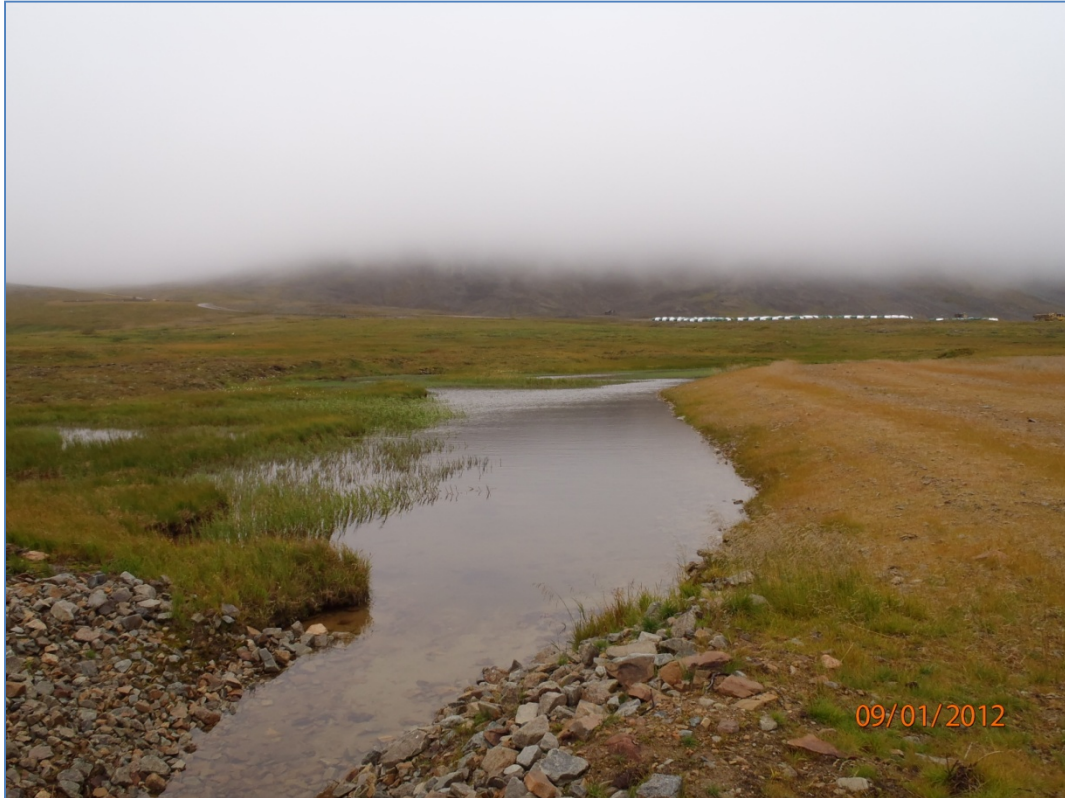
Photo 14: Site 9 Landfill – East side of landfill and adjacent pond, facing southwest.

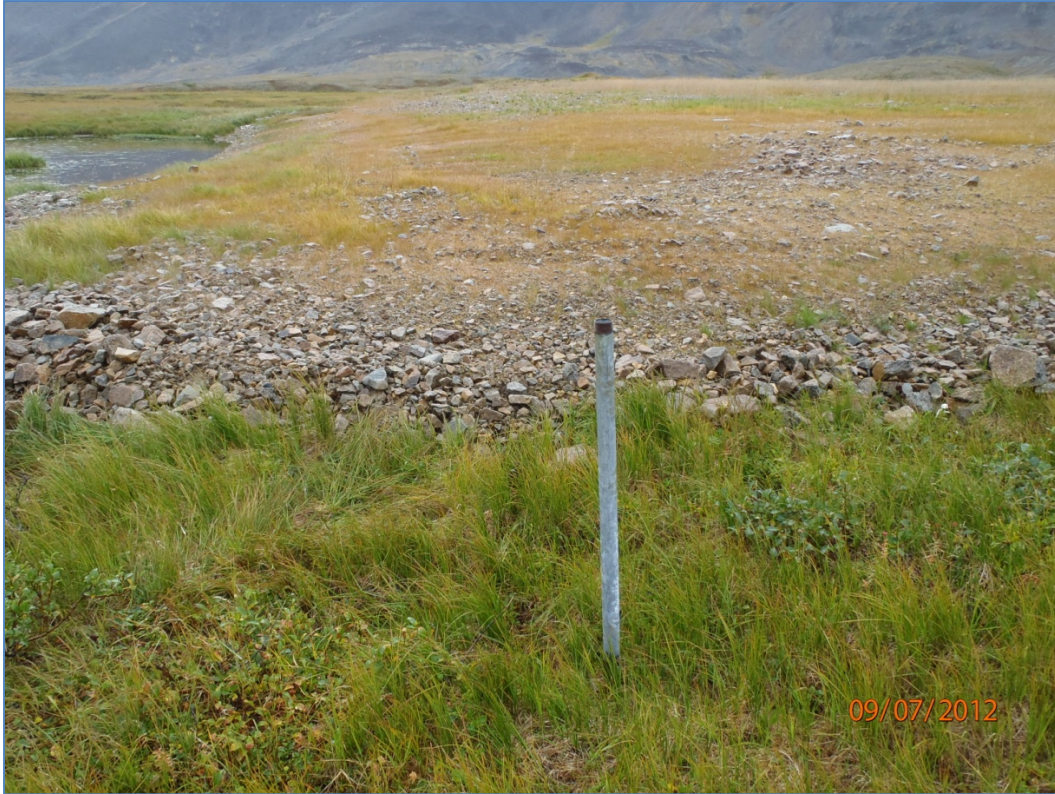
Photo 15: Site 9 Landfill – Drive point well on east corner of landfill (removed in 2012) facing southwest.

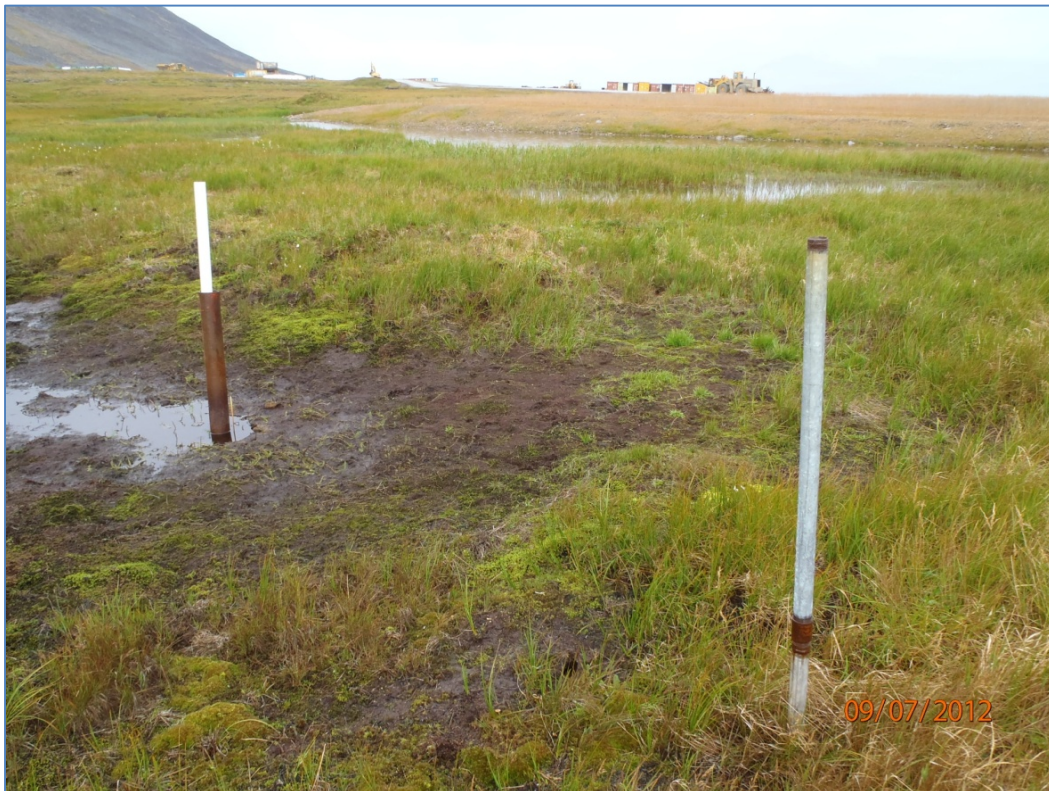
Photo 16: Site 9 Landfill – Drive point well (removed in 2012) and PVC monitoring well on east side of landfill, facing west.
