Visual Inspection Checklist (Post-Closure) Site 7 Landfill

This form is to be filled out annually for 5 years after landfill closure.

Name of Inspector: Jeremy Craver Date: 3 Aug 2014
 Weather conditions: Sunny w/ few clouds Precipitation Yes No
 Temperature: 65°F Prevailing Wind Direction: SW Speed: 5 mph
 Photographs Taken: YES

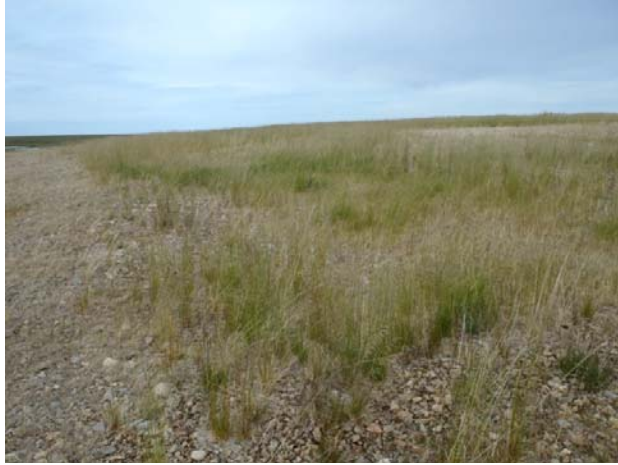
Photo 1: View of upper SW side of landfill cap, facing NW.

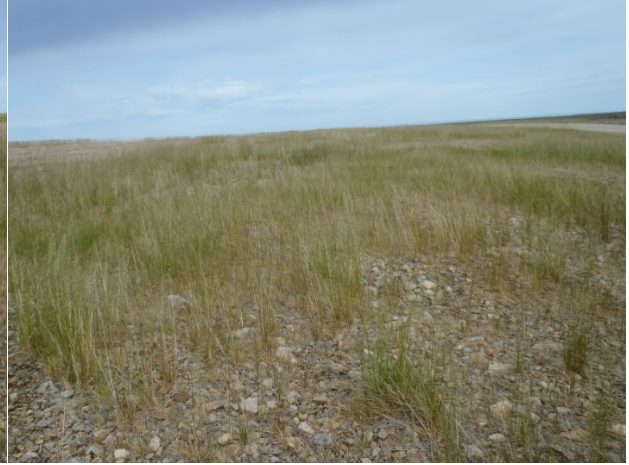
Photo 2: View of top of landfill cap, facing north.

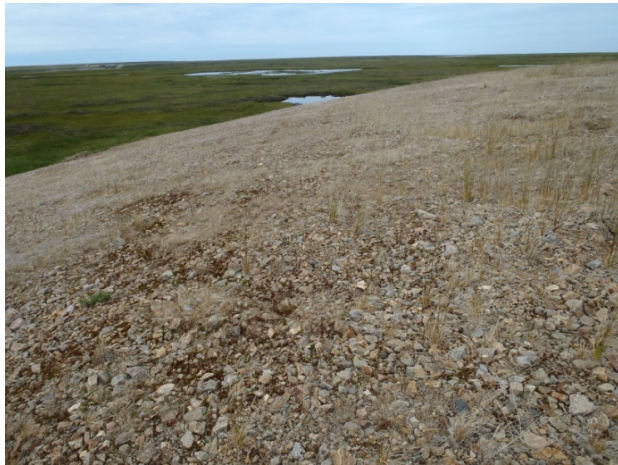
Photo 3: West side of cap, facing NW.

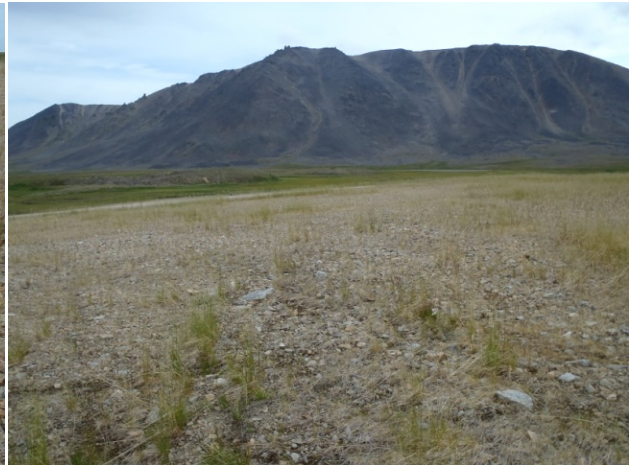
Photo 4: Northern side of top cap, facing east.

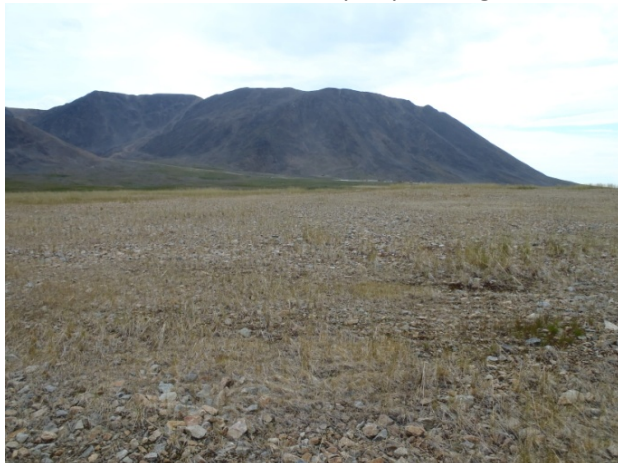
Photo 5: Eastern side of top cap, facing south toward MOC (in background).

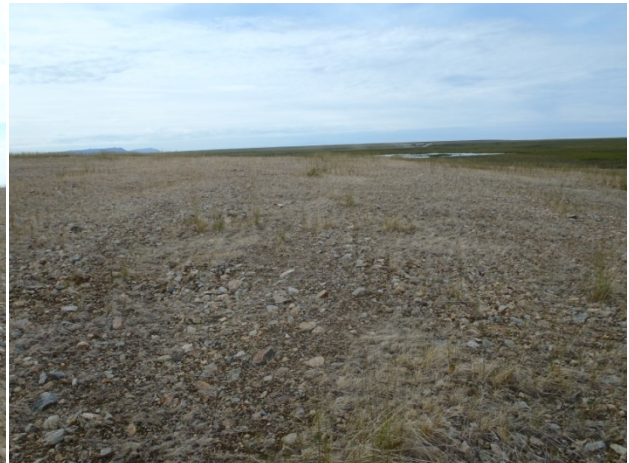
Photo 6: Western side of top cap, facing SW toward MOC (in background).

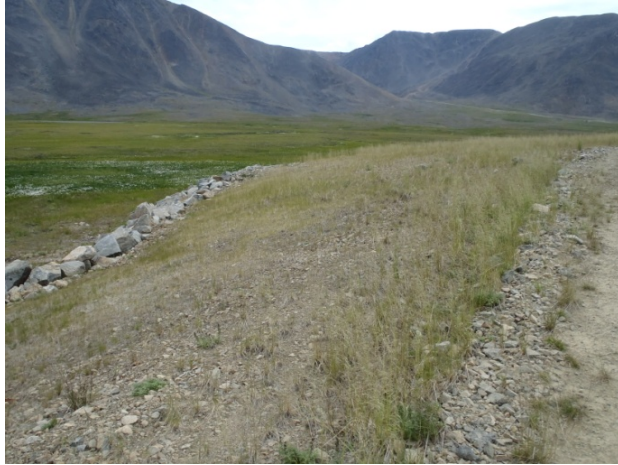
Photo 7: East side of cap, east side of road, facing SW. Road to right of photo.

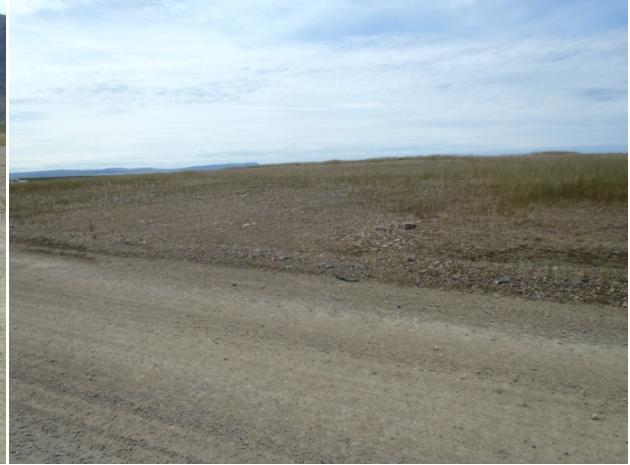
Photo 8: Road in foreground, west side of cap in background, facing west.

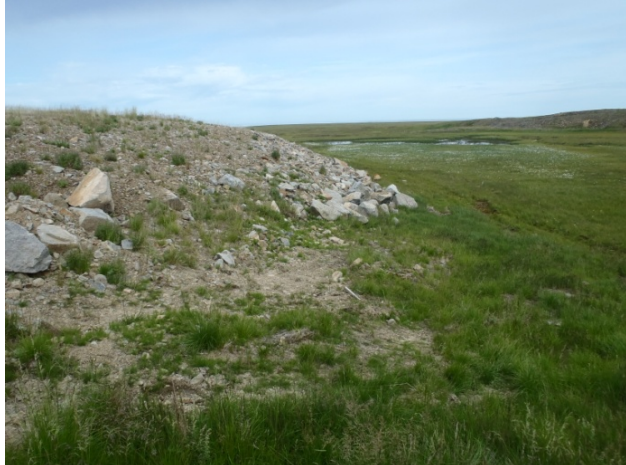
Photo 9: East side of cap, east side of road, toe of slope facing north.

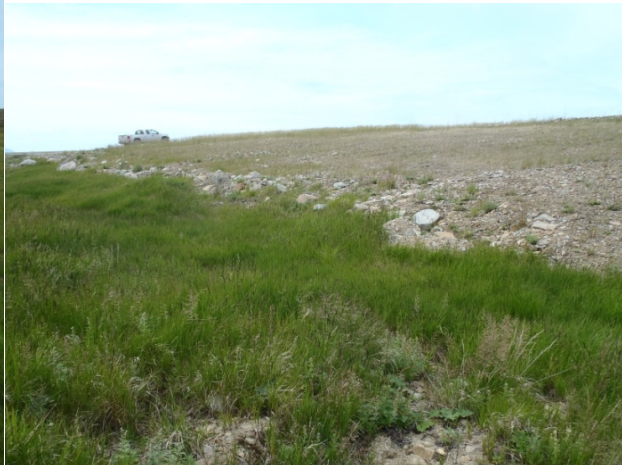
Photo 10: East side of cap, east side of road, south side facing west.

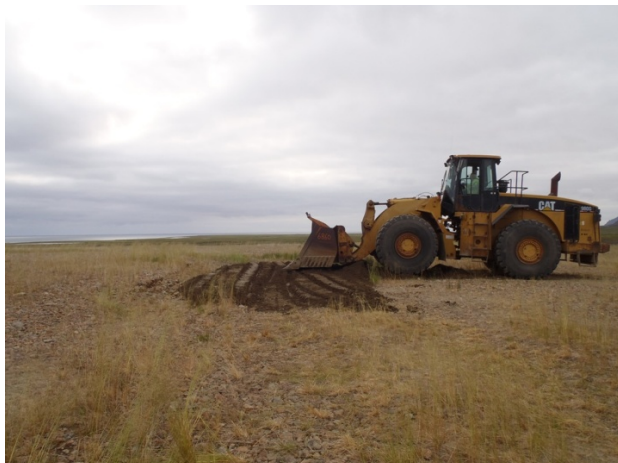
Photo 11: Cap maintenance: A depression near the top of the cap on the west side of the road was filled with clean fine-grained material from the borrow area, compacted, fertilized, and seeded, facing NW.

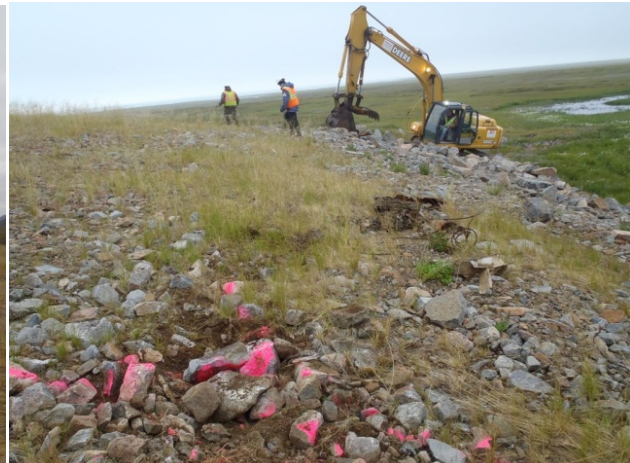
Photo 12: Cap maintenance: Surface debris, mostly metal and cable, was removed primarily from the landfill cap on the east side of the road. Photo shows workers and an excavator removing only visible surface debris, facing NW.

General Comments: Structural integrity of landfill cap = great condition. Contractor plans to remove debris by hand and cap any with 2' gravel that can't be removed by hand.
