# **U.S. Army Corps of Engineers Alaska District**

## **FIRST FIVE-YEAR REVIEW REPORT**

### **NORTHEAST CAPE FUDS ST. LAWRENCE ISLAND, ALASKA**

**FINAL  
FEBRUARY 2015**

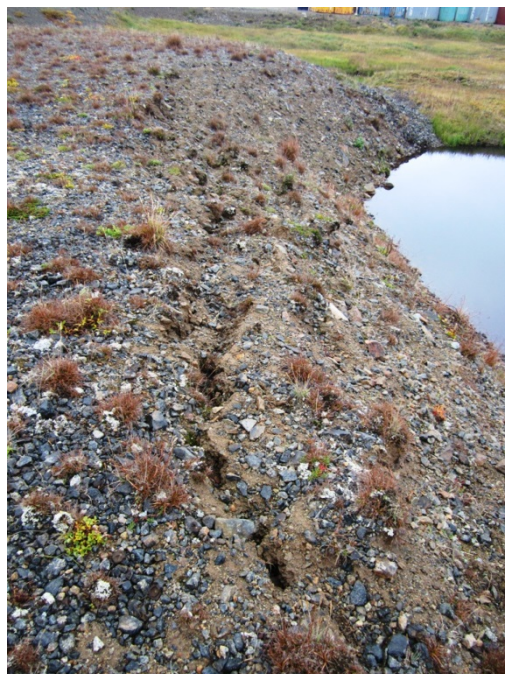
**Photo No. 5 – 14 September 2013  
Cracking along the border of the runway at Site 1. View facing east.**

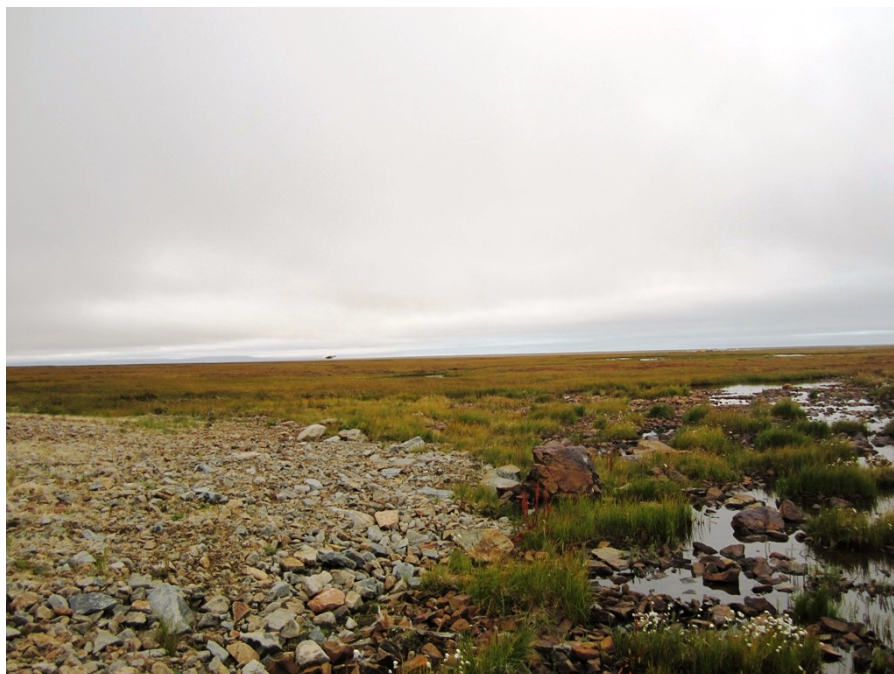
**Photo No. 25 – 13 September 2013**  
**Condition of northern edge of landfill cap at Site 7. View facing west.**

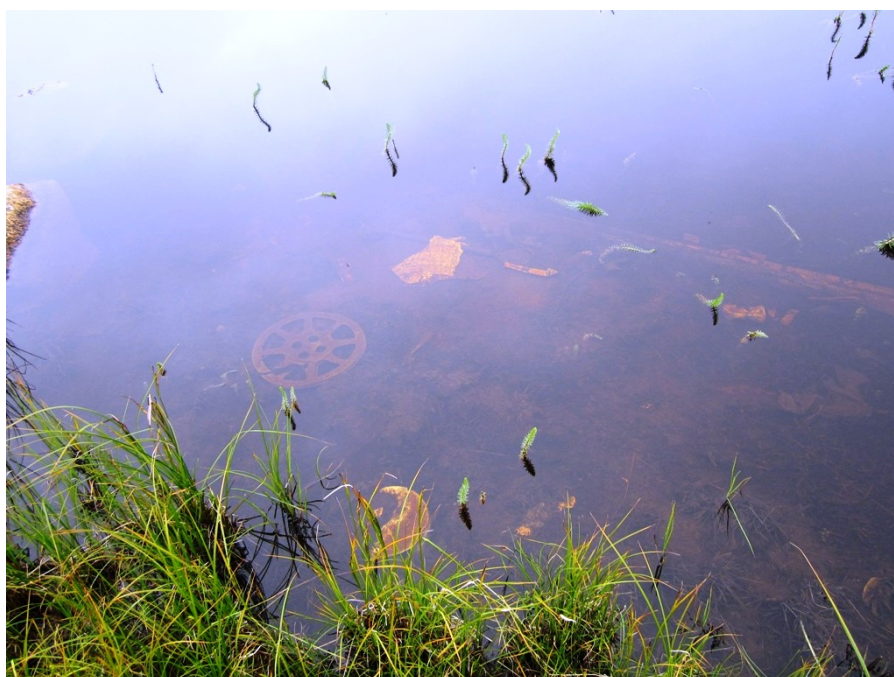
**Photo No. 26 – 13 September 2013**  
**Miscellaneous debris in pond adjacent to landfill cap at Site 7. View facing north.**

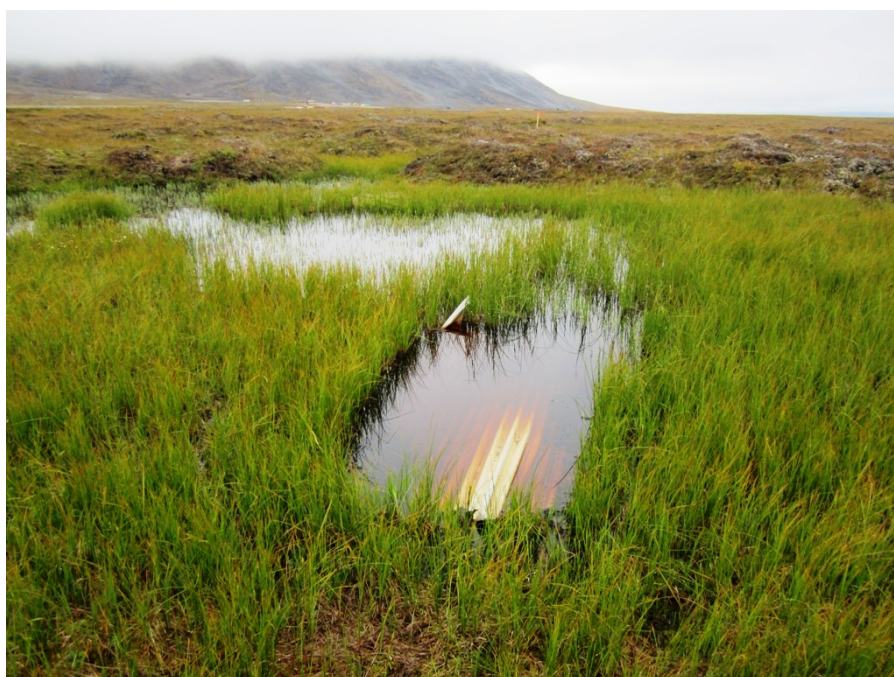
**Photo No. 28 – 13 September 2013**  
**Metal debris in pond adjacent to landfill cap at Site 7. View facing north.**

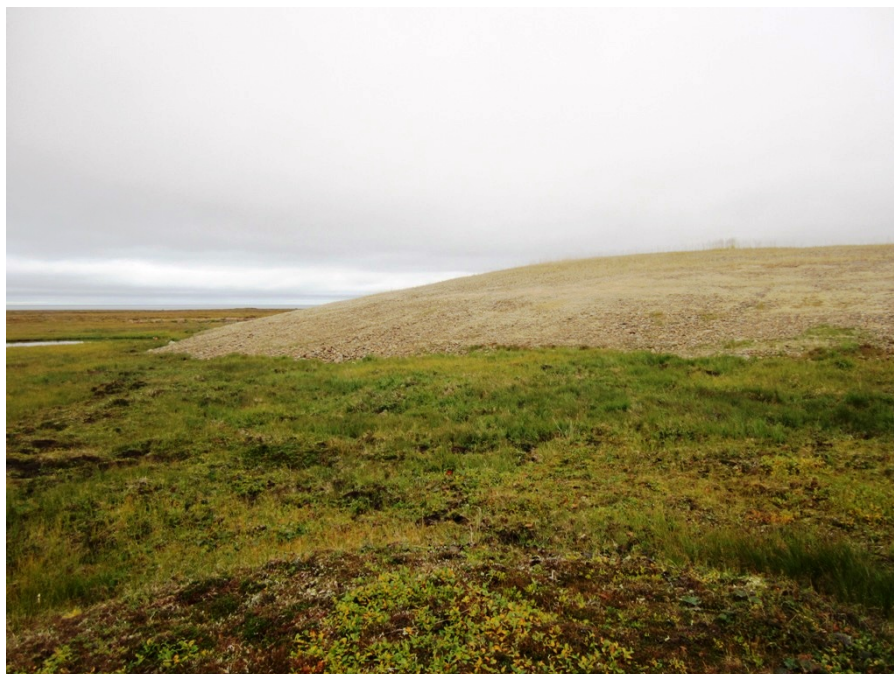
**Photo No. 29 – 13 September 2013**  
**Condition of northern edge of the landfill cap at Site 7. View facing west.**

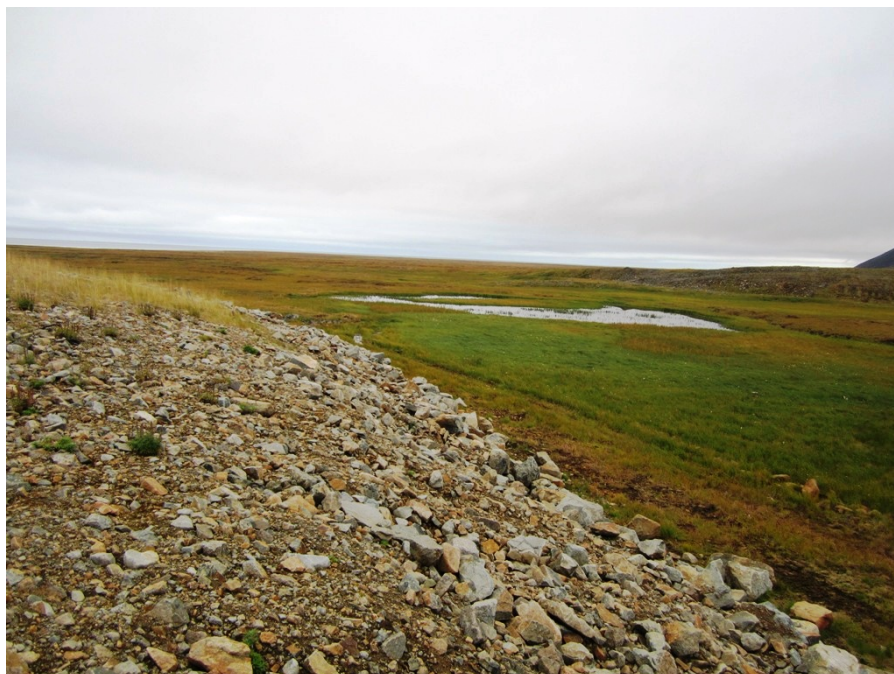
**Photo No. 31 – 13 September 2013**  
**Condition of armored rock on the southern border of the landfill cap at Site 7. View facing east.**

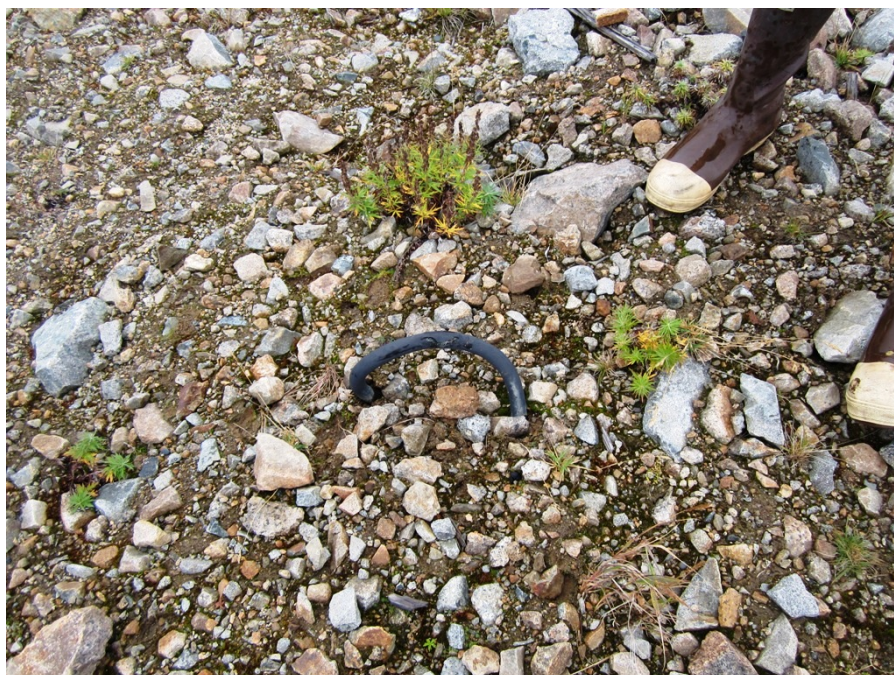
**Photo No. 32 – 13 September 2013**  
**Debris protruding through the southern side of the landfill cap at Site 7.**

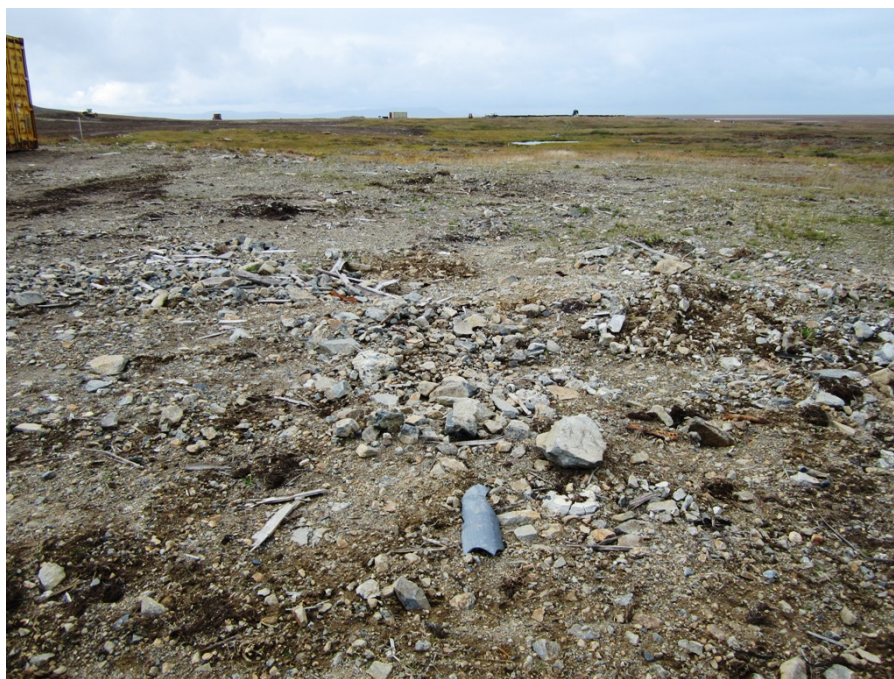
**Photo No. 52 – 14 September 2013  
Miscellaneous debris at Site 10. View facing west.**

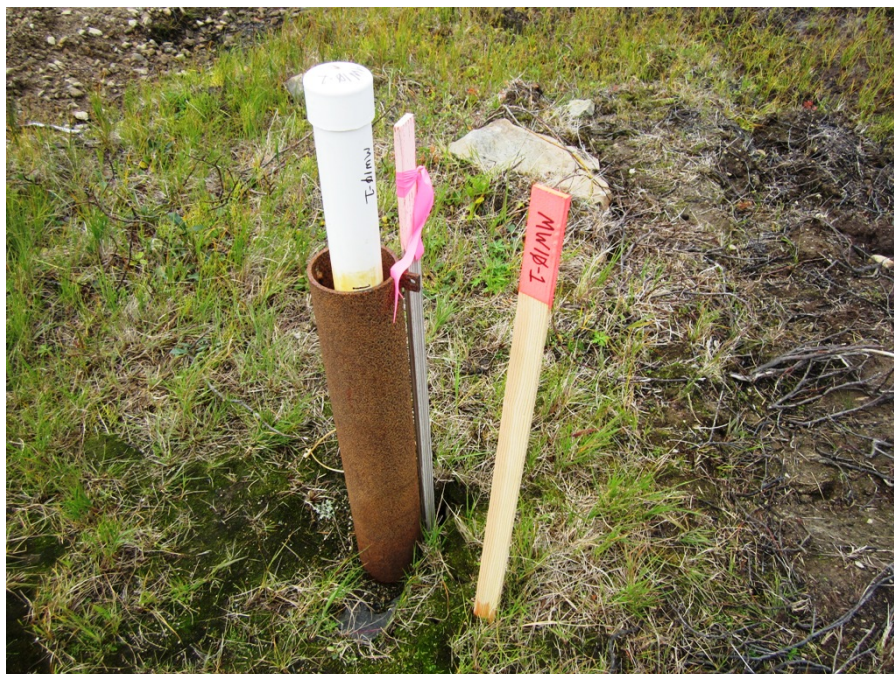
**Photo No. 53 – 14 September 2013  
Existing non-secured, frost-jacked monitoring well at Site 10.**

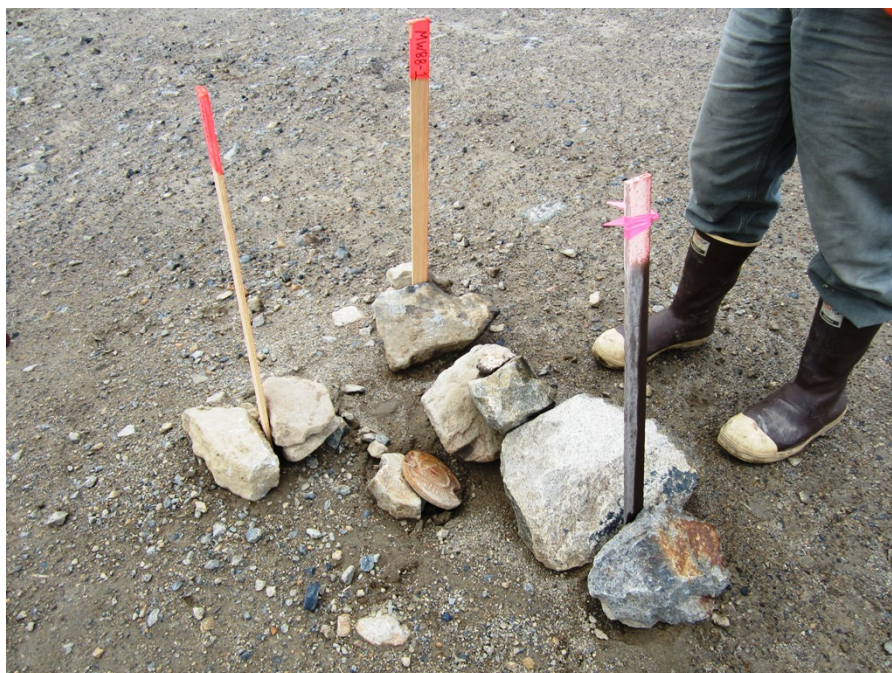
**Photo No. 72 – 15 September 2013  
Existing non-secured, frost-jacked monitoring well at Site 19. View facing north.**

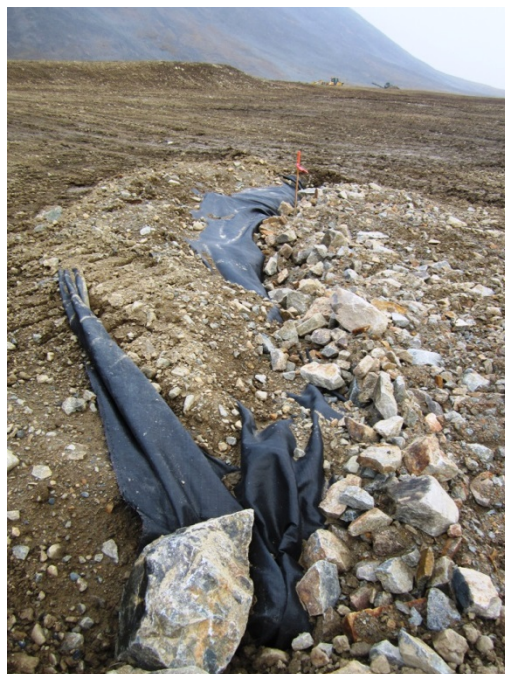
**Photo No. 73 – 15 September 2013  
Exposed geotextile liner identified at Site 19. View facing west.**

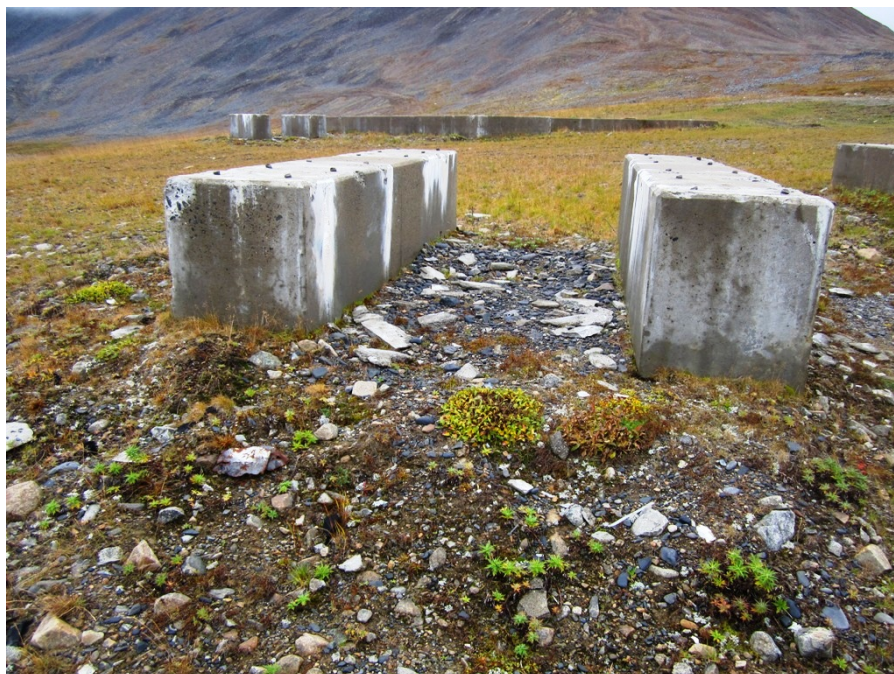
**Photo No. 111 – 13 September 2013  
Miscellaneous debris at Site 31. View facing east.**
