Visual Inspection Checklist (Post-Closure) Site 7 Landfill

Visual Inspection Checklist (Post-Closure) Site 9 Landfill

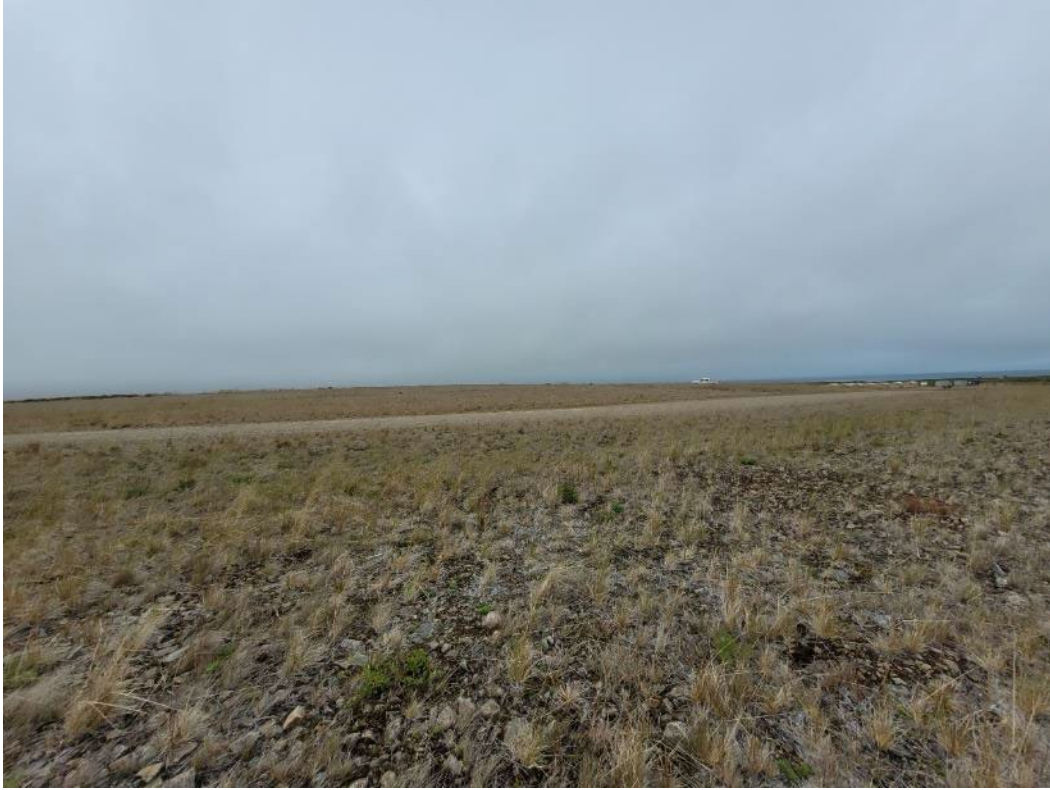
Photo 1: View of landfill looking NW from SE side of road that bisects landfill

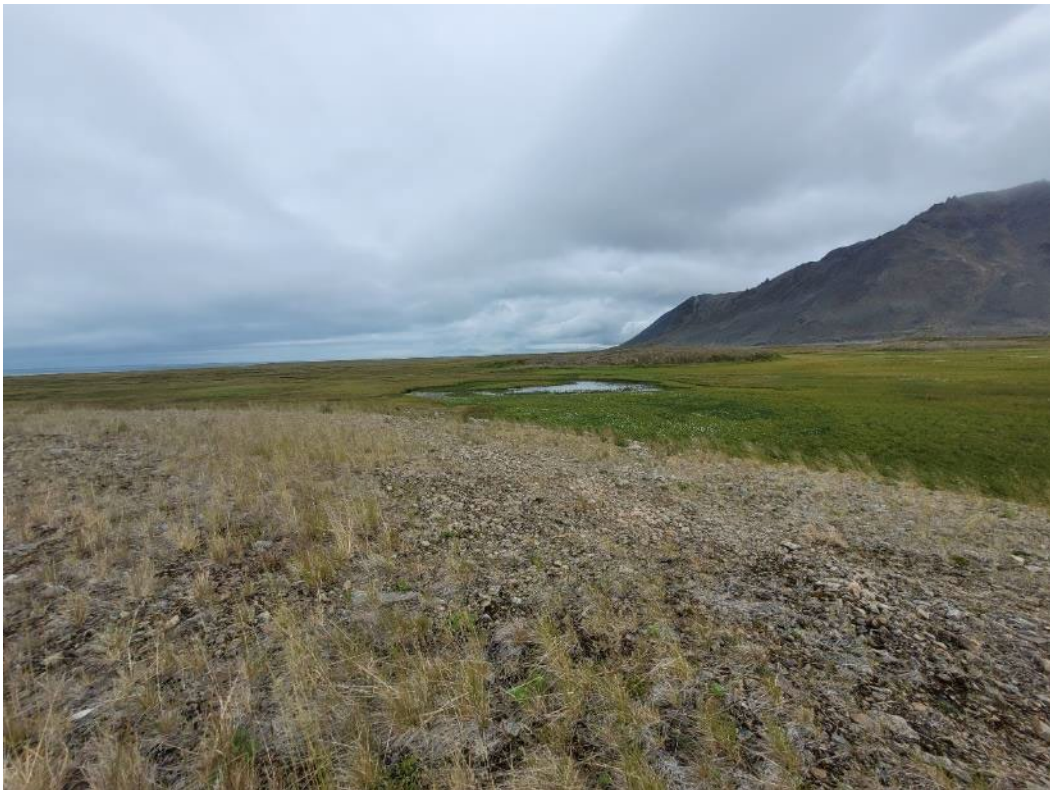
Photo 2: Looking SE from SE edge of landfill

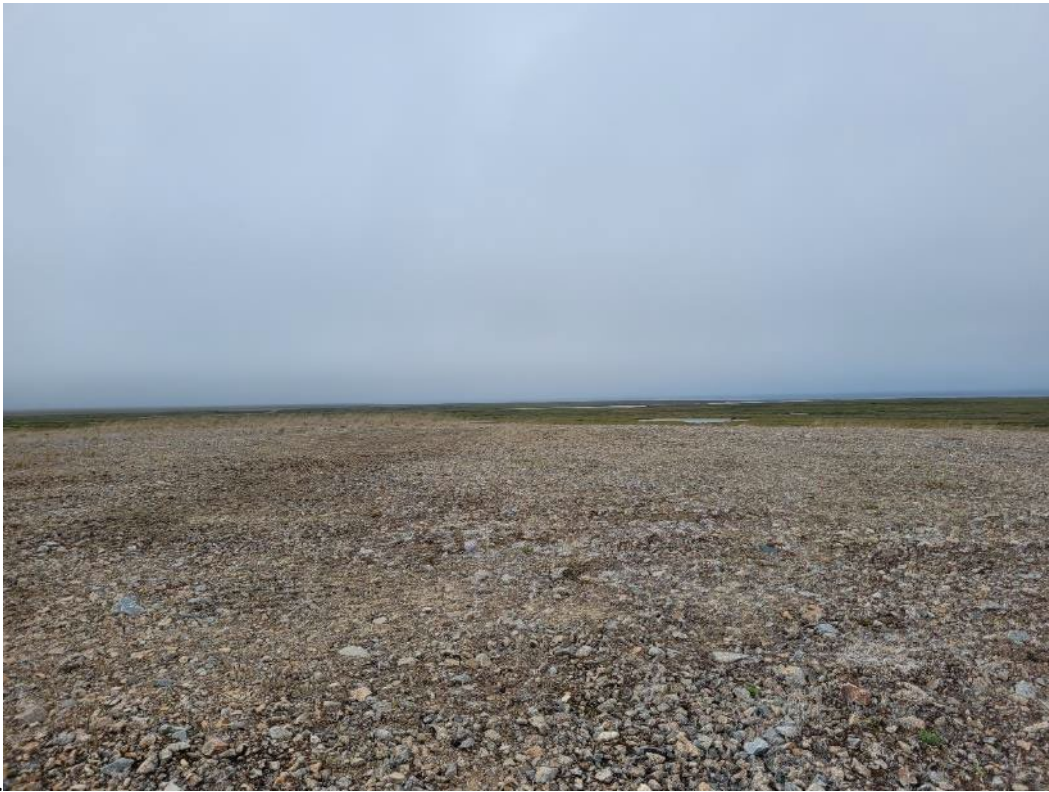
Photo 3: Looking NE from top of landfill cap

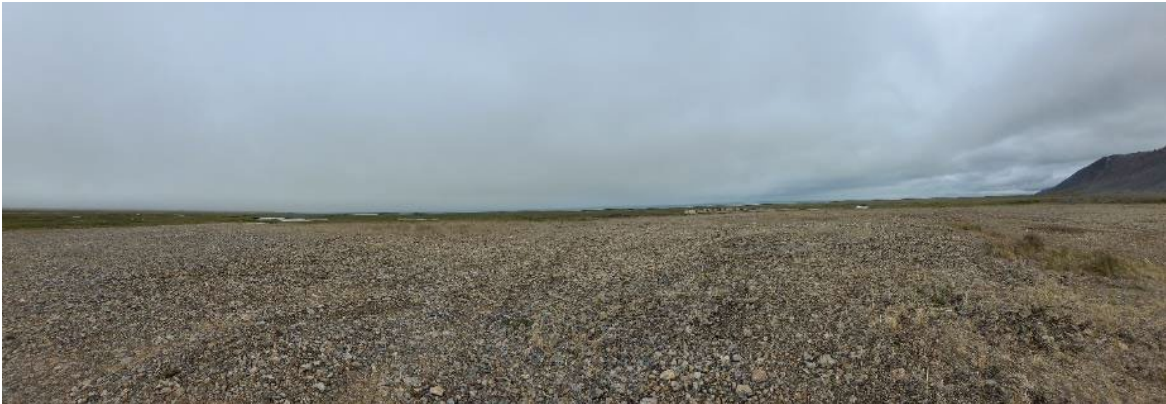
Photo 4: Looking N from top of landfill cap; camp in view

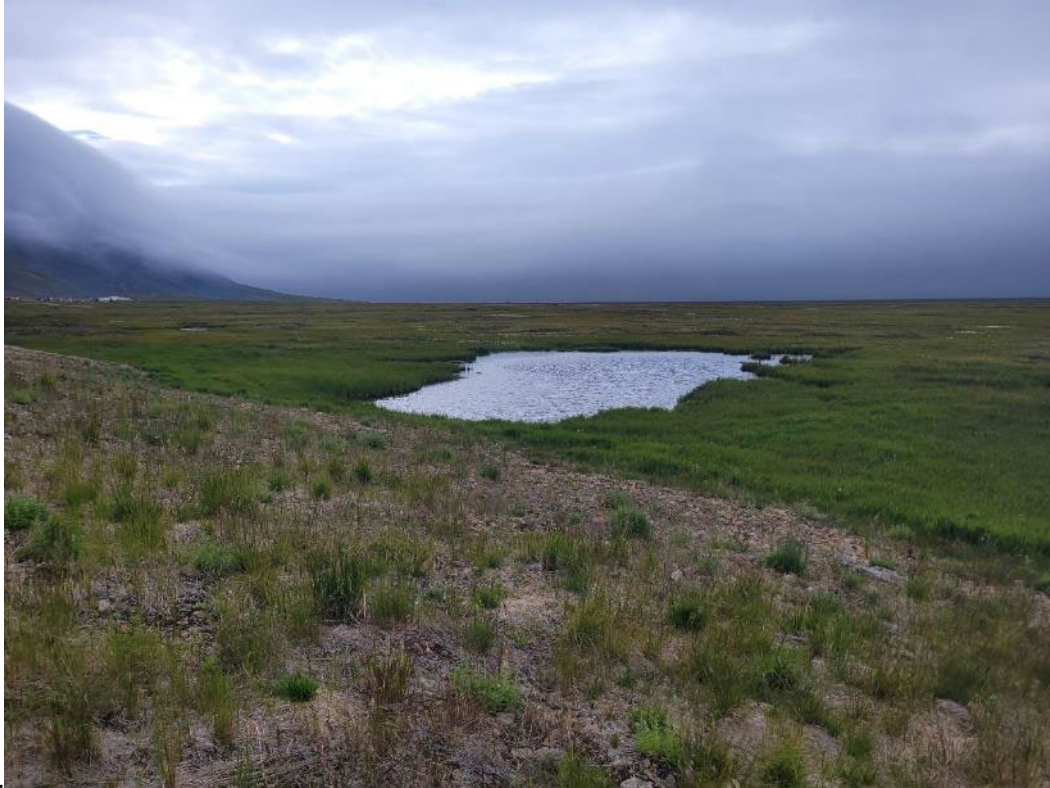
Photo 5: Looking SW at pond at toe of slope of landfill toward MOC

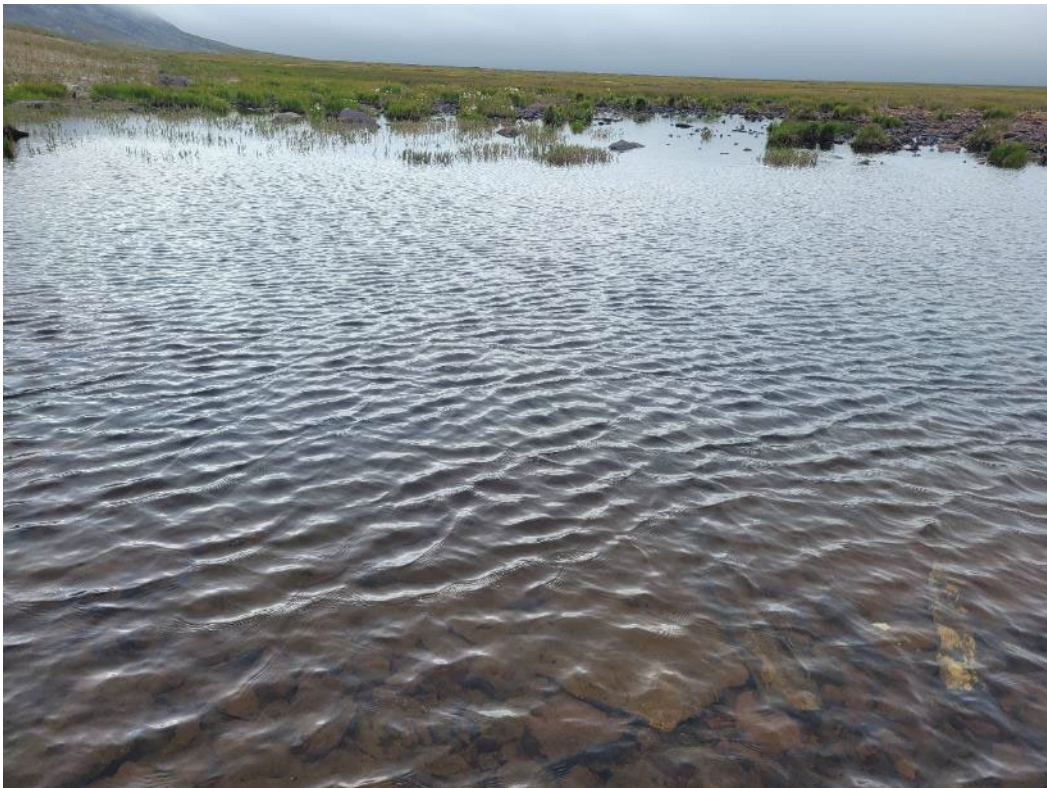
Photo 6: Looking S at pond adjacent to landfill cap; inert debris in water

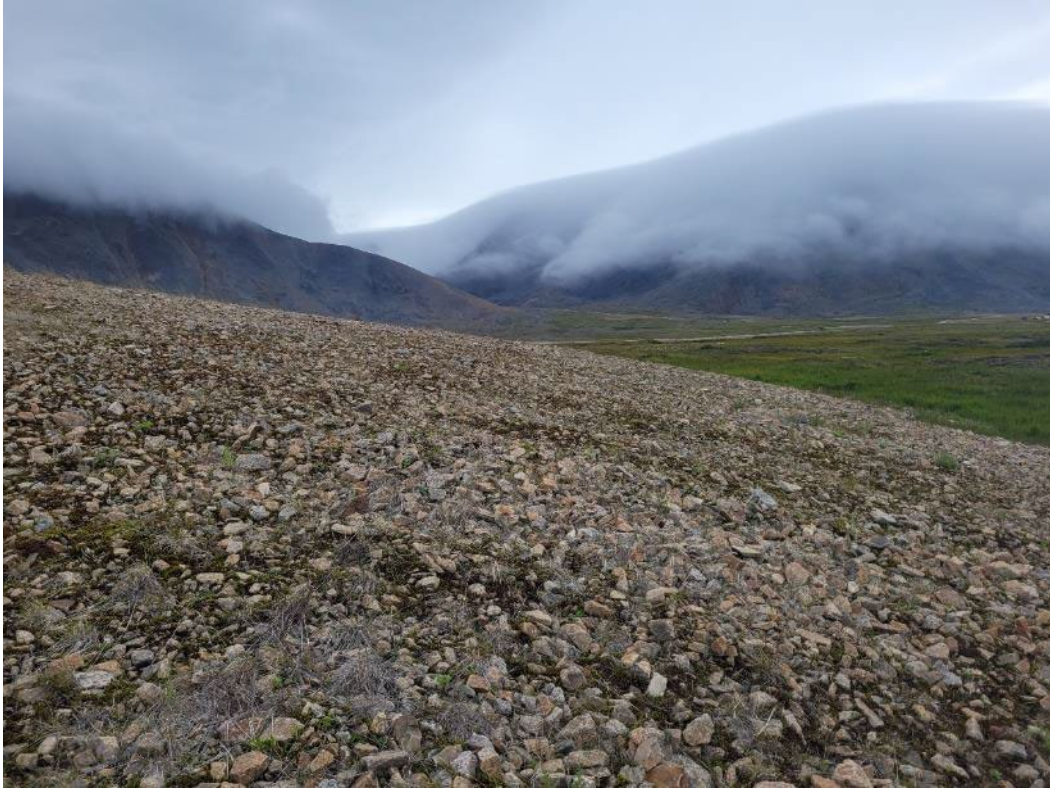
Photo7: Looking S/SW from west slope of landfill cap. View of Kinipaghulghat Mountains

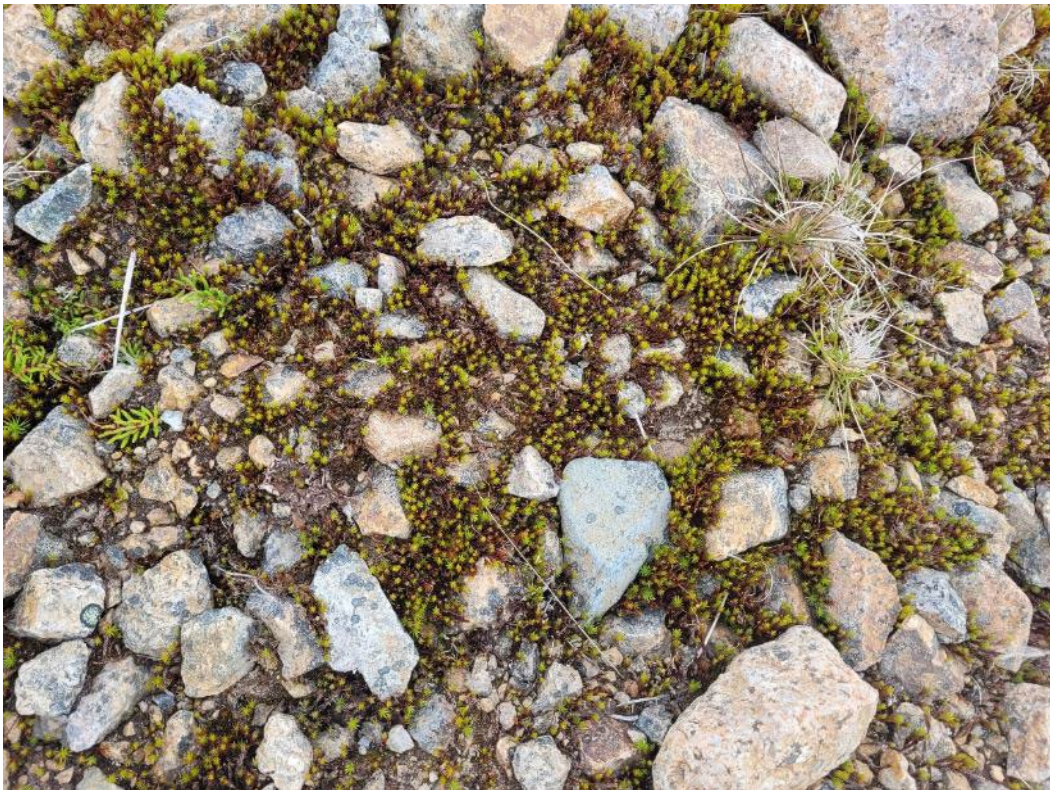
Photo 8: Close up view of vegetation on landfill cap

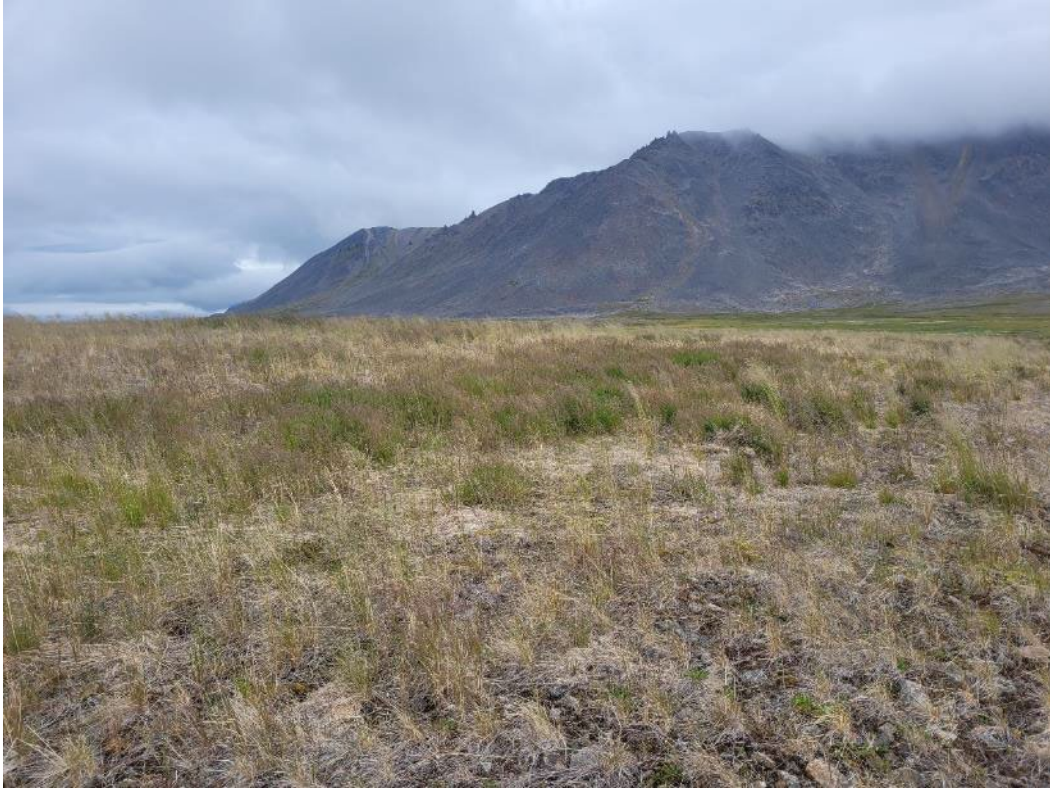
Photo 10: Vegetation growing on slope of landfill cap looking SE

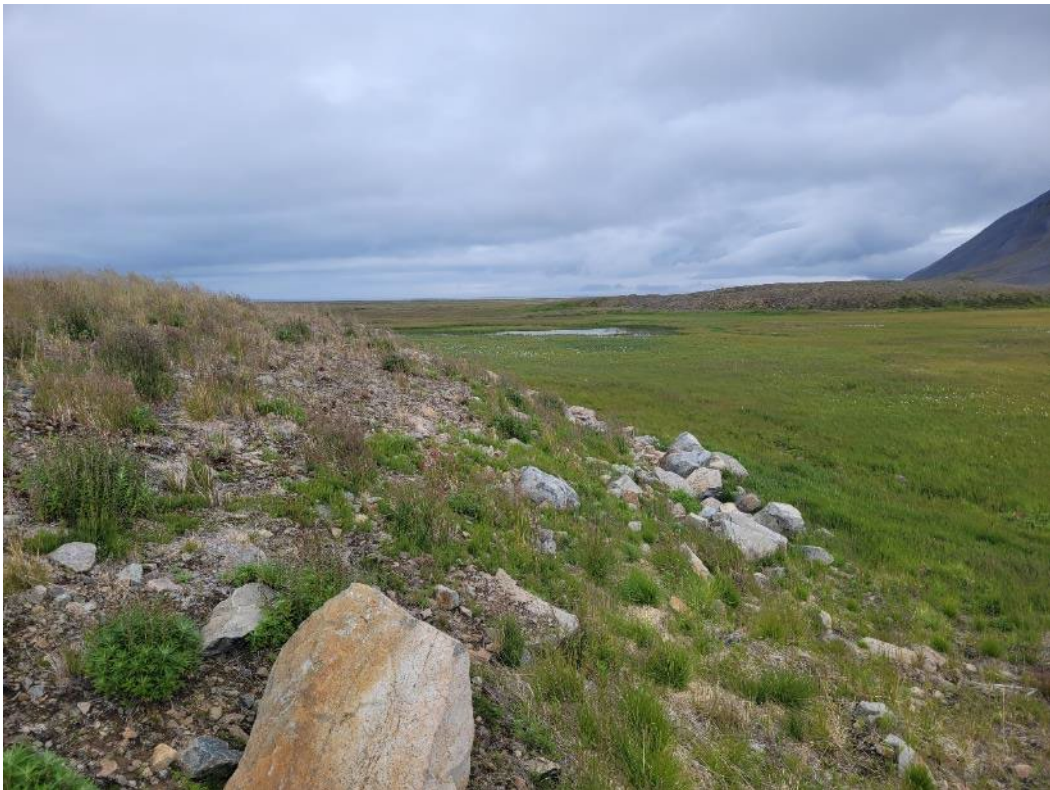
Photo 11: Vegetation growing on lower slope of landfill cap looking SE

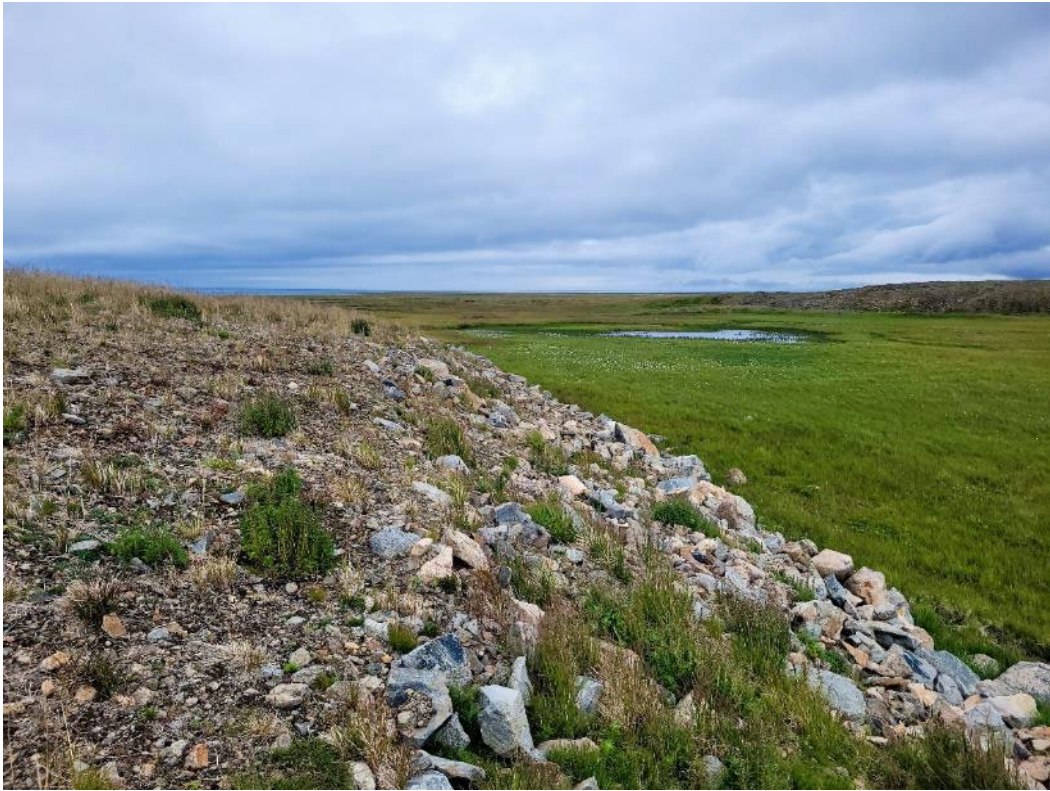
Photo 12: Vegetation growing on lower slope of landfill cap looking SE

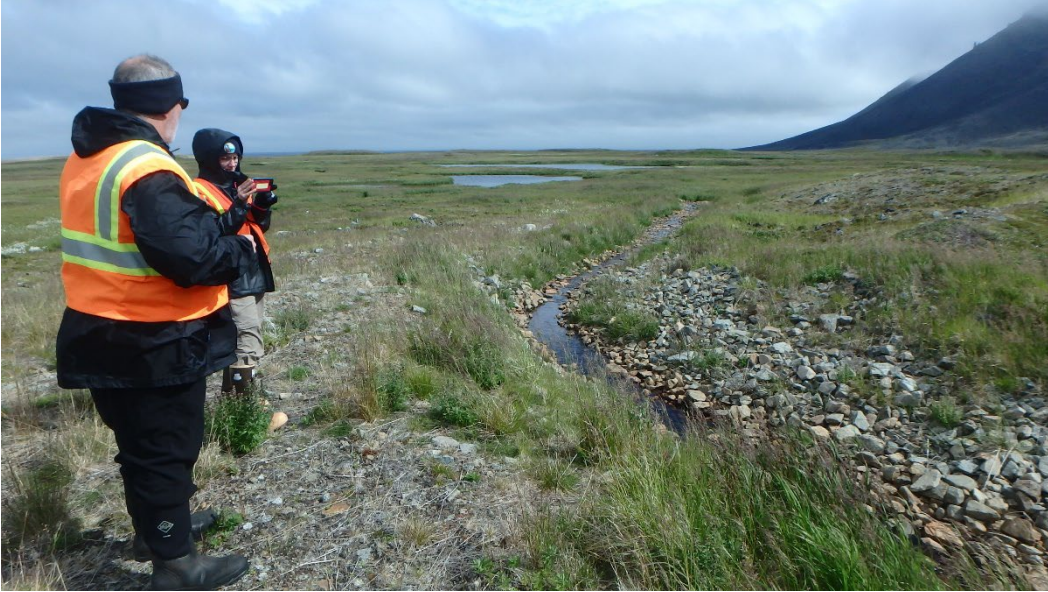
Photo 1: View toward the NE of diversion channel at north end of pond located southeast of Site 9 landfill cap with ADEC representatives in foreground
