TECHNICAL MEMORANDUM

Re: Request for Site 7 Landfill Closure at Northeast Cape, St. Lawrence Island, Alaska

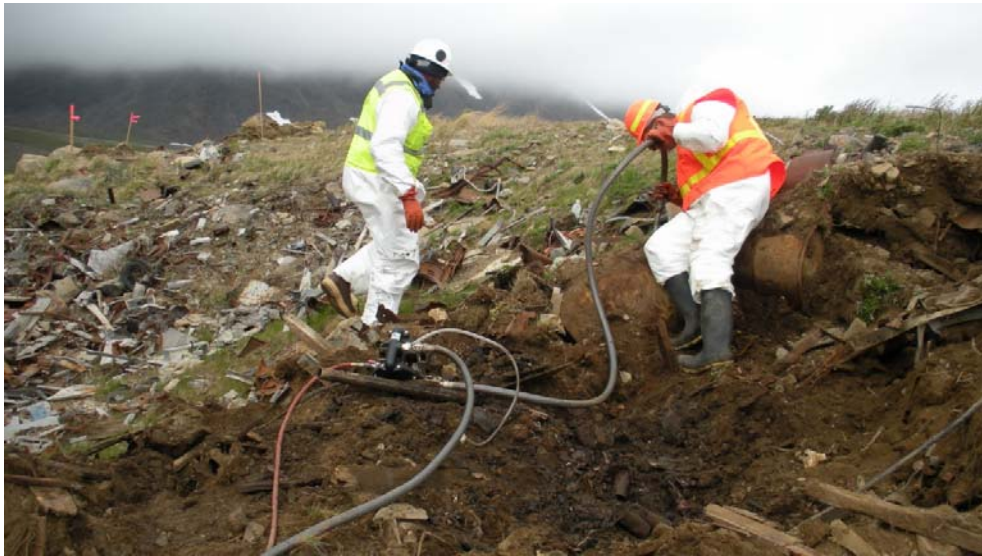
Photograph 3. Field crew pumping liquid out of a corroded drum in the landfill.

The excavation areas were chosen based on the metallic anomalies and the information yielded from test pits and trenching. Surface material was excavated and staged along the section of landfill being worked on. Debris was moved and piled until a drum was found. Upon discovery, the drum was checked with the aid of a drum thief. Drums found to have retrievable petroleum product, or residue determined to not be water, were moved to the Hazardous Waste Accumulation Point (HWAP) or were pumped in place into empty barrels and moved to the HWAP (Photograph 3).

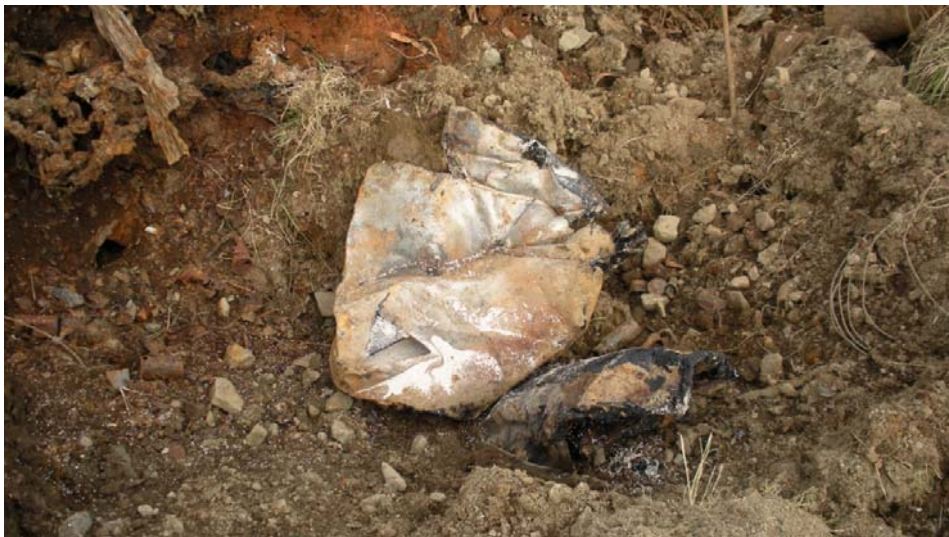
Photograph 4. Crushed drum that was cleaned, coated with Oil-Dri[®] absorbent, and returned to landfill.

Oil found in drums was drained and put in new containers for eventual petroleum recycling. Fifty drums were shipped off-island for disposal, and the rest of the drums were cleaned and returned to the landfill prior to capping. Drums that were extremely corroded or crushed were thoroughly cleaned on the outside and filled with Oil-Dri[®] absorbent, before being returned to the landfill (Photograph 4).

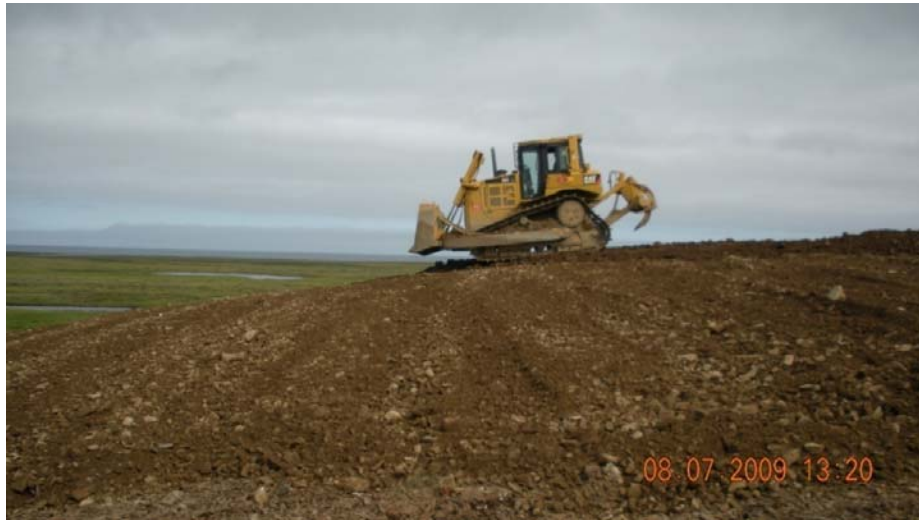
Photograph 5. Laying down and track-walking 6-inch lifts for a minimum of a 24-inch landfill cap.

Bristol placed each section of fill material in a series of four lifts to a minimum thickness of 24 inches above the trash and debris. A lift was spread and repeatedly track-walked with the equipment prior to laying each subsequent lift (Photograph 5). Work progressed section by section, until the entire landfill was covered with fill material, tracked-walked, and graded. Appropriate grading was done to ensure minimal erosion of the cap. Grade was set by a dozer operator with oversight from the foreman and site superintendent.

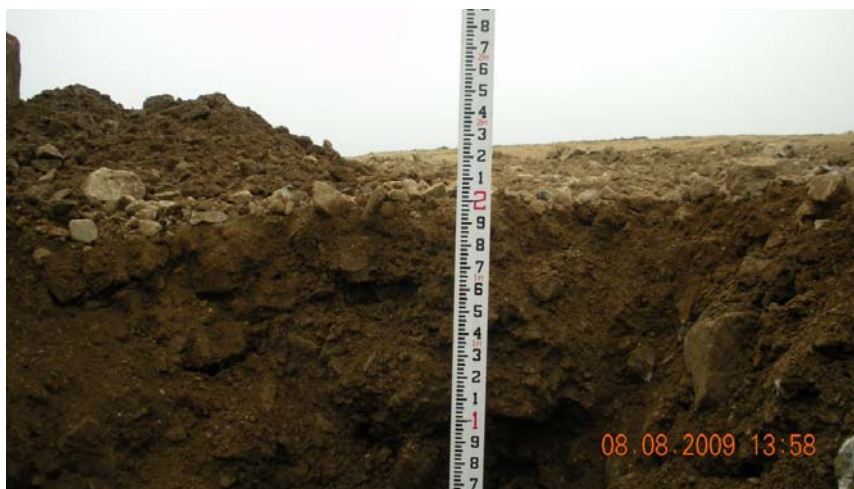
Photograph 6. Measurement showing a 2-foot-thick cap in a test pit in the landfill.

Quality control measures taken in the field to ensure appropriate cap thickness consisted of excavating test pits through the capping material to its interface with the debris. The thickness of the material was noted, and fill stakes were placed at all locations that required additional material (Photograph 6).

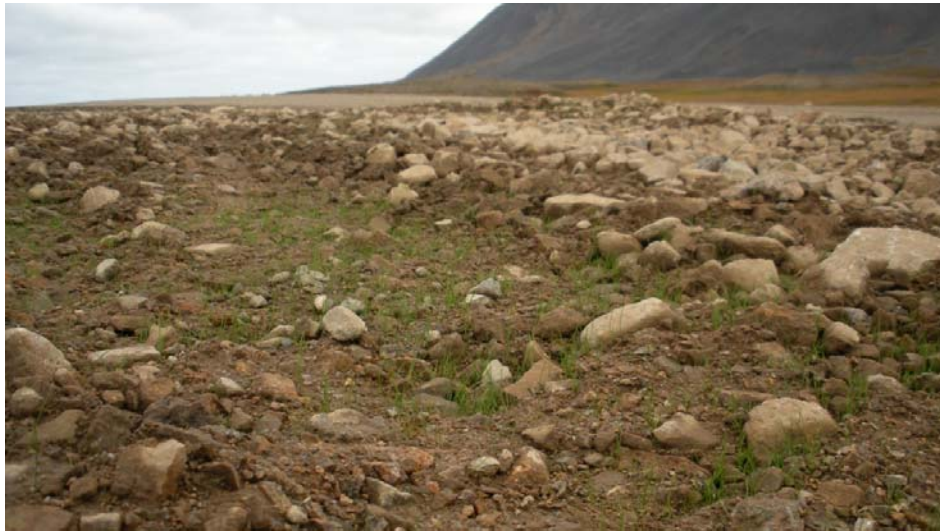
Photograph 7. Germinated grass seed on landfill (September 11, 2009).

Seed was applied at a uniform rate of one pound per 100 square feet. Fertilizer was applied at a rate of 450 pounds per acre, and had a nitrogen-phosphorus-potassium ratio of 20 percent nitrogen; 20 percent phosphorus; and 10 percent potassium. Bristol did not water seeded areas; however, seeding was completed during days of light precipitation. As of September 11, 2009, grass seed had taken root and was growing on the landfill cap (Photograph 7).

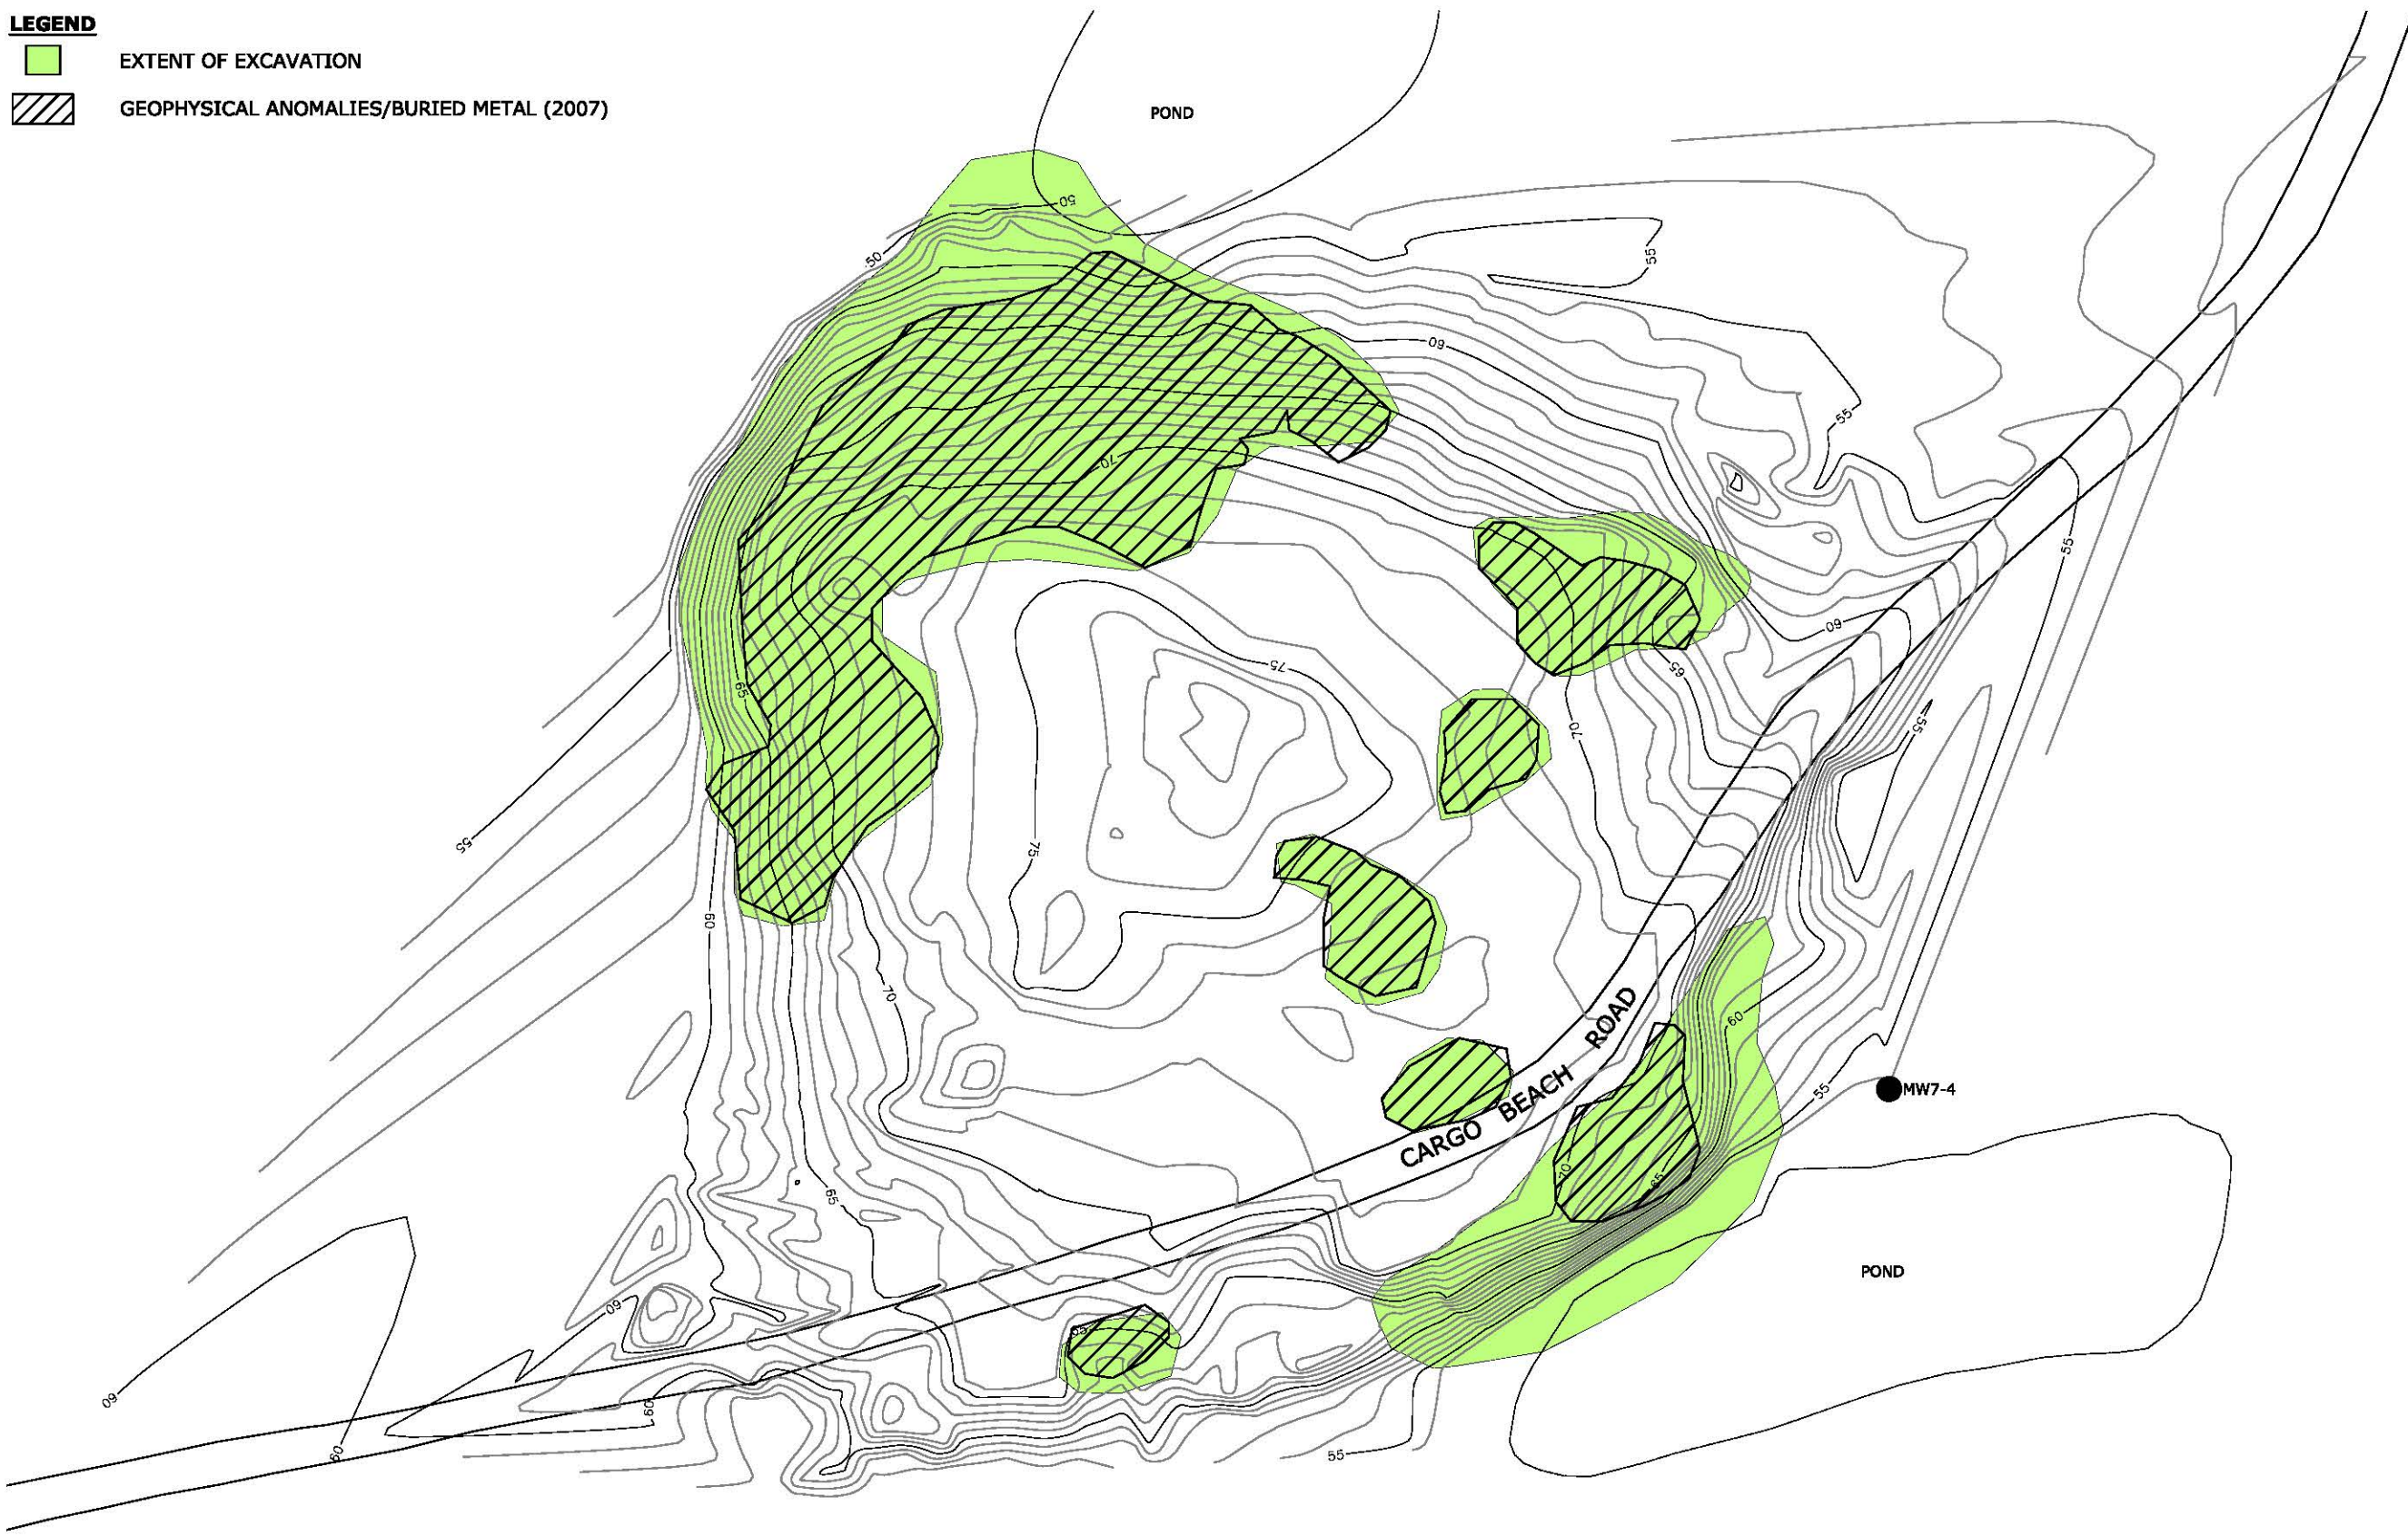
FIGURE 4
NORTHEAST CAPE, ST. LAWRENCE ISLAND, ALASKA
IN-SITU CHEMICAL OXIDATION AND INTRUSIVE
DRUM REMOVAL/LANDFILL CAP
EXTENT OF SITE 7 EXCAVATION

In 2007, a geophysical survey was conducted at the Site 7 Landfill by R&M Consultants, Inc., for the USACE. Areas within the landfill that displayed high levels of magnetic activity were examined by Bristol for the presence of drums. Bristol initially completed 11 test pits and/or trenches in these magnetic anomaly areas (see Figure 3 and Photograph 1). After the initial test pits were completed, all of the magnetic anomalies were investigated, solid wastes were turned over, and if any drums were filled with liquid, they were removed. Some anomalies proved to be small, isolated metal debris and this debris was not moved. During the excavation, Bristol encountered over 1,000 empty drums that were crushed and placed back in the landfill. The total area, over 150,000 square feet, that was eventually excavated by Bristol in 2009 is shown in Figure 4.

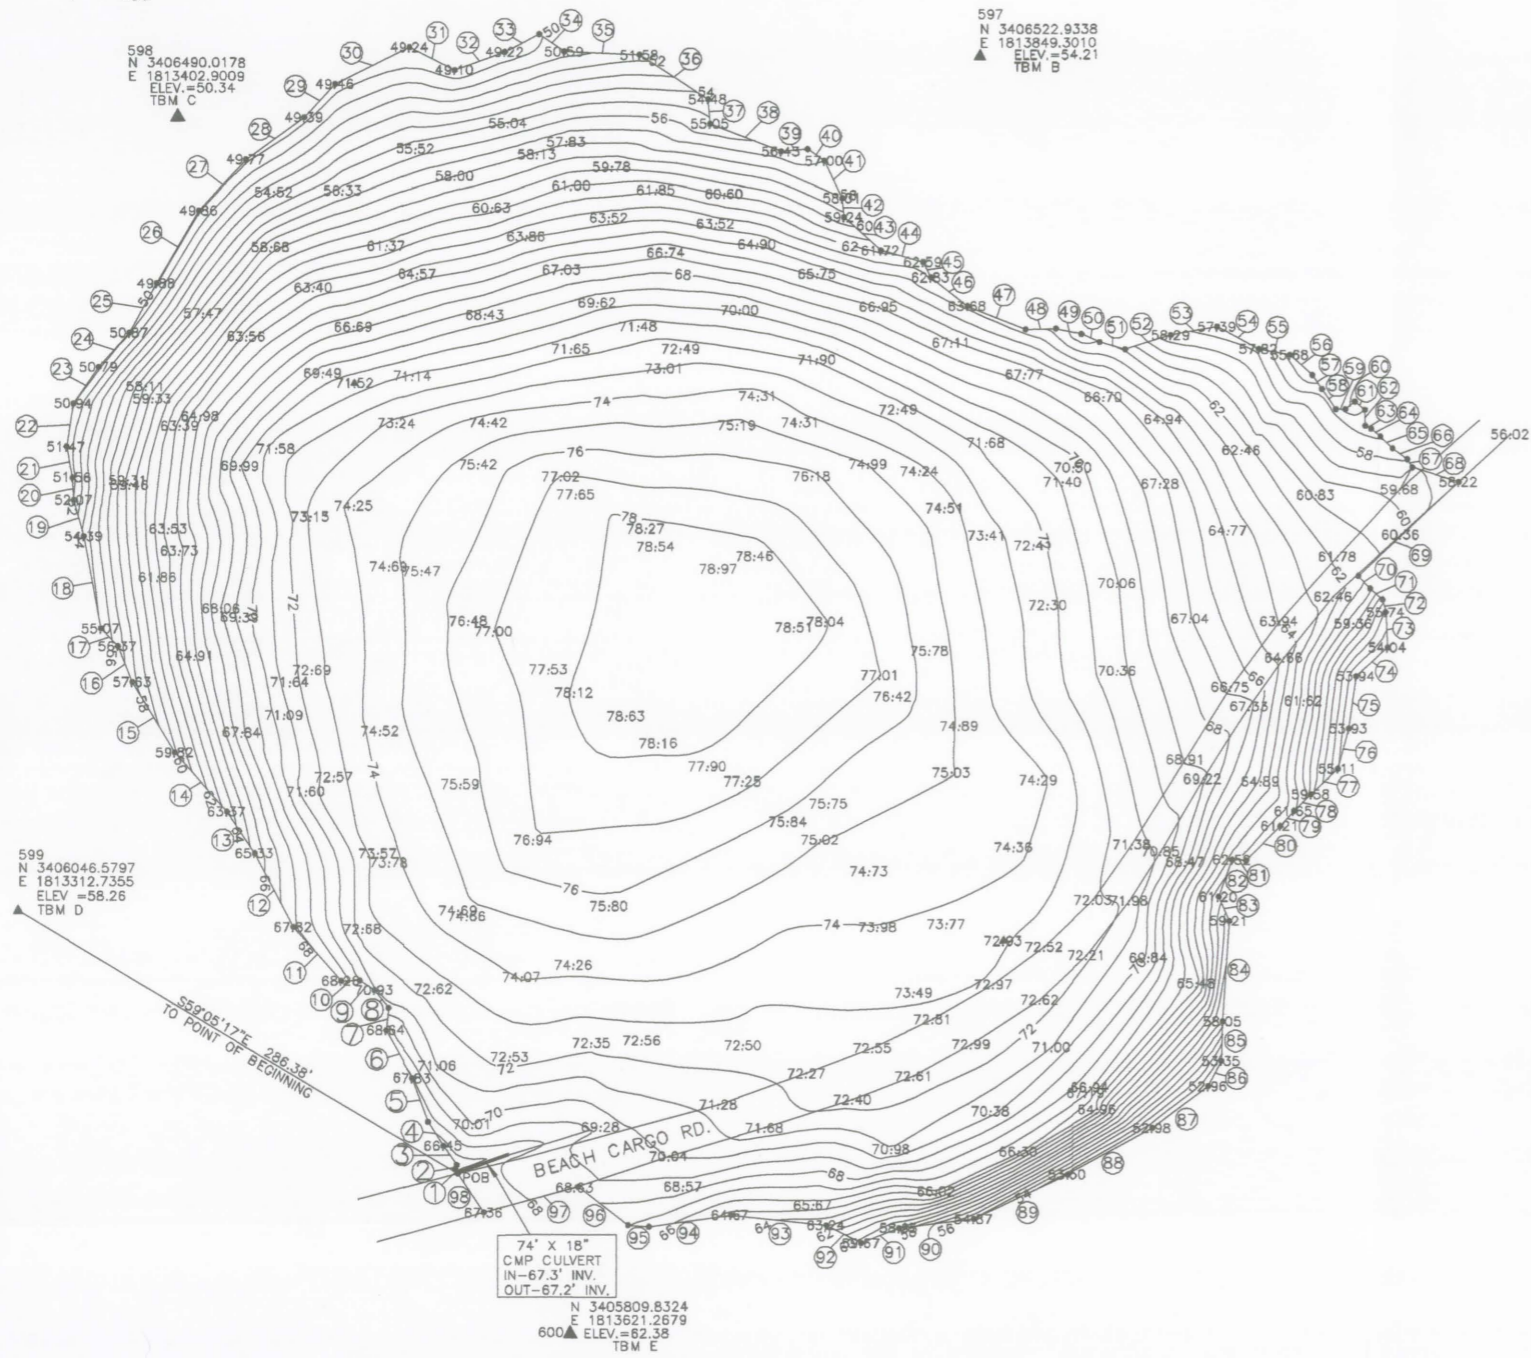
Figure 5

Professional land surveys were conducted before and after the completion of the Site 7 Landfill cap. The post-landfill cap survey is shown on Figure 5.
