Visual Inspection Checklist (Post-Closure)

Site 7 Landfill

Site 9 Landfill

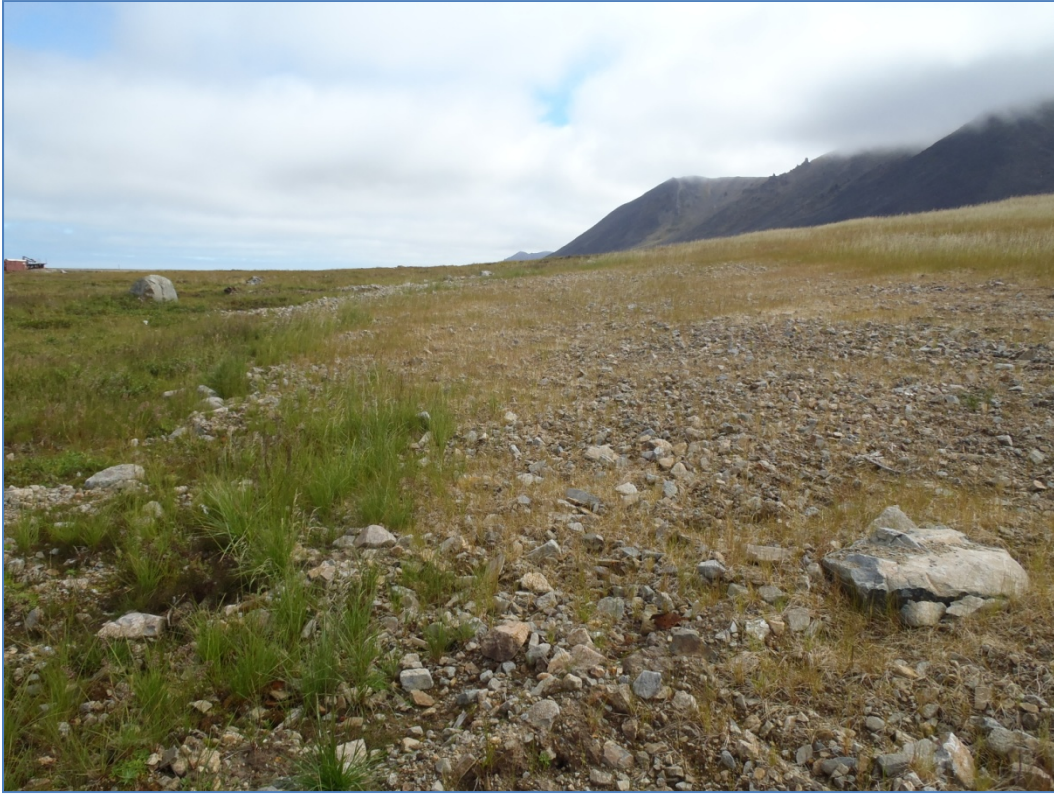
Photo 1: Site 7 Landfill – North slope of landfill, facing east.

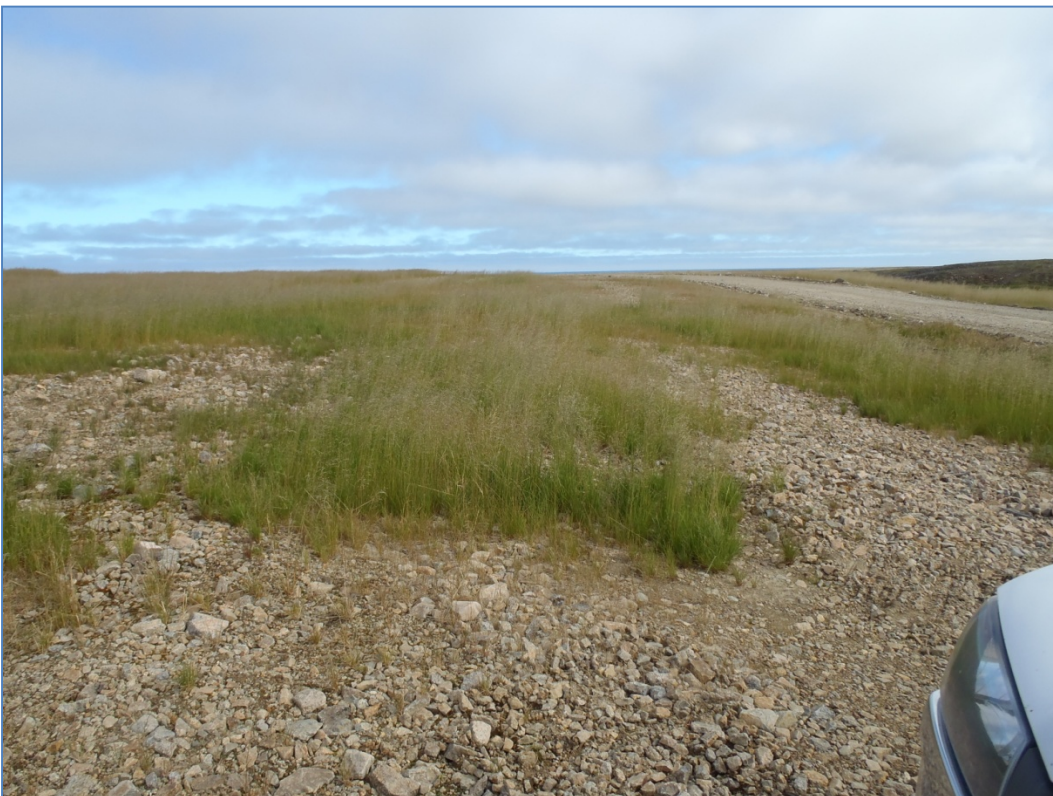
Photo 2: Site 7 Landfill – East slope of landfill, facing northeast.

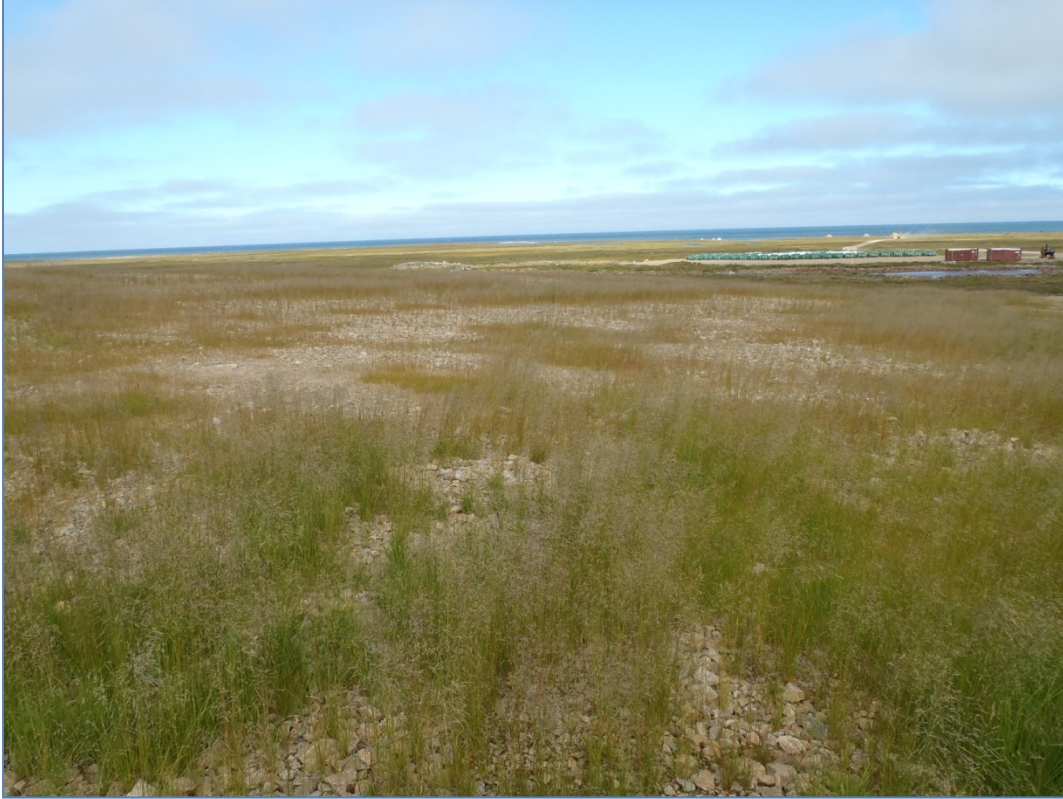
Photo 3: Site 7 Landfill – View from approximate center of landfill, facing northeast.

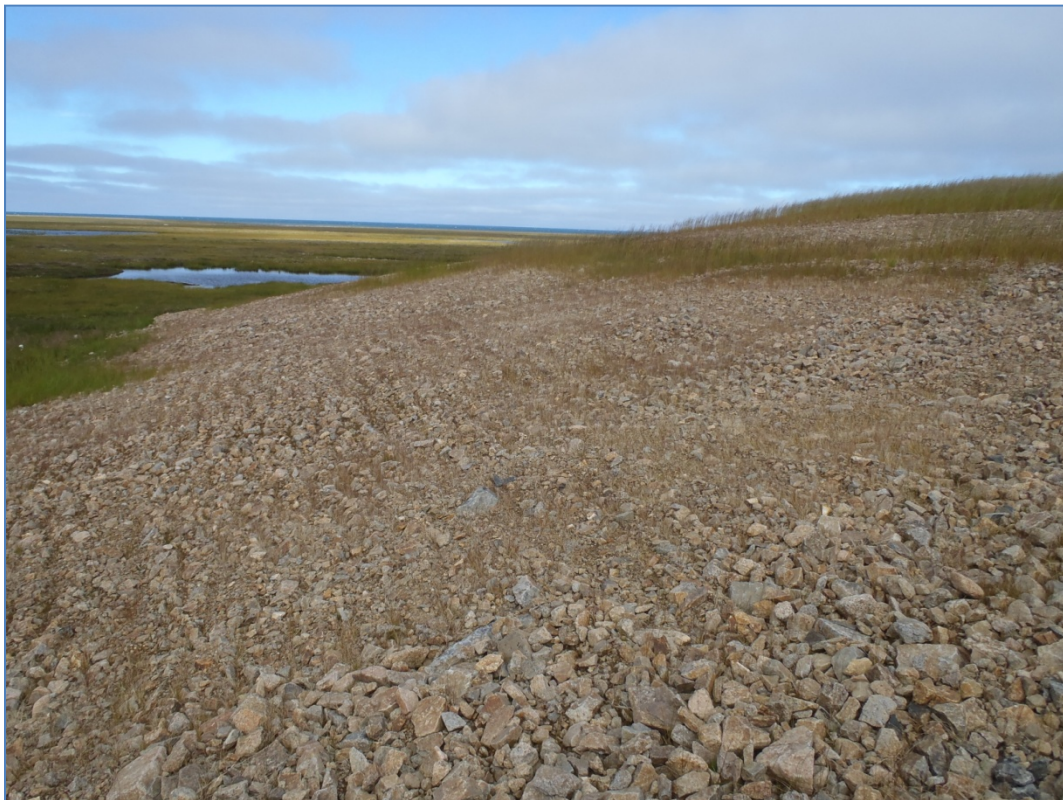
Comments: South + ~~East~~^{West} sideslopes less vegetated. Very rocky and wind likely blew off seed when initially applied last year.

Photo 4: Site 7 Landfill – South slope of landfill, facing west.

Corrective Actions Taken: None.^{SC} Seed was spread by Bristol Environmental on 9-13-11 at bare areas. Hope to promote vegetation in these areas even though rocky.

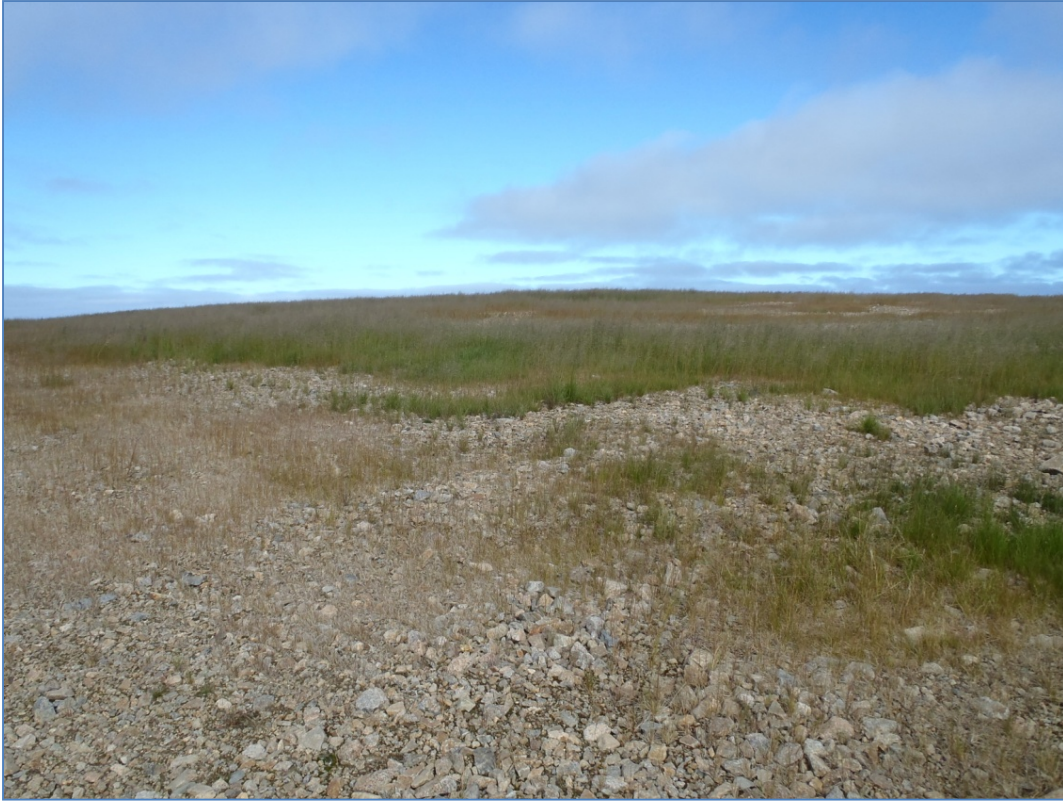
Photo 5: Site 7 Landfill – View of top of landfill from south end, facing north.

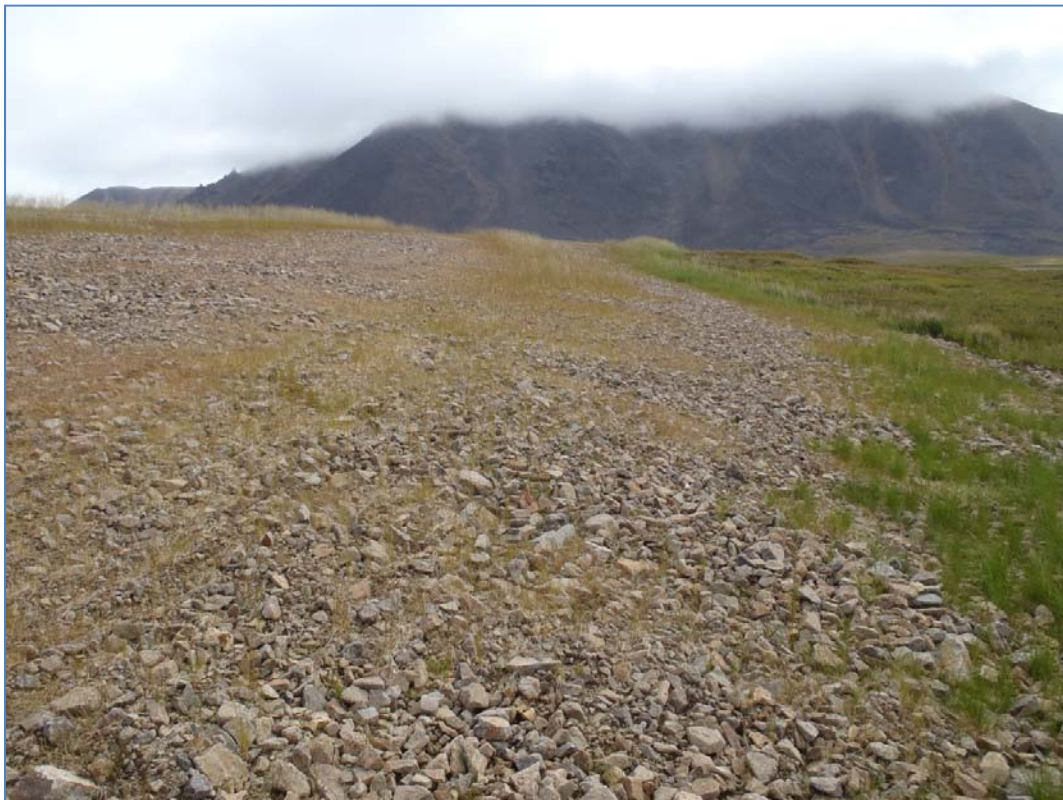
Photo 6: Site 7 Landfill – South slope of landfill, facing west.

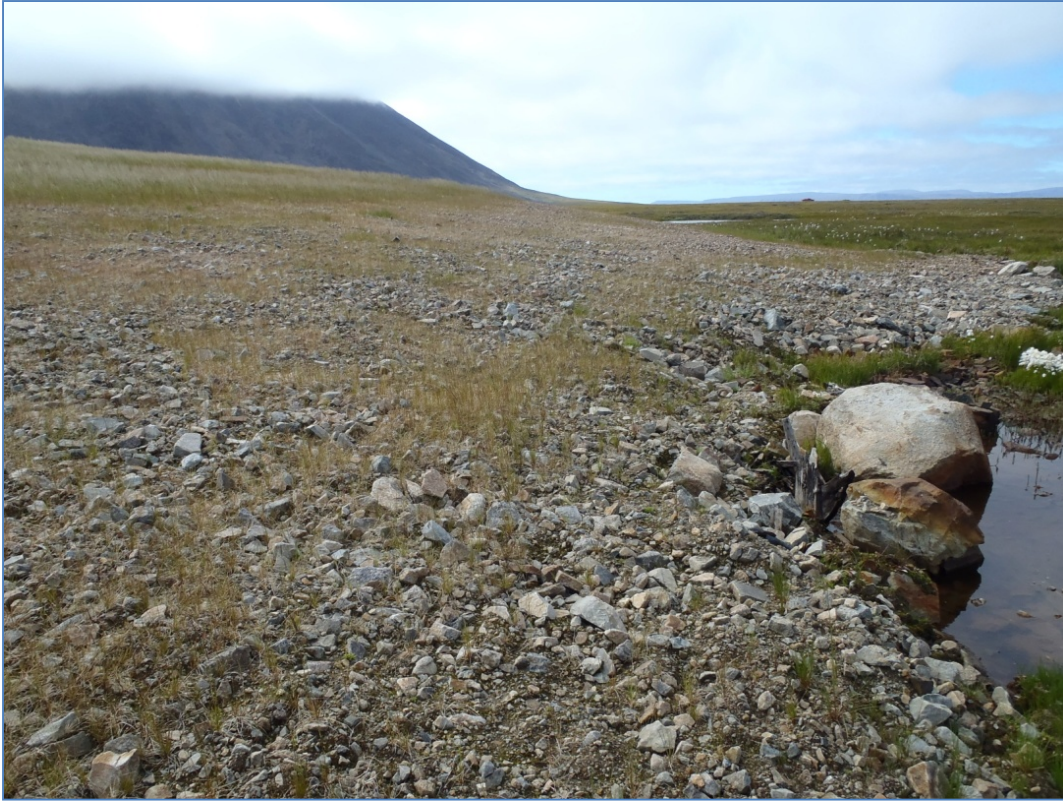
Photo 7: Site 7 Landfill - West slope of landfill, facing south.

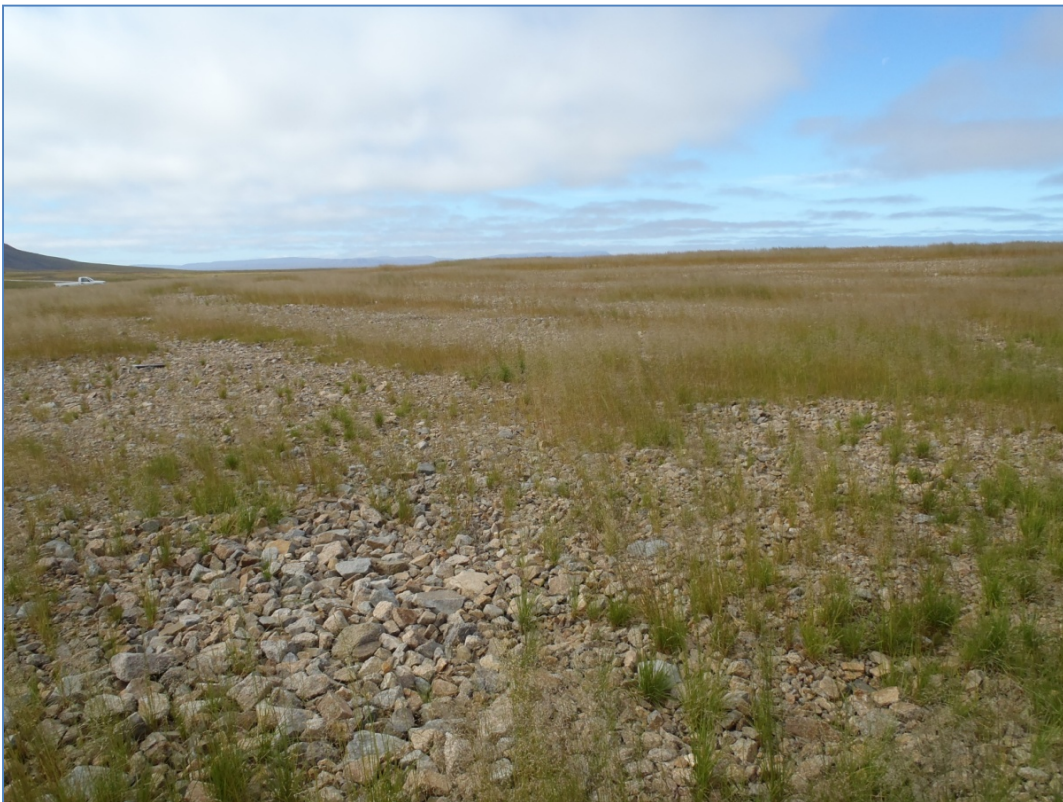
Photo 8: Site 7 Landfill - View of top of landfill from northeast corner, facing southwest.

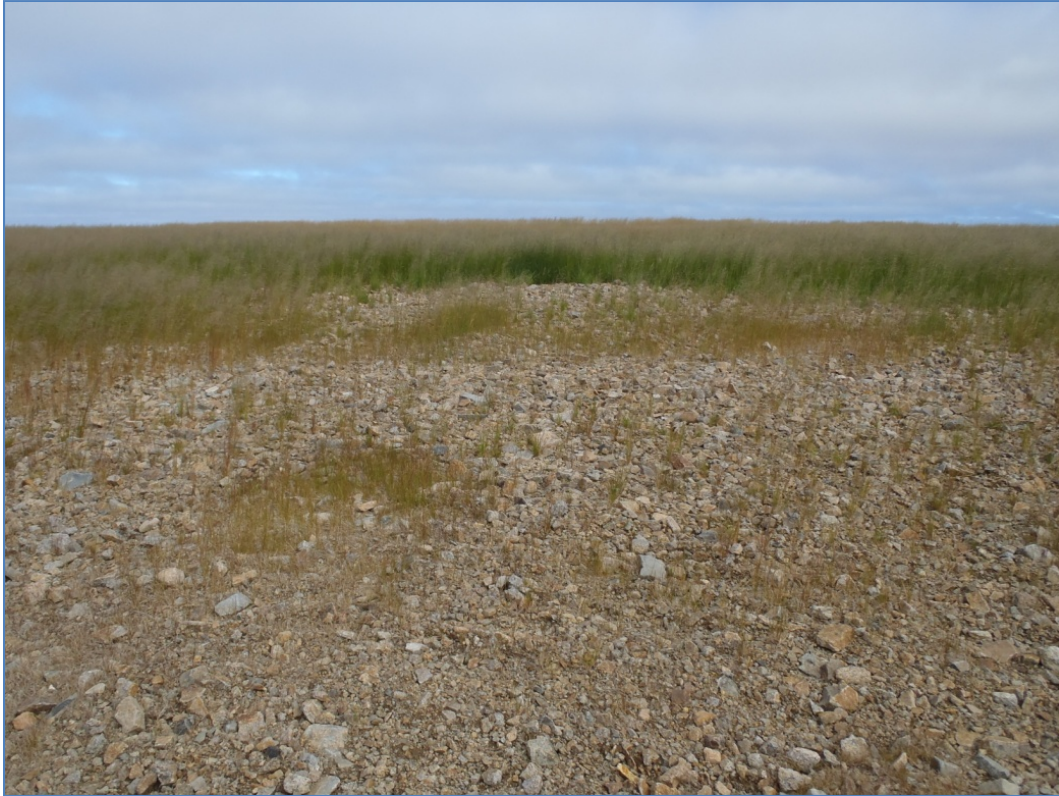
Photo 9: Site 7 Landfill – View of top of landfill from east side (from road), facing west.

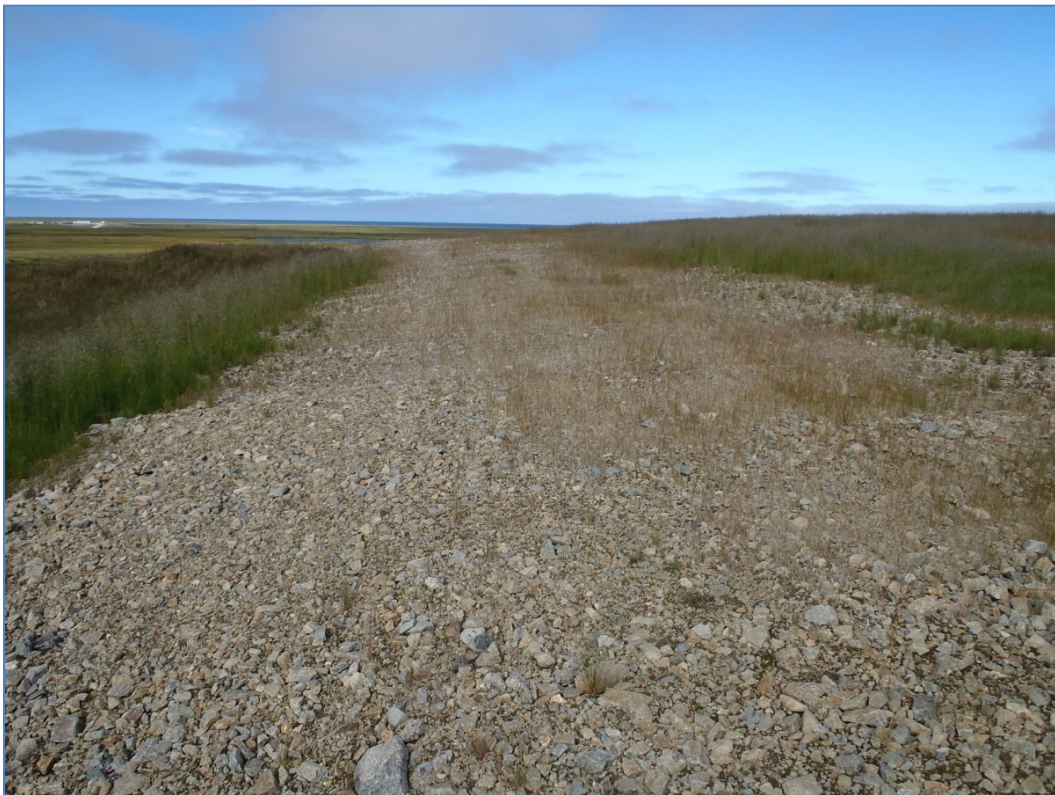
Photo 10: Site 7 Landfill – South slope of landfill, facing northwest with camp in background.

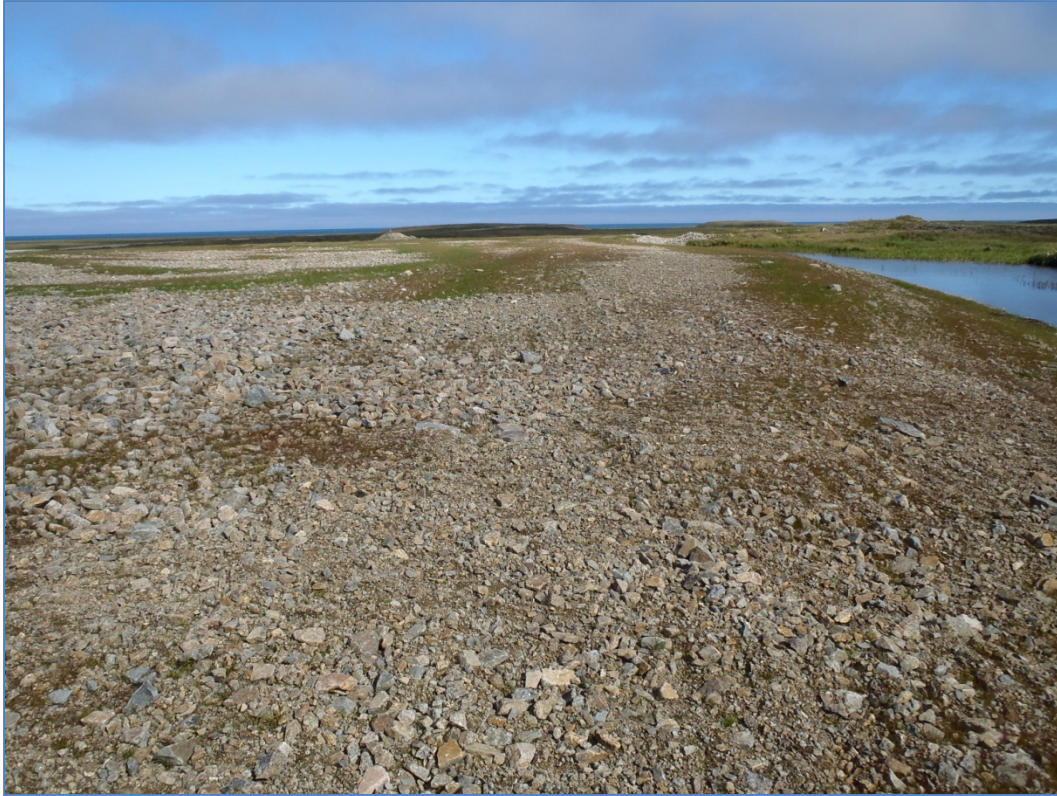
Photo 13: Site 9 Landfill – East side of landfill, facing north.

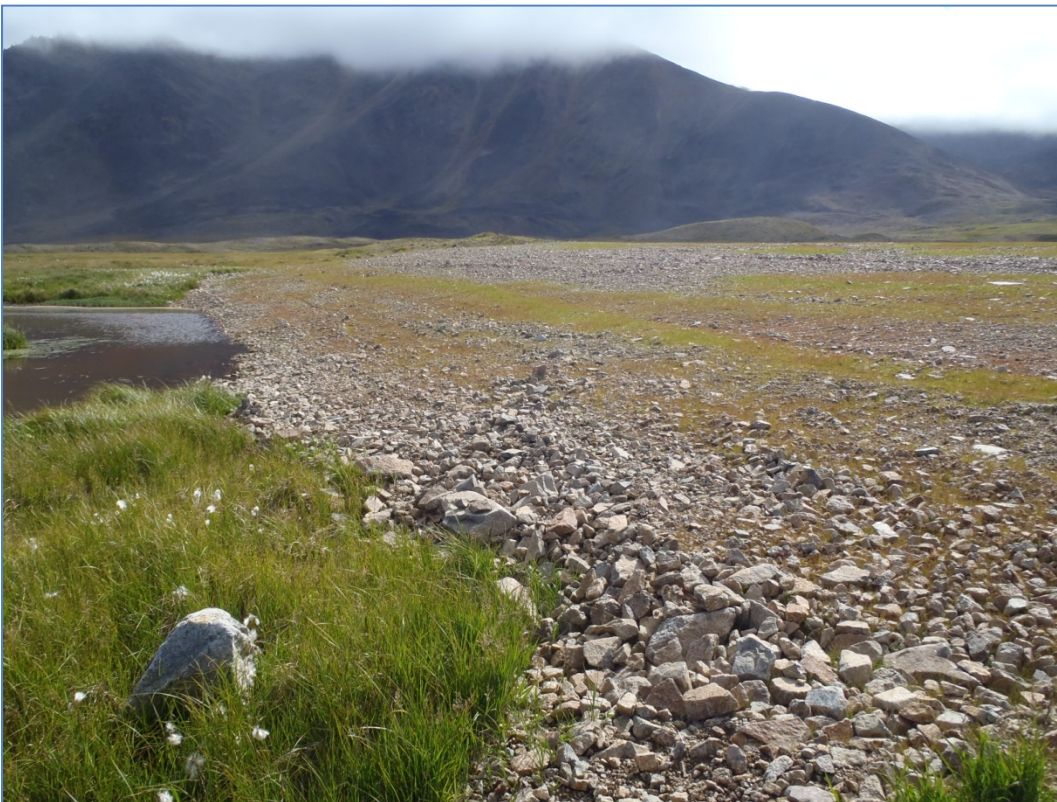
Photo 14: Site 9 Landfill – North side of landfill, facing east.

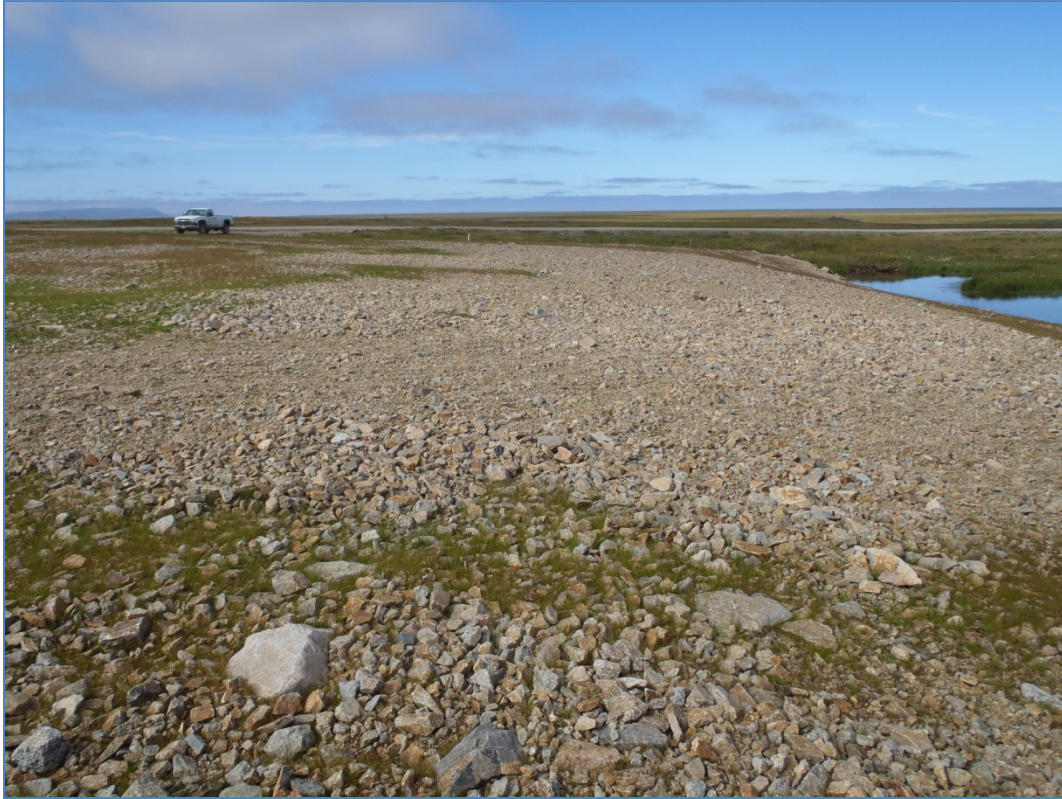
Photo 15: Site 9 Landfill – North side of landfill, facing northwest.

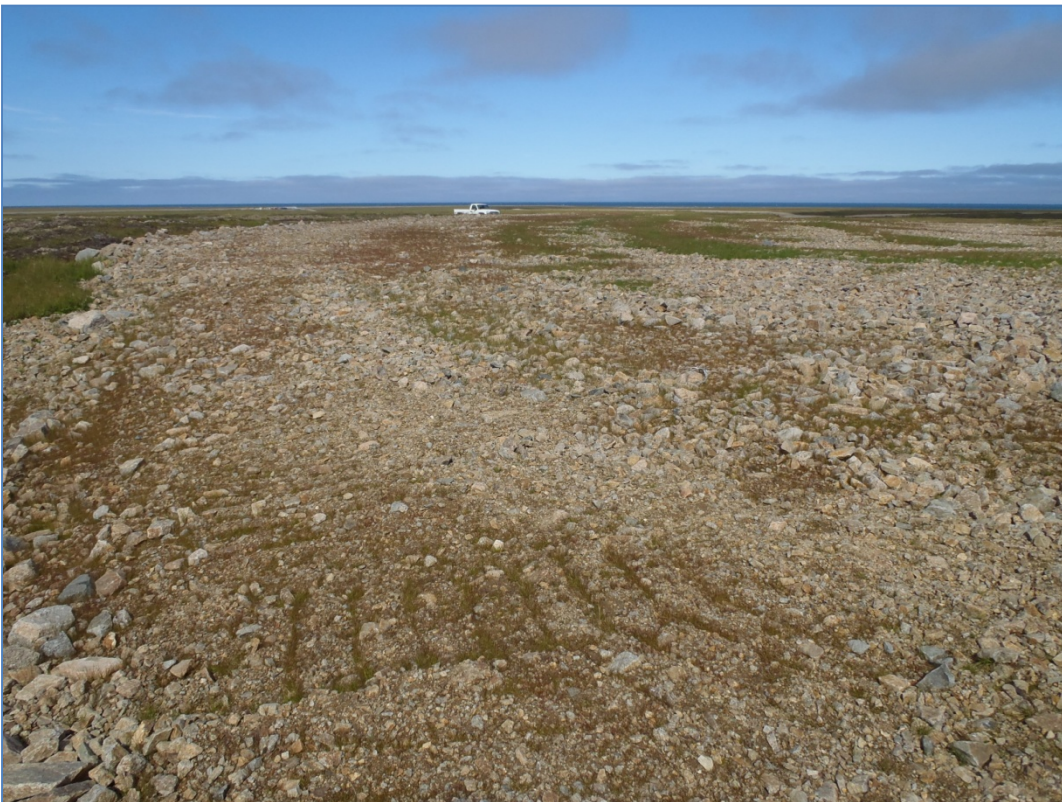
Photo 16: Site 9 Landfill – Southeast side of landfill, facing northwest.

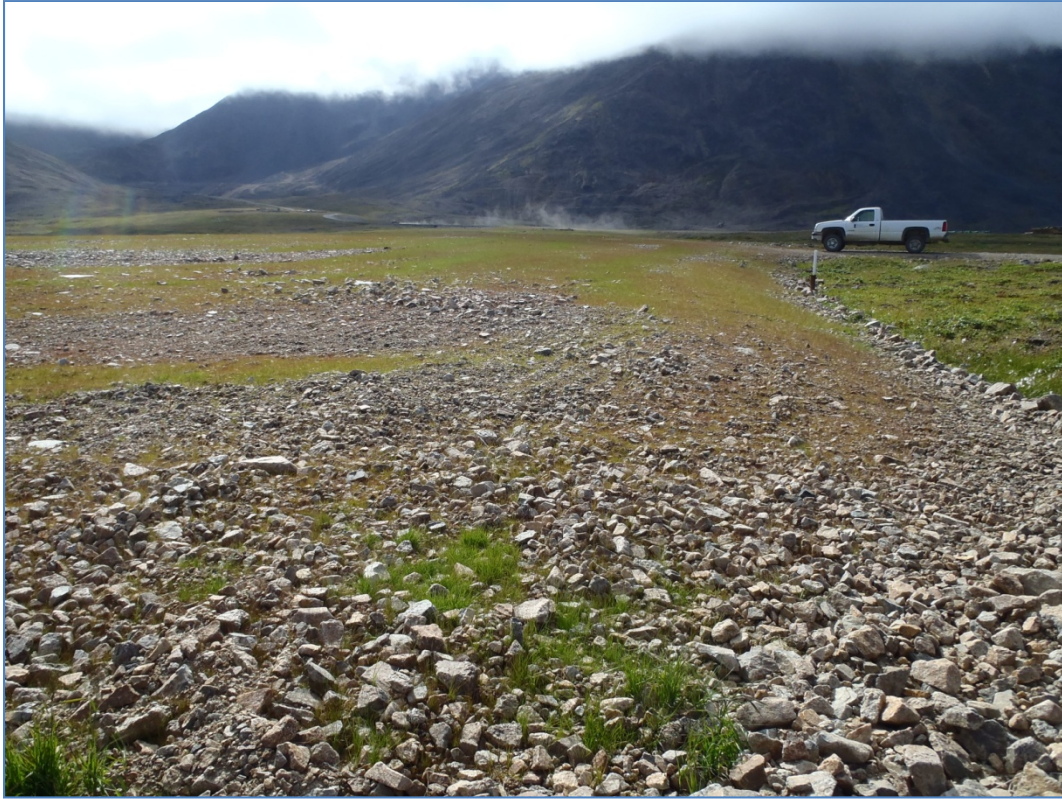
Photo 17: Site 9 Landfill –West side of landfill, facing southwest.

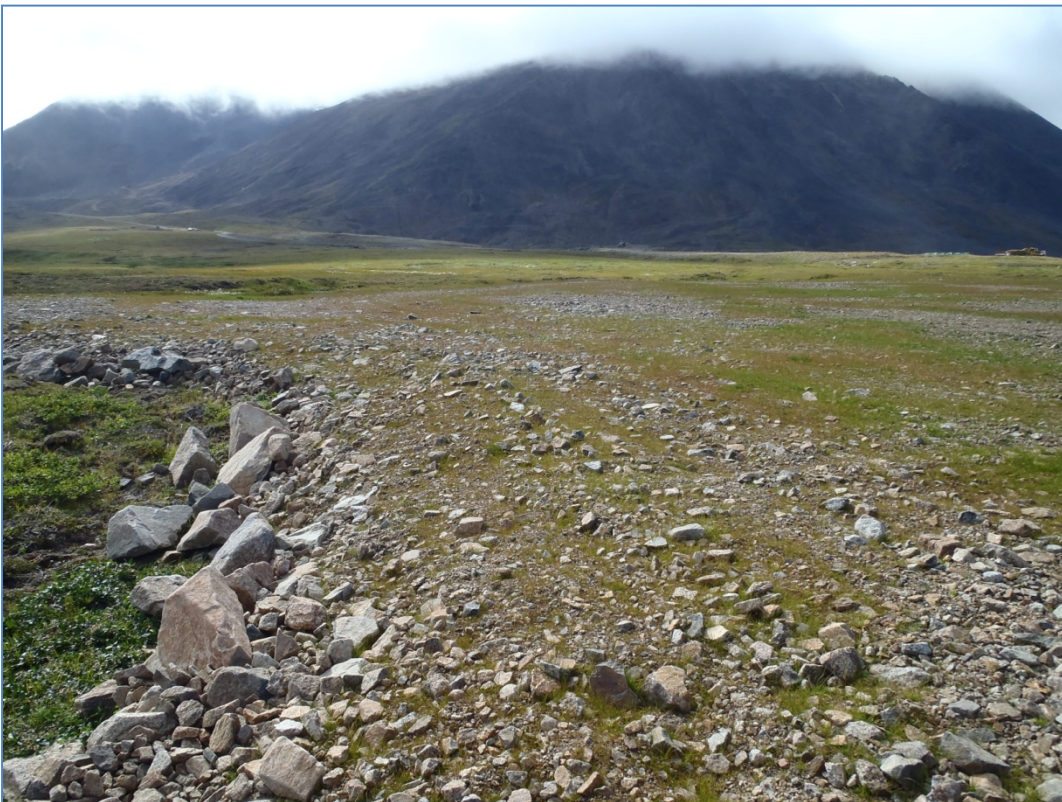
Photo 18: Site 9 Landfill – East side of landfill, facing southwest.

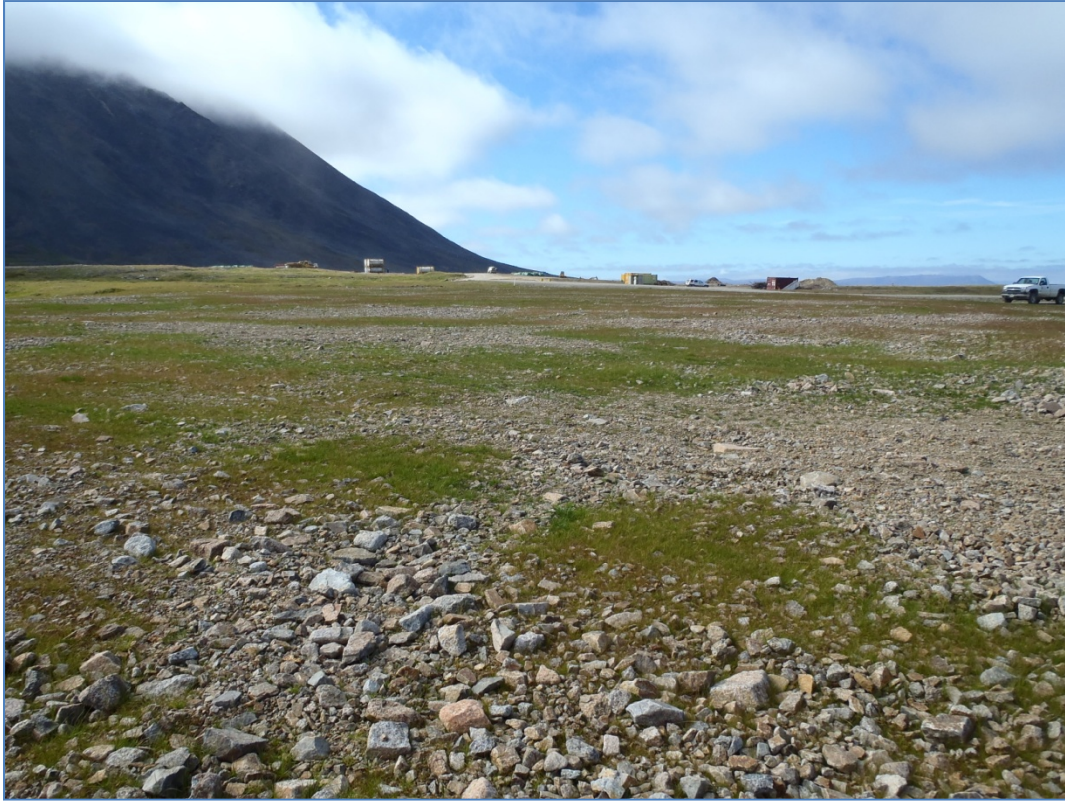
Photo 19: Site 9 Landfill – View of landfill from east side, facing west.
