## Visual Inspection Checklist (Post-Closure) Site 7 Landfill

Name of Inspector:  Lisa Geist  Date:  August 7, 2013

## Visual Inspection Checklist (Post-Closure) Site 9 Landfill

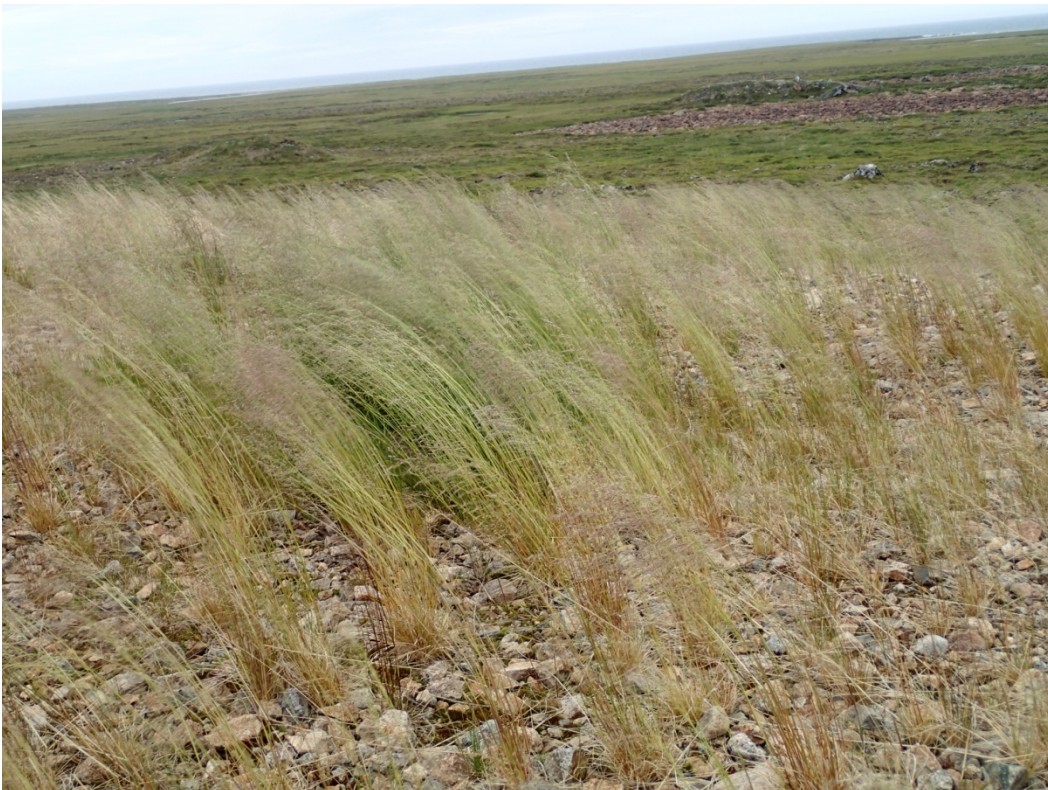
Photo 6: Site 7 Landfill – North slope of landfill, note tall grass tufts with seed, facing NW.

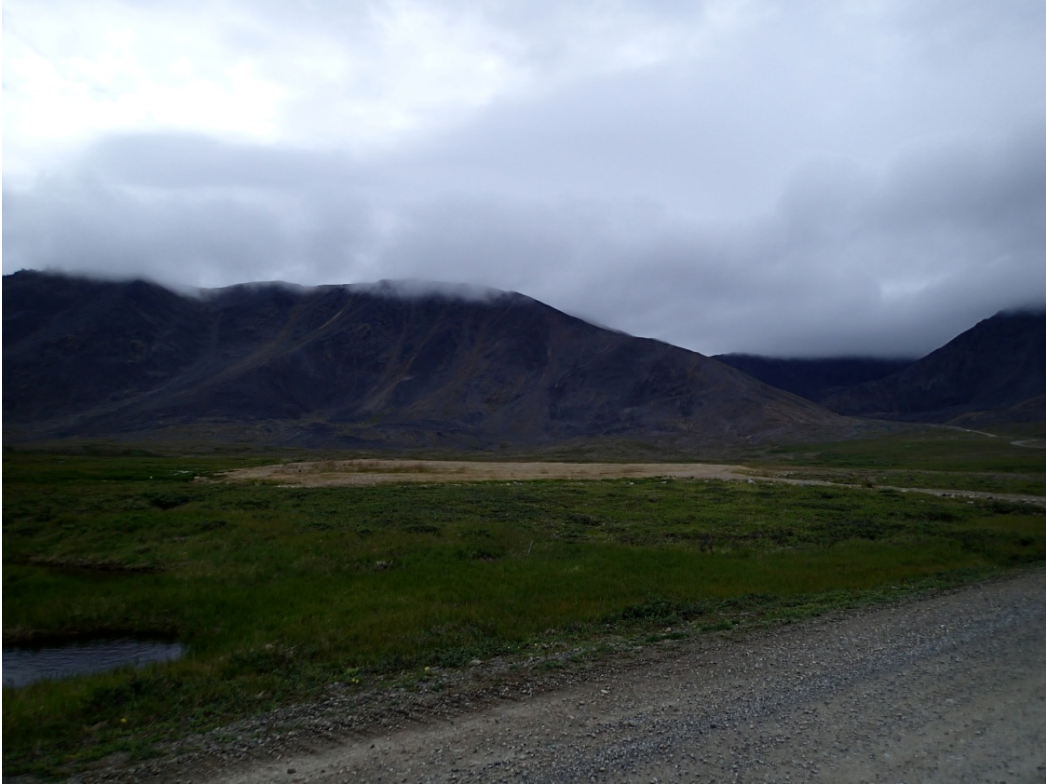
Photo 7: Site 9 Landfill – Overview of entire landfill area from site access road, facing south.

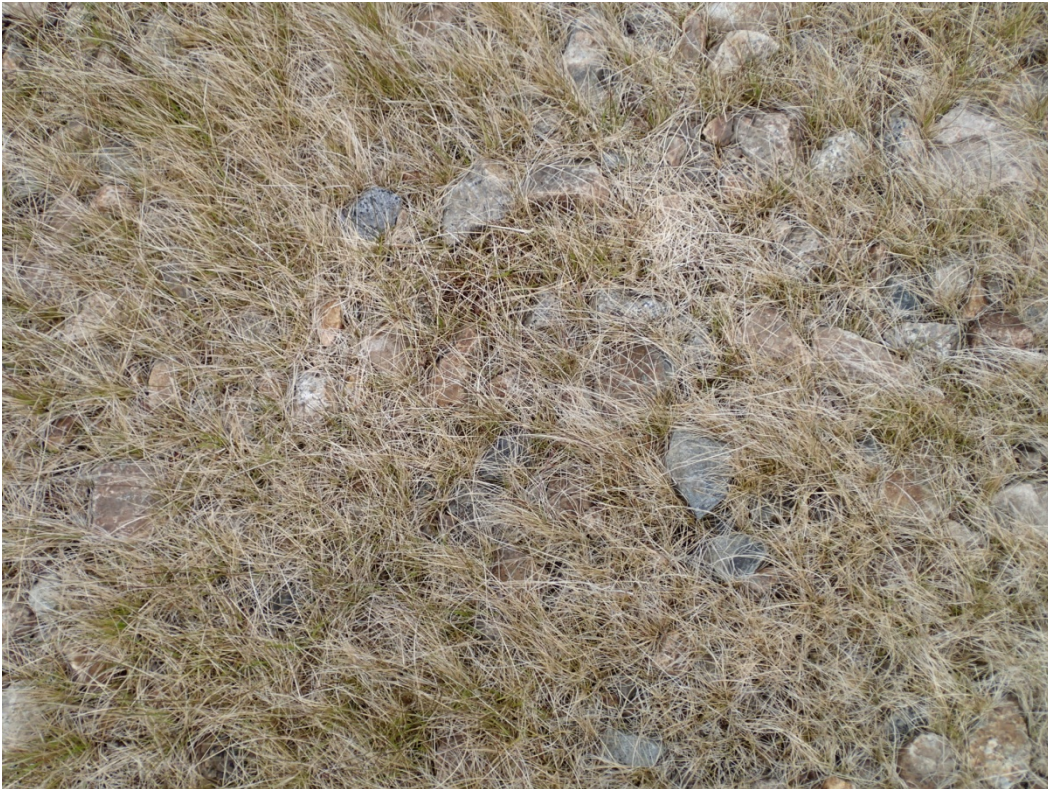
Photo 10: Site 9 Landfill – Close-up view of landfill vegetation.
