## TECHNICAL MEMORANDUM

Re: Request for Site 7 Landfill Closure at Northeast Cape, St. Lawrence Island, Alaska

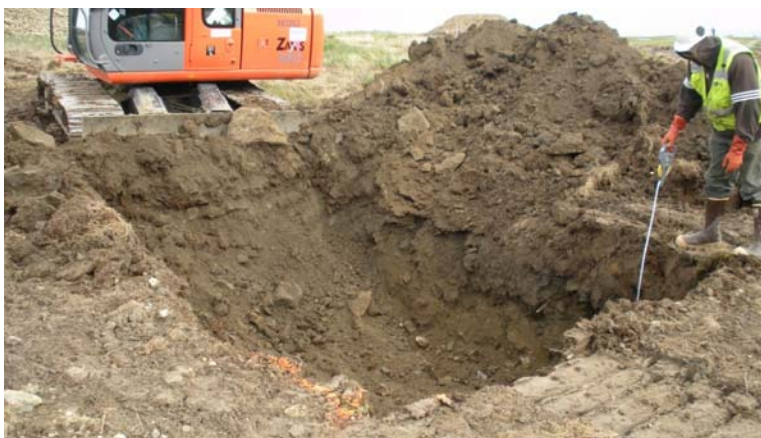
Photograph 1. A 100-square-foot by 4-foot-deep investigation trench in area of metallic anomalies.

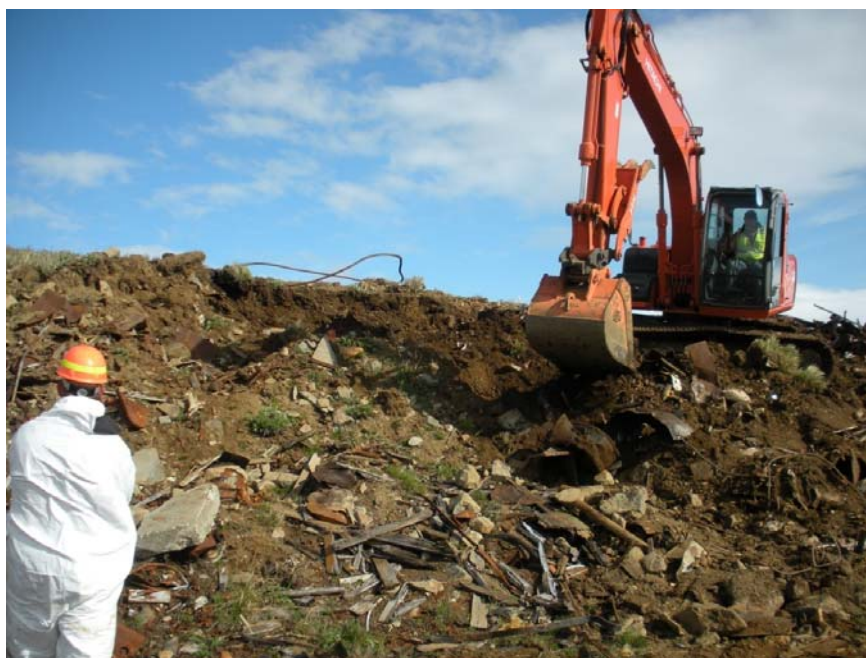
Photograph 2. Excavation of soil and drums from the Site 7 Landfill.

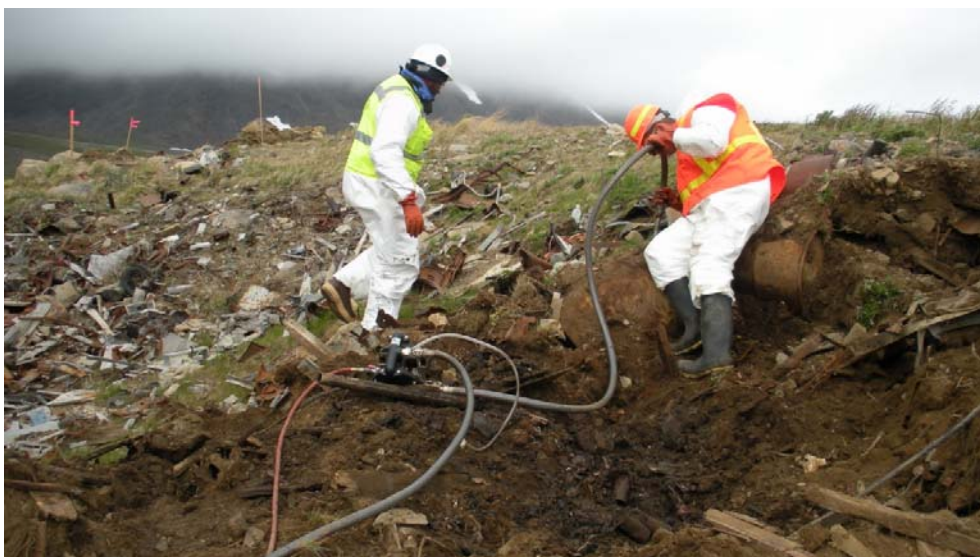
Photograph 3. Field crew pumping liquid out of a corroded drum in the landfill.

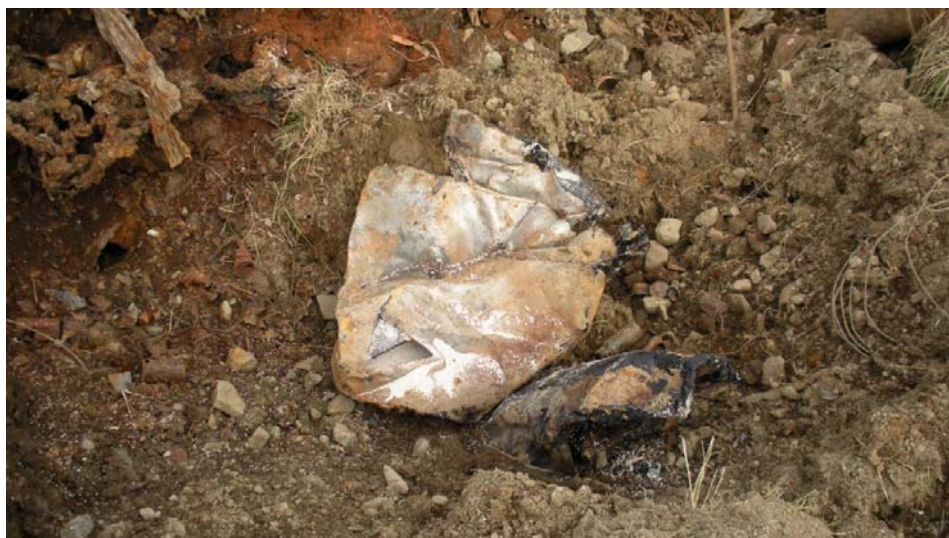
Photograph 4. Crushed drum that was cleaned, coated with Oil-Dri<sup>®</sup> absorbent, and returned to landfill.

Oil found in drums was drained and put in new containers for eventual petroleum recycling. Fifty drums were shipped off-island for disposal, and the rest of the drums were cleaned and returned to the landfill prior to capping. Drums that were extremely corroded or crushed were thoroughly cleaned on the outside and filled with Oil-Dri<sup>®</sup> absorbent, before being returned to the landfill (Photograph 4).

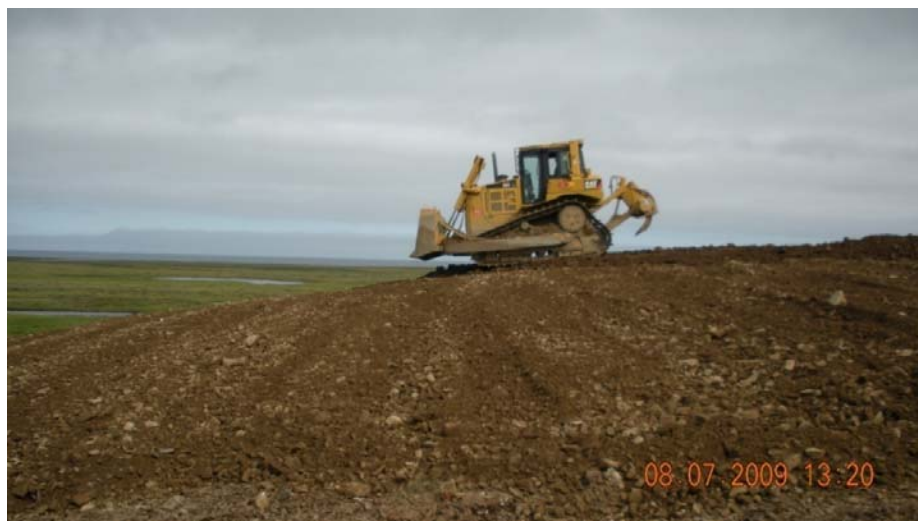
Photograph 5. Laying down and track-walking 6-inch lifts for a minimum of a 24-inch landfill cap.

Bristol placed each section of fill material in a series of four lifts to a minimum thickness of 24 inches above the trash and debris. A lift was spread and repeatedly track-walked with the equipment prior to laying each subsequent lift (Photograph 5). Work progressed section by section, until the entire landfill was covered with fill material, tracked-walked, and graded. Appropriate grading was done to ensure minimal erosion of the cap. Grade was set by a dozer operator with oversight from the foreman and site superintendent.

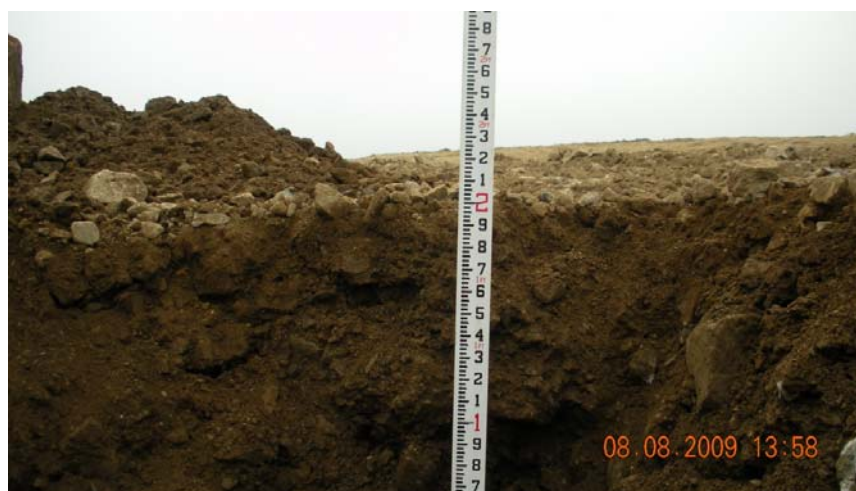
Photograph 6. Measurement showing a 2-foot-thick cap in a test pit in the landfill.

Quality control measures taken in the field to ensure appropriate cap thickness consisted of excavating test pits through the capping material to its interface with the debris. The thickness of the material was noted, and fill stakes were placed at all locations that required additional material (Photograph 6).

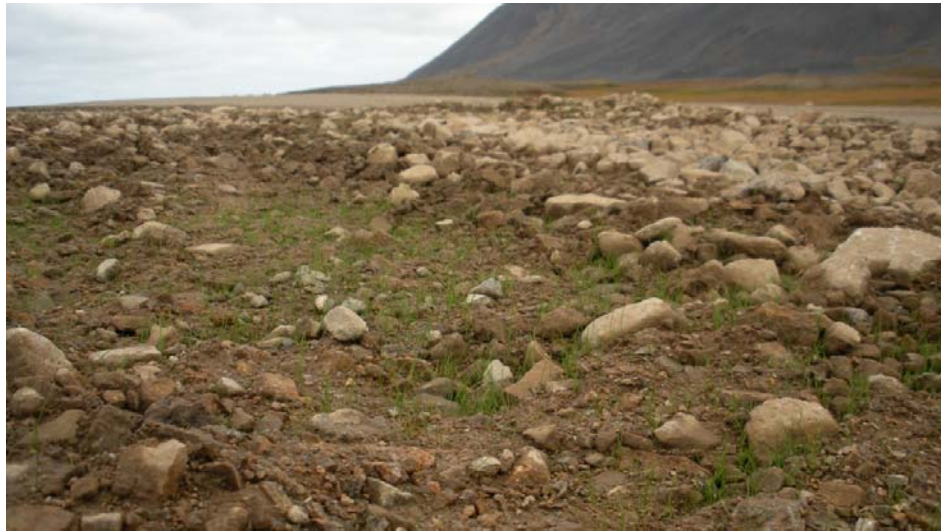
Photograph 7. Germinated grass seed on landfill (September 11, 2009).

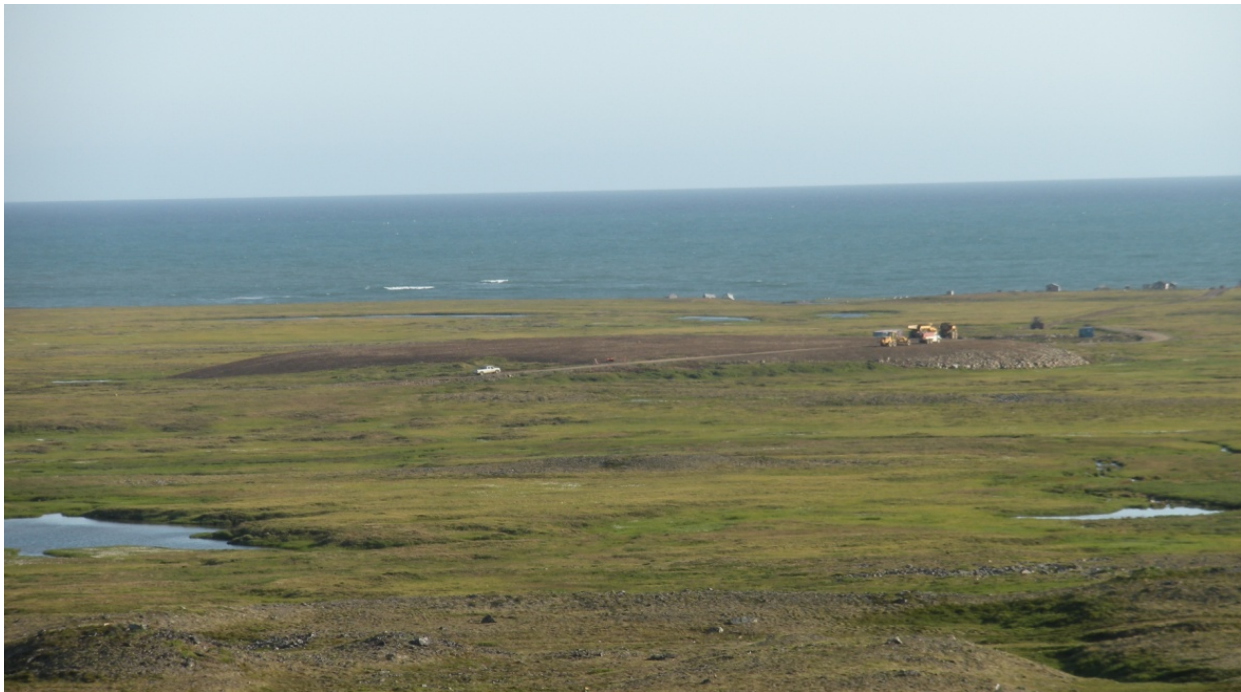
Photograph 8. View looking north at the capped Site 7 Landfill (August 18, 2009).
