FIRST PERIODIC REVIEW REPORT

SITE 7 CARGO BEACH ROAD LANDFILL NORTHEAST CAPE FUDS ST. LAWRENCE ISLAND, ALASKA

Formerly Used Defense Site No. F10AK0969-05

FINAL FEBRUARY 2015

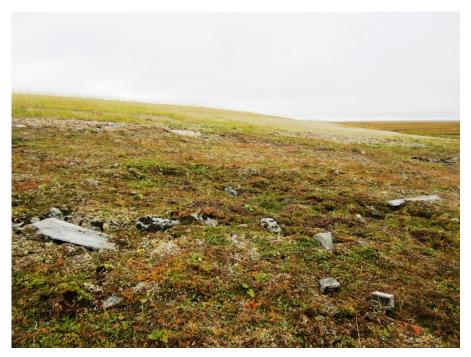
Photo No. 7 – 13 September 2013 Wood debris at Site 7. View facing north.

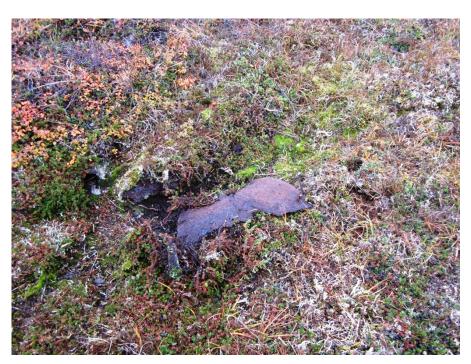
Photo No. 8 – 13 September 2013 Metal debris at Site 7.

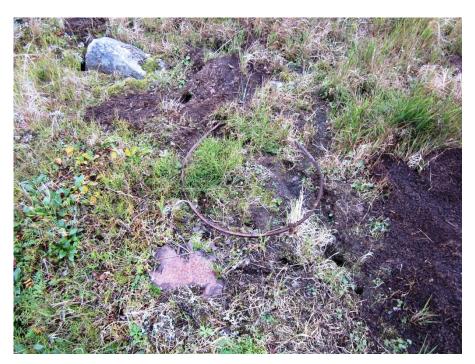
Photo No. 9 – 13 September 2013 Metal debris at Site 7.

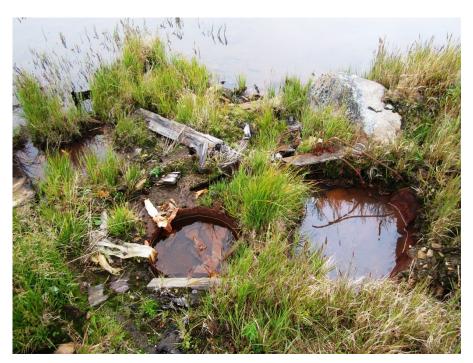
Photo No. 10-13 September 2013 Drum debris located near a pond at Site 7. View facing north.

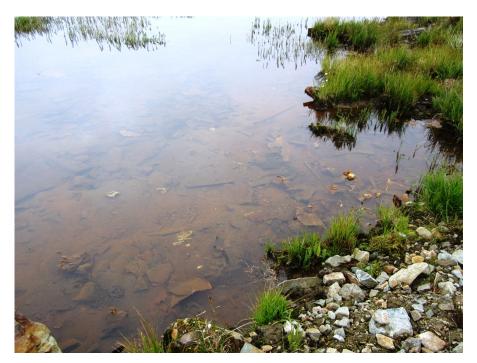
Photo No. 11-13 September 2013 Debris in pond located adjacent to landfill cap at Site 7. View facing north.

Recommendation: Remove debris identified in and around ponds to the landfill cap.			and ponds adjacent			
Affect Current Protectiveness	Affect Future Protectiveness		Implementing Party	Regulatory Party		Milestone Date
No	No		USACE	ADEC		2018
PROTECTIVENESS STATEMENT						
ε					Addendum Due Date (if applicable):	
<i>Protectiveness Statement:</i> The remedy at Site 7 is expected to be protective of human health and the environment upon completion. In the interim, no exposure pathways that could result in unacceptable risks have been noted.

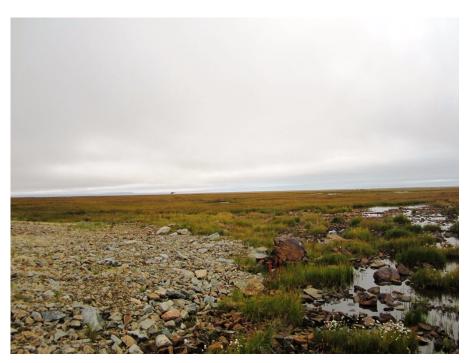
Photo No. 12-13 September 2013 Condition of northern edge of landfill cap at Site 7. View facing west.

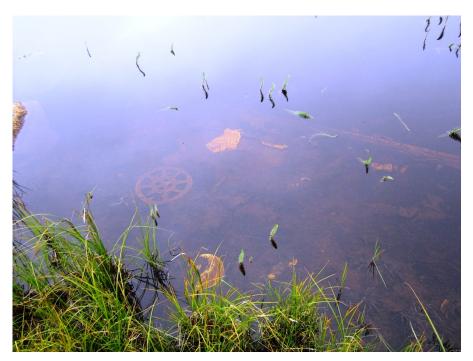
$Photo\ No.\ 13-13\ September\ 2013$ Miscellaneous debris in pond adjacent to landfill cap at Site 7. View facing north.

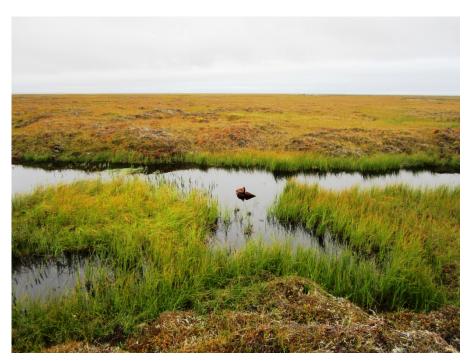
Photo No. 14-13 September 2013 Miscellaneous debris in pond near landfill cap at Site 7. View facing northwest.

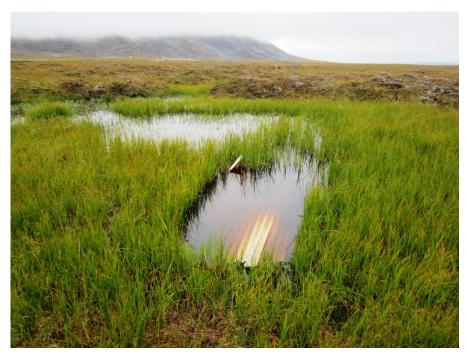
$Photo\ No.\ 15-13\ September\ 2013$ Metal debris in pond adjacent to landfill cap at Site 7. View facing north.

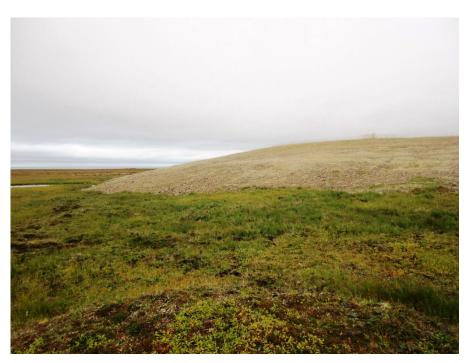
Photo No. 16-13 September 2013 Condition of northern edge of landfill cap at Site 7. View facing west.

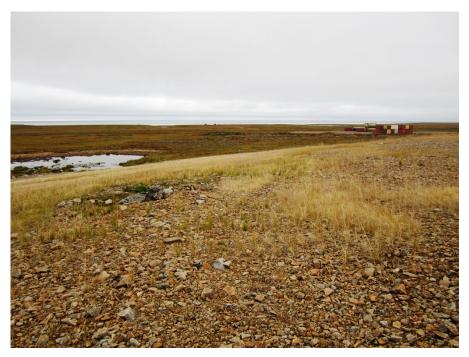
The landfill cap at Site 7 was observed in good condition with no apparent signs of erosion or cracking. The soil used for vegetative cover was observed to be very coarse, making vegetative growth difficult and sparse. There was a small amount of debris protruding from the cap on the southern side of the cap near the armored rock (Photo No. 15, Appendix D). Several metal items were observed in ponds located immediately north of the landfill cap (Photo Nos. 6, 7, 9, 10, 11, 18, and 19, Appendix D). A few rusted open drums were observed in ponds located to the north and southeast of the landfill cap (Photo Nos. 6 and 19, Appendix D). Bentonite was observed on the ground surface and thought to be an abandoned monitoring well southeast of the landfill cap (Photo No. 17, Appendix D).

$\begin{array}{c} Photo\ No.\ 17-13\ September\ 2013 \\ View\ standing\ on\ top\ of\ landfill\ cap\ at\ Site\ 7.\ View\ facing\ northwest. \end{array}$

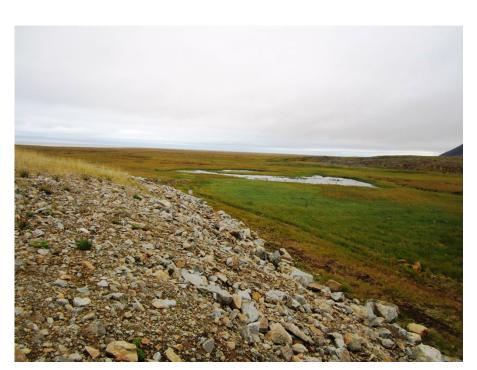
$Photo\ No.\ 18-13\ September\ 2013$ Condition of armored rock on the southern border of landfill cap at Site 7. View facing east.

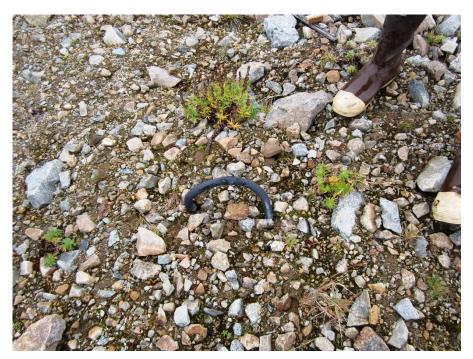
Photo No. 19-13 September 2013 Debris protruding through the southern side of landfill cap at Site 7.

An additional visual inspection event is recommended for the Site 7 landfill cap. The

inspection is recommended to occur following the removal of the identified debris protruding

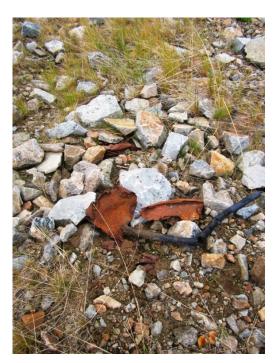
Photo No. 20-13 September 2013 Debris located with the armored rock at Site 7. View facing south.

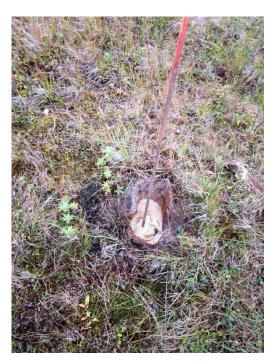
$\begin{array}{c} Photo\ No.\ 21-13\ September\ 2013 \\ Abandoned\ monitoring\ well\ filled\ with\ bentonite\ at\ Site\ 7. \end{array}$

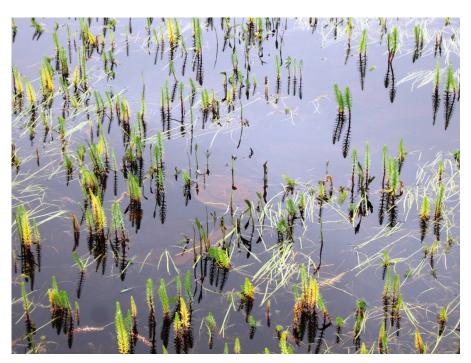
Photo No. 22-13 September 2013 Debris in pond south of landfill cap at Site 7. View facing south.

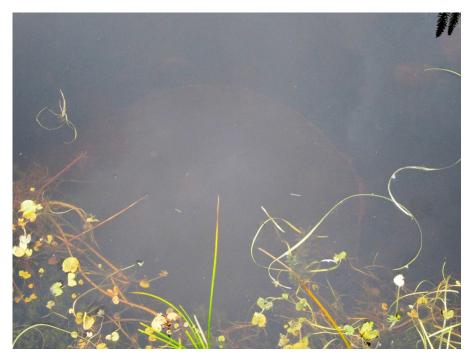
$\begin{array}{c} Photo\ No.\ 23-13\ September\ 2013 \\ Apparent\ drum\ located\ in\ pond\ south\ of\ landfill\ cap\ at\ Site\ 7. \end{array}$
