FIRST FIVE-YEAR REVIEW REPORT

NORTHEAST CAPE FUDS ST. LAWRENCE ISLAND, ALASKA

Formerly Used Defense Site No. F10AK0969-03

**FINAL
FEBRUARY 2015**

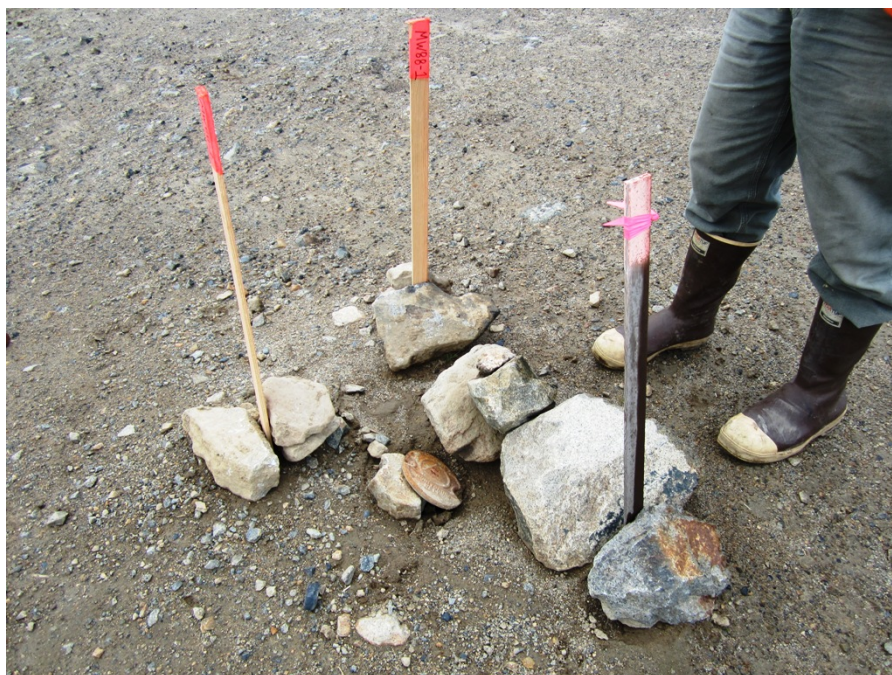
**Photo No. 72 – 15 September 2013
Existing non-secured, frost-jacked monitoring well at Site 19. View facing north.**

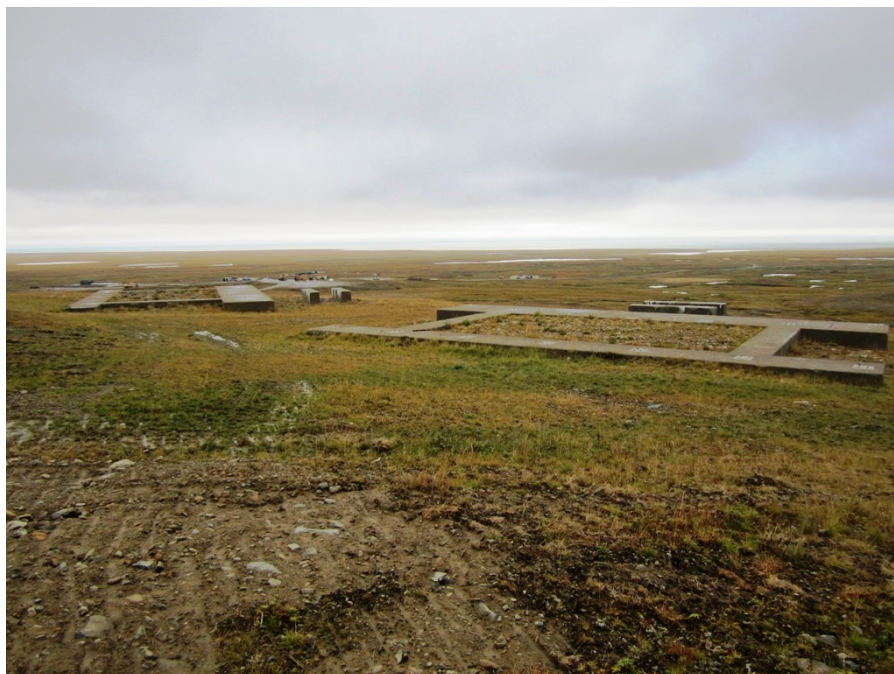
**Photo No. 109 – 13 September 2013
Remaining foundation (B) at Site 31. View facing north.**

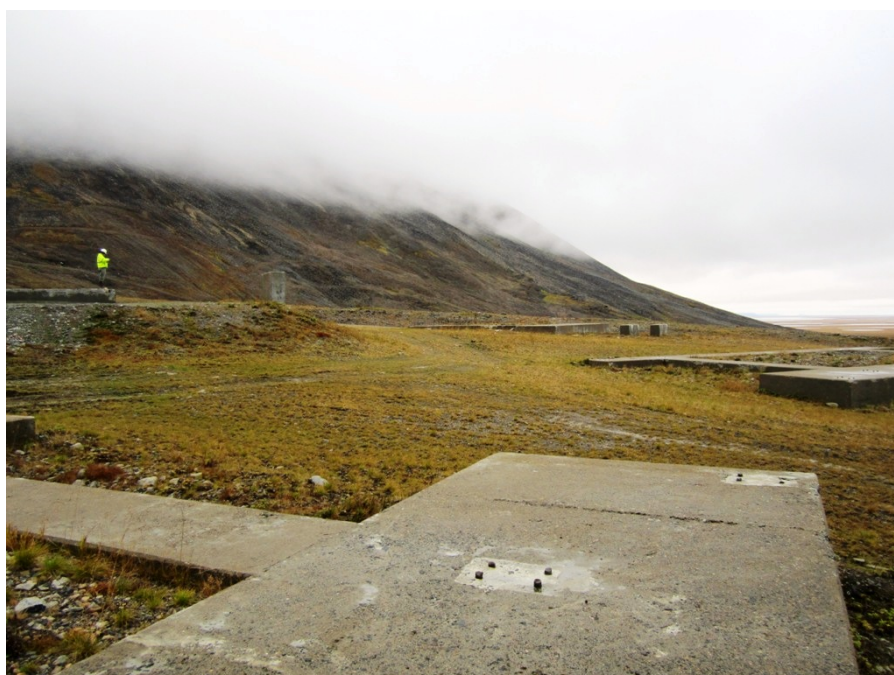
**Photo No. 110 – 13 September 2013
Remaining foundations (B, C, D) at Site 31. View facing west.**

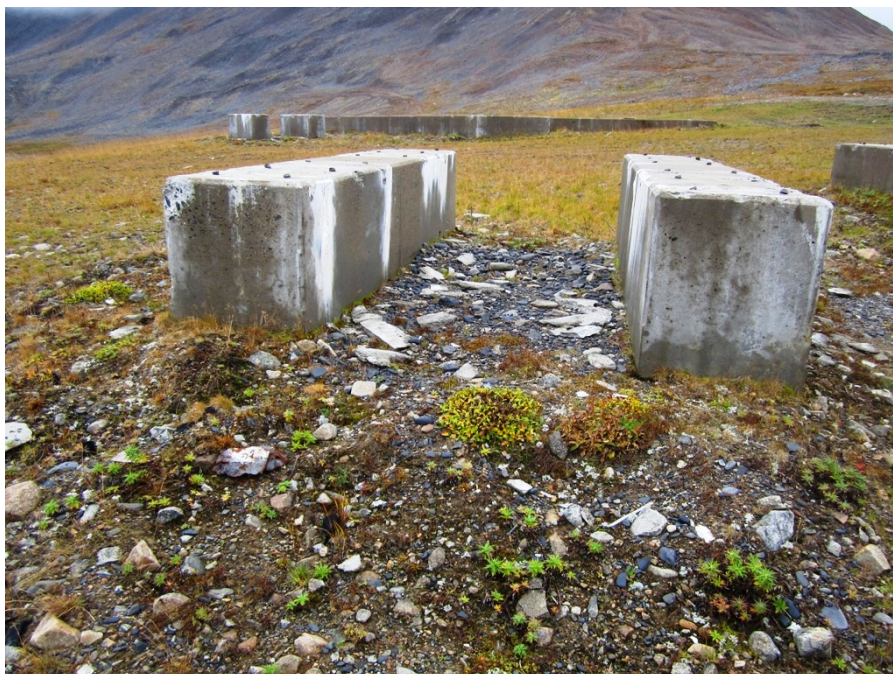
**Photo No. 111 – 13 September 2013
Miscellaneous debris at Site 31. View facing east.**

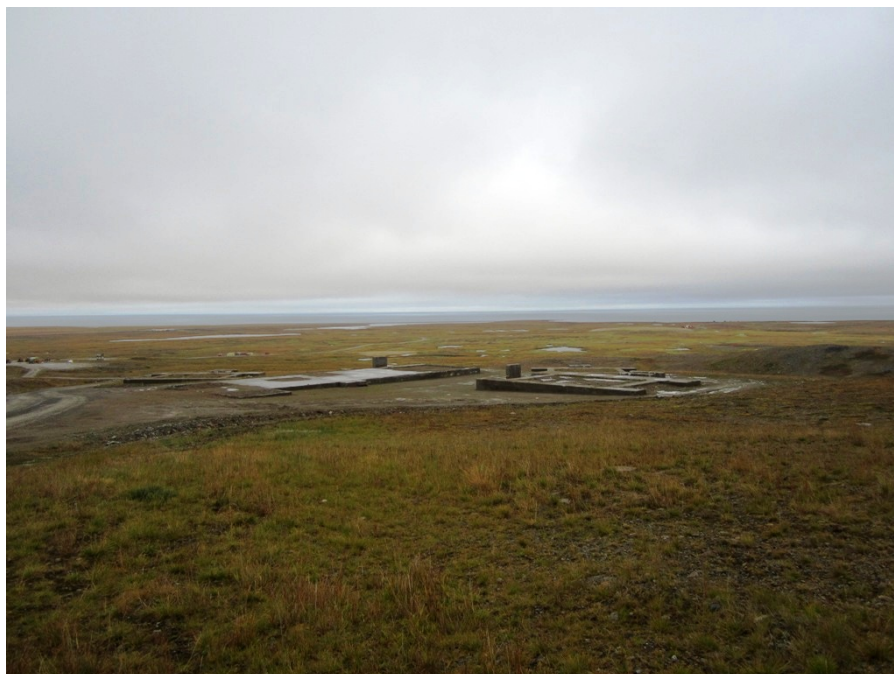
**Photo No. 115 – 13 September 2013
Remaining foundations (A, E) at Site 31. View facing north.**

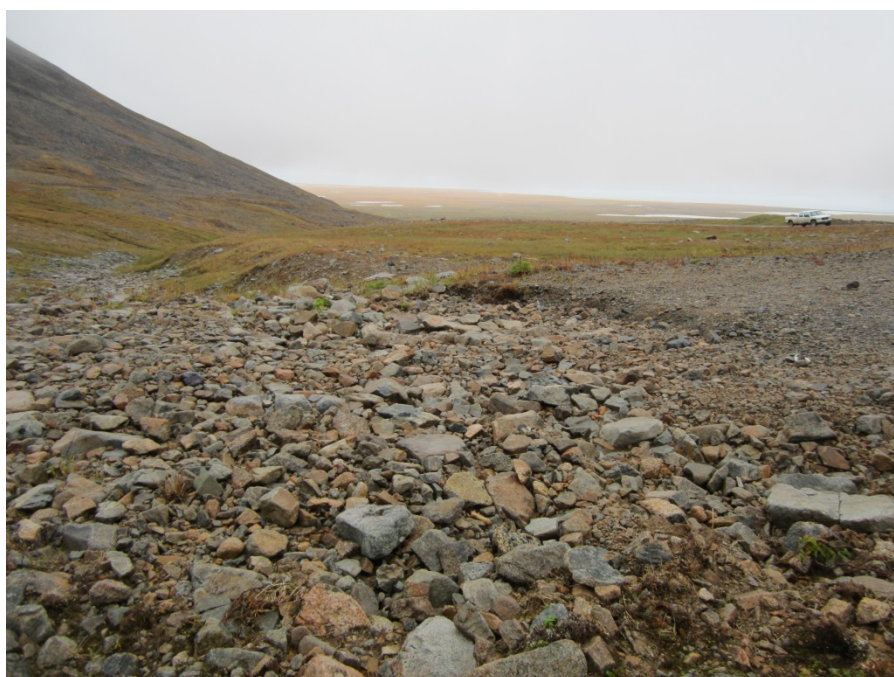
**Photo No. 116 – 13 September 2013
Condition of the road leading to Site 32. View facing north.**

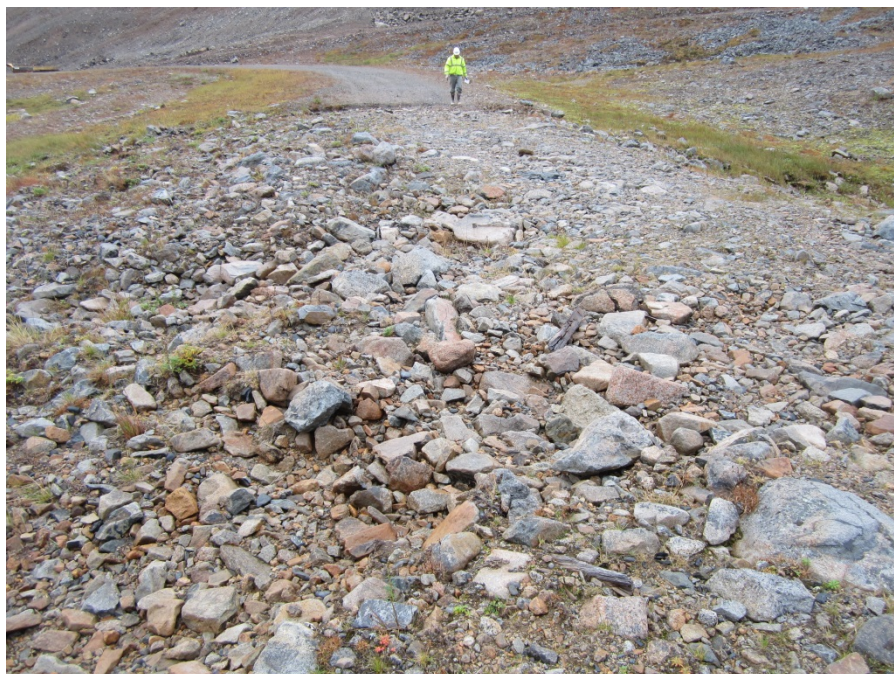
**Photo No. 117 – 13 September 2013
Condition of the road leading to Site 32. View facing east.**
