WORK PLAN ADDENDUM

2014 Northeast Cape HTRW Remedial Actions
Northeast Cape, St. Lawrence Island, Alaska

Contract No. W911KB-14-D-0006
Task Order 0002

August 2015

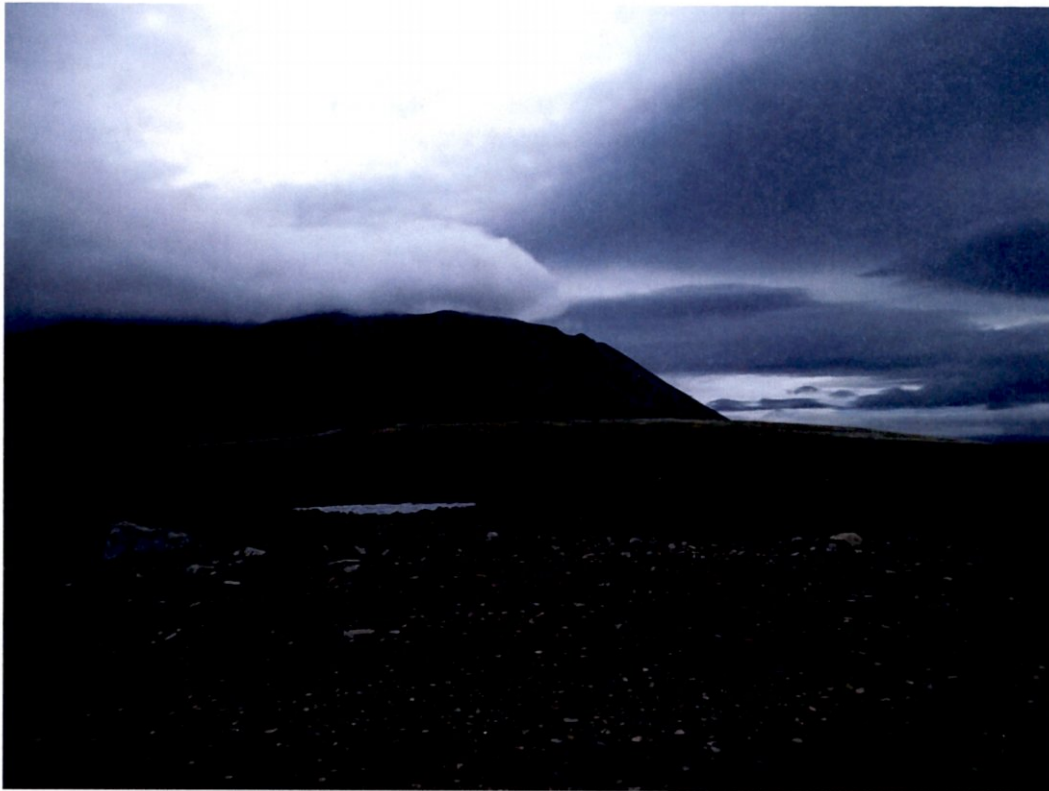
Photo 1: Site 7 Landfill - Overview of landfill area, facing SW.

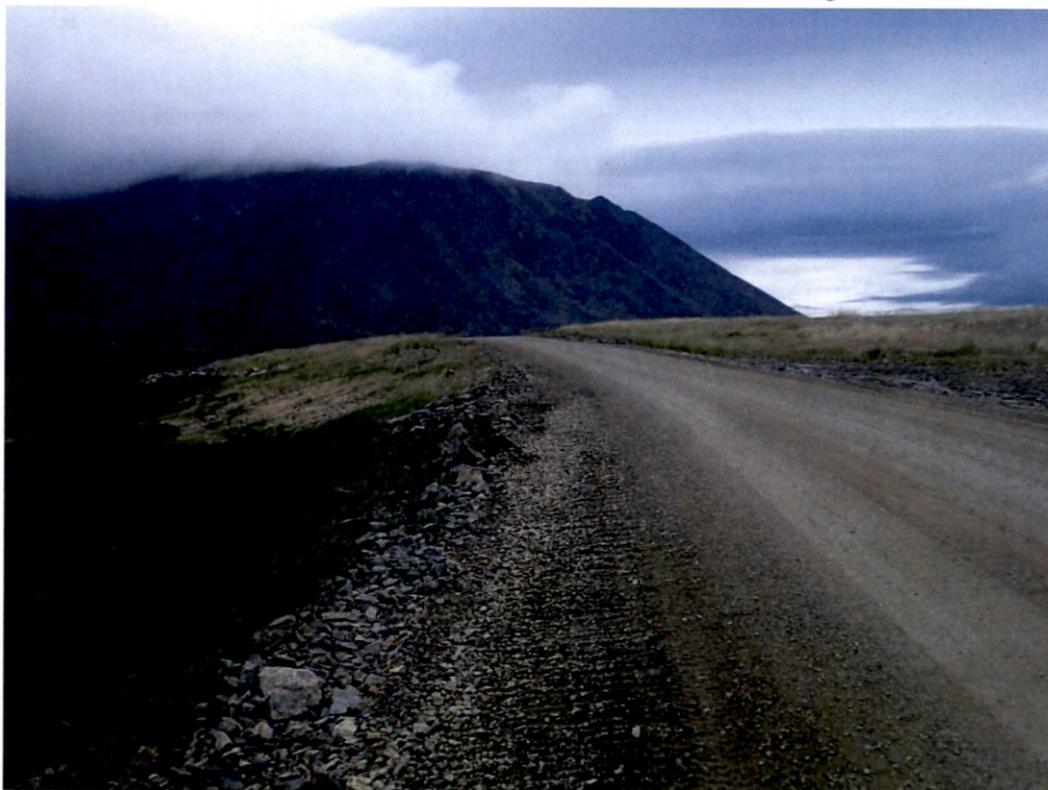
Photo 2: Site 7 Landfill - View of south side of landfill from Cargo Beach Road, facing SW.

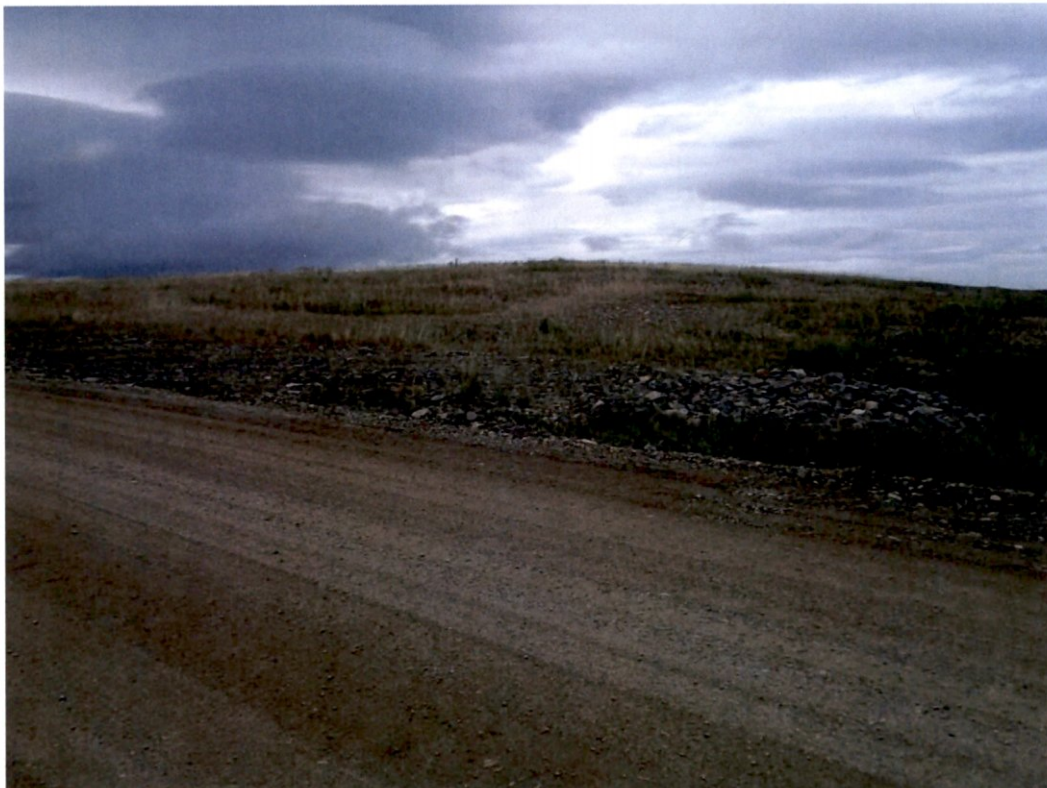
Photo 4: Site 7 Landfill – Southeast side of landfill from Cargo Beach Road, facing NW.

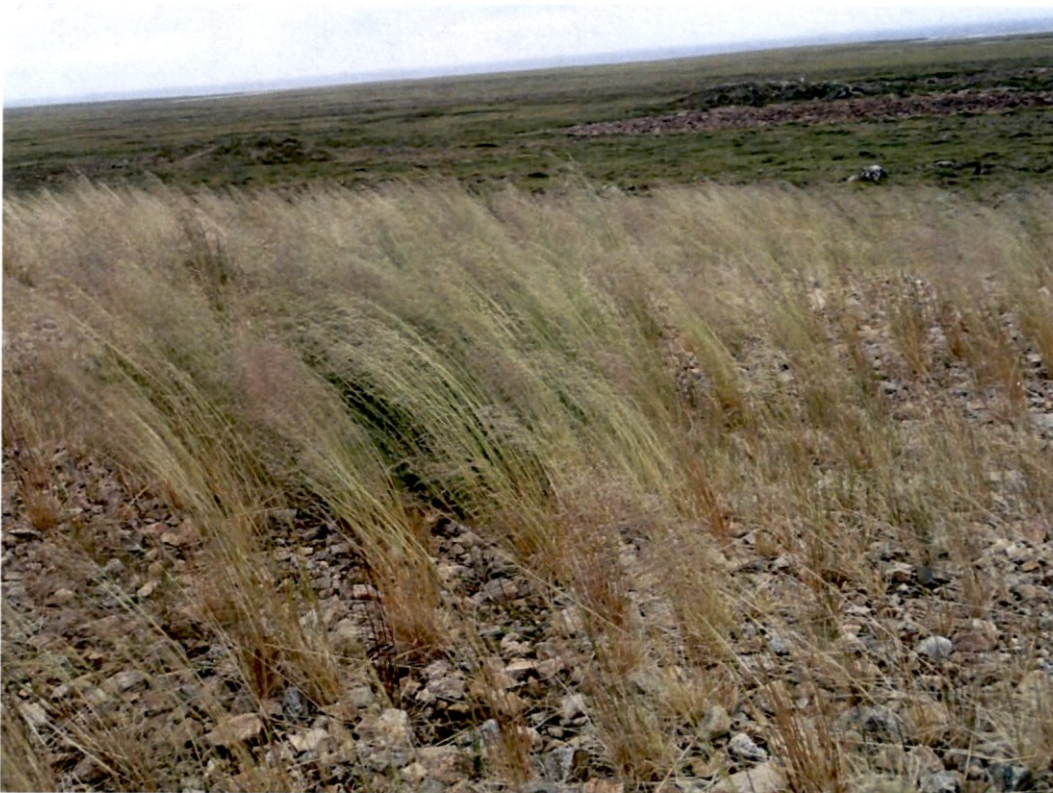
Photo 6: Site 7 Landfill – North slope of landfill, note tall grass tufts with seed, facing NW.

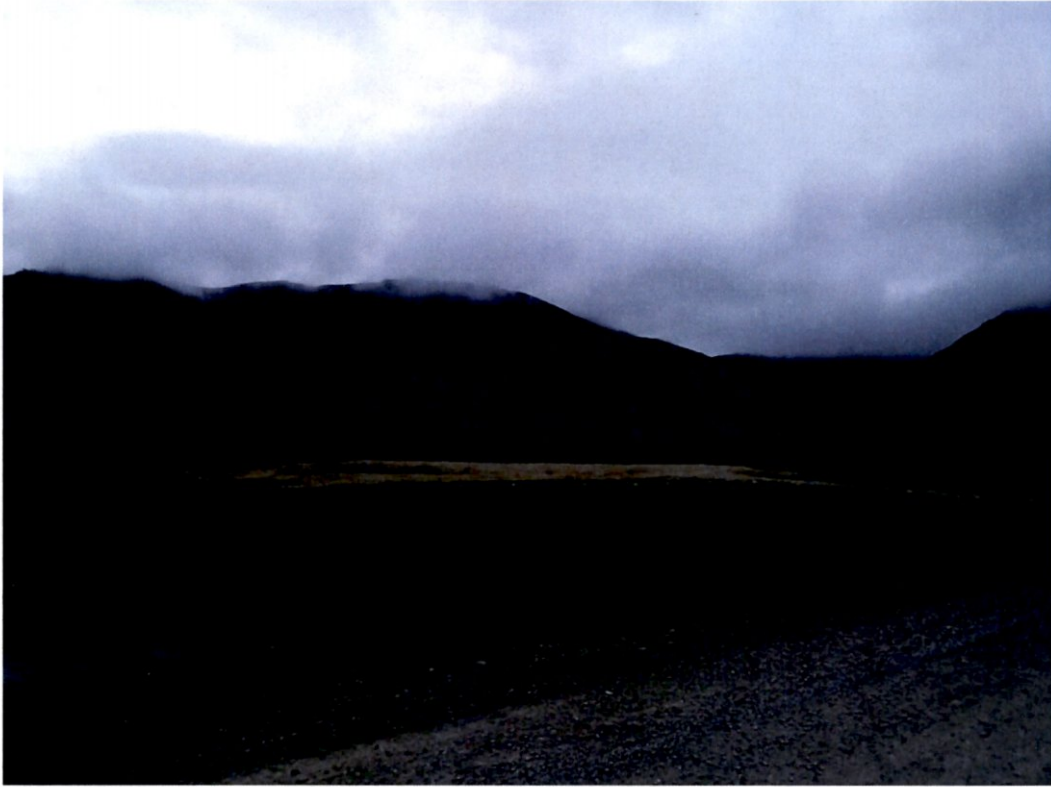
Photo 7: Site 9 Landfill – Overview of entire landfill area from site access road, facing south.

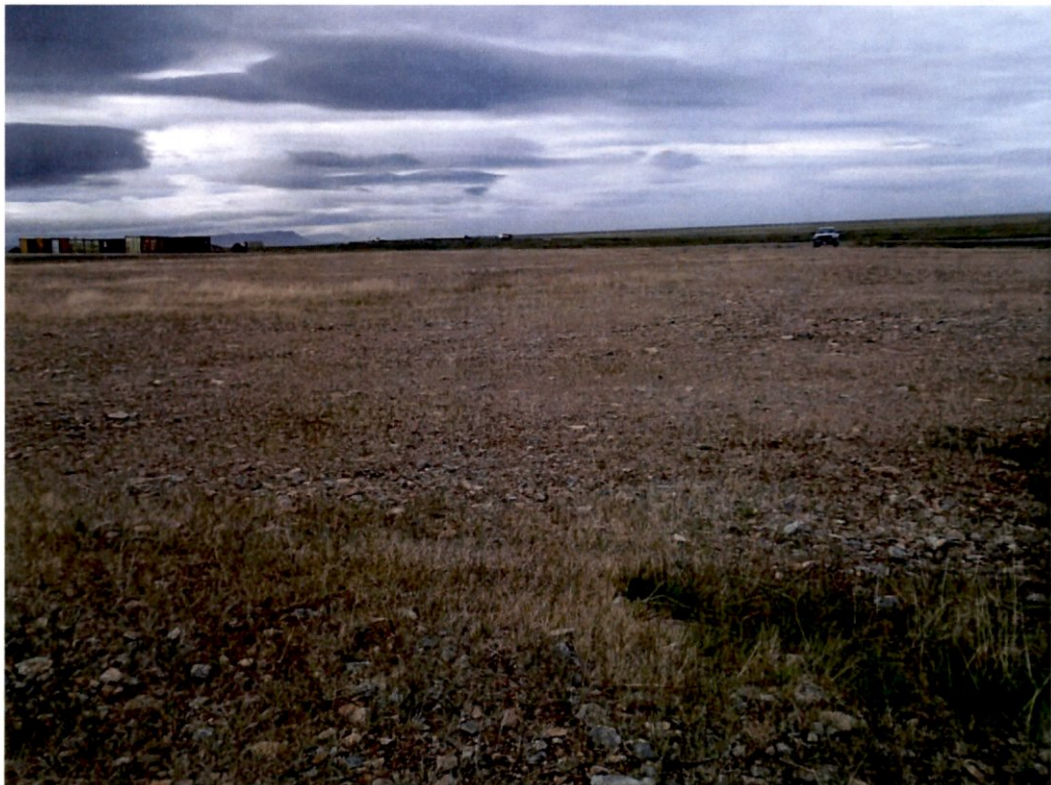
Photo 8: Site 9 Landfill – View of landfill facing west, MOC in background.

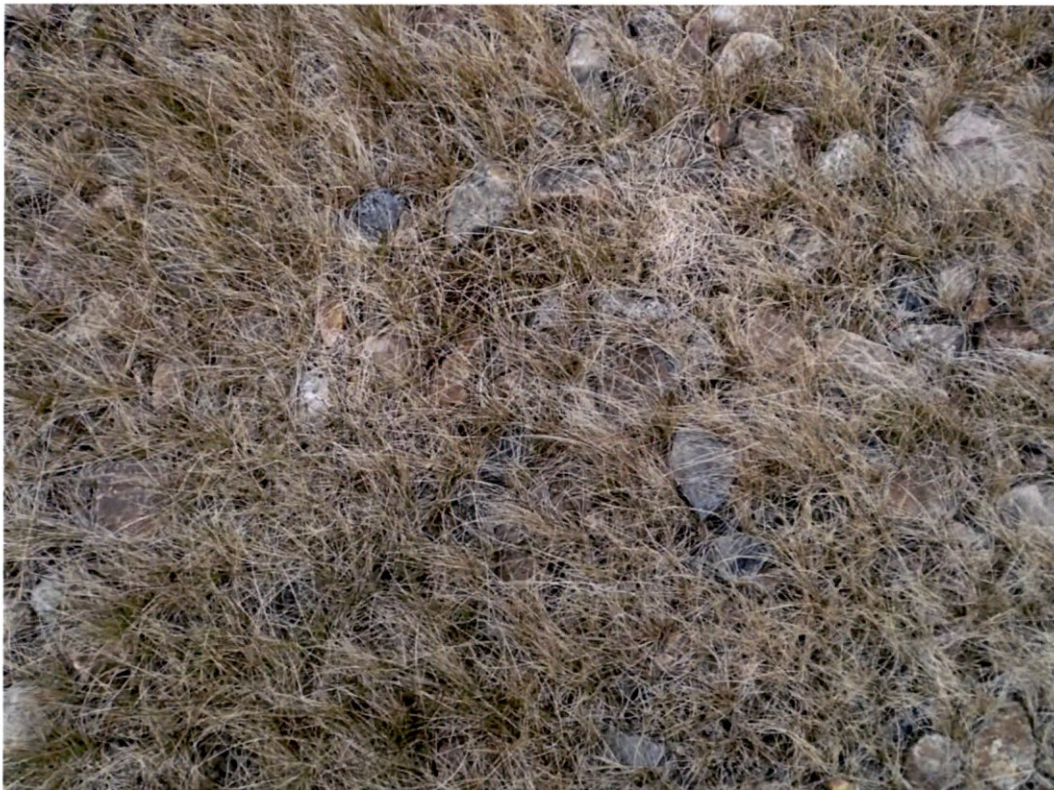
Photo 10: Site 9 Landfill – Close-up view of landfill vegetation.

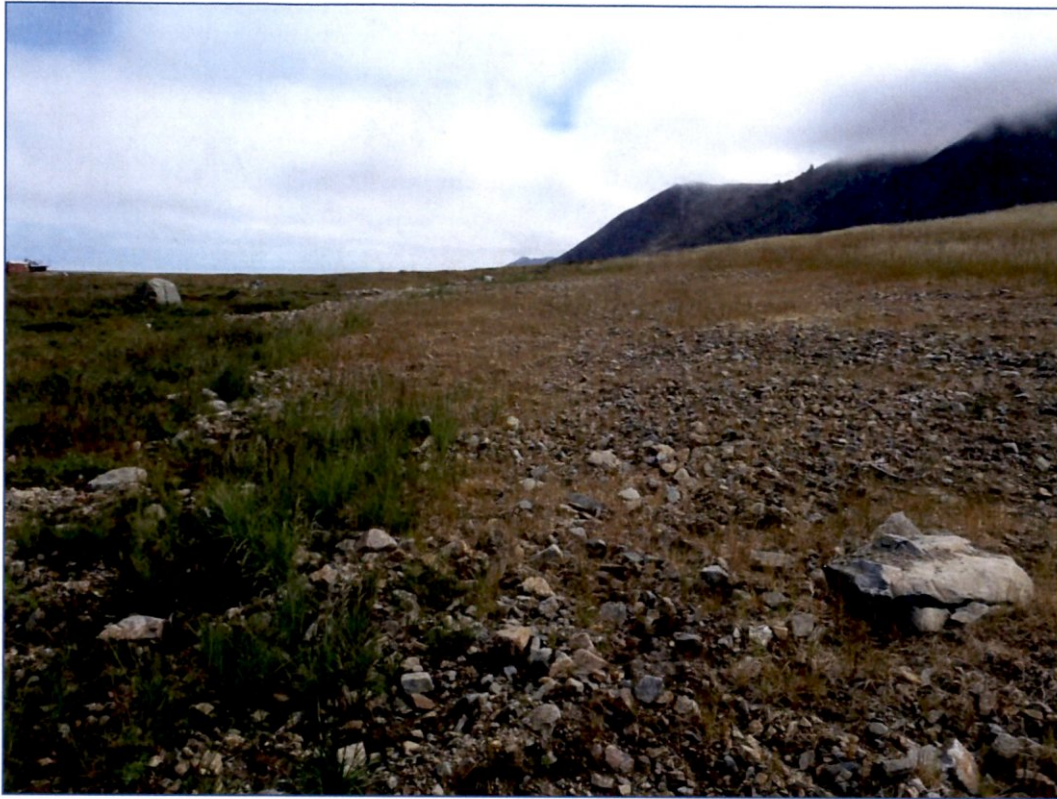
Photo 1: Site 7 Landfill – North slope of landfill, facing east.

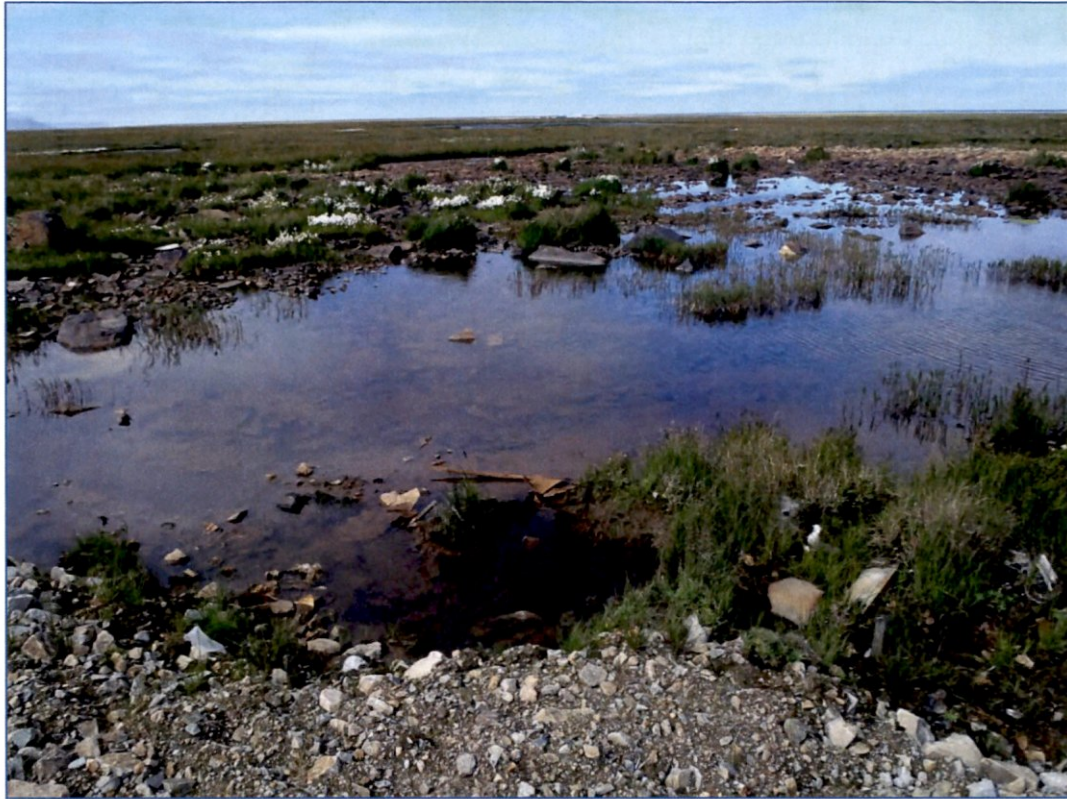
Photo 11: Site 7 Landfill – Surface water pond on northwest side of landfill, facing northwest with camp in background.

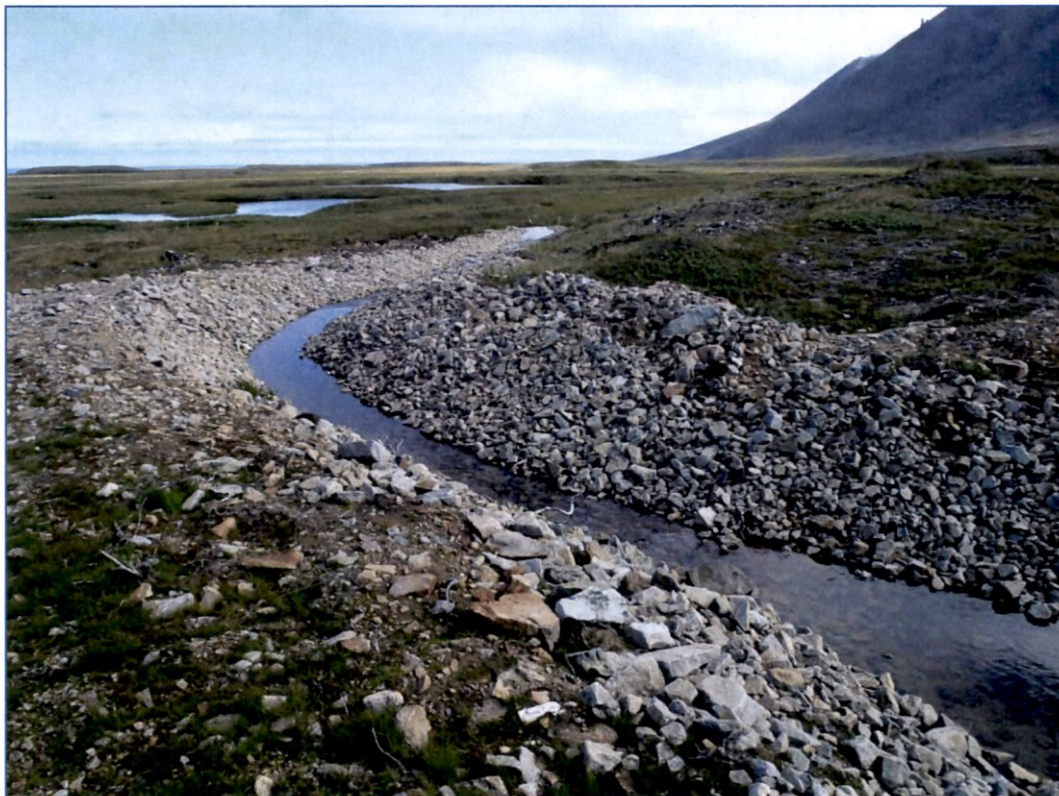
Photo 12: Site 9 Landfill – Drainage ditch operating well and in good condition, facing northeast.

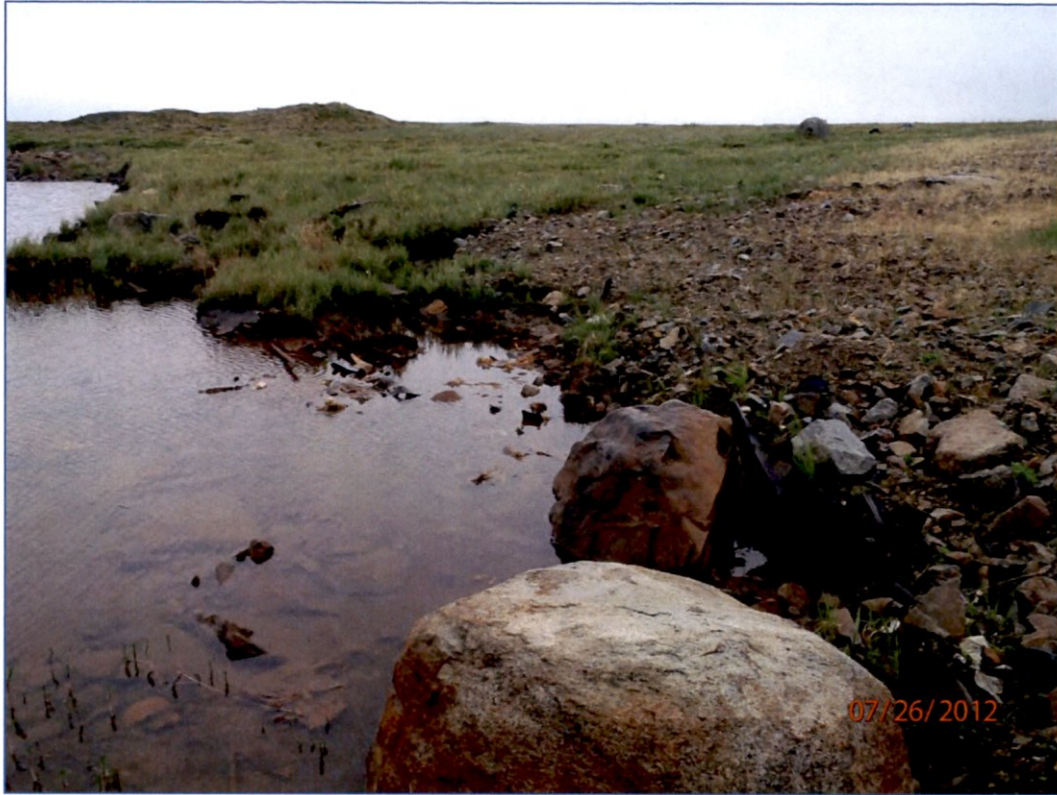
Photo 1: Site 7 Landfill – Pond on west side of landfill, facing north.

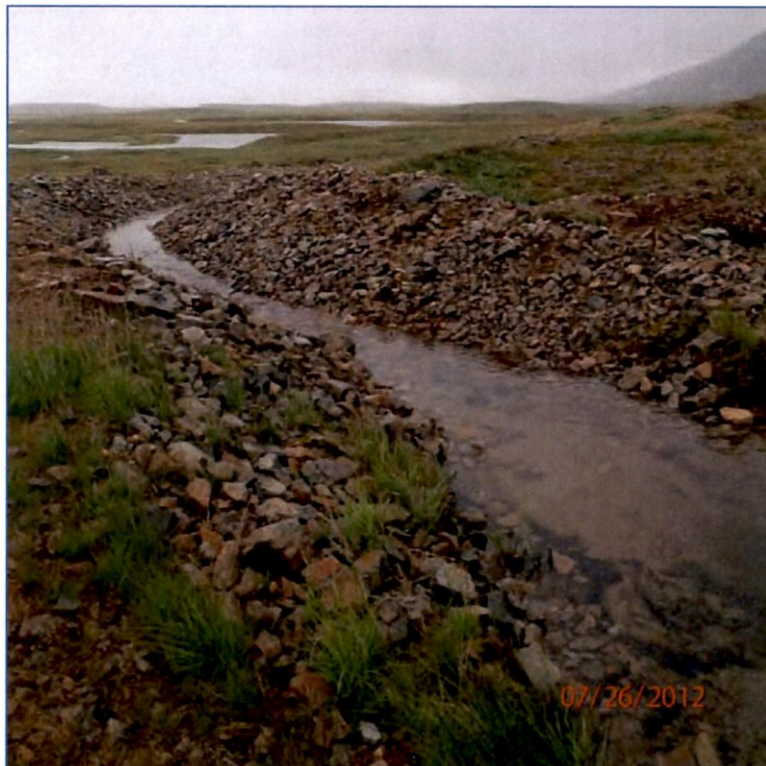
Photo 10: Site 9 Landfill – Pond outlet ditch in good condition and operating efficiently, facing northeast.

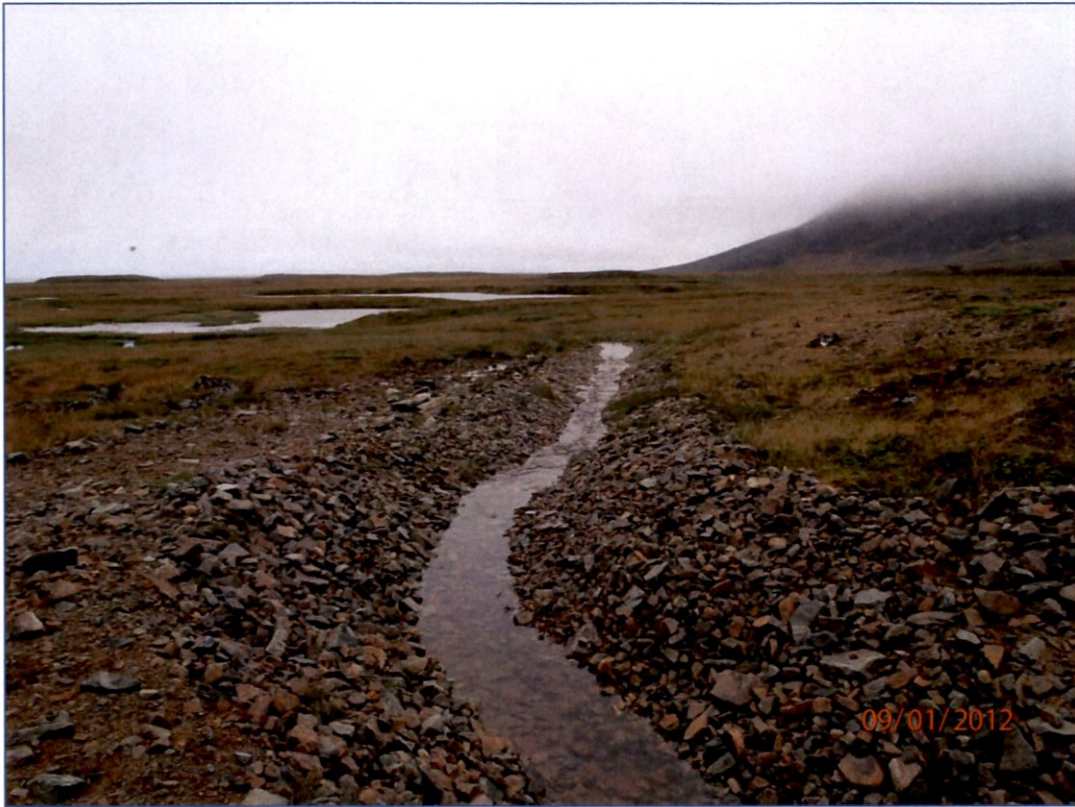
Photo 11: Site 9 Landfill – Diversion ditch in good condition, facing northeast.

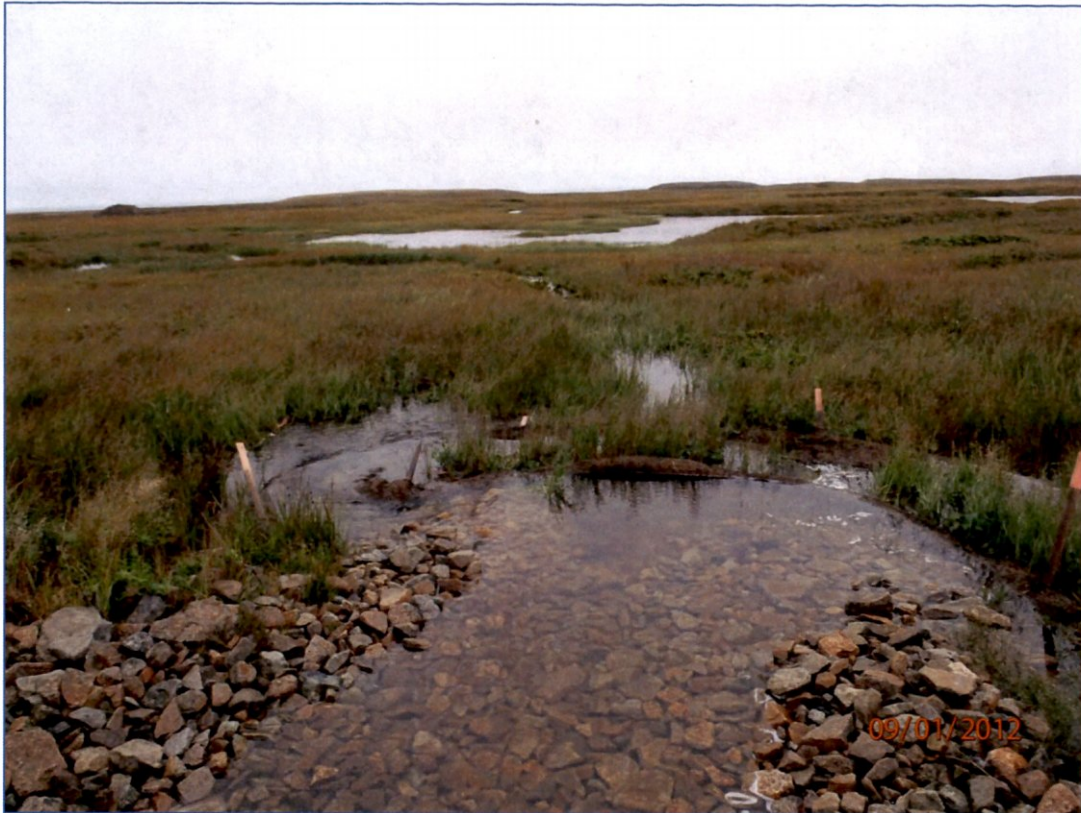
Photo 13: Site 9 Landfill – Diversion ditch outfall area into wetland, facing north.

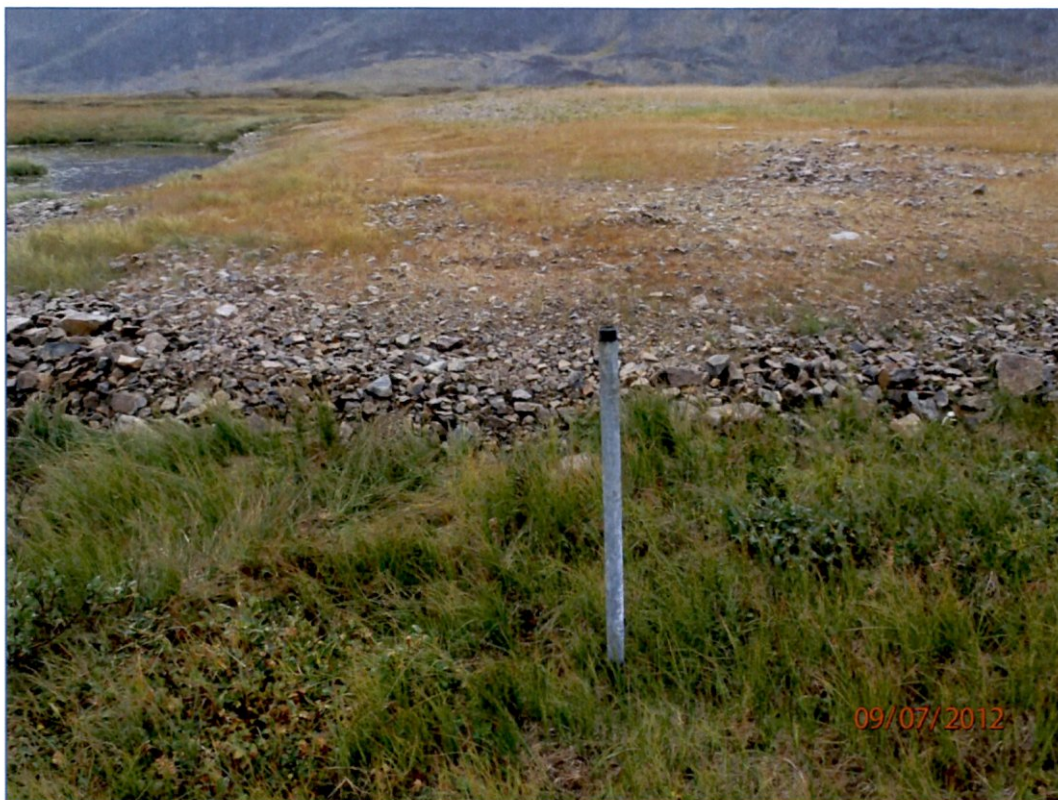
Photo 15: Site 9 Landfill – Drive point well on east corner of landfill (removed in 2012) facing southwest.

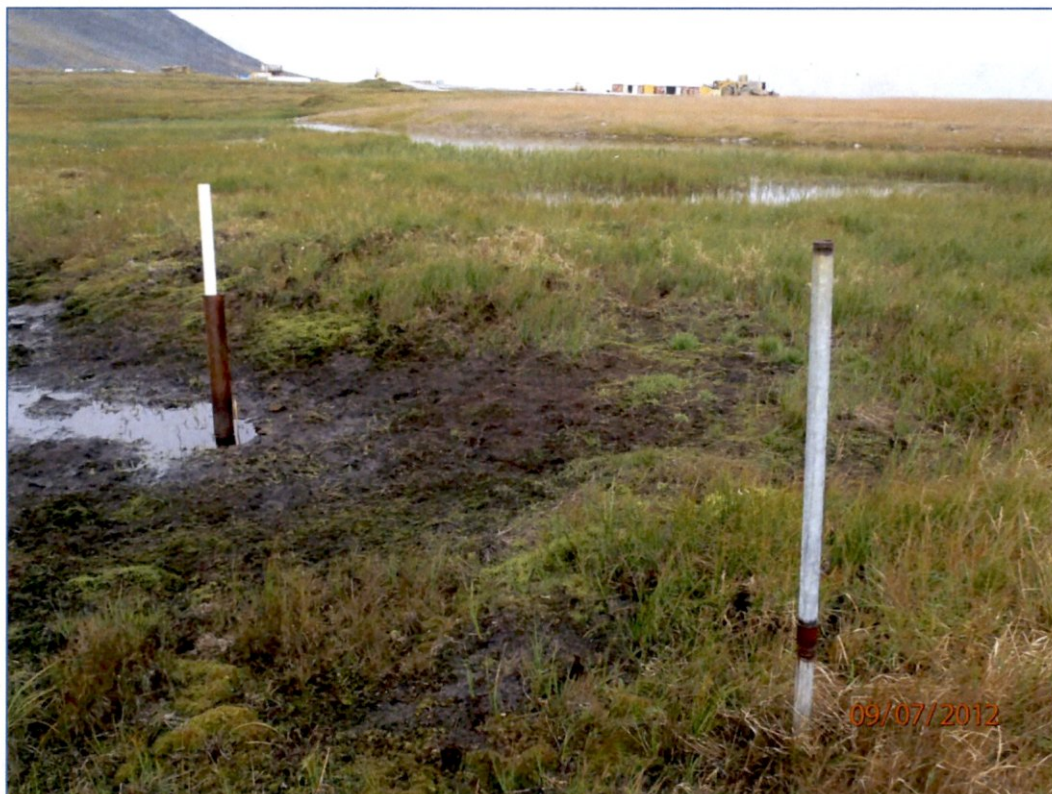
Photo 16: Site 9 Landfill – Drive point well (removed in 2012) and PVC monitoring well on east side of landfill, facing west.

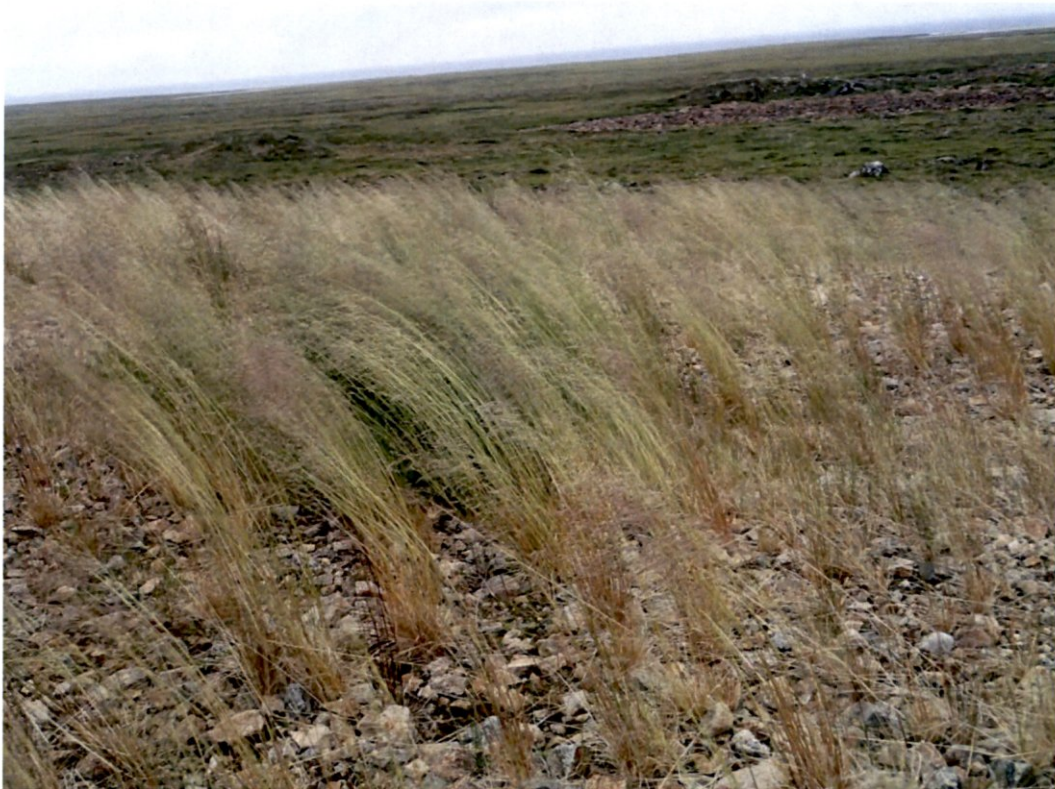
Photo 6: Site 7 Landfill – North slope of landfill, note tall grass tufts with seed, facing NW.

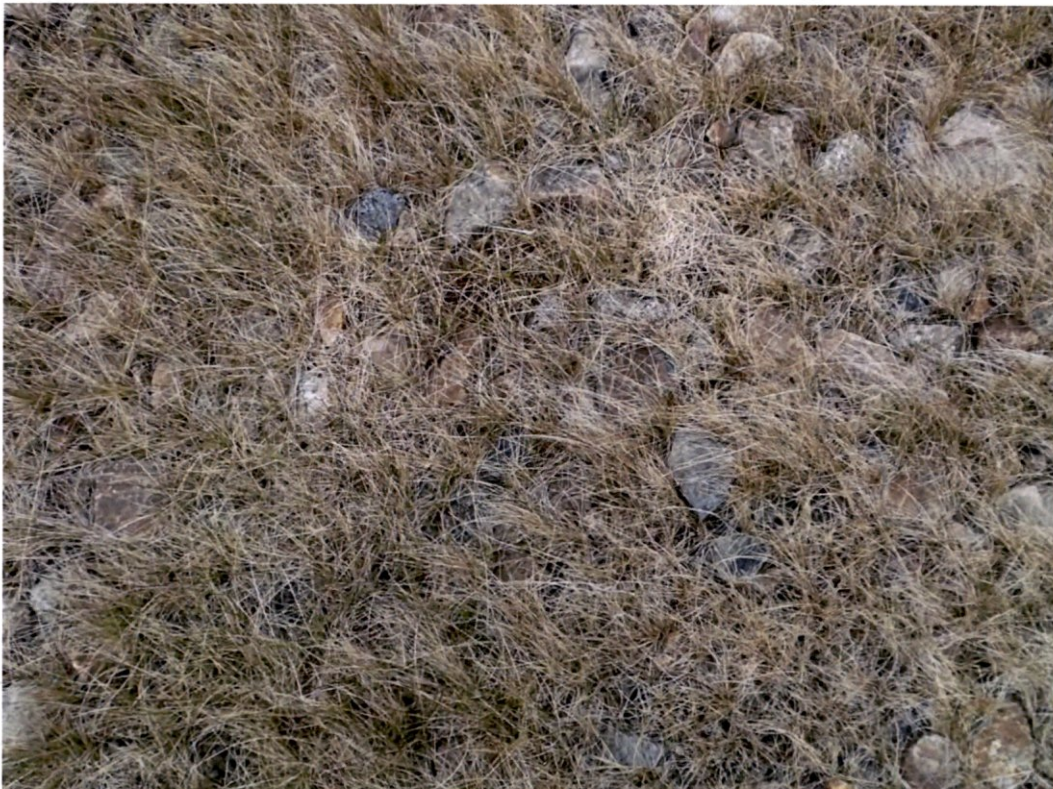
Photo 10: Site 9 Landfill – Close-up view of landfill vegetation.

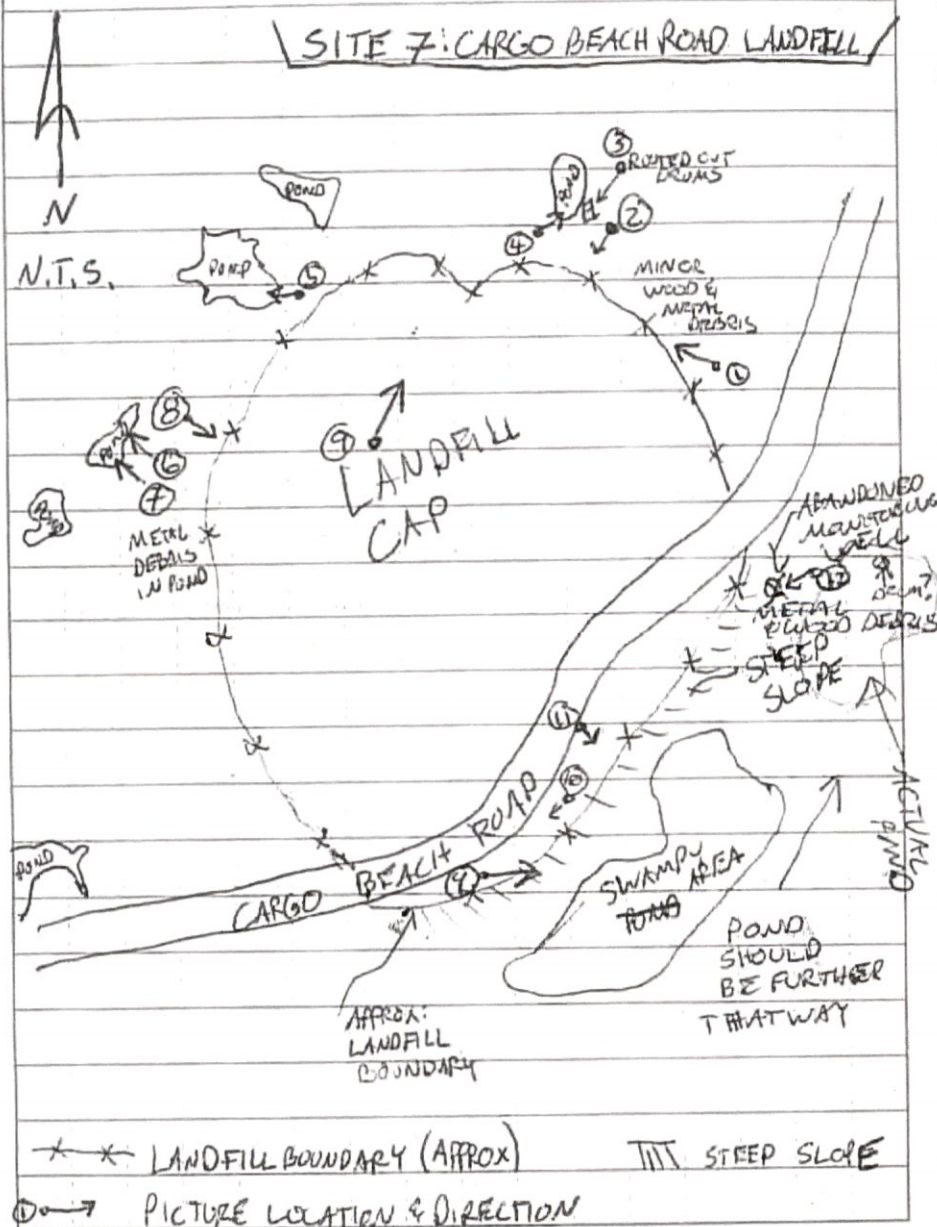
1517 THE LANDFILL COVER APPEARS TO CONSIST OF FINE AND COARSE GRAVEL AT THE SURFACE WITH PATCHY GRASS COVER

1523 CARGO BEACH ROAD CROSSES THE LANDFILL CAP. NO SETTLEMENT OBSERVED GRADING/DRAINAGE APPEARS ADEQUATE
