NATIVE VILLAGE OF NORTHEAST CAPE SITE INVESTIGATION REPORT REVISION 1

**Northeast Cape, St. Lawrence Island, Alaska
December 2009**

**Prepared for:
Native Village of Savoonga IRA Council
P.O. Box 120
Savoonga, Alaska 99769**

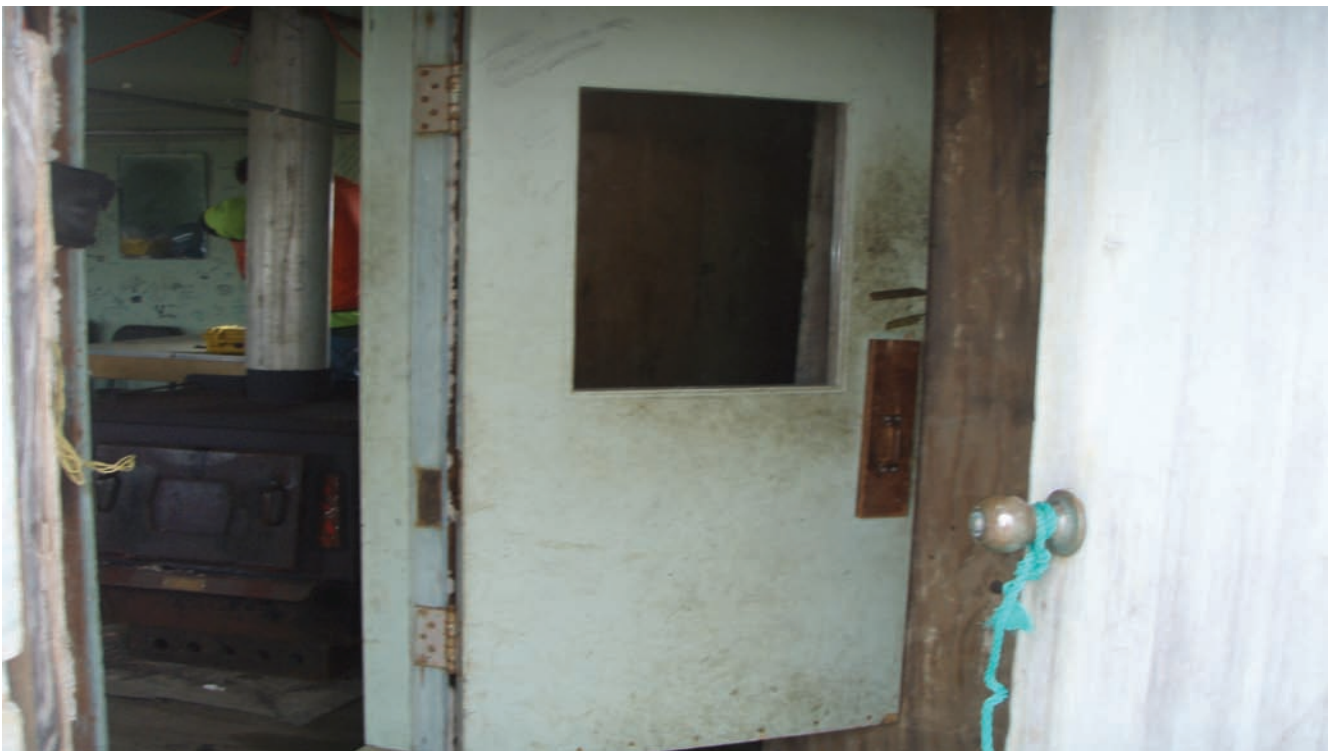
Photograph #2: Structure #1 Interior Door with Green LBP
Direction: East

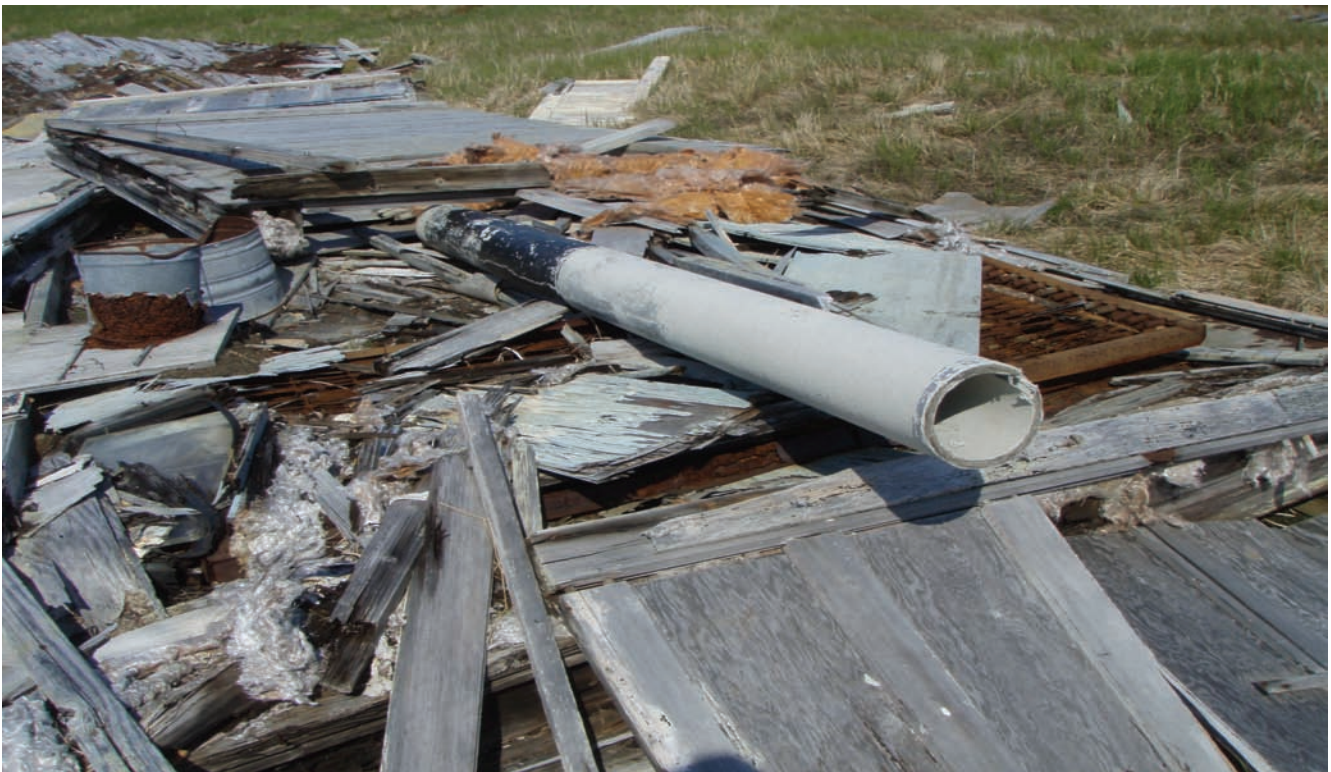
Photograph #4: NVNC Debris Pile with 6" ACM Transite Pipe
Direction: West

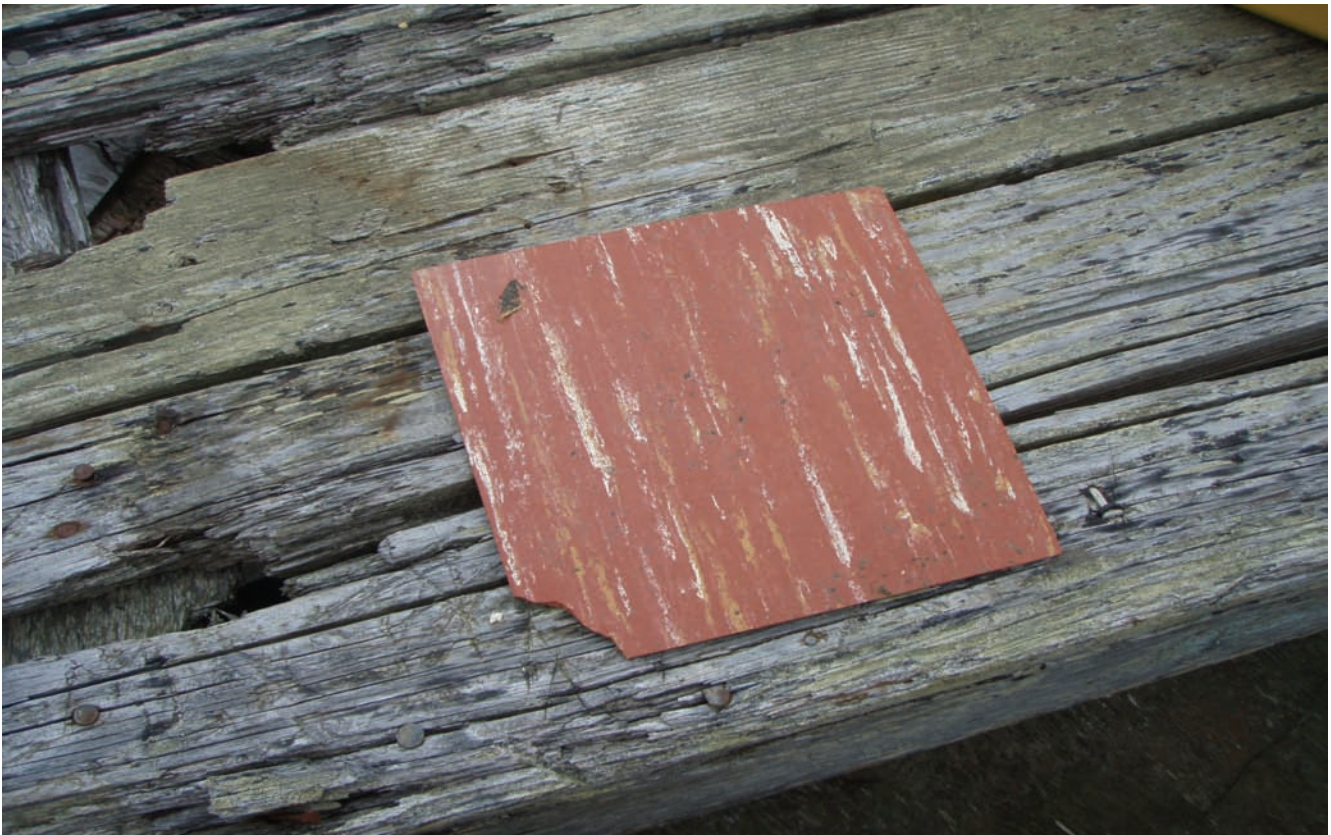
Photograph #7: 9" x 9" ACM Tile Outside Structure #3
Direction: N/A

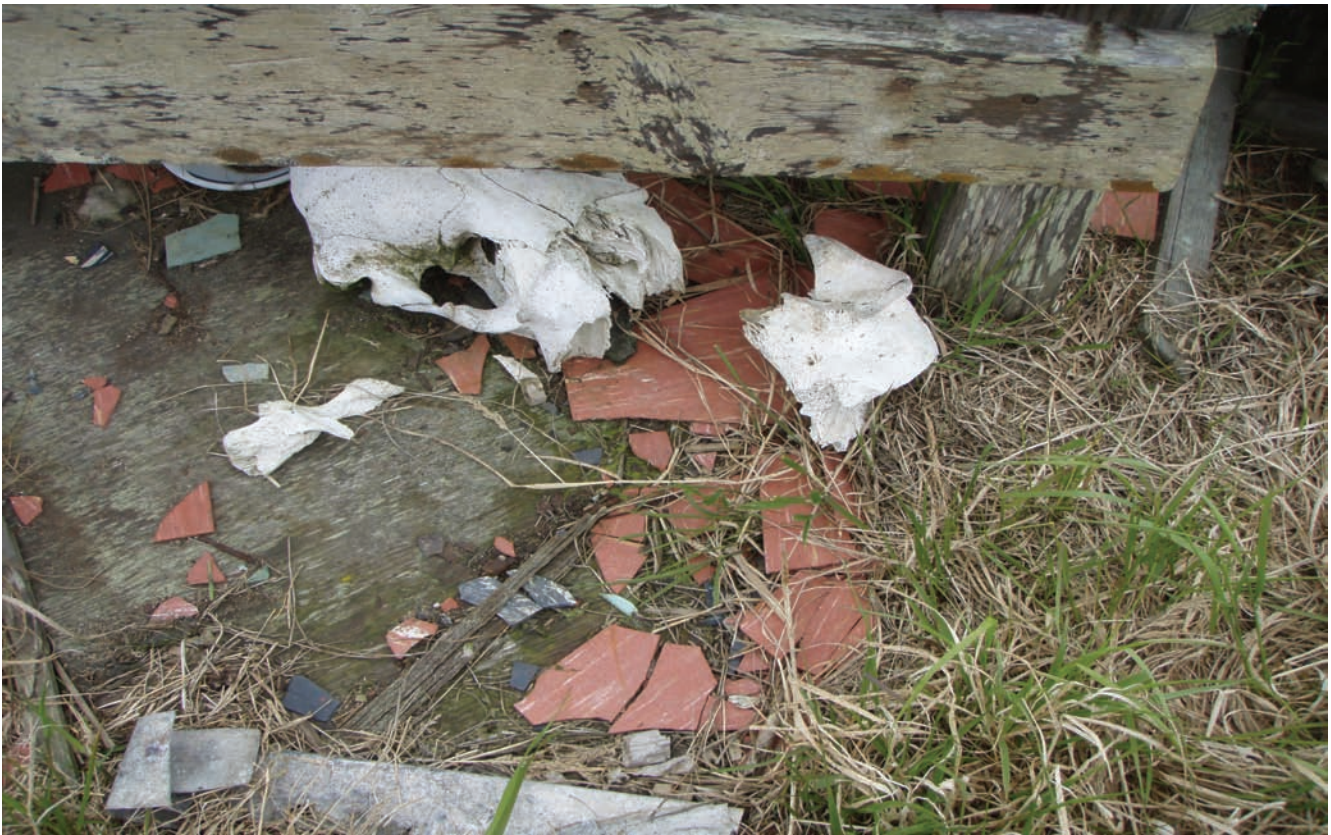
Photograph #9: Broken 9' x 9' ACM Tile Outside Structure #3
Direction: N/A

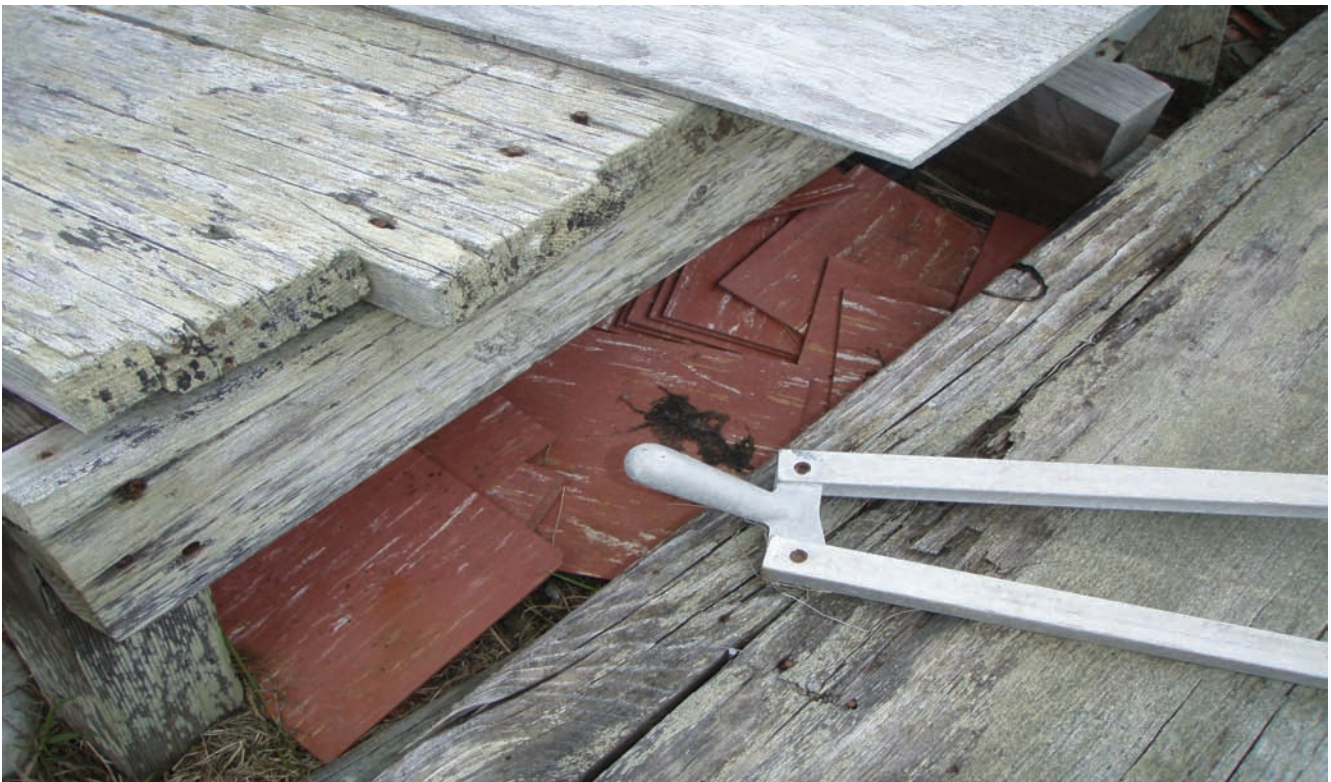
Photograph #10: Intact 9' x 9' ACM Tile Outside Structure #3
Direction: N/A

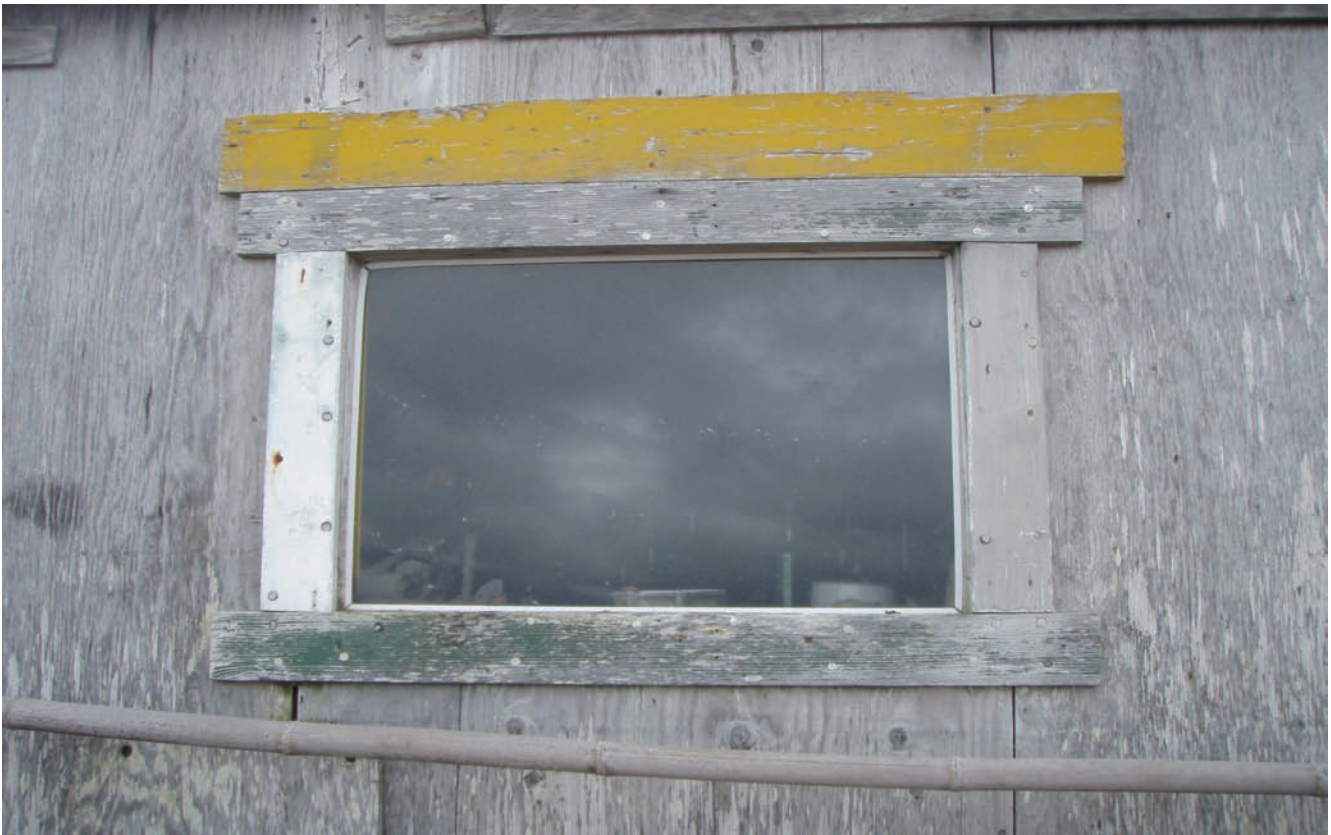
Various building materials tested positive for lead. These materials include window trim, walls, ceiling rafters, interior and exterior doors, and miscellaneous debris. The highest concentration of lead detected was $5.8 \text{ mg}/\text{cm}^2$, which was found in the yellow window trim in Structure #3. Structure #3 is owned by Mr. Eugene Toolie.

Photograph #11: Structure #3 Window Trim with LBP
Direction: South

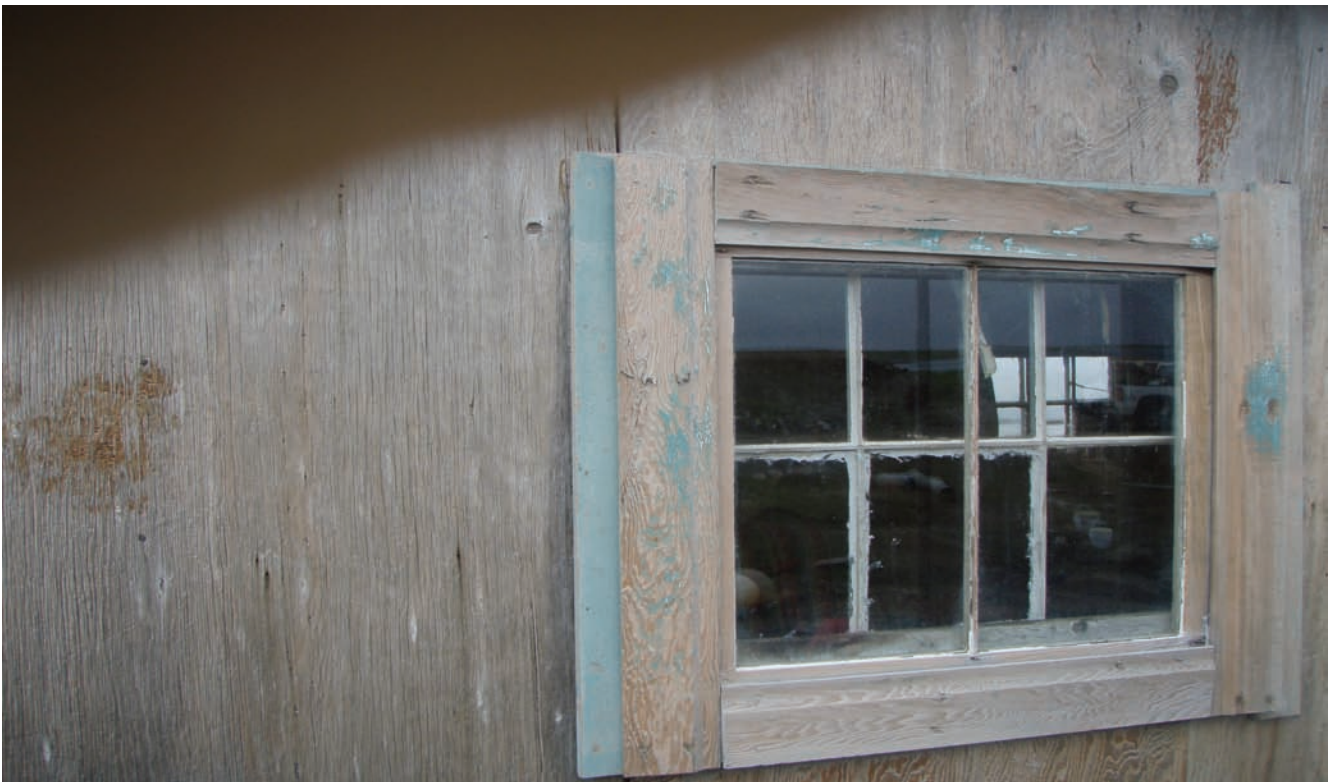
Photograph #12: Structure #3 Green Window Trim with LBP
Direction: West

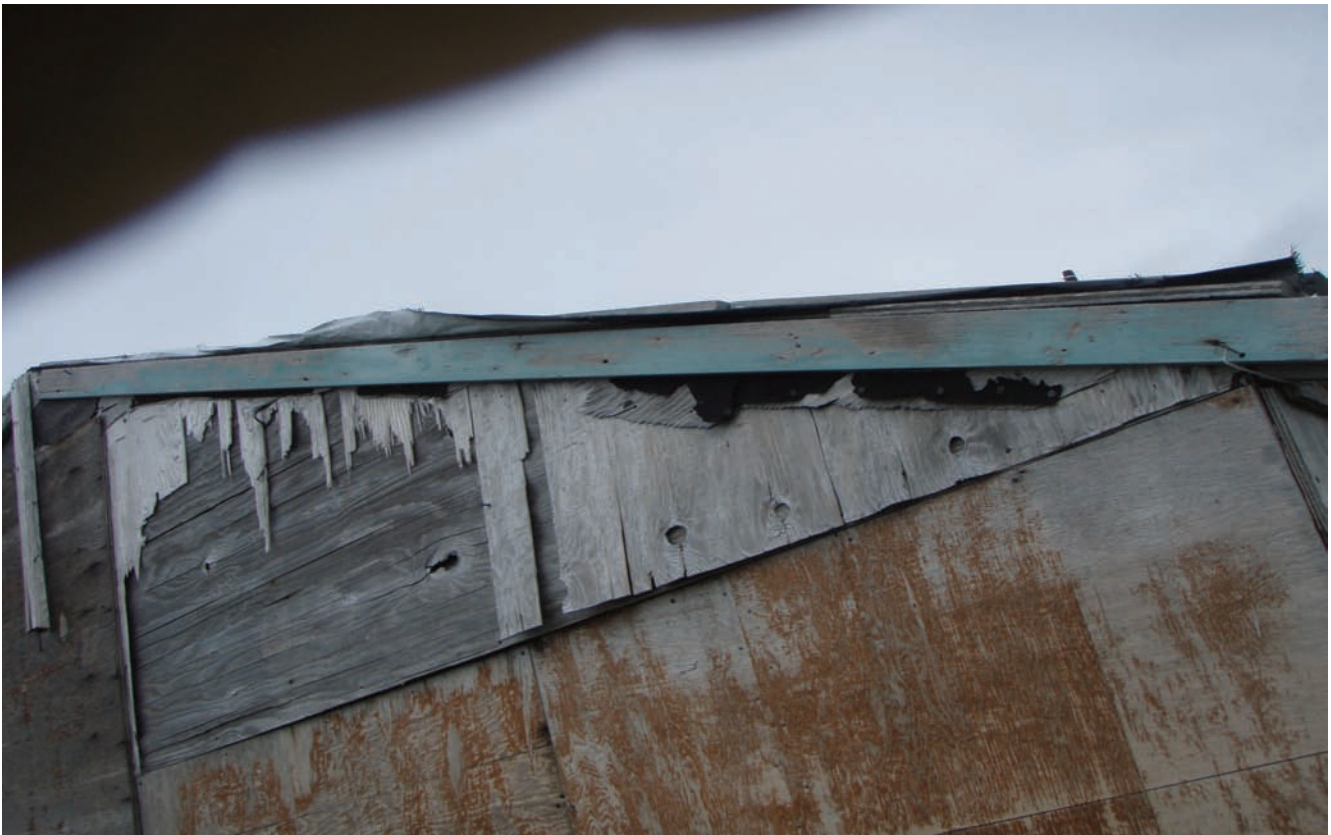
Photograph #13: Structure #3 Green Fascia with LBP
Direction: Unknown

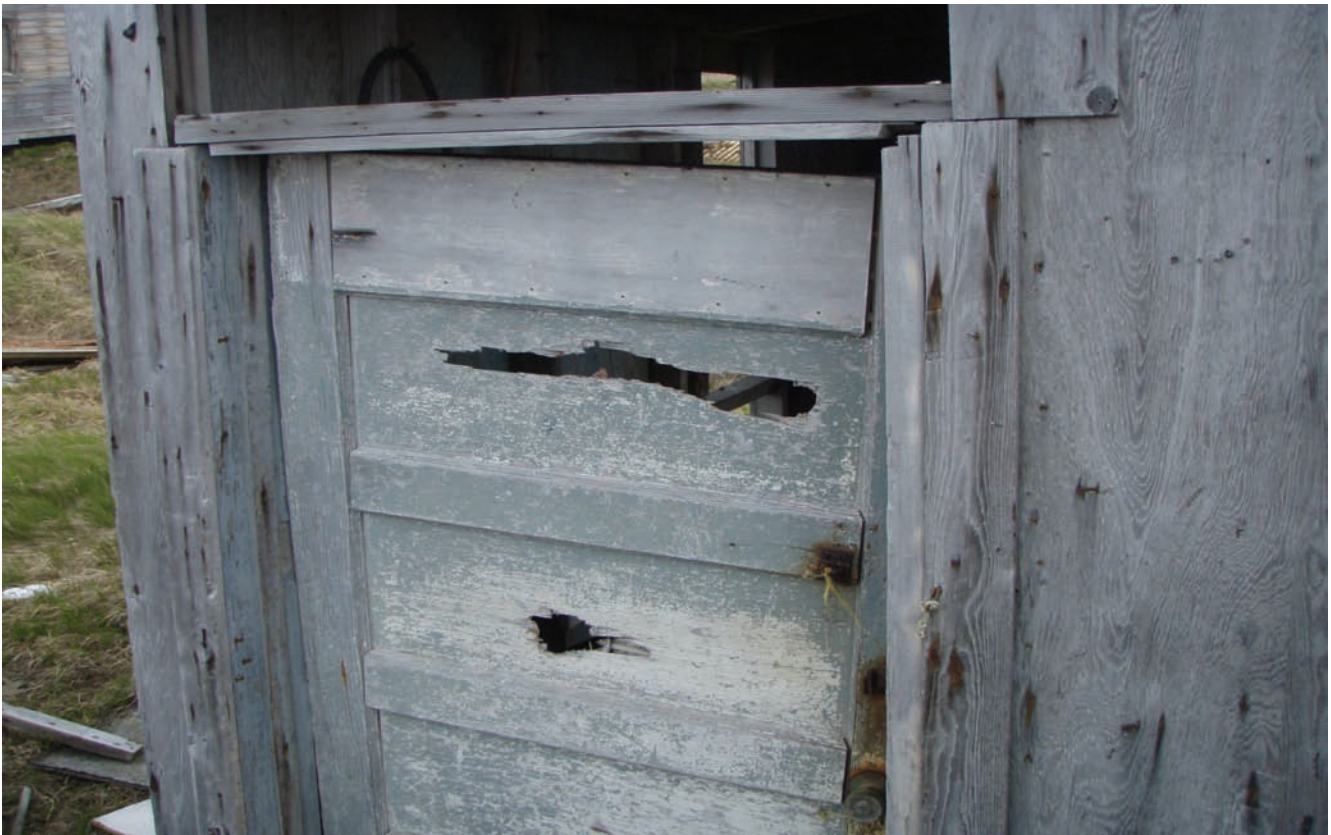
Photograph #15: Structure #4 Exterior Door with LBP
Direction: East

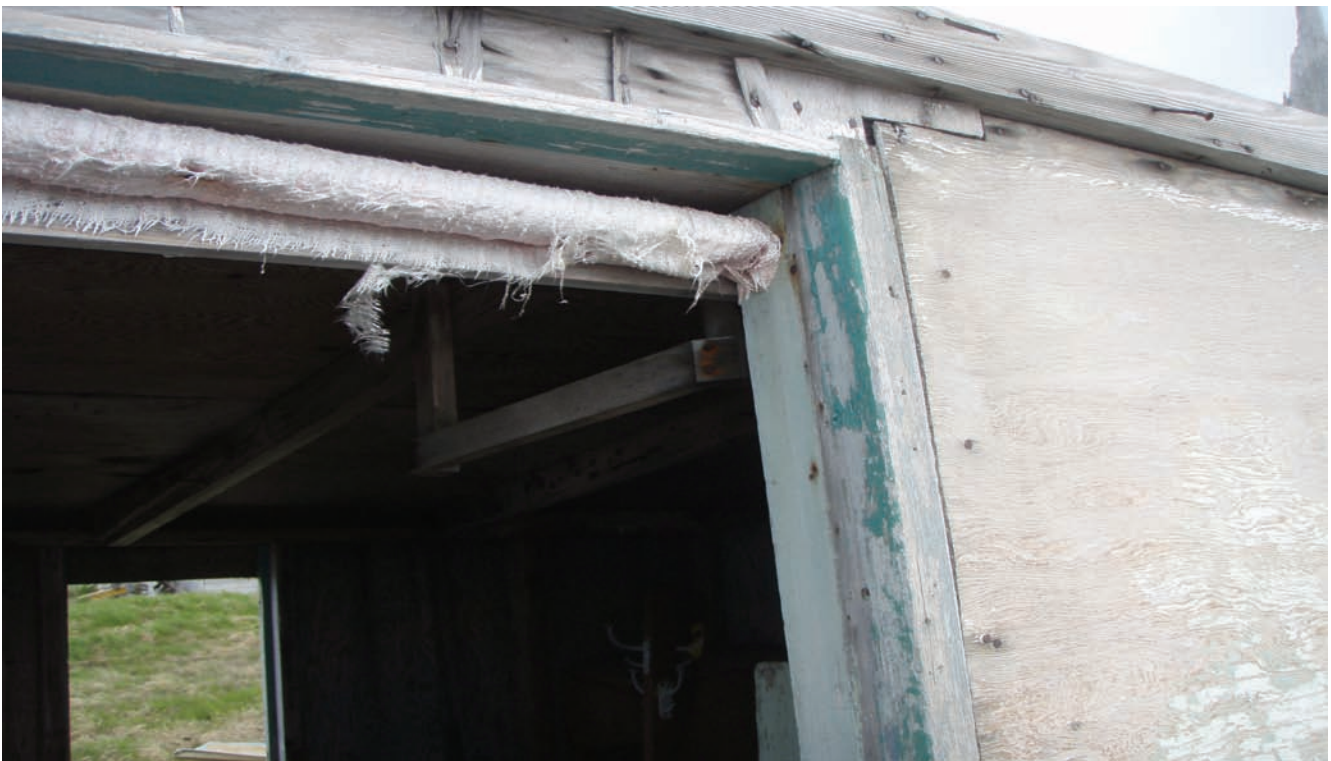
Photograph #16: Structure #4 Green Door Frame with LBP
Direction: North

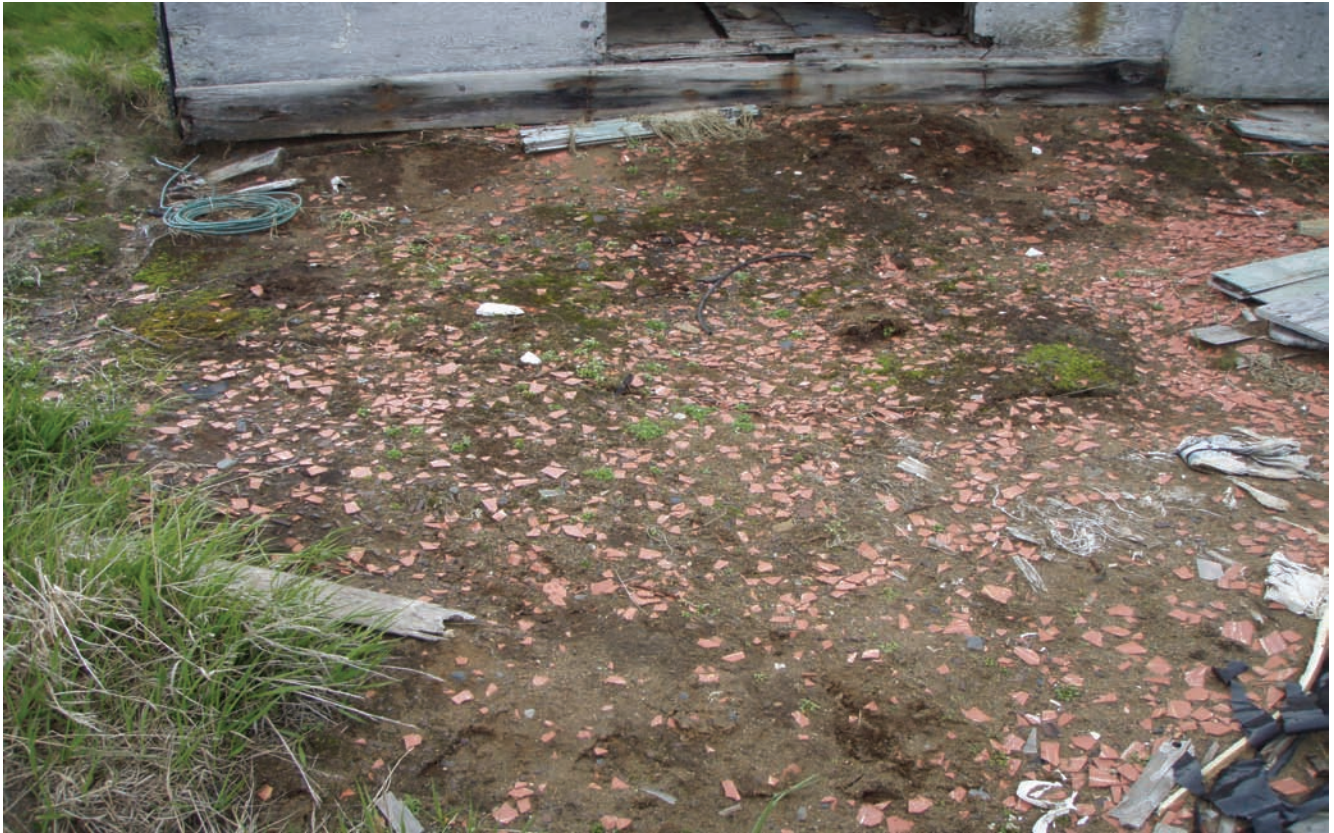
Photograph #17: Structure #5 ACM Suspect Broken Tile
Direction: South

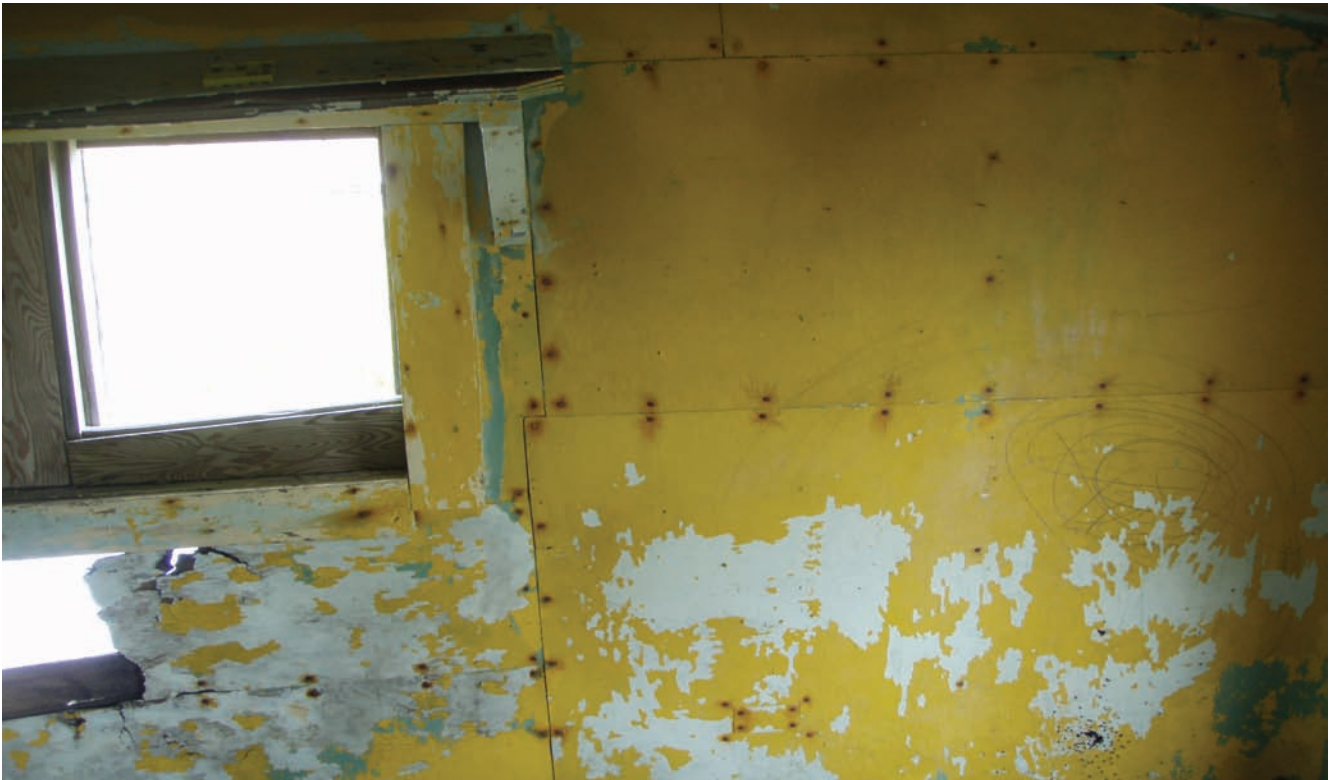
Photograph #18: Structure #6 Interior with Yellow LBP
Direction: East

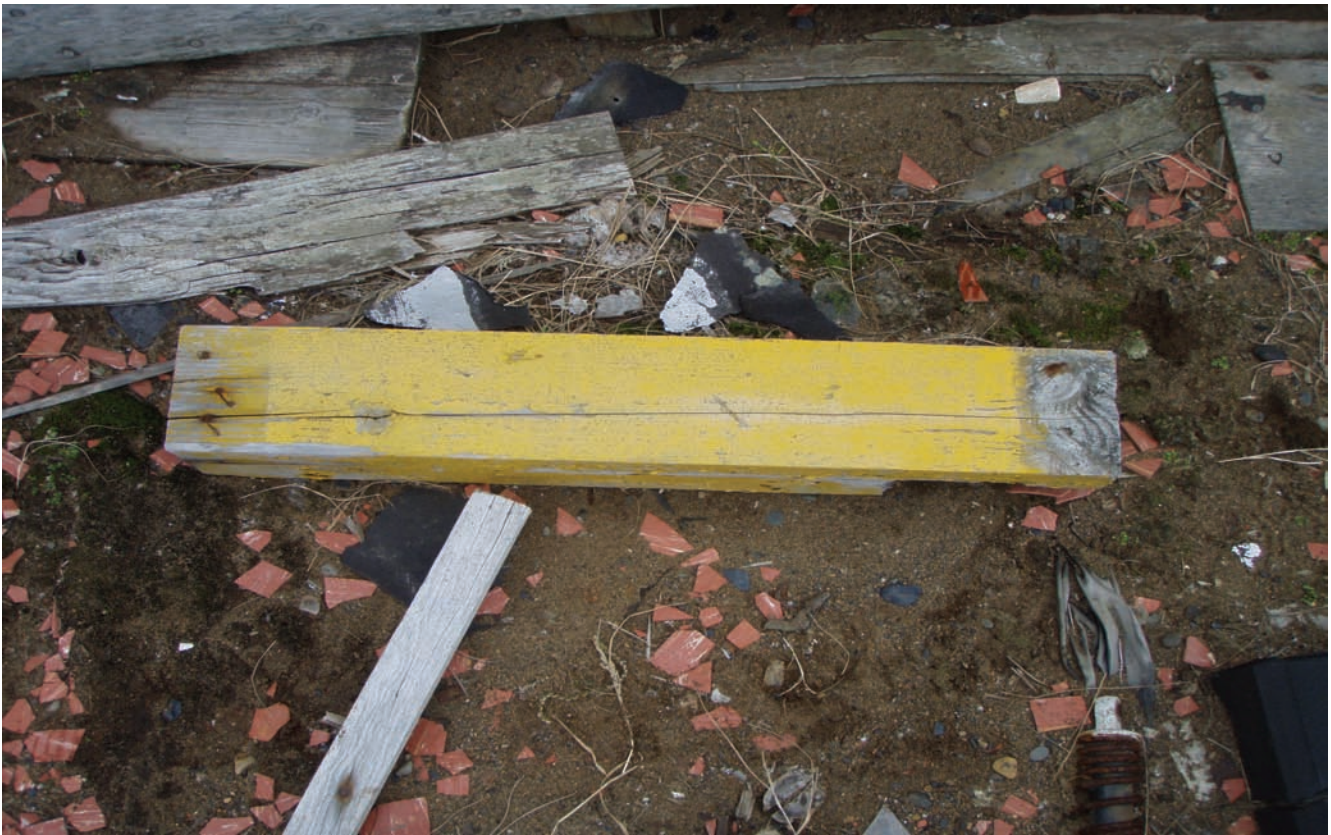
Photograph #19: Structure #5 Exterior 4" x 4" Post with Yellow LBP
Direction: South

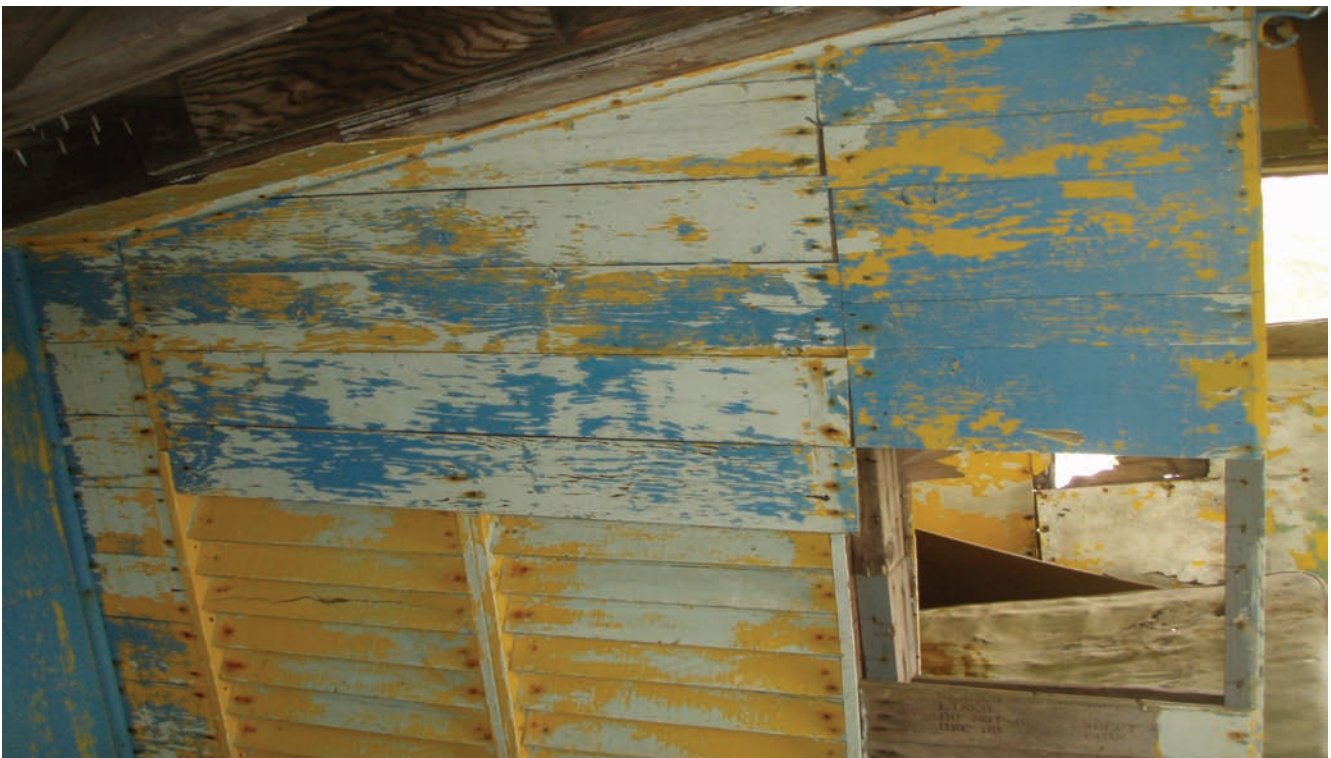
Photograph #20: Structure #6 Interior with LBP
Direction: East

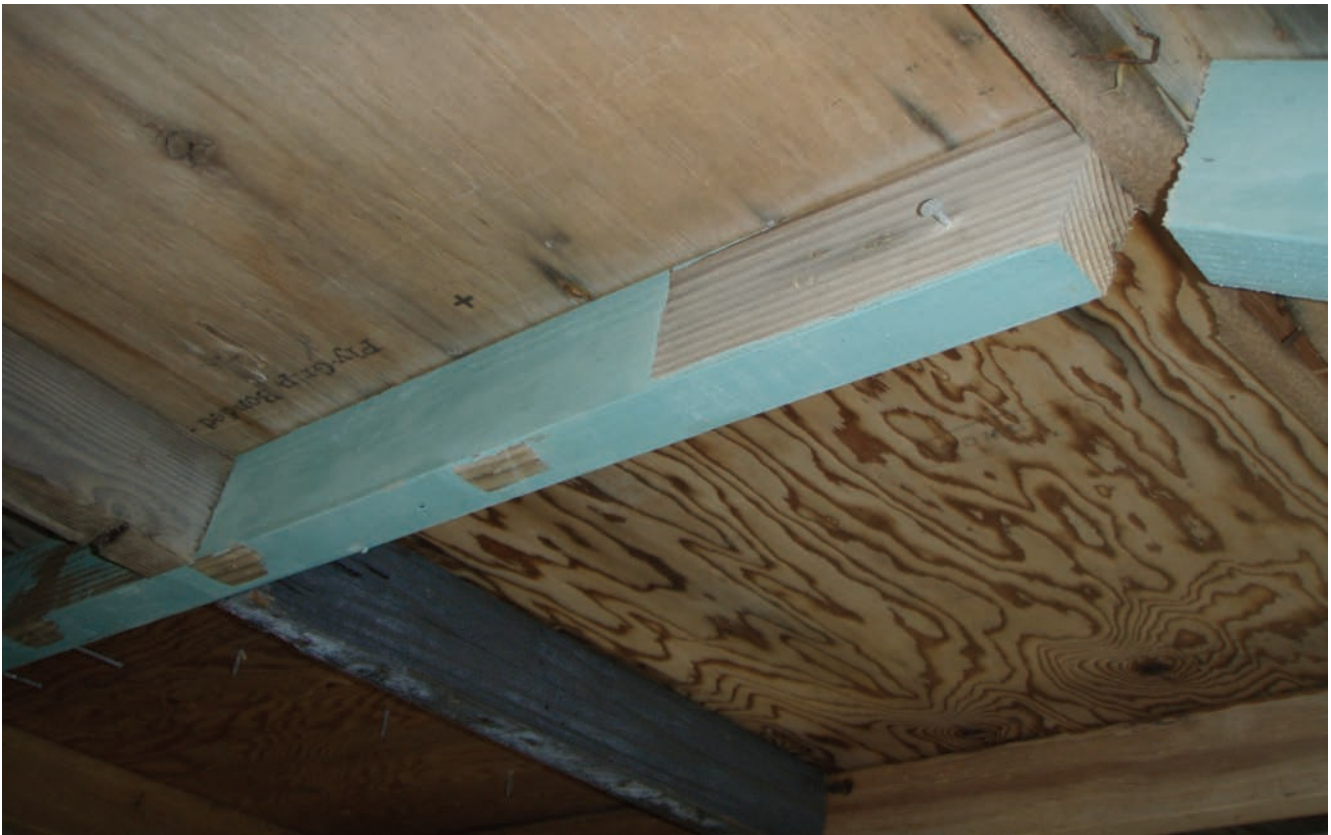
Photograph #21: Structure #7 Interior Roof Joist with LBP
Direction: East

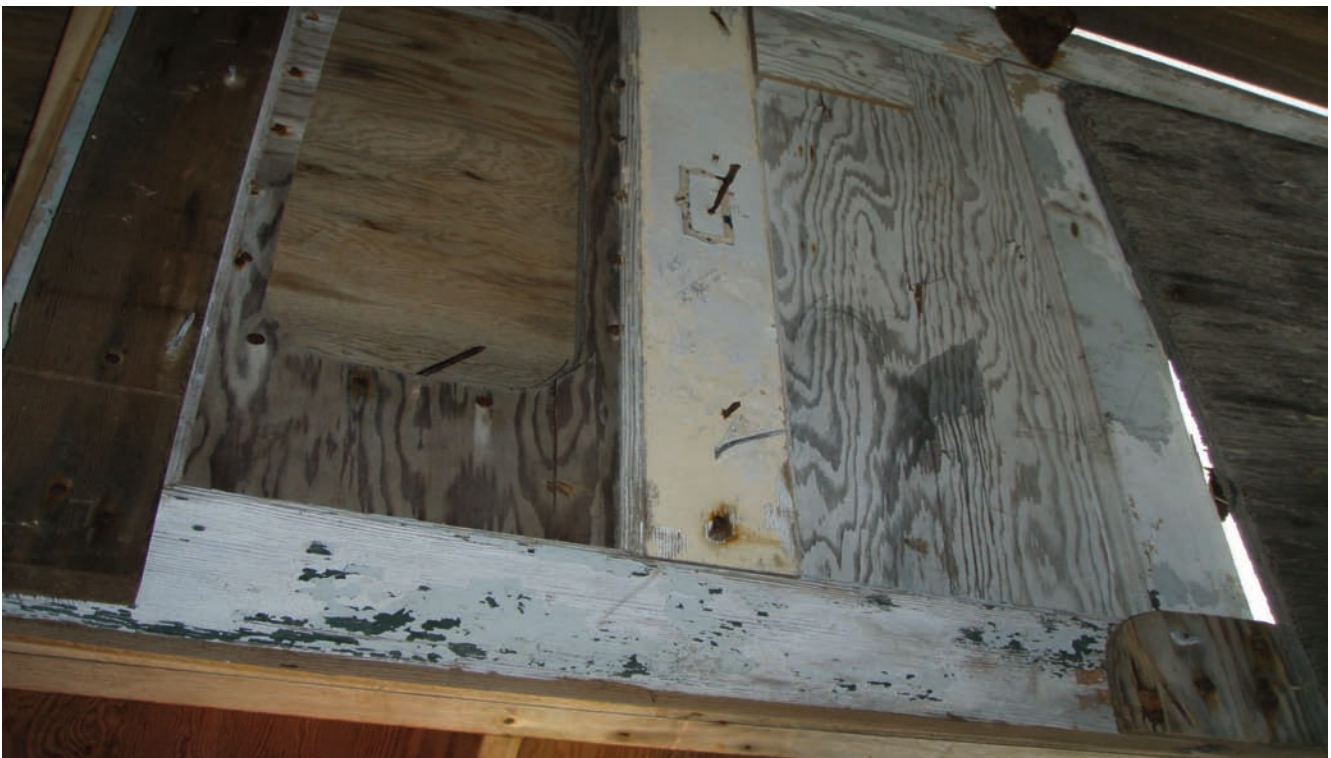
Photograph #22: Structure #7 Interior Door with Light Blue LBP
Direction: North

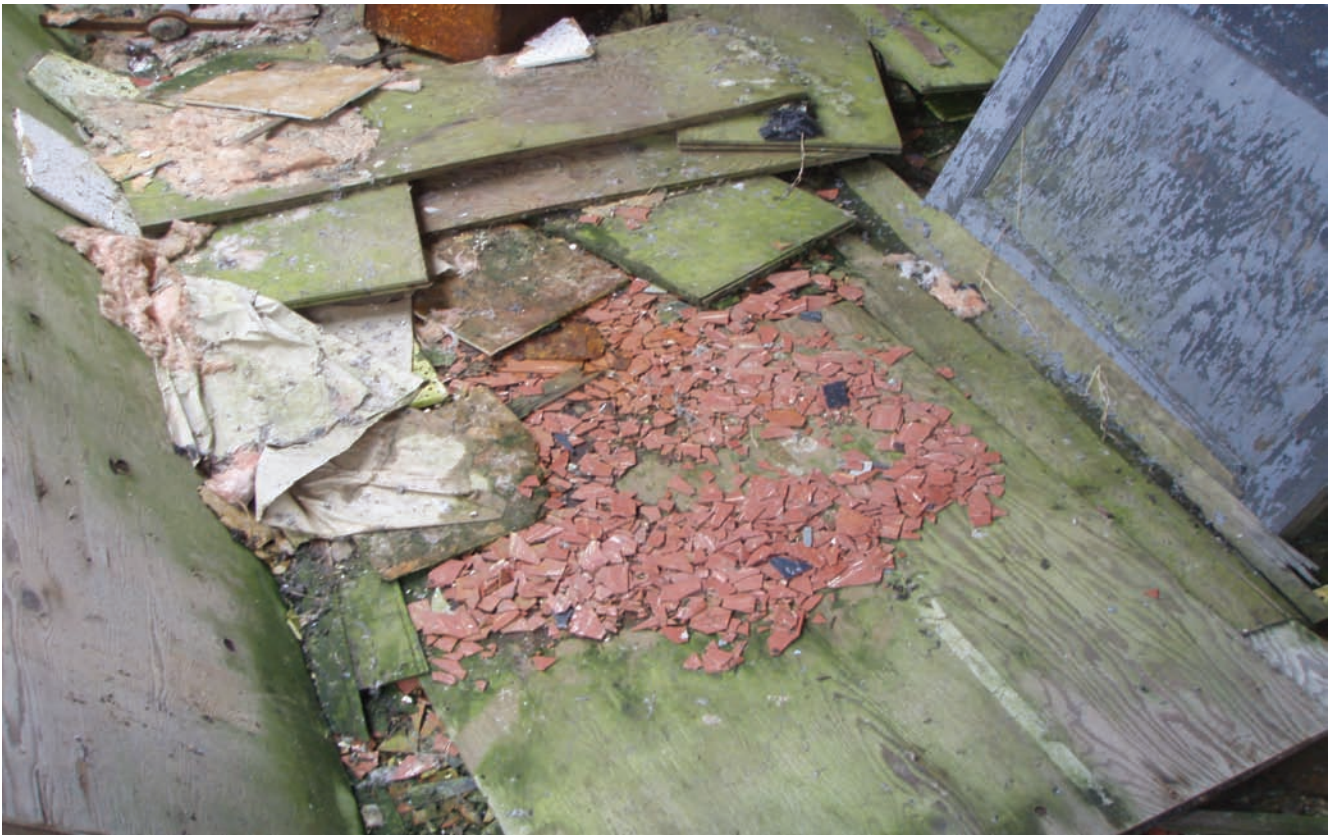
Photograph #25: Structure #8 ACM Tile Near North Entry Door
Direction: North

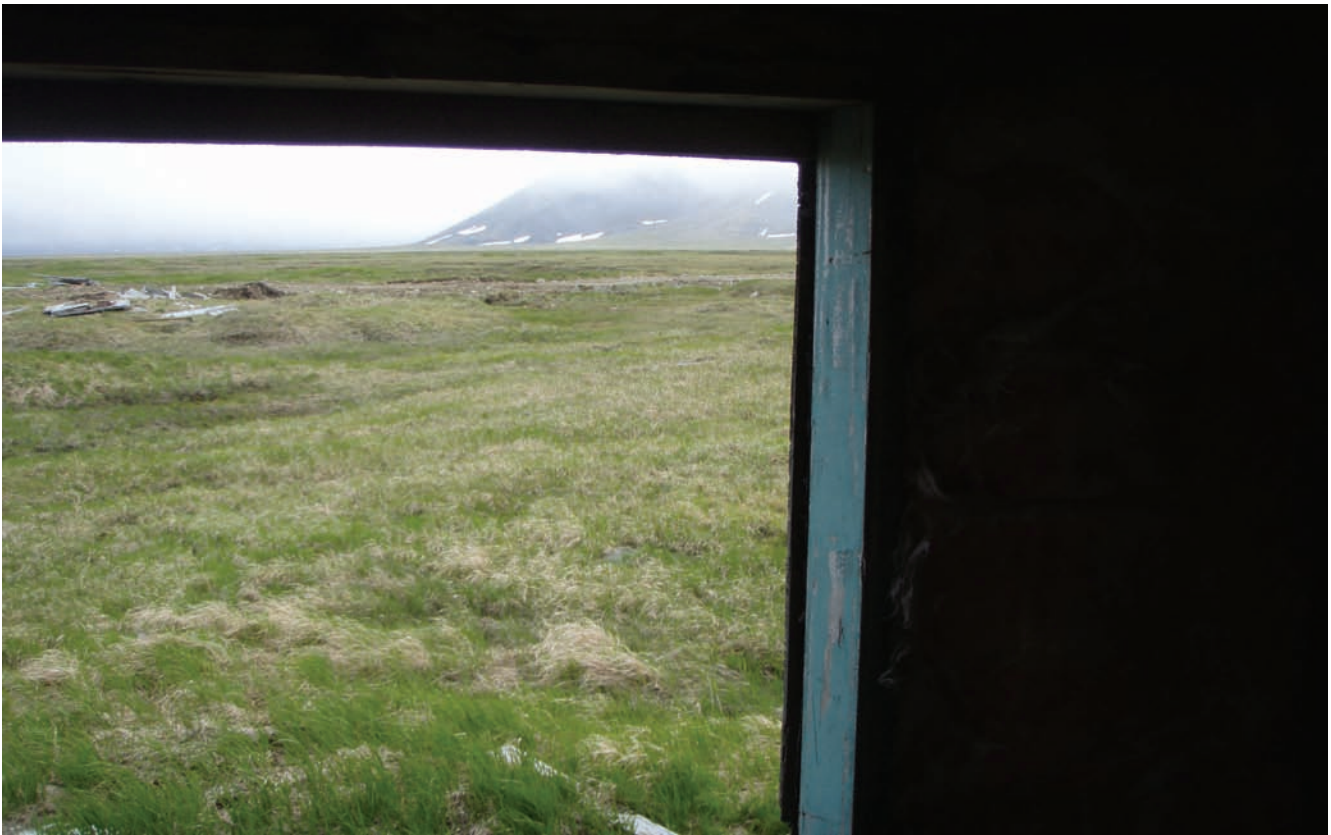
Photograph #29: Structure #8 Blue Paint on Window Frame with LBP **Date: July 8, 2009**
Direction: East **Photographer: T. Ellingboe**

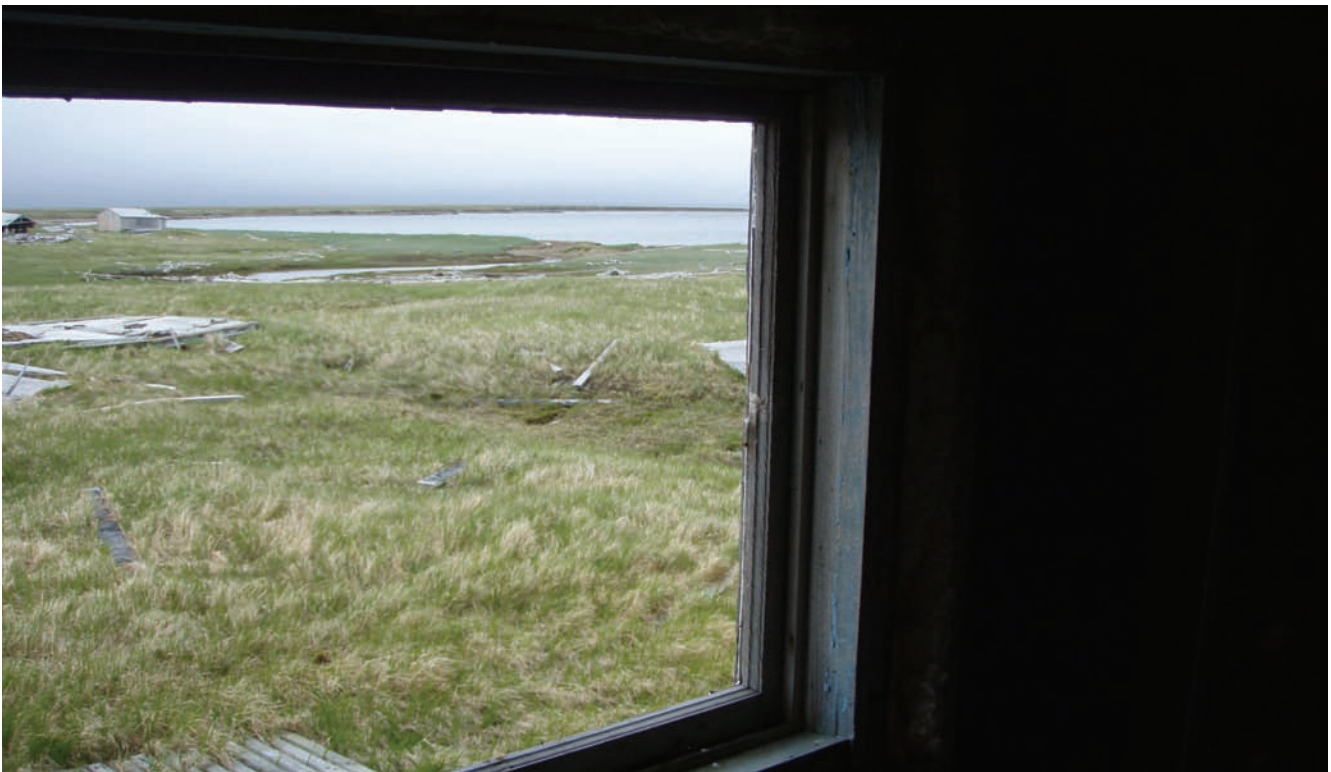
Photograph #30: Structure #8 Blue Paint on Window Frame with LBP **Date: July 8, 2009**
Direction: West **Photographer: T. Ellingboe**

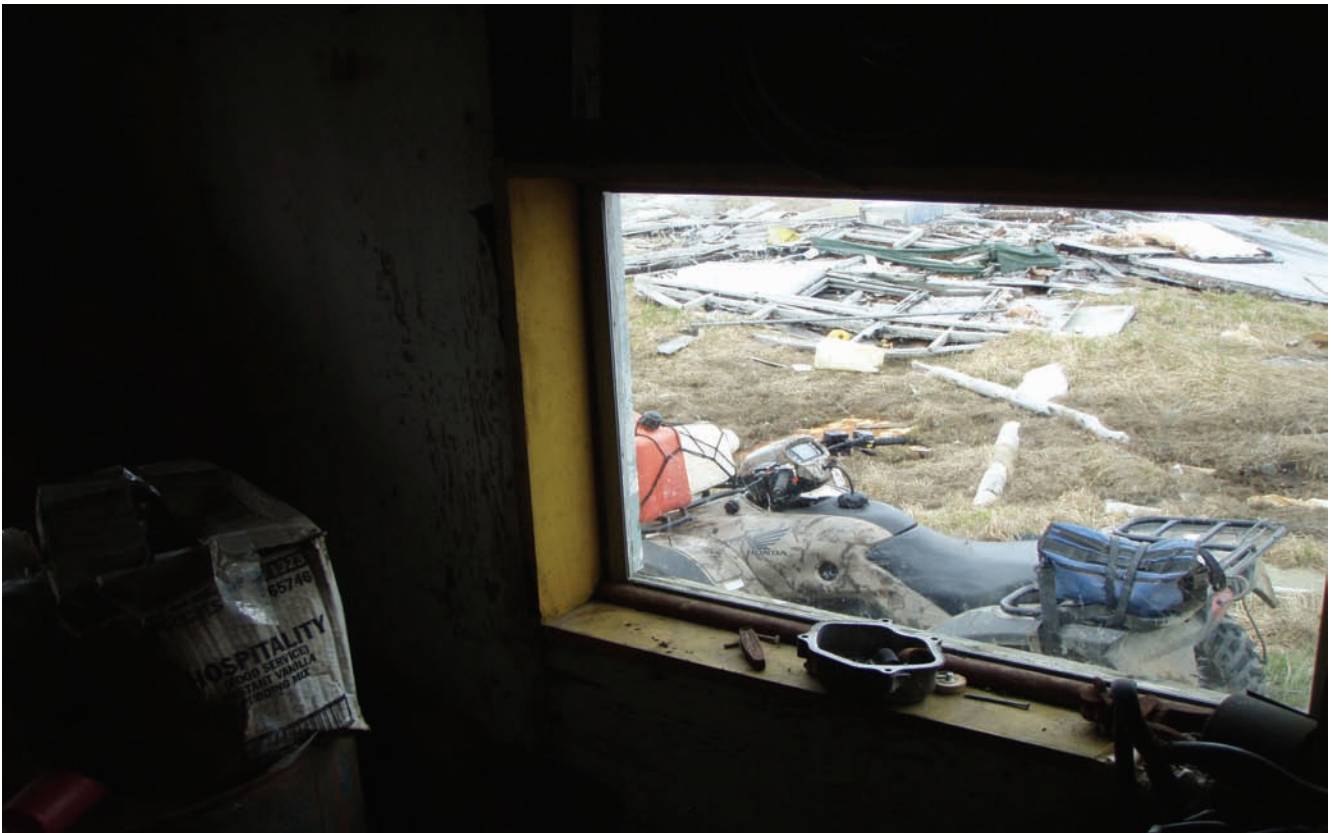
Photograph #31: Structure #3 Interior with Yellow Paint with LBP
Direction: North

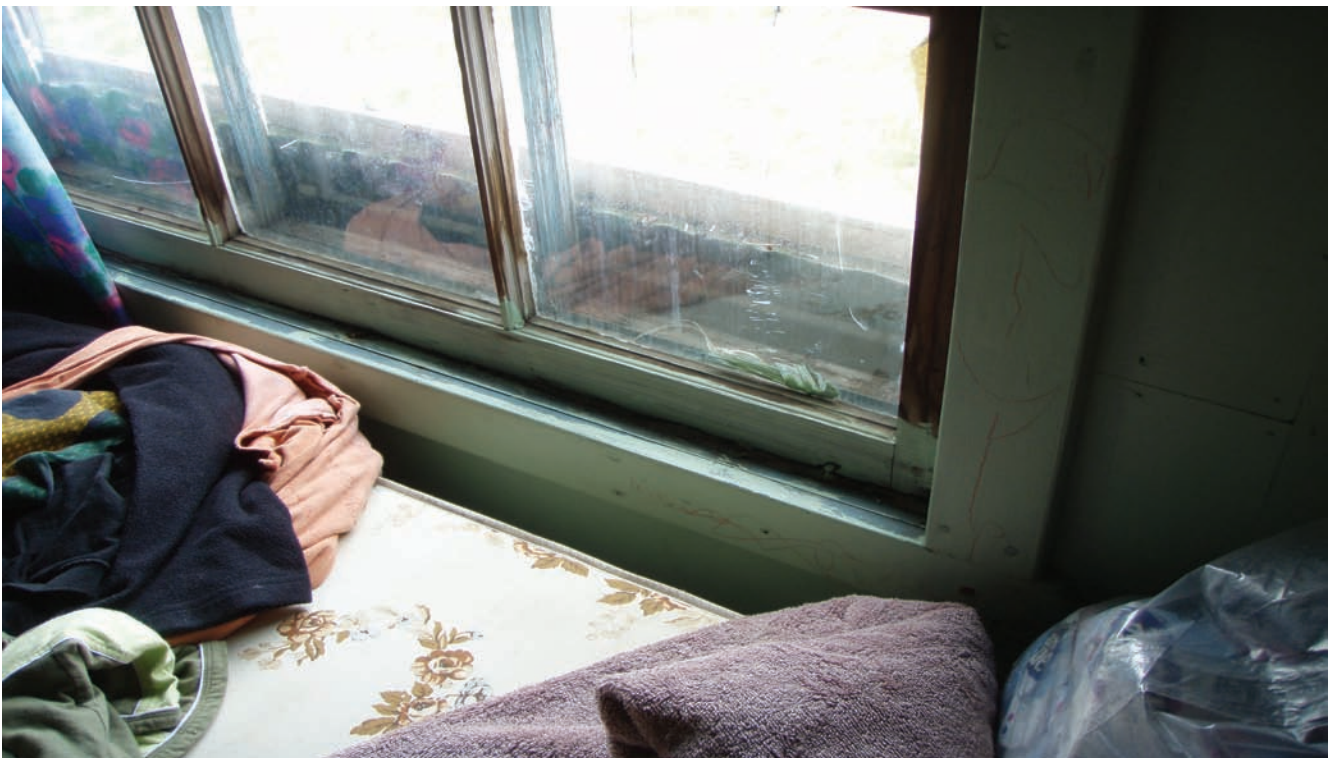
Photograph #32: Structure #3 Green Paint on Window Frame with LBP
Direction: West
