NATIVE VILLAGE OF NORTHEAST CAPE SITE INVESTIGATION REPORT REVISION 1

**Northeast Cape, St. Lawrence Island, Alaska
December 2009**

**Prepared for:
Native Village of Savoonga IRA Council
P.O. Box 120
Savoonga, Alaska 99769**

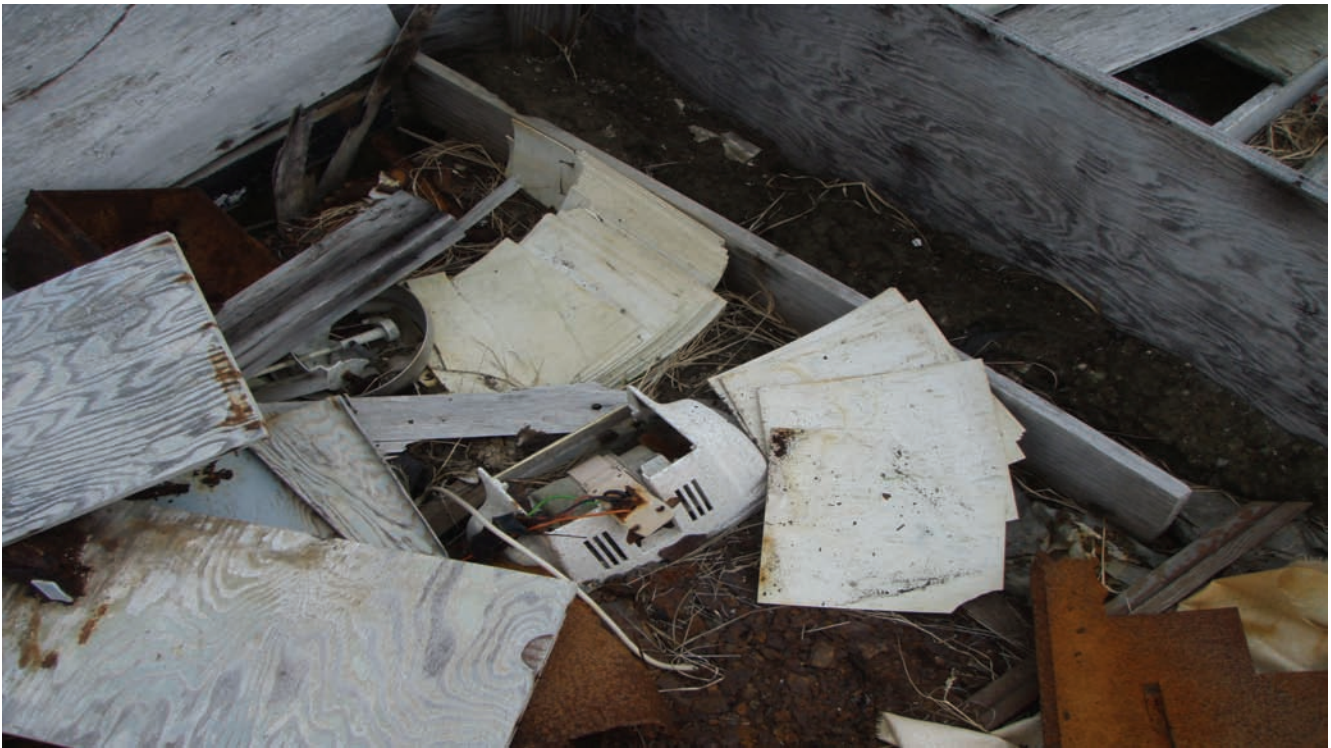
Photograph #34: Structure #9 Exterior with Suspect ACM White Tile
Direction: Southeast

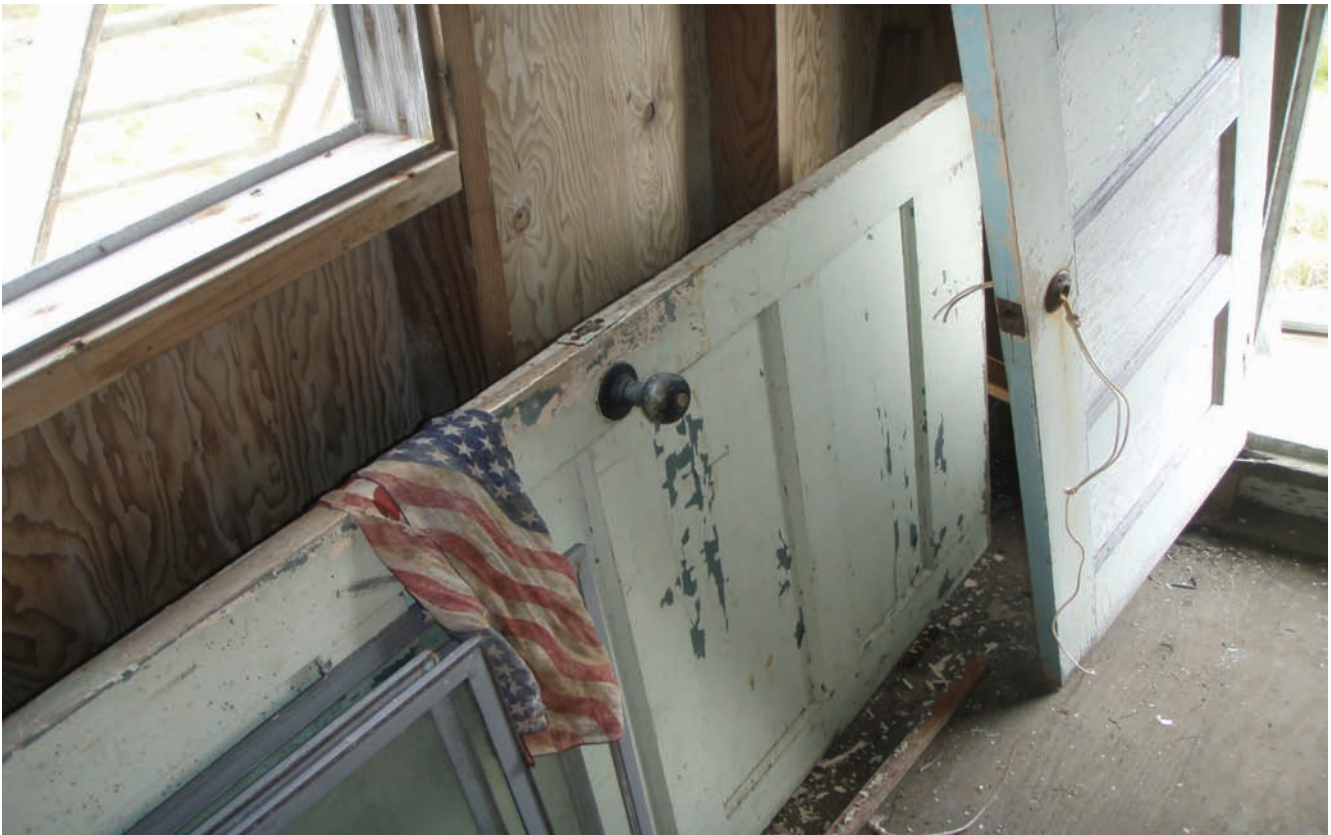
Photograph #37: Structure #11 Interior Door Laying on Ground with LBP Date: July 8, 2009
Direction: Northeast Photographer: T. Ellingboe

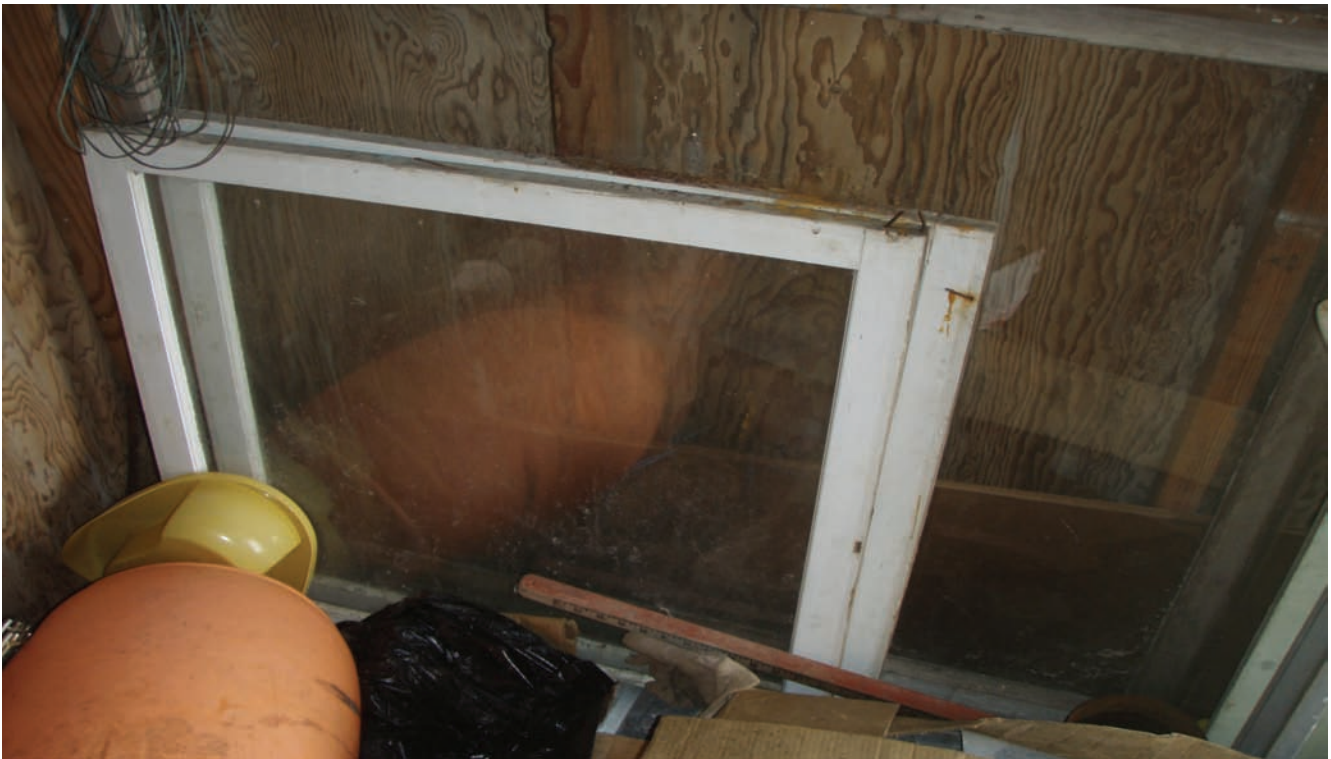
Photograph #38: Structure #11 Interior Window on Floor with White LBP Date: July 8, 2009
Direction: North Photographer: T. Ellingboe

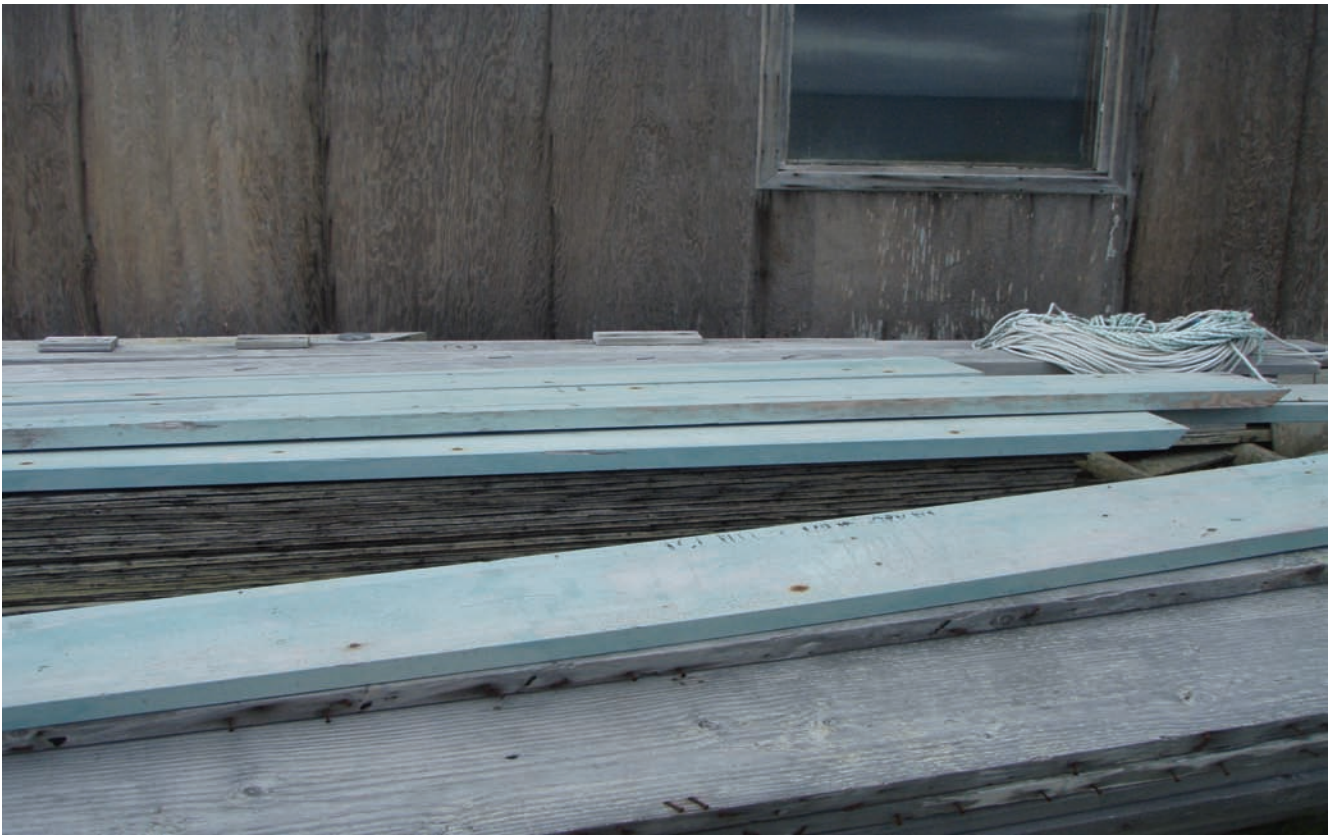
Photograph #39: Structure #11 Exterior Lumber Pile with LBP
Direction: West

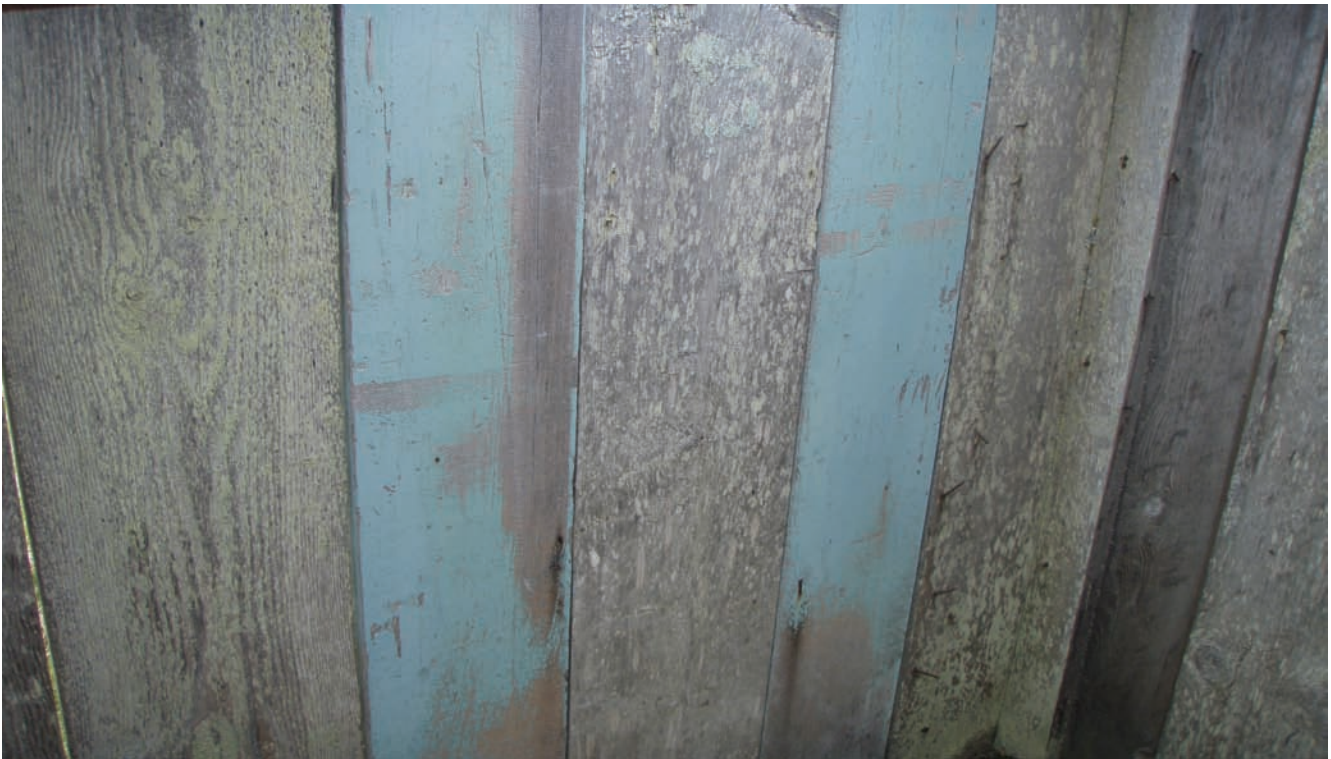
Photograph #50: Structure #12 Interior with Blue LBP
Direction: South
