**Final Strategic Project Implementation Plan**

**Gambell, St. Lawrence Island, Alaska  
Contract No. DACA85-98-D-0007  
Delivery Order No. 18, Task 1**

December 2000

Montgomery Watson  
4100 Spenard Road  
Anchorage, Alaska 99517

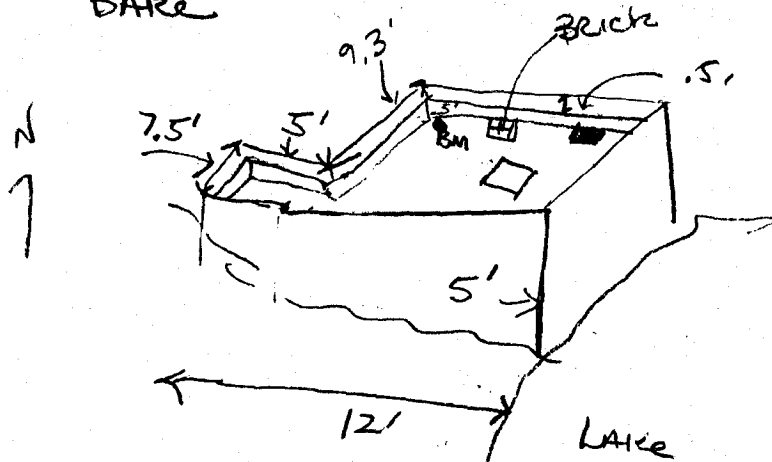
6-27-00 SP1P  
 NW Troutman Lake - Gambell  
 Former Pump House  
 Concrete foundation  
 Reinforced  
 BARE

Per Winnie James this  
 was FAA structure  
 clearing WWT. The Navy  
 & Army used them  
 until their camp was built.  
 Unable to determine  
 if any piping associated  
 with housing

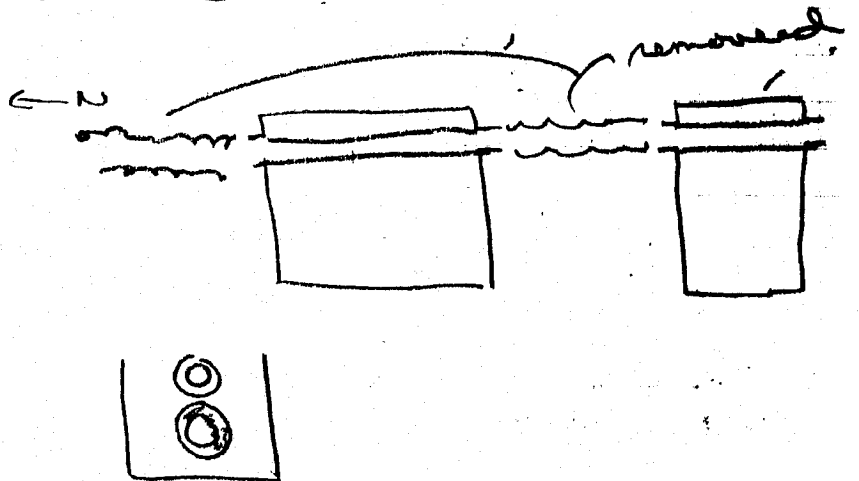
with one 1 1/2" pipe and  
one 3" pipe covered  
with fiberglass like material  
NO hard joints were found  
The connecting runs  
were dismantled during  
VSW work - disposal  
Site work.

The blanketing had fallen  
off and remained in the bottom  
of the utiladon along with  
other debris.

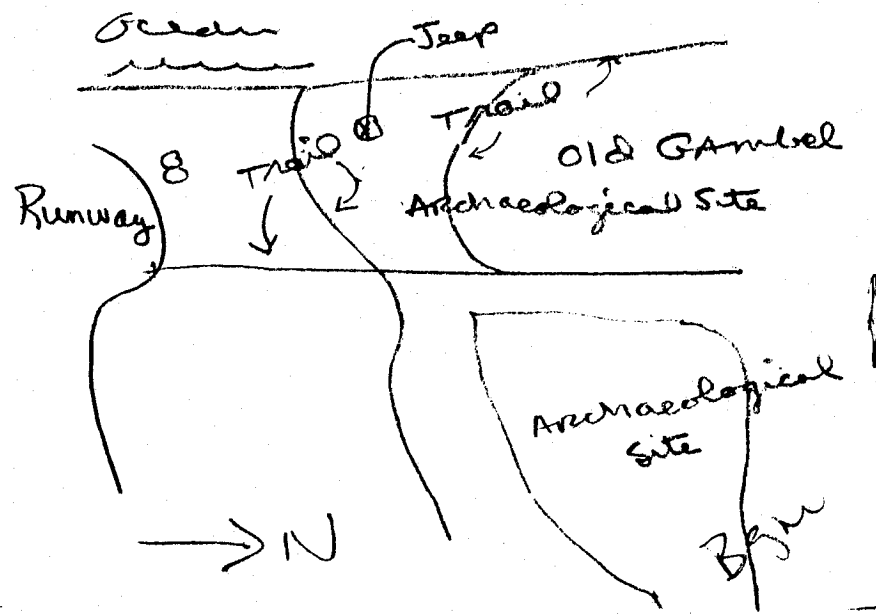
- Army
- Helmet (used WWII - AK Territory guard WWII)
- rifle
- engine
- truck frame
- drums

Recommendation:

Area to be surveyed Approx. 200' x 1000'
