**Final
Phase II Remedial Investigation
Northeast Cape,
St. Lawrence Island, Alaska**

Volume 2: Appendices A and C - H

August, 1999

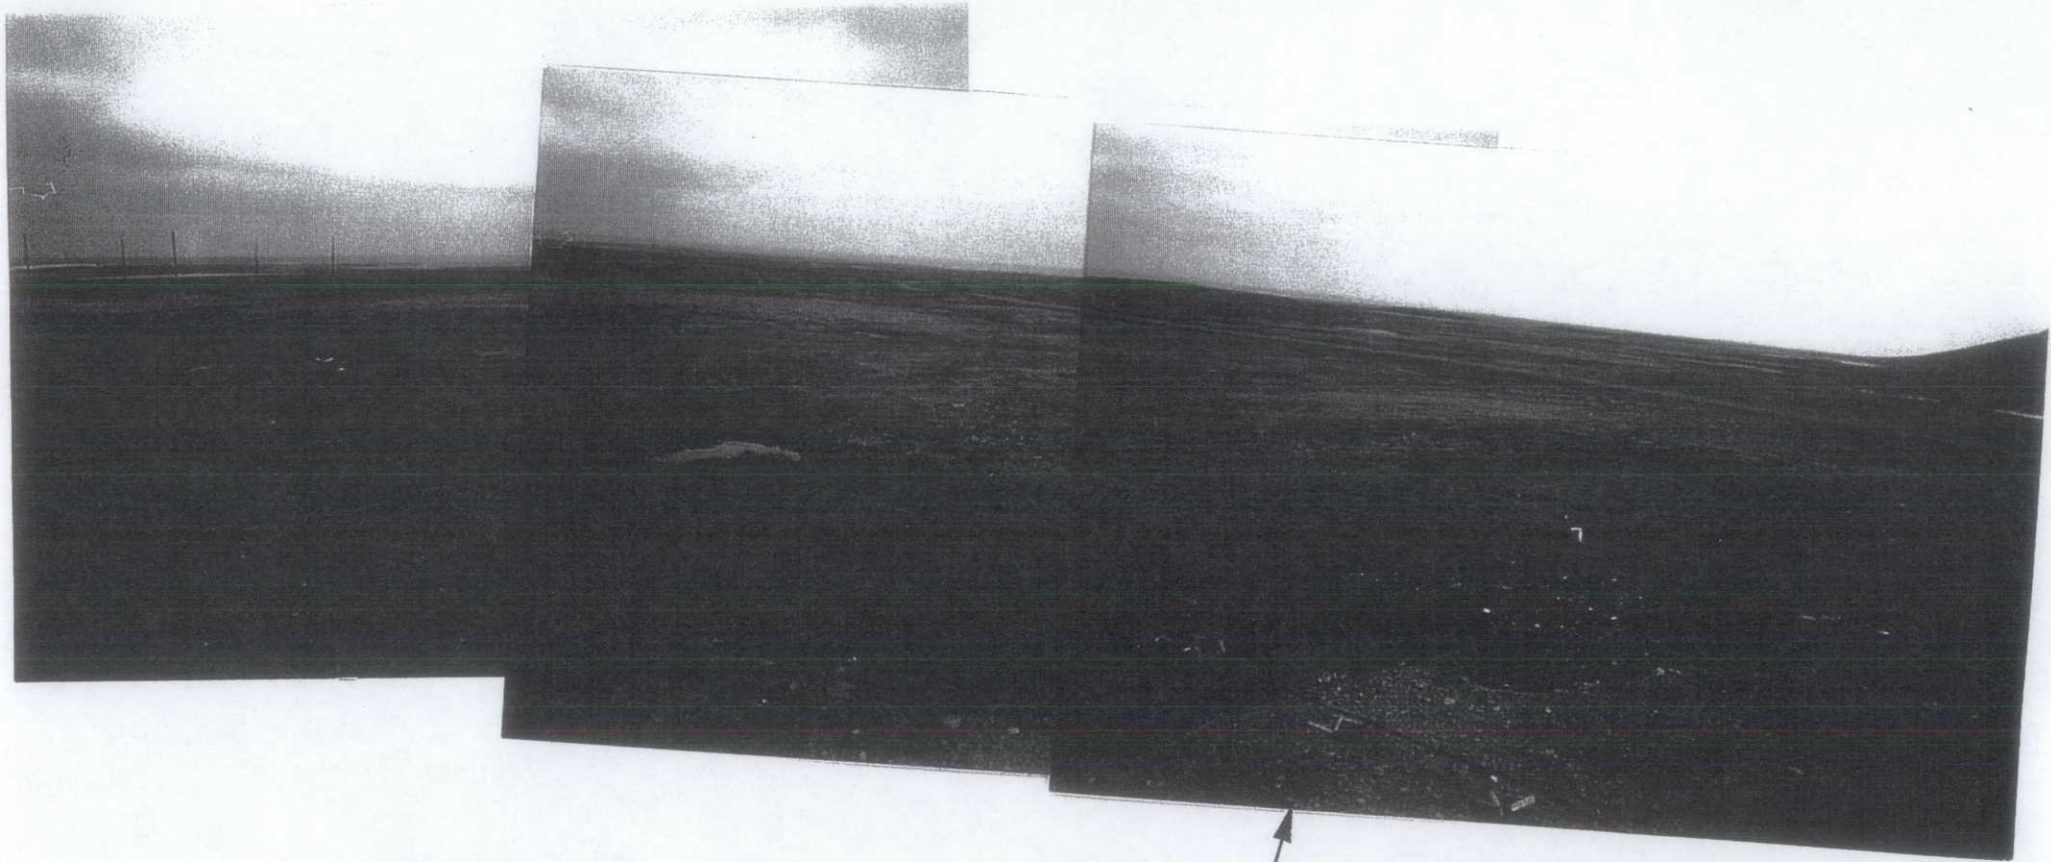
SITE 11, FUEL STORAGE

SITE 11 LOOKING NORTH TO EAST
NOTE: SURFACE SOIL STAINING

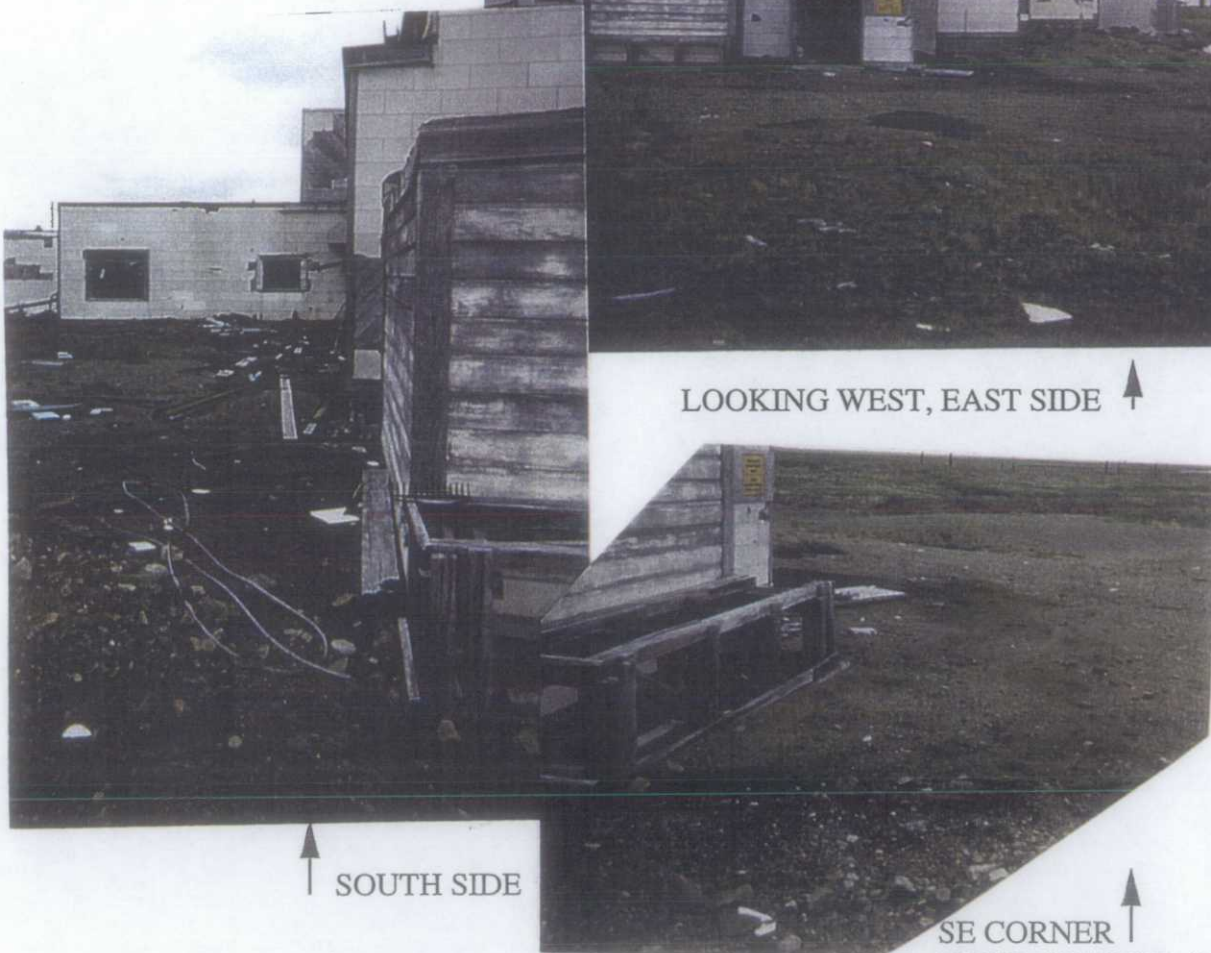
SE CORNER ↑
NOTE: STAINED SOILS

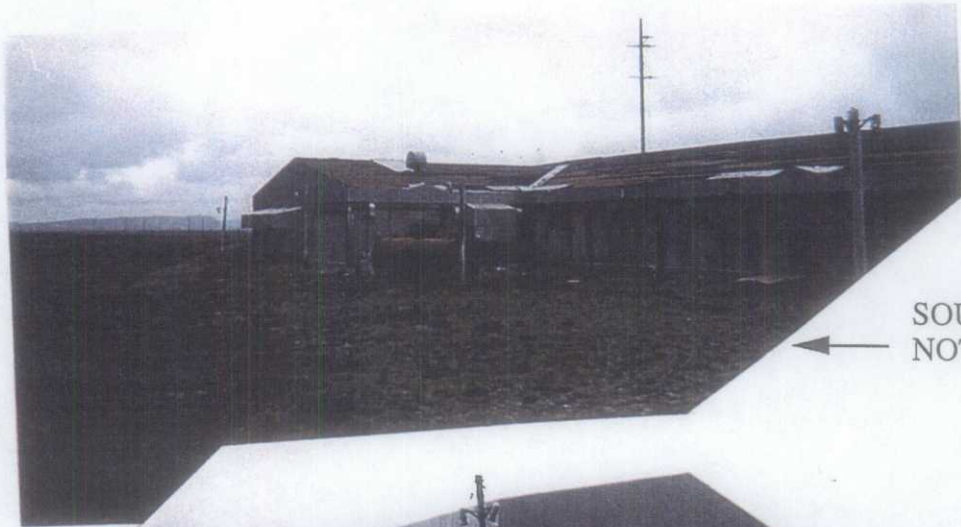
UNITED STATES ARMY ENGINEER DISTRICT, ALASKA
NORTHEAST CAPE, ALASKA AUGUST 1996
SITE 14, EMERGENCY POWER PLANT / OPERATIONS, BLDG. 98

SOUTH SIDE
NOTE: TANK 14-1

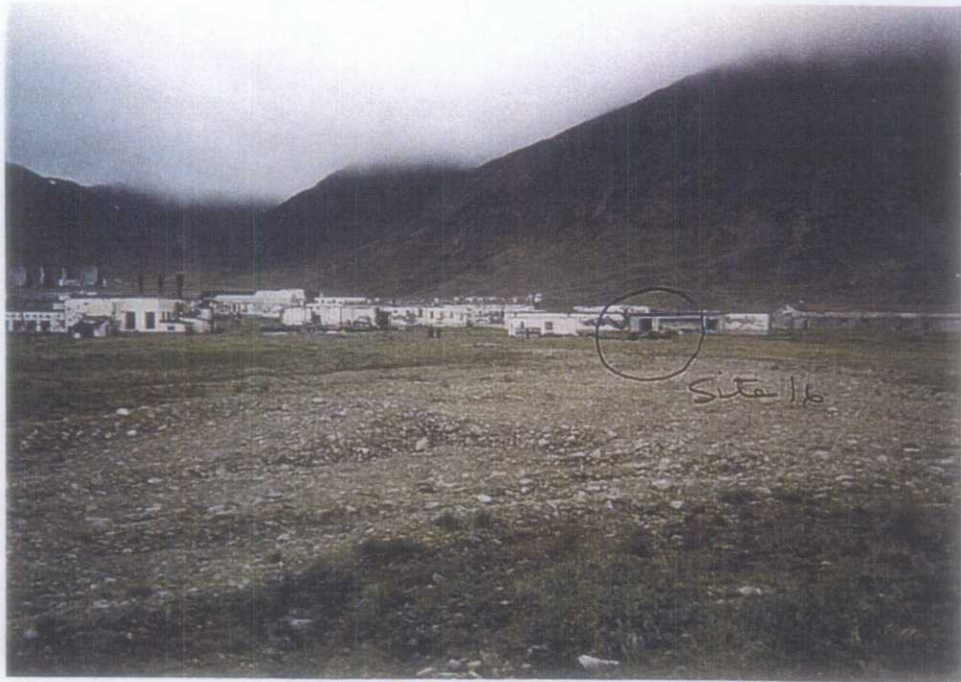
UNITED STATES ARMY ENGINEER DISTRICT, ALASKA
NORTHEAST CAPE, ALASKA AUGUST 1996
SITE 16, PAINT DOPE STORAGE, BLGD. 112

LOOKING SOUTH
REPORTED FUEL BURNING AREA IN FOREGROUND

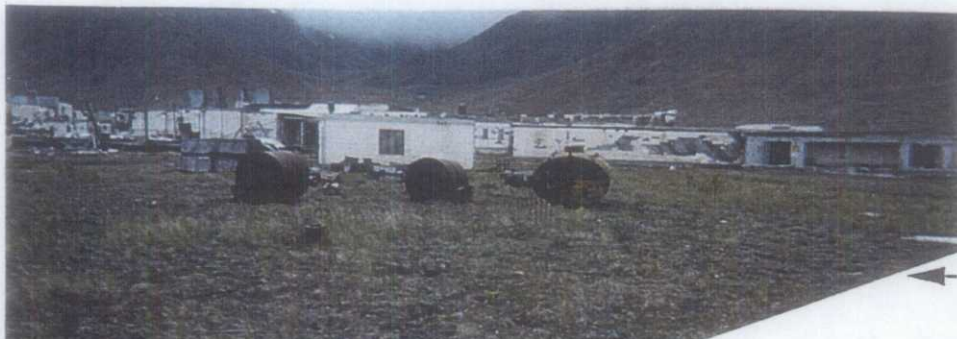
LOOKING SOUTH
TANK 16-1 AT RIGHT

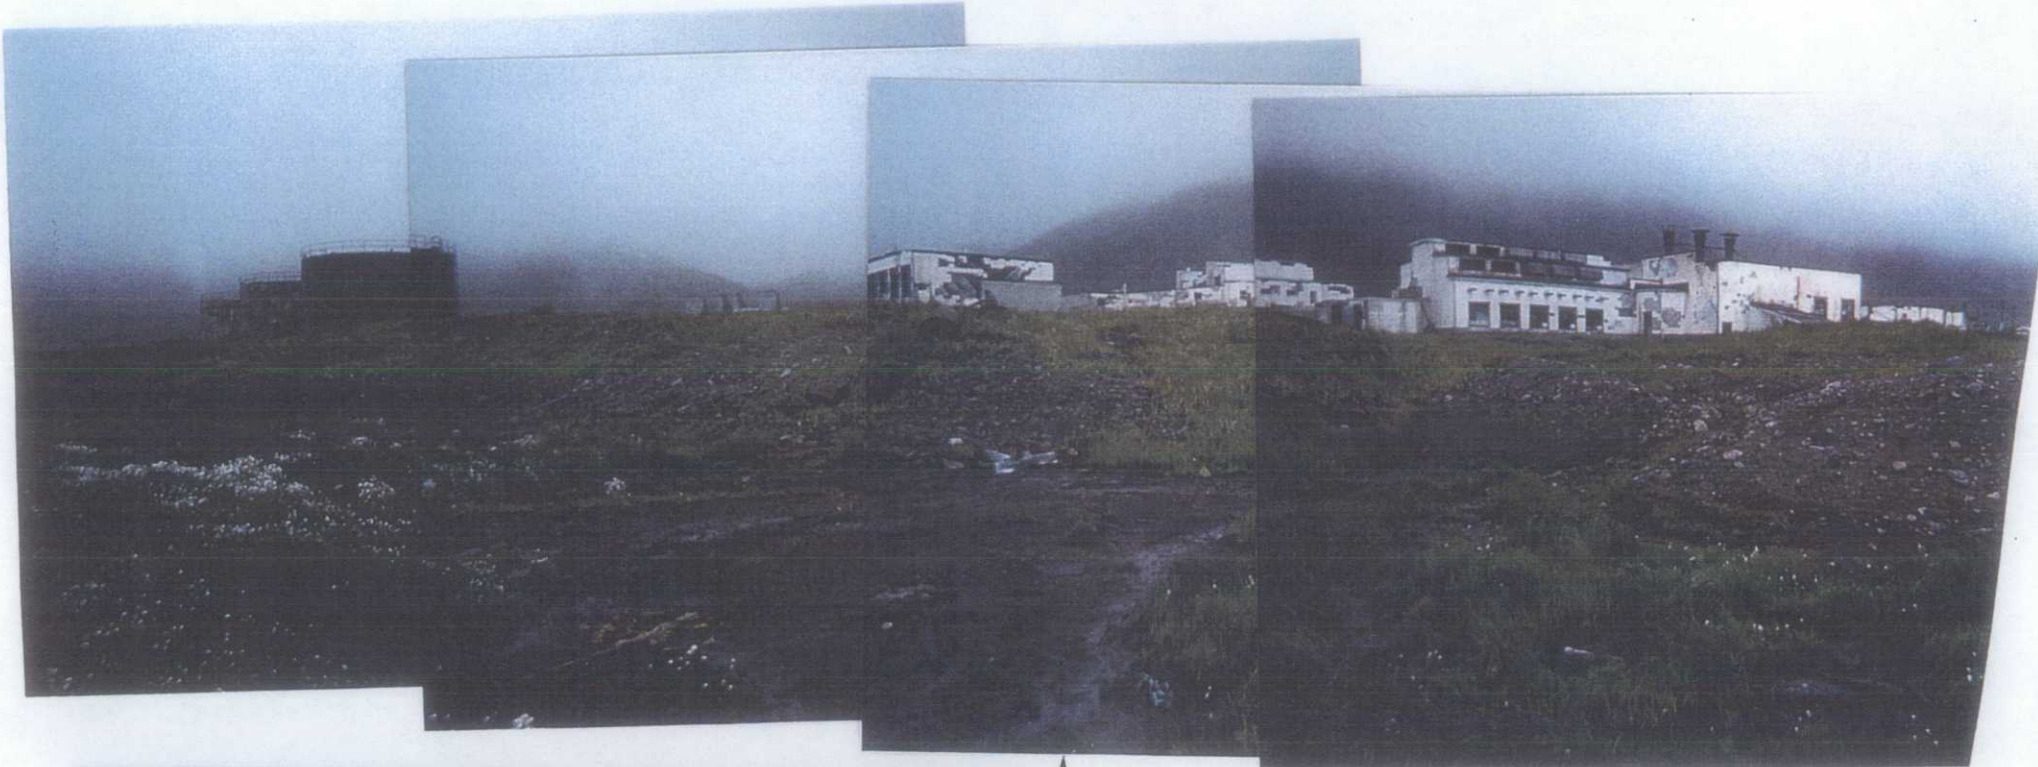
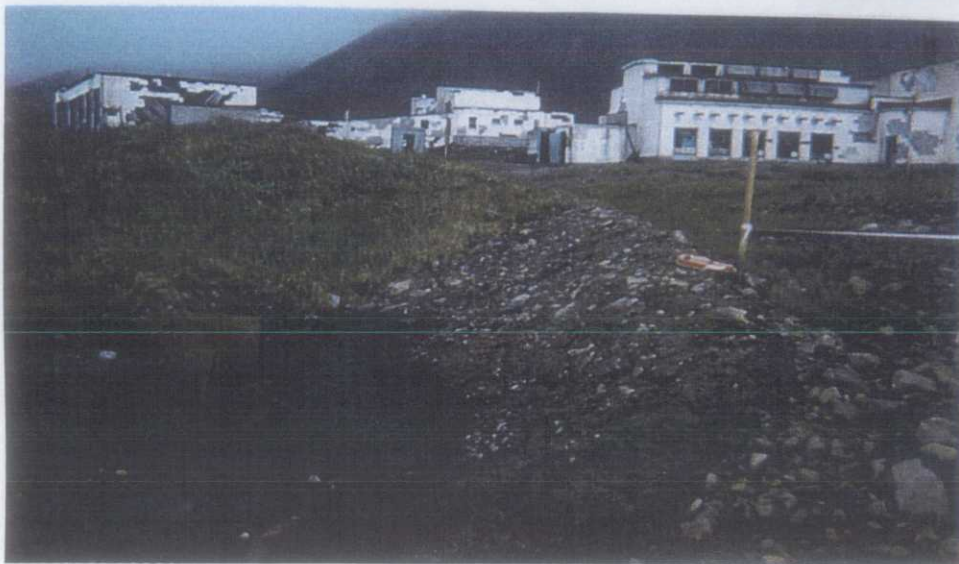
UNITED STATES ARMY ENGINEER DISTRICT, ALASKA
NORTHEAST CAPE, ALASKA AUGUST 1996
SITE 27, FUEL PUMP ISLAND

↑ VIEW SE TO SW : SITE 11 (TANKS), SITE 19 (BLGD. 108),
SITE13 (BLDG. 110)

← SURFACE SOIL STAINING ↑

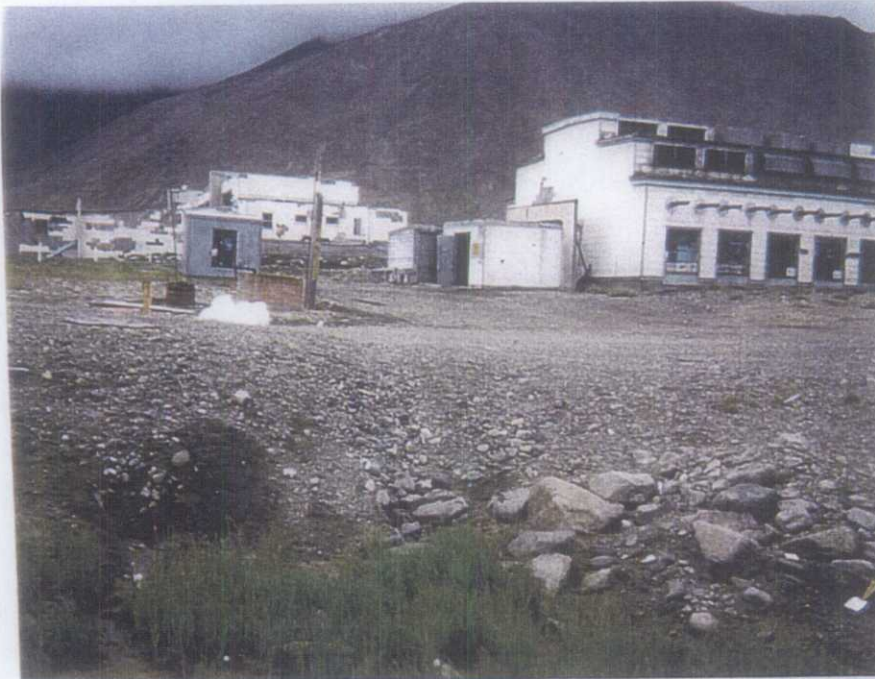
SITE 27, FUEL PUMP ISLAND

LOOKING SOUTH
SITE 13, B. 110 ON RIGHT
NOTE: STAINED SOIL
AT CULVERT

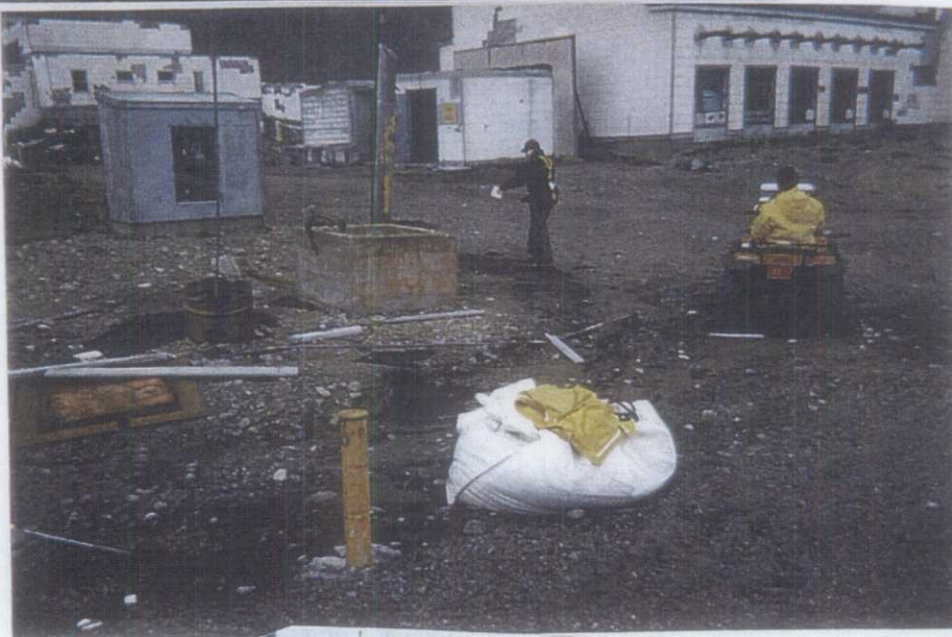
LOOKING SOUTH
MW 27-1 FOREGROUND
NOTE: STAINED SOIL

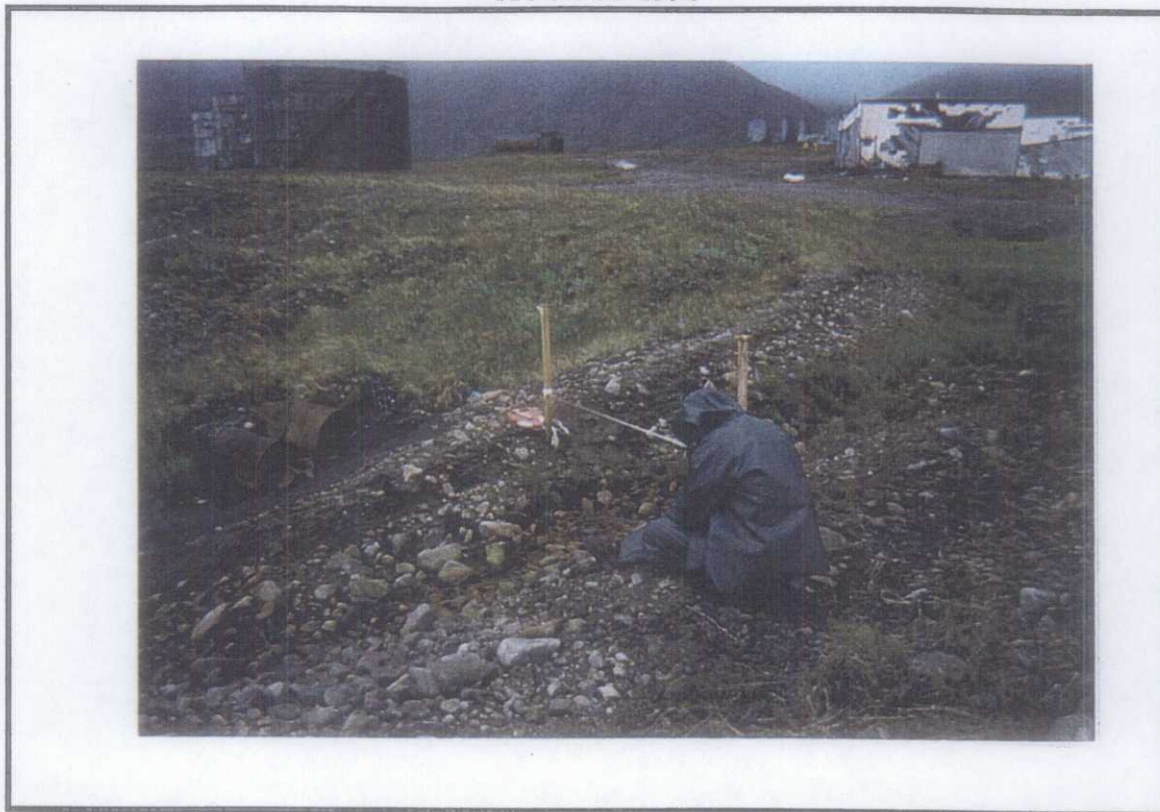
Drainage Basin; view from North, located just North of Site 27.
Stream Flow measurement #5
Note: drums and surface soil staining
Site 11 in left background
