**Phase IV Remedial Investigation  
Northeast Cape  
St. Lawrence Island, Alaska**

June 2005

By:  
**Shannon & Wilson, Inc.**  
5430 Fairbanks Street, Suite 3  
Anchorage, Alaska 99518  
Phone: 907-561-2120  
Fax: 907-561-4483

Project Number: 32-1-16821  
F10AK096903\_03.10\_0020\_a  
200-1e

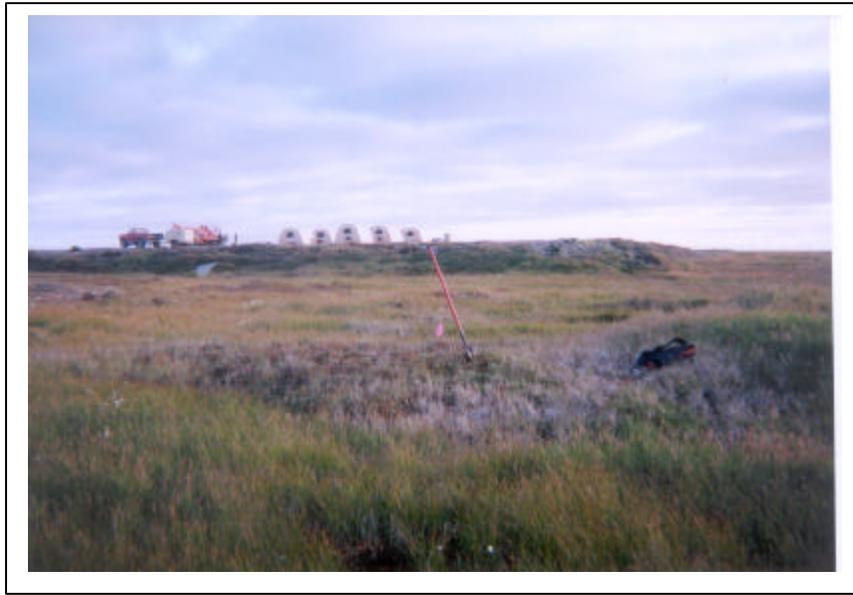
Photograph 3: Typical vegetation in the Site 1 "Burn Site," study area, looking north-northeast past field screening location FS1-8 to field camp. No apparent burn area was encountered, so field screening and surface sampling were performed over a large area in the vicinity of the gravel pad.

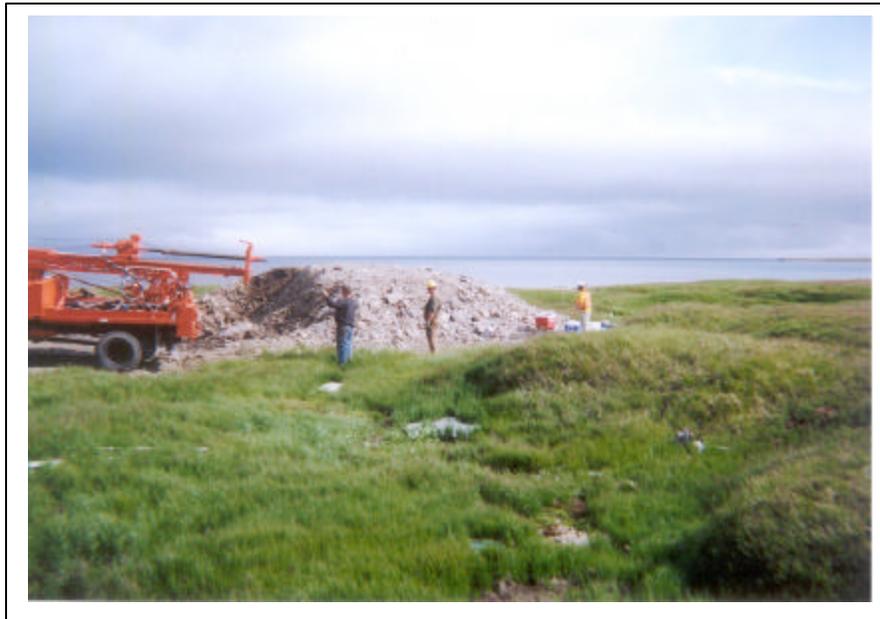
Photograph 4: Excavated soil at the former pumphouse of Site 3. Some adjustments to boring locations were necessary. Wellpoint 03WP103 and Kitnagak Bay are visible in the background.

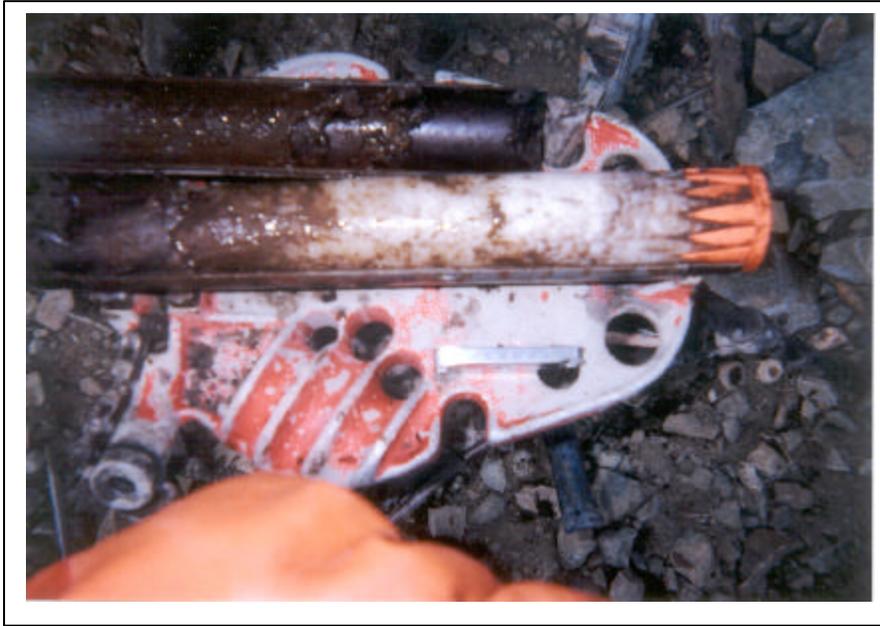
Photograph 5: Ice recovered in split-spoon sampler from 5 feet bgs in Site 3 boring 03B3.

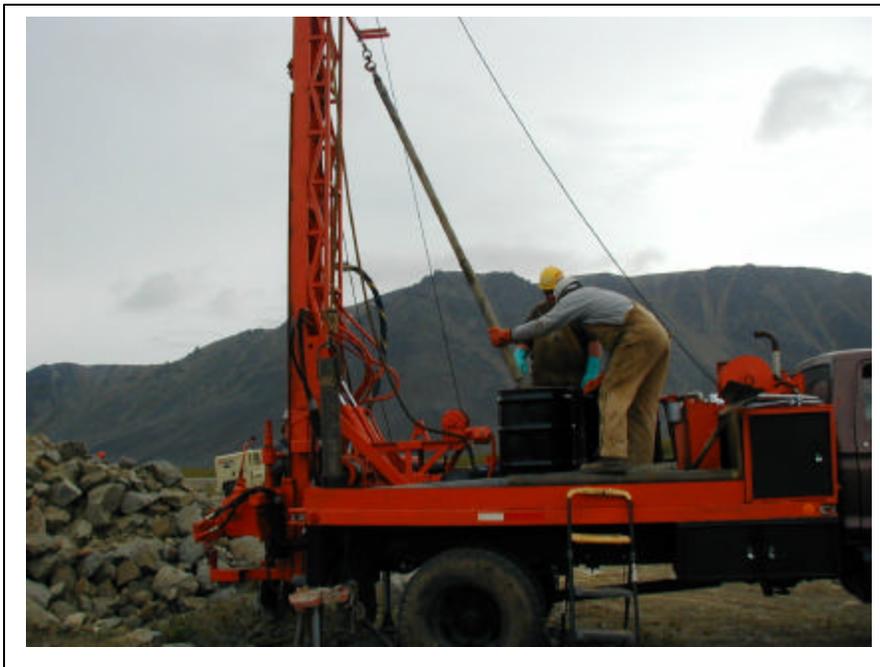
Photograph 6: Site 6 Boring 06B2 completed, decontaminating drill auger and rod in alconox solution and rinse water drums on the drill rig, looking southeast.

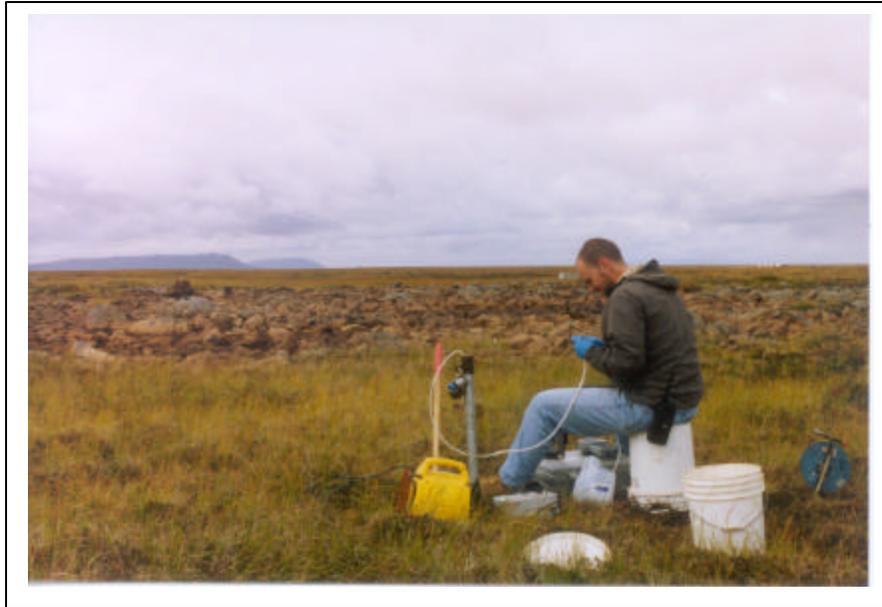
Photograph 7: Sampling wellpoint 06WP5 with a peristaltic pump. The boulder field is west of the site, and is one sign of frost-influenced surface topography.

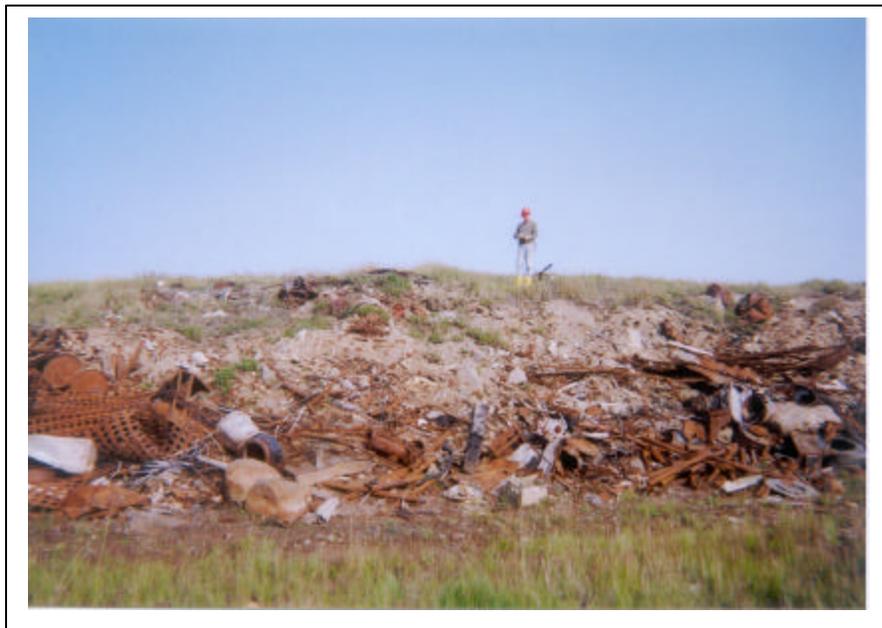
Photograph 8: Exposed debris at the base of the Site 7 landfill's southeast side. Soil samples were collected on the bench behind the pictured person, and to the left of the photo.

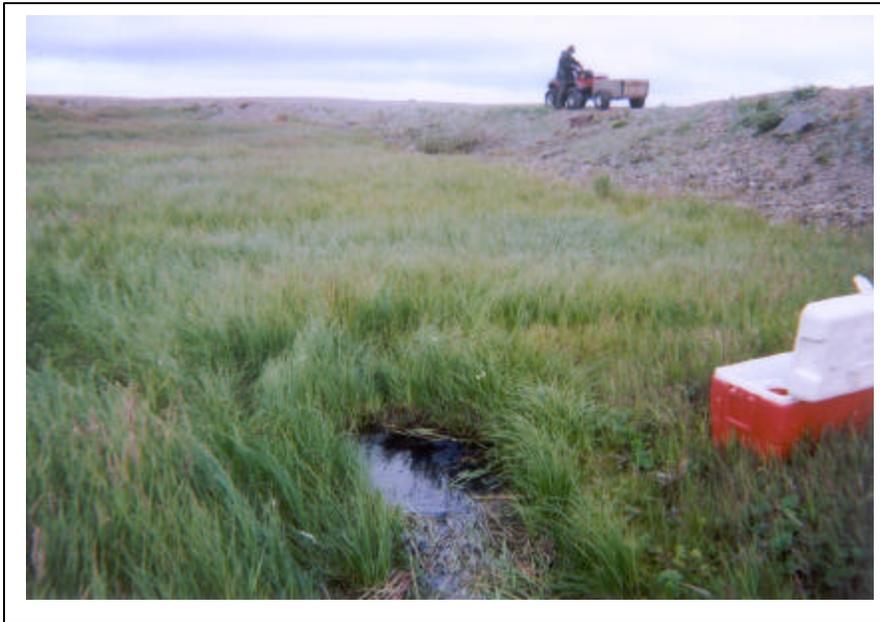
Photograph 9: Looking north-northeast across Site 8 from the bank of the Suqitughneq River to the Cargo Beach Road/Airport Access Road intersection. The spring in the foreground and two locations in the wetland were sampled.

The POL Spill Site is a wetland with thick surface vegetation, typical of locations along roads and the Airstrip where a thick tundra mat was removed before construction. The roughly 40-foot wide wetland slopes southward for approximately 300 feet toward the Suqi. River. Photograph 9 is a view across the site from the bank of the Suqi. River. The wetland narrows as it approaches the river.

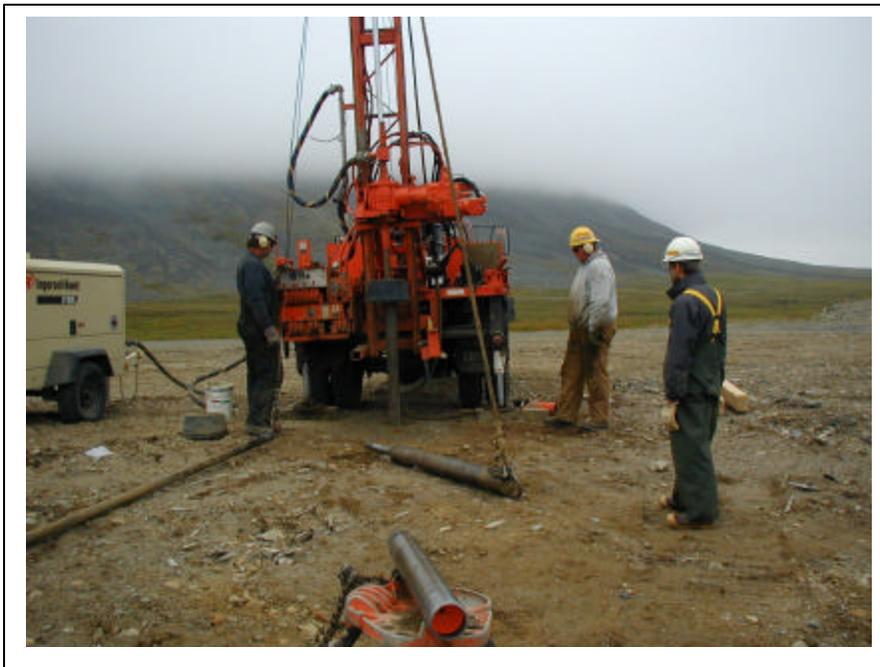
Photograph 10: Conducting the boring for installation of Monitoring Well 18MW1 using Tubex type air-rotary drilling on the regraded surface of the MOC. A cleaned split spoon sampler is in the foreground, looking southwest.

Soil samples were collected during the advancement of two borings and three monitoring wells at the MOC. Photograph 10 shows the general method for subsurface soil sampling at the site, and boring and monitoring well locations are shown in Figure 5-9. Boring depths ranged from 21.5 feet bgs for Monitoring Well 17MW1, to 41.5 feet bgs for Boring 13B1. Soil samplers were driven to recover field screening and potential laboratory samples at approximately 5-foot intervals. The rocky nature of the subsurface required adjusting sample intervals to maximize soil recovery. Three samples were selected for laboratory analysis from the boreholes for wells 17MW1, 18MW1, 20MW1, and Boring 19B1. Four analytical samples were selected from Boring 13B1. Sample 13SB101, collected at 5 feet bgs, and Sample 19SB103, collected approximately 18 feet bgs, were selected for the additional natural

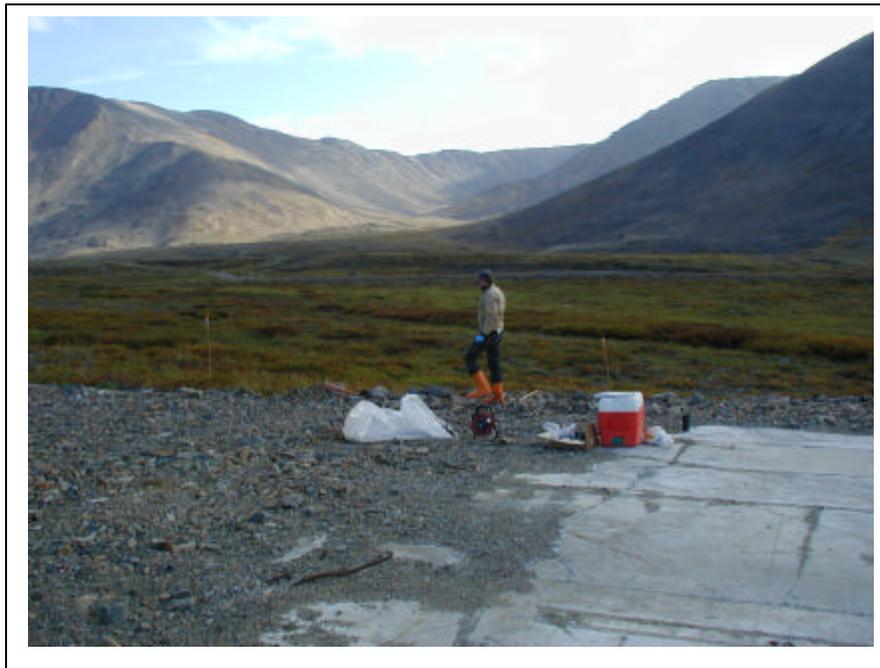
Photograph 12: Preparing to collect near-surface soil samples for PCB analysis at Site 14, looking south-southeast.

Two surface soil samples and two co-located subsurface soil samples were collected approximately 10 feet southeast and 10 feet southwest of previous sample location 01NE14SS102. The sample locations were along an embankment of recently placed rocky fill, visible in Photograph 12 of Appendix A. The shallow samples were collected in older fill beneath the recent fill. The deeper samples were collected just below the apparent contact between older fill and native soil. The sample depths were achieved using hand tools, and the samples were analyzed for PCBs. Sample descriptions are included in Table 5-10a and sample locations are shown on Figure 5-10.

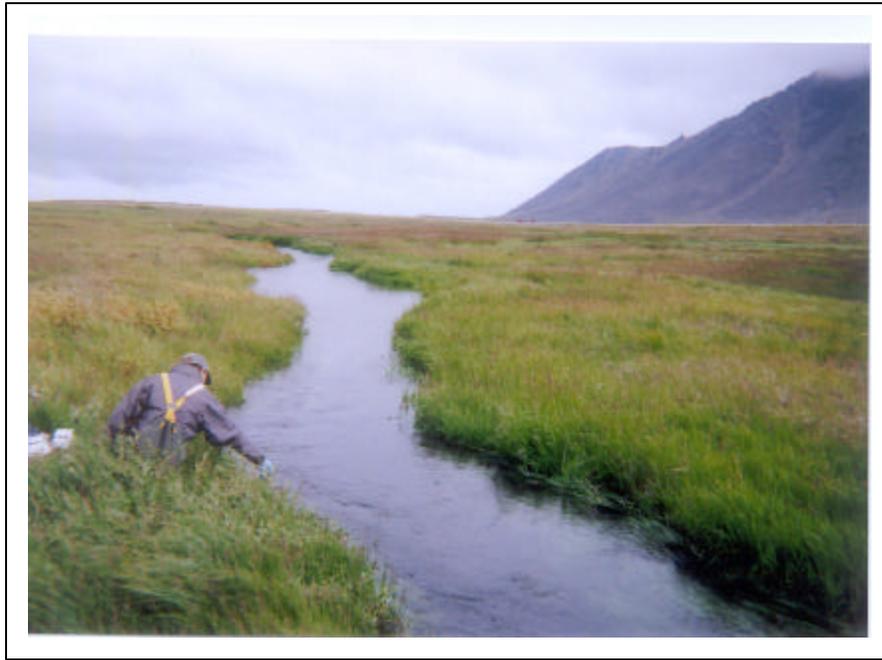
Photograph 13: Sampling the middle reach of the Suqitughneq River, just downstream of the MOC drainage basin, looking east.

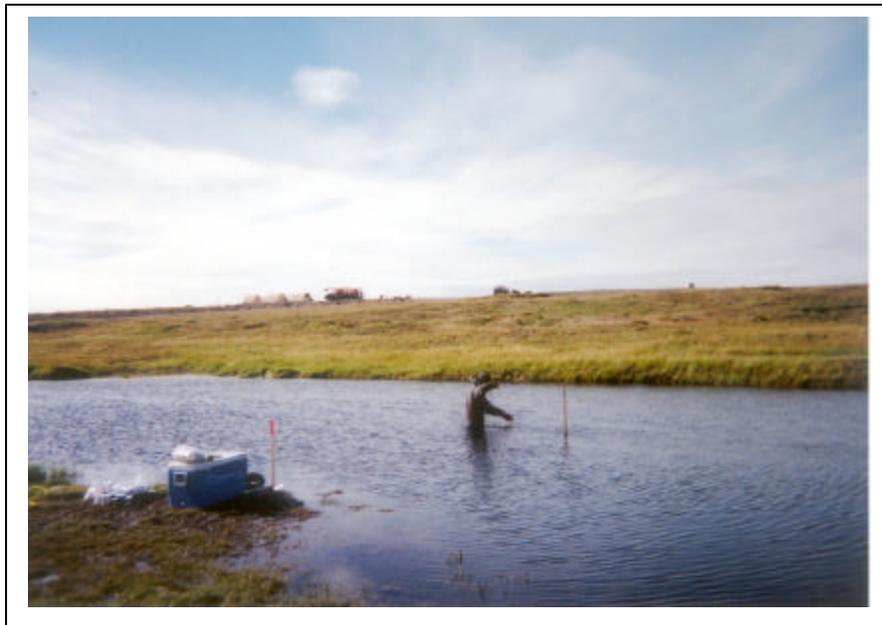
Photograph 14: Sediment samples were collected from depositional areas of the Suqitughneq River Estuary with an Eckman Dredge, looking west-northwest. Tidal influence was not observed in the estuary, which was essentially a fresh water impoundment for the duration of the field activities.

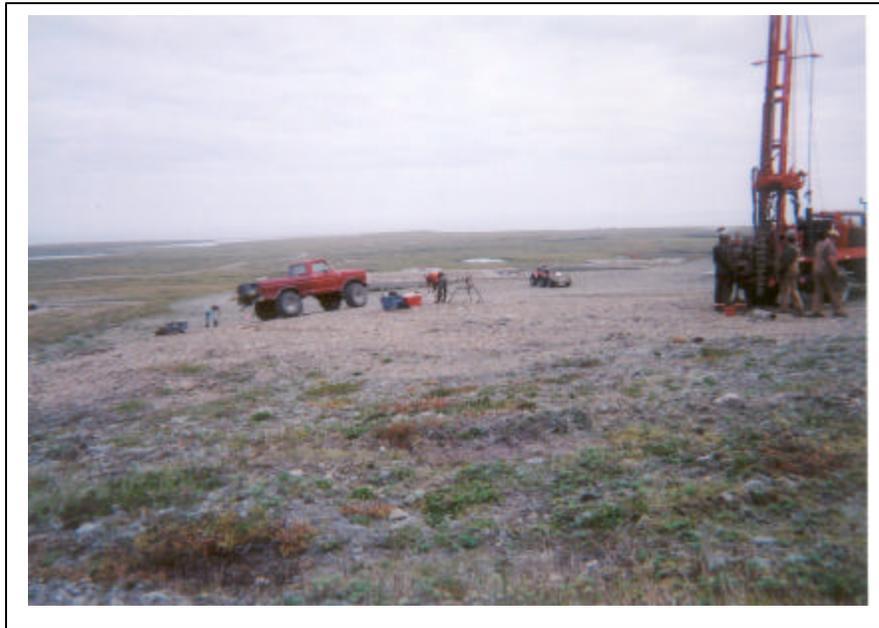
Photograph 15: Sampling being performed at the White Alice Site by hand (left) and drill rig (right). Pipe stand is at the former tank impoundment, looking north.

Field activities occurred at Site 31 on August 31, 2004. A summary of samples collected, including a description of sample location and classification, is presented in Table 5-15a, and Figure 5-15 depicts the sample locations. Photograph 15 in Appendix A shows soil sampling activities on the western portion of the site, with the northeastern portion of the site visible in the background.
