Northeast Cape HTRW Remedial Actions

Northeast Cape, St. Lawrence Island, Alaska

Site 28 Phase I Sediment

Removal Report

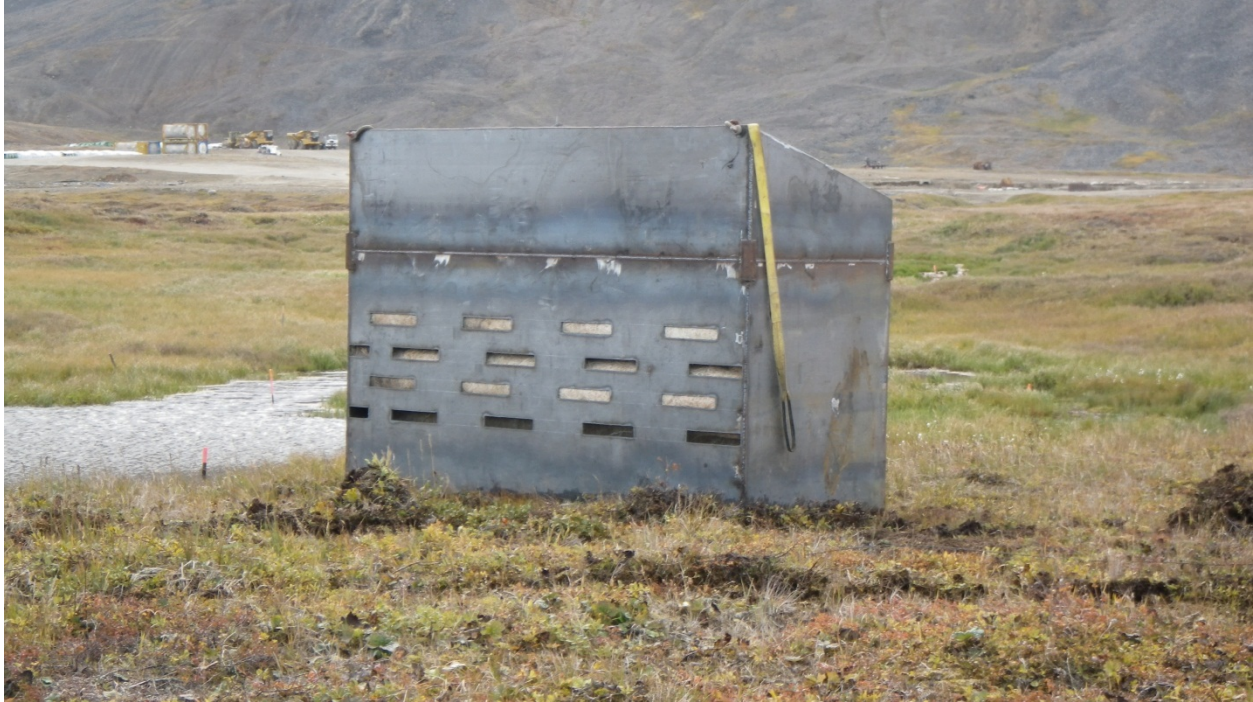
Photograph 9 Site 28 in stream sediment trap
prior to placement
September 15, 2012

The sediment trap was placed downstream of Removal Area 4. Initially the trap was put in place and filled with rolls of jute matting to act as a medium for sediment collection. The rolled jute mats were too tightly wrapped and water began to pool and flow around the trap. The jute rolls were removed and unrolled and then loosely placed inside of the sediment trap and placed upstream and downstream of the trap. The jute matting inside

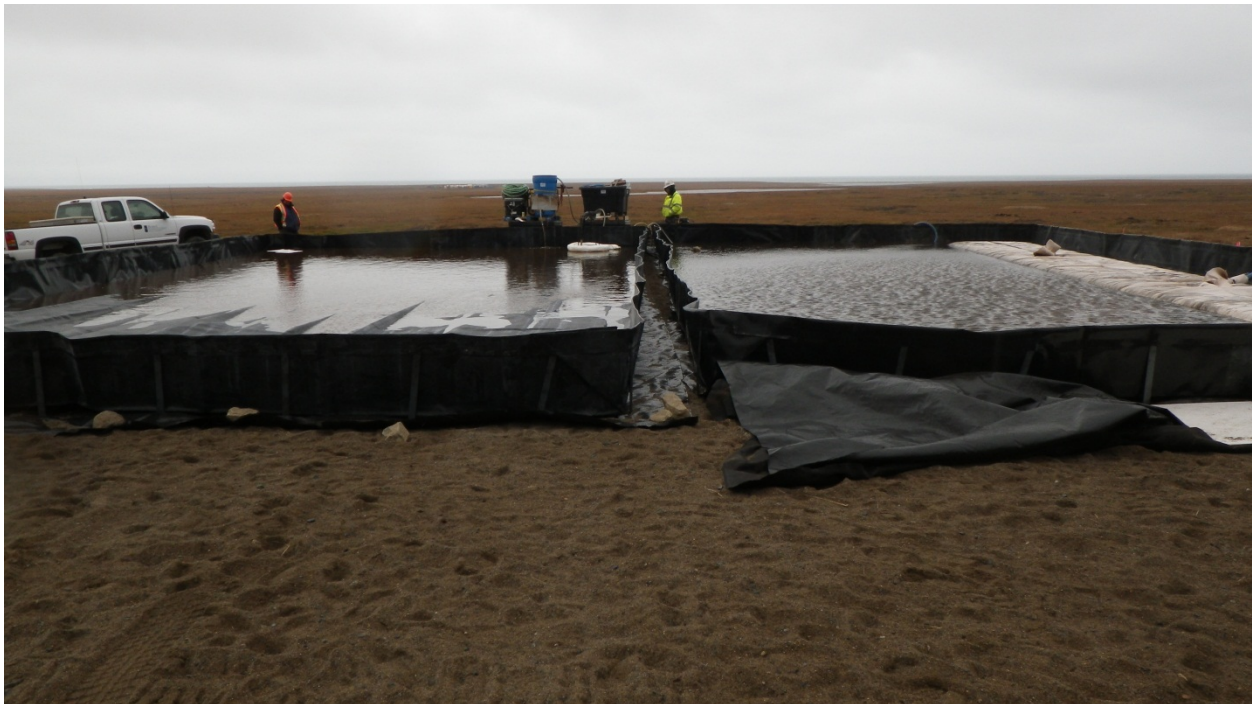
Photo 24 Overview of Containment No. 1 (right) and Containment
No. 2 (left) with dewatering geotextile container and water-scrubbing system
September 18, 2012

Future sediment removal at Site 28 using the venturi dredge will require handling and treating large volumes of water. In 2012, over the course of 2 to 3 hours of active dredging, approximately 30,000 gallons of water were generated. The remaining areas recommended for removal at the site include Area 3, which consists of a narrow, flowing streambed channel; the remainder of Area 4; and multiple ponded areas in the northern portion of the drainage leading up to the confluence of the Suqitughneq River. Based on the locations of the remaining contaminated sediments, effective water treatment and dewatering will be critical. The construction of additional lined containments for holding untreated water and sediment will allow dredging operations to progress more efficiently.
