**2013 SAMPLING CONDUCTED IN  
CONJUNCTION WITH THE 2013 FIVE-YEAR  
REVIEW AT  
NORTHEAST CAPE**

**NORTHEAST CAPE  
ST. LAWRENCE ISLAND, ALASKA**

**FUDS No. F10AK0969-03**

**Final  
February 2014**

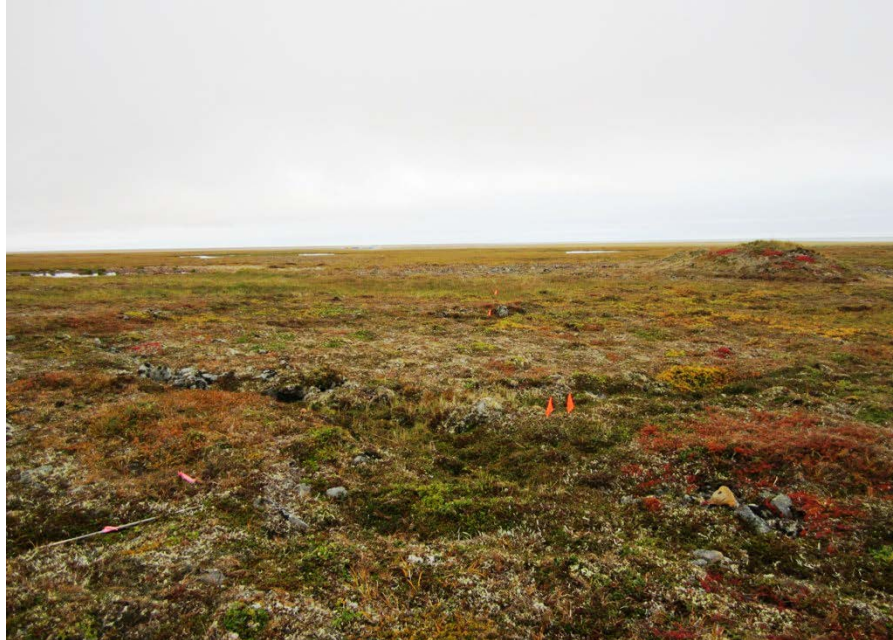
**Photo No. 4 – 12 September 2013**  
Attempted groundwater grab sampling locations at Site 7. Facing north.

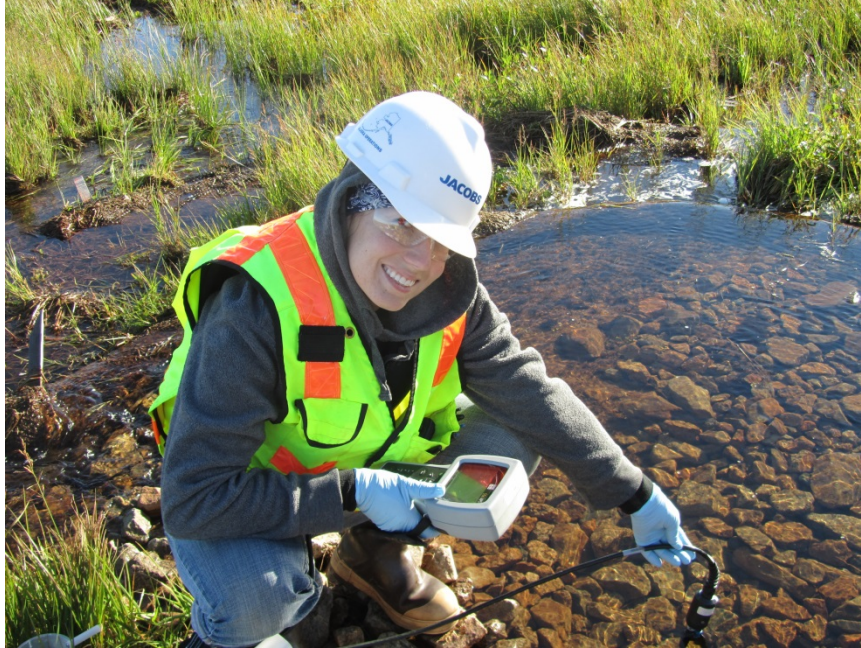
**Photo No. 5 – 12 September 2013**

Measuring surface water quality parameters prior to sampling at Site 9. Facing northeast.

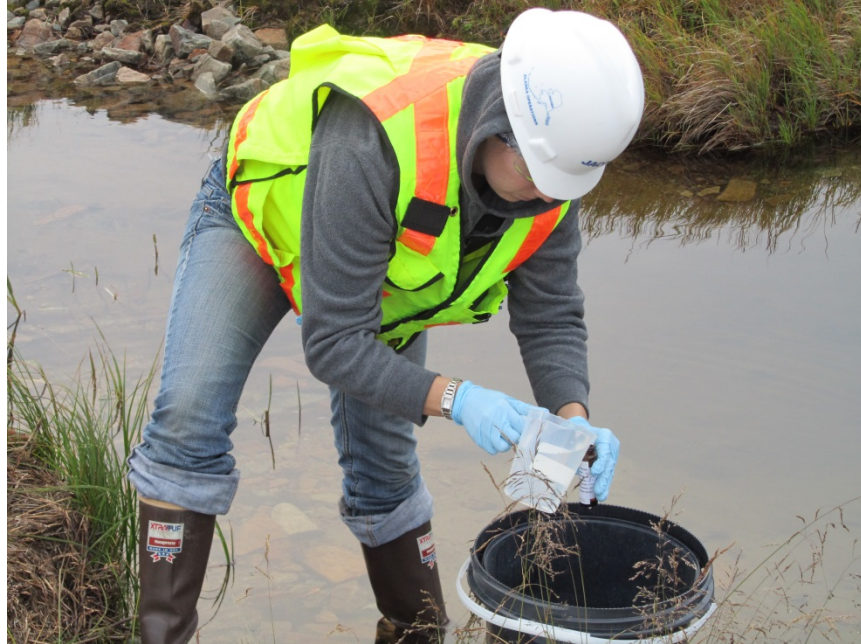
**Photo No. 6 – 21 September 2013**

Sampling surface water at Site 9. Facing northeast
