**SECOND FIVE-YEAR REVIEW REPORT FOR  
NORTHEAST CAPE FORMERLY USED DEFENSE SITE  
FUDS NO. F10AK0969-03  
ST. LAWRENCE ISLAND, ALASKA**

**U.S. Army Corps of Engineers  
Alaska District  
Anchorage, Alaska**

**FINAL**

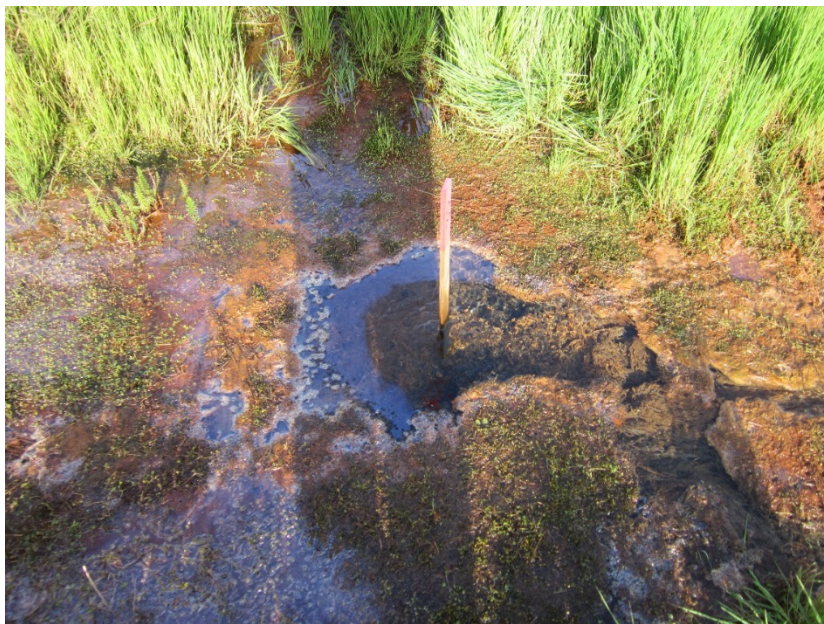
Removal Areas 10 and 11 include ponded areas interconnected by elongated features. This area also contained an abundance of tall grass and a vegetative mat (Photograph F-4-4). A small section of stream is found in the vegetative mat in Removal Area 10 south of sample location S28-12 (Photograph F-4-5). The main Site 28 confluence with the Suqi River occurs at sample location S28-1 (Photograph F-4-6) where a narrow flowing water feature is observed. Flow measurements recorded from the Suqi River in 2016 concluded that both velocity and discharge increased downstream of the Site 28 confluence as a result of in-flow from Site 28 (USACE 2017b).

**Photograph F-4-1: Artesian upwelling at S28-35. View facing down.**

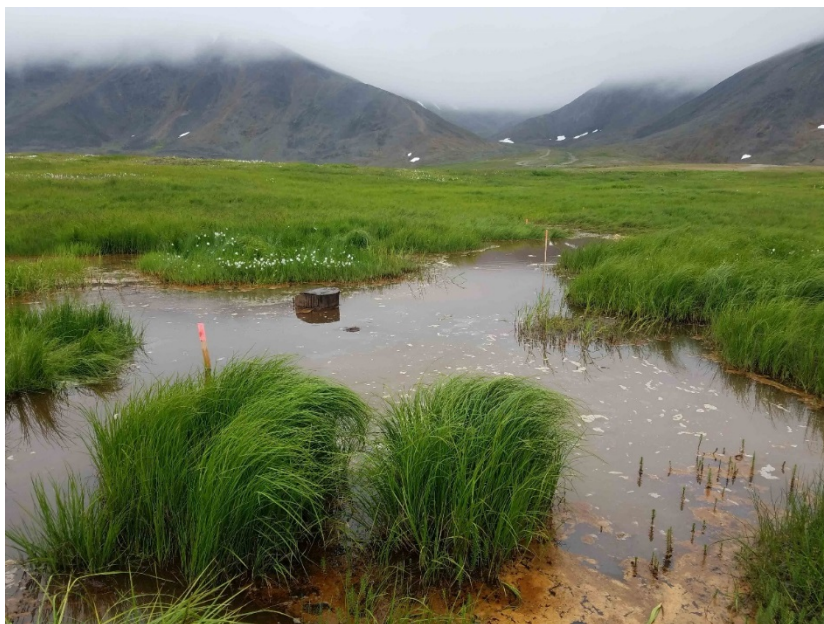
Debris consisting of submerged utility poles, plywood, cable wire, and rubber rigging mats were scattered throughout Site 28 in 2018. The partially submerged utility poles were observed above the water line (Photograph F-4-7). Other obstructions were noted during the sediment mapping activities within transect profiles P15 and P17. The plywood, cable wire, and rubber rigging were observed both submerged and unsubmerged within Site 28 (Photograph F-4-8).

**Photograph F-4-7: Partially submerged utility pole within Site 28 Drainage. View facing south.**

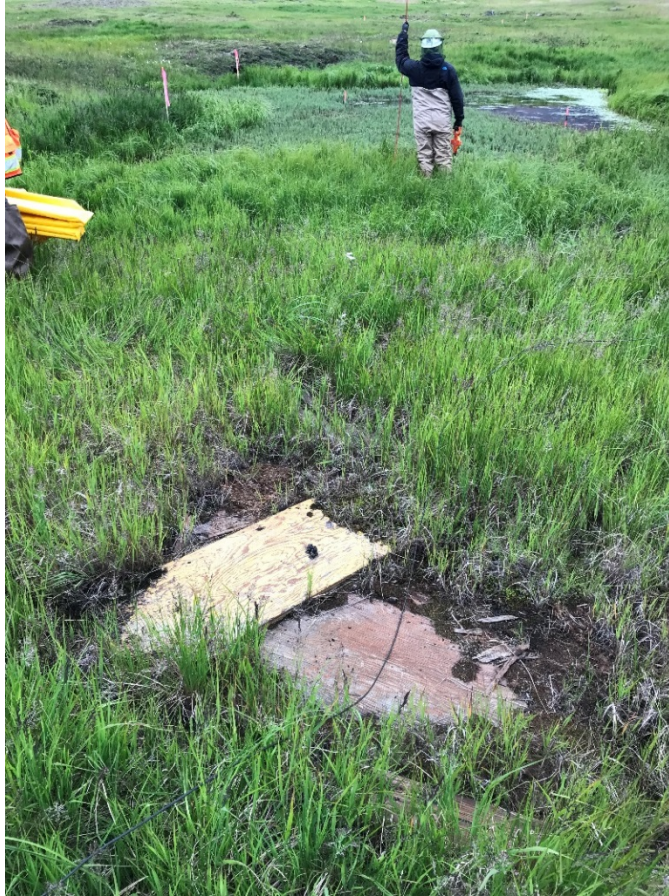
**Photograph F-4-8: Plywood debris within Site 28. View facing north.**
