From: Welker, Molly [mwelker@bristol-companies.com]
Sent: Thursday, April 16, 2009 4:24 PM
To: james.spires@alaska.gov
Cc: Cossaboom, Carey C POA; Woods, Travis; Johnson, Steve
Subject: Proposed Landfill Cap Northeast Cape, AK

Summary of the 2009 Northeast Cape Landfill Cap Project

Background of the Cargo Beach Road Landfill

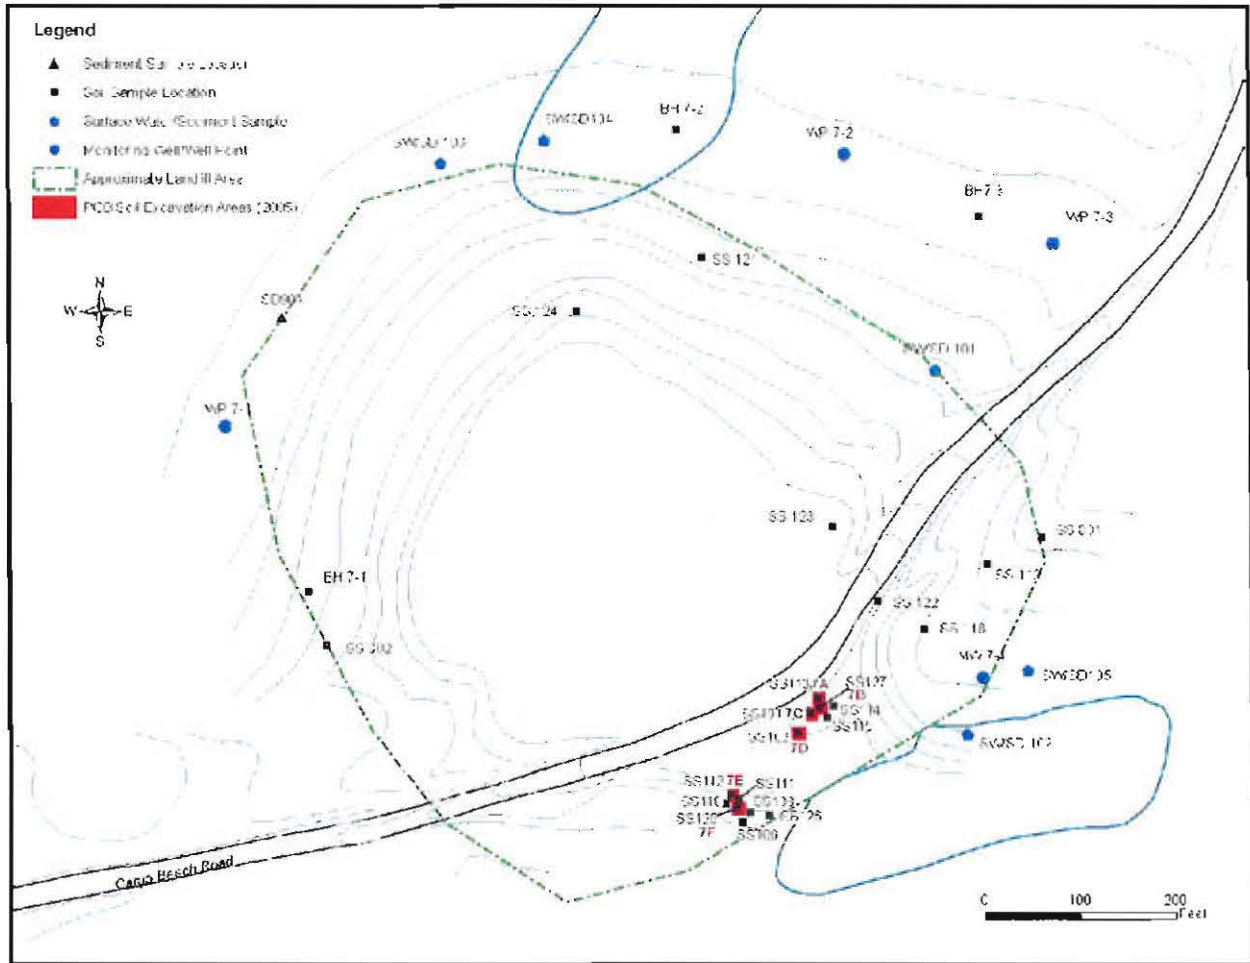
Figure 1. Cargo Beach Road Landfill sampling locations.

Environmental sampling activities at Cargo Beach Road Landfill have included the collection of soil, sediment, surface, and shallow groundwater samples (See Figure 1). Samples were analyzed for petroleum-related compounds, volatile organic compounds, semi-volatile organic compounds, metals, pesticides, and PCBs. Based on the results of the phased Remedial Investigations, contaminants exceeding action levels in the soil were diesel range organics (DRO), residual range organics (RRO), PCBs, arsenic, chromium, and lead. The Cargo Beach Road Landfill has a limited amount of soil contamination remaining above the applicable site-specific risk-based cleanup levels.

The following information is taken from the MWH 2001 Phase III RI, Northeast Cape, Alaska - Final Report on the Groundwater and Surface Water Sampling (Section 2.1.4.4). An attached table shows the analytical results and another image of Figure 1 is attached. The well points (WP 7-1, 7-2, and 7-3) are shown as blue dots on Figure 1. I can't find any information on MW 7-4 shown on Figure 1. I believe this is the only groundwater samples that have been collected at this site.

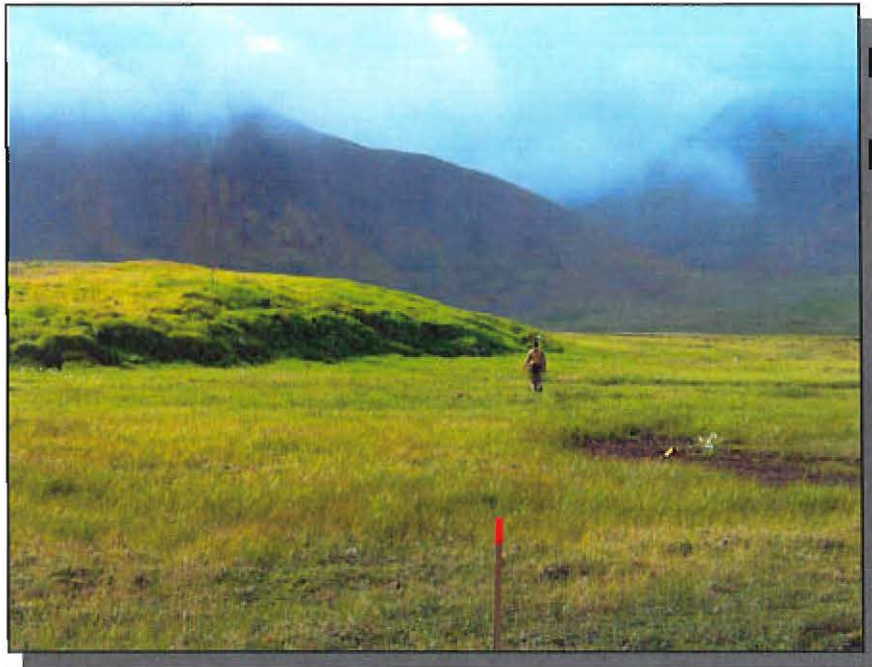
Electromagnetic data collection underway at Site 7, looking south.
(9 August 2007)

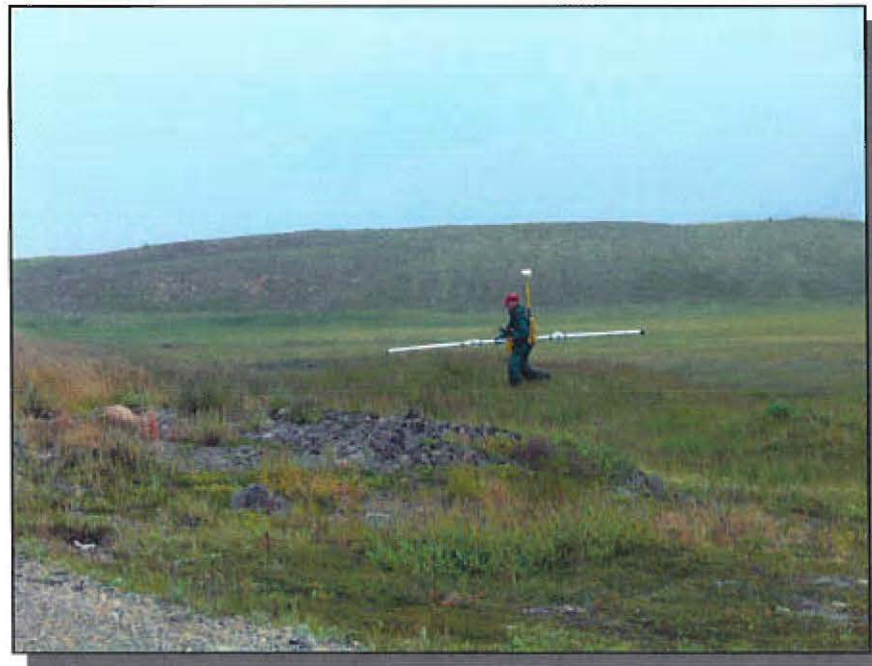
Magnetic data collection underway at Site 7, looking southeast.
(9 August 2007)

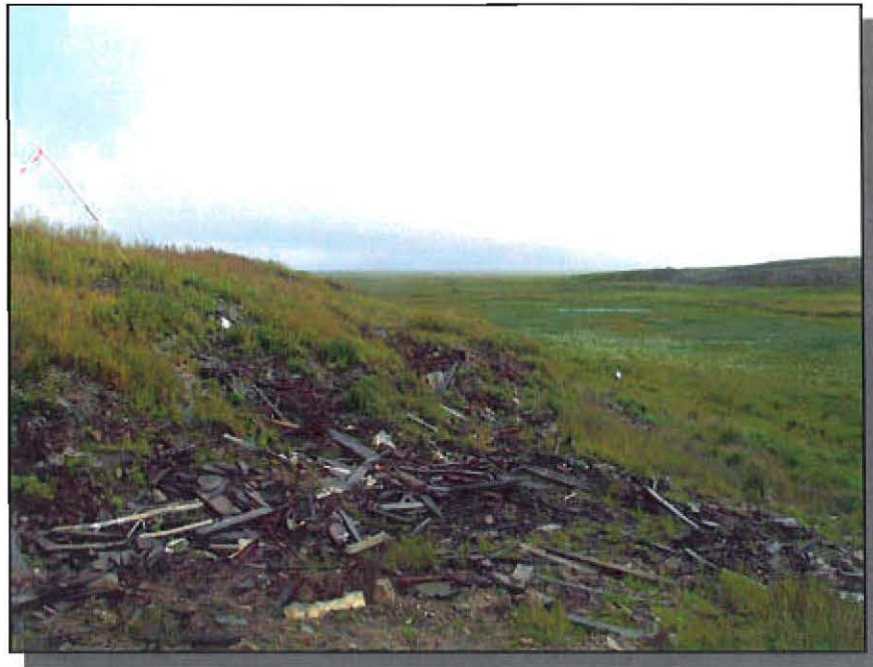
Existing debris on the south side of the Site 7 mound, looking east.
(9 August 2007)

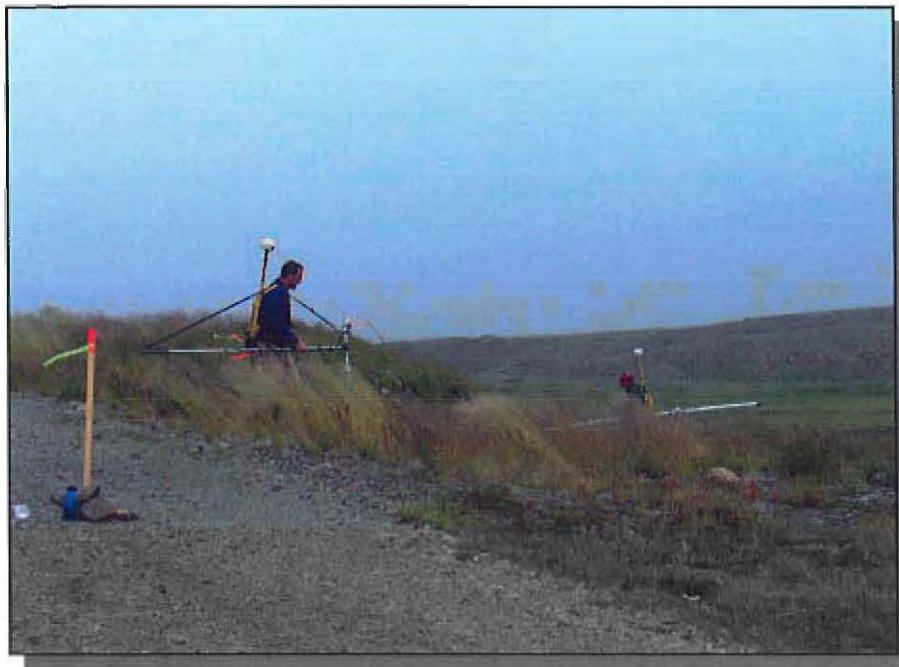
Simultaneous data collection underway at Site 7, looking southeast.
(9 August 2007)
