SECOND PERIODIC REVIEW REPORT SITE 7 CARGO BEACH ROAD LANDFILL

**NORTHEAST CAPE FUDS
ST. LAWRENCE ISLAND, ALASKA**

FUDS No. F10AK0969-05

**FINAL
AUGUST 2020**

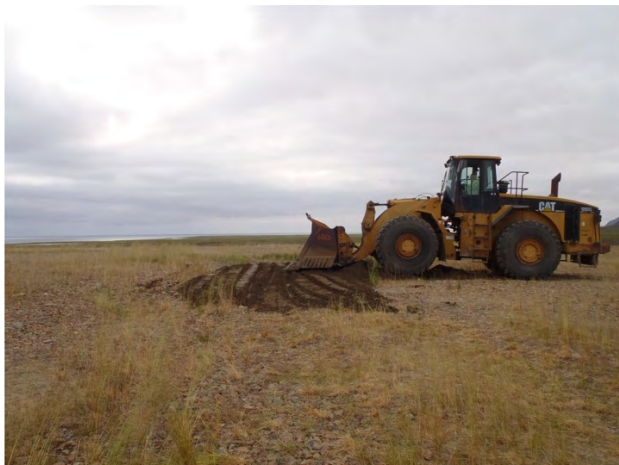
Photo 11: Cap maintenance: A depression near the top of the cap on the west side of the road was filled with clean fine-grained material from the borrow area, compacted, fertilized, and seeded, facing NW.

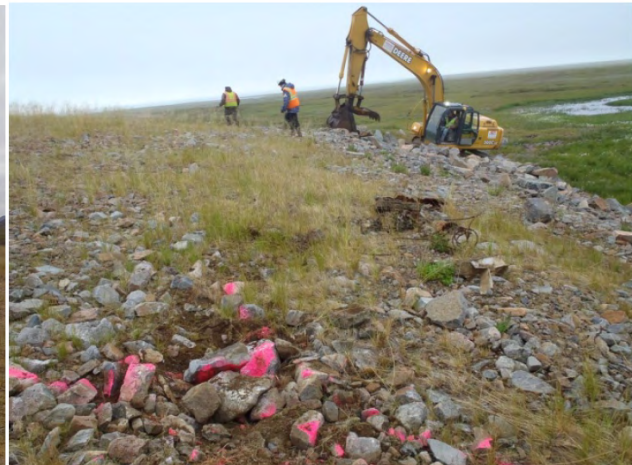
Photo 12: Cap maintenance: Surface debris, mostly metal and cable, was removed primarily from the landfill cap on the east side of the road. Photo shows workers and an excavator removing only visible surface debris, facing NW.

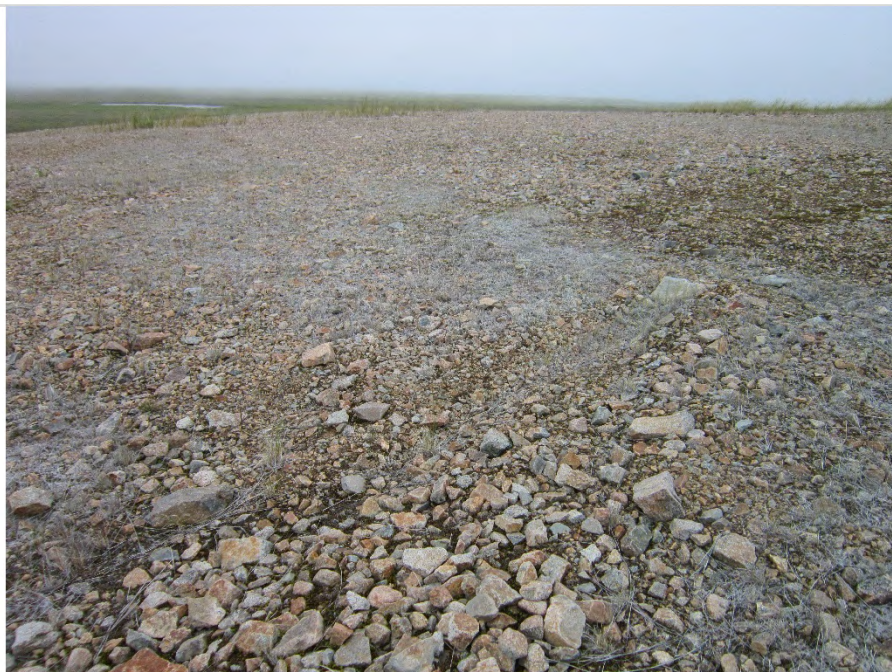
Photo No. 3 – 02 August 2018

Southwestern slope of the Site 7 landfill cap showing sparse vegetation. View facing north.

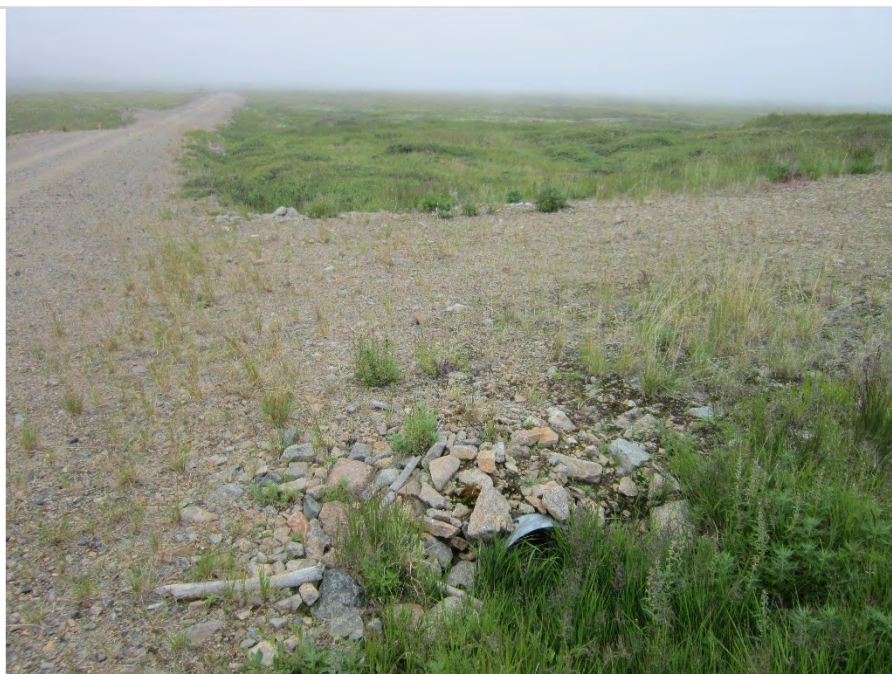
Photo No. 5 – 02 August 2018

Cargo Beach Road crossing and extending south of the Site 7 landfill cap, with culvert to provide drainage off landfill cap. View facing southwest.

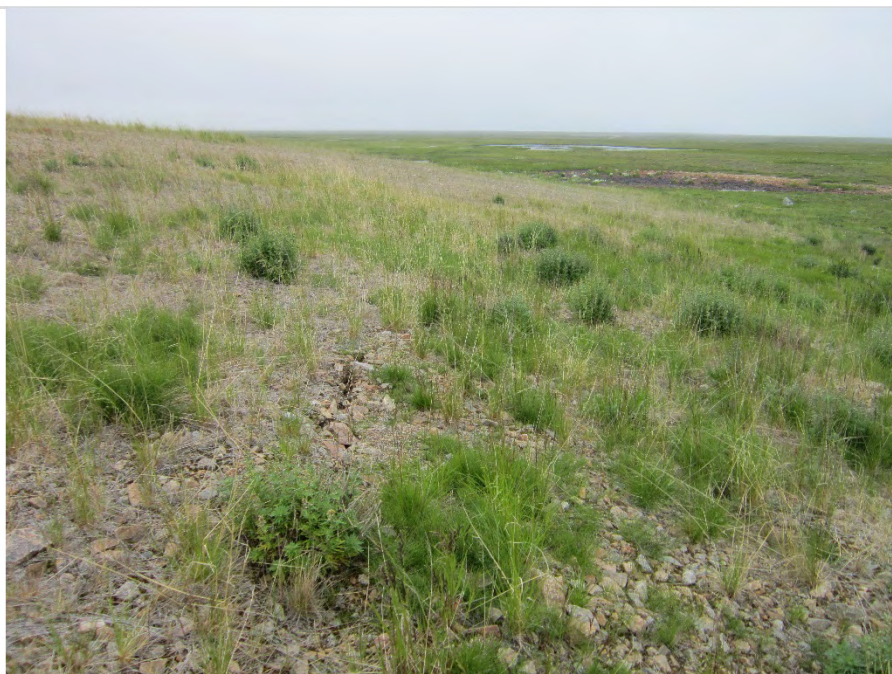
Photo No. 7 – 02 August 2018

The landfill cap at Site 7 was observed in good condition with no apparent signs of erosion. One minor crack was observed near the northern perimeter (Photo No. 7 [Appendix D]). The soil used for vegetative cover was observed to be very coarse, making vegetative growth sparse (Photo Nos. 3, 7, 11, and 12 [Appendix D]). Consistent with the 2013 Periodic Review, debris was noted adjacent to the landfill along the northwestern perimeter. Debris appeared to be wood fragments, pipes, sheet metal, rubber matting, wire, and a film reel (Photo Nos. 8, 9, 10, 11 and [Appendix D]). Limited wood debris was noted along the toe of the armored rock to the southeast (Photo Nos. 17 and 18 [Appendix D]). The ponded surface water areas adjacent to the landfill were nearly dry at the time of the 2018 site inspection, and water levels were much lower than those observed in 2013 (Photo Nos. 8 and 15 [Appendix D]).

Minor cracking observed at the northern edge of the landfill cap. View facing northwest.

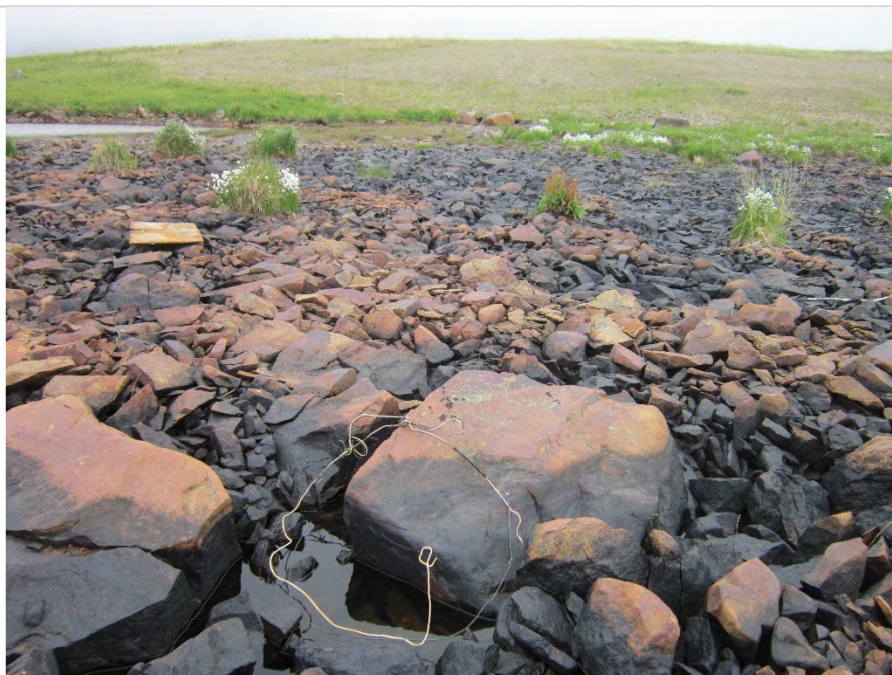
Photo No. 8 – 02 August 2018

Photo showing low water level in pond to the northwest of the Site 7 landfill cap. Some scattered debris shown. View facing southeast.

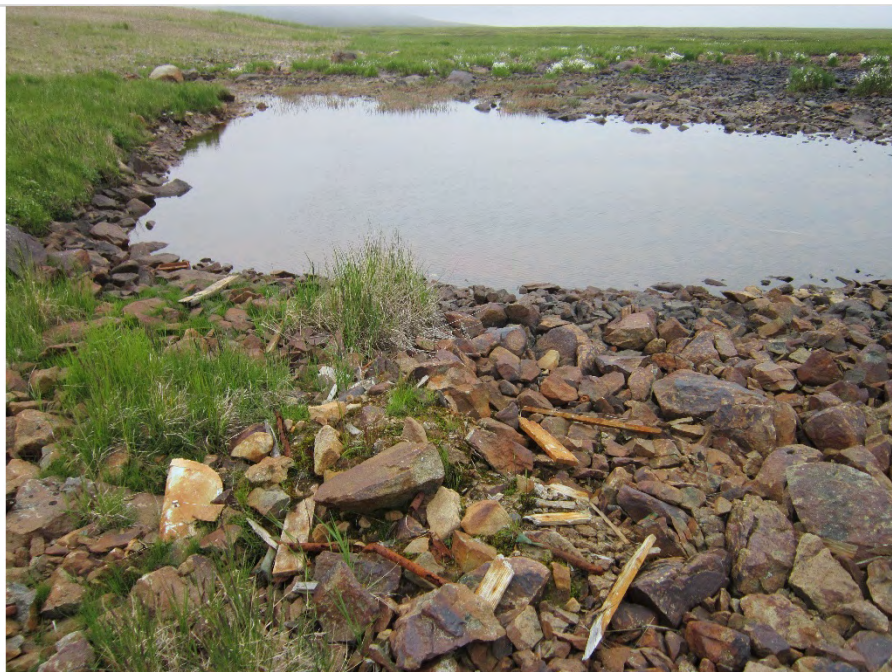
Photo No. 9 – 02 August 2018
Pond to the northwest of the Site 7 landfill cap with debris including wood and pipe fragments. View facing southwest.

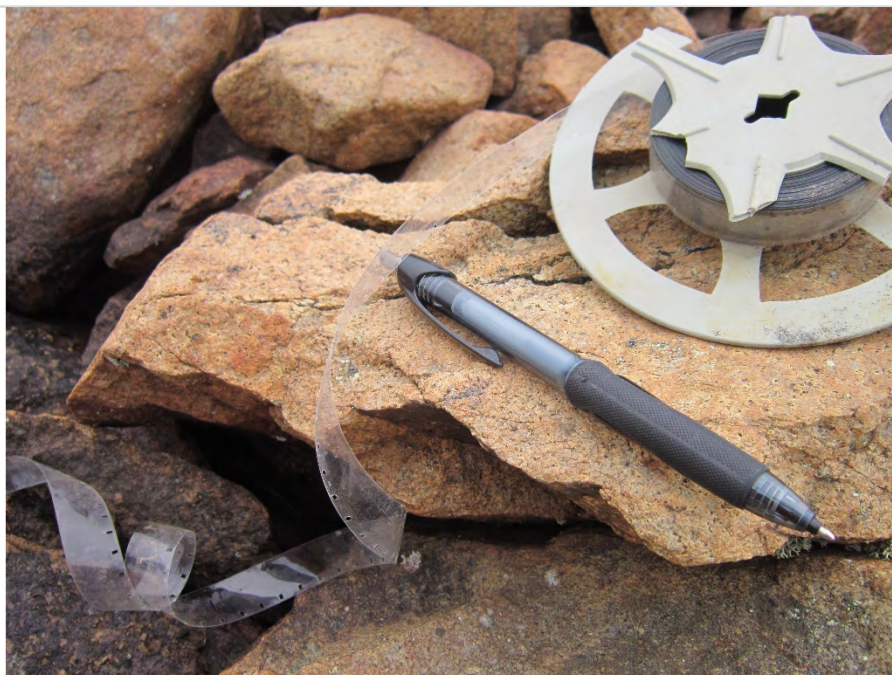
Photo No. 10 – 02 August 2018
Debris included film reels present in ponds to the northwest of the Site 7 landfill cap. View facing down.

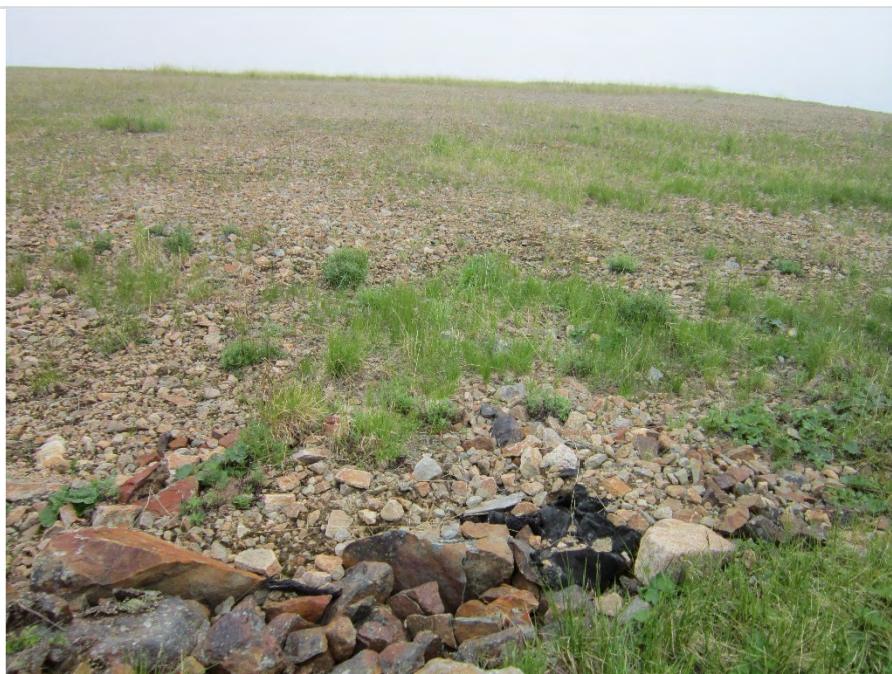
Photo No. 11 – 02 August 2018

Rubber mat exposed at the perimeter of the Site 7 landfill cap along the northwest side. View facing southeast.

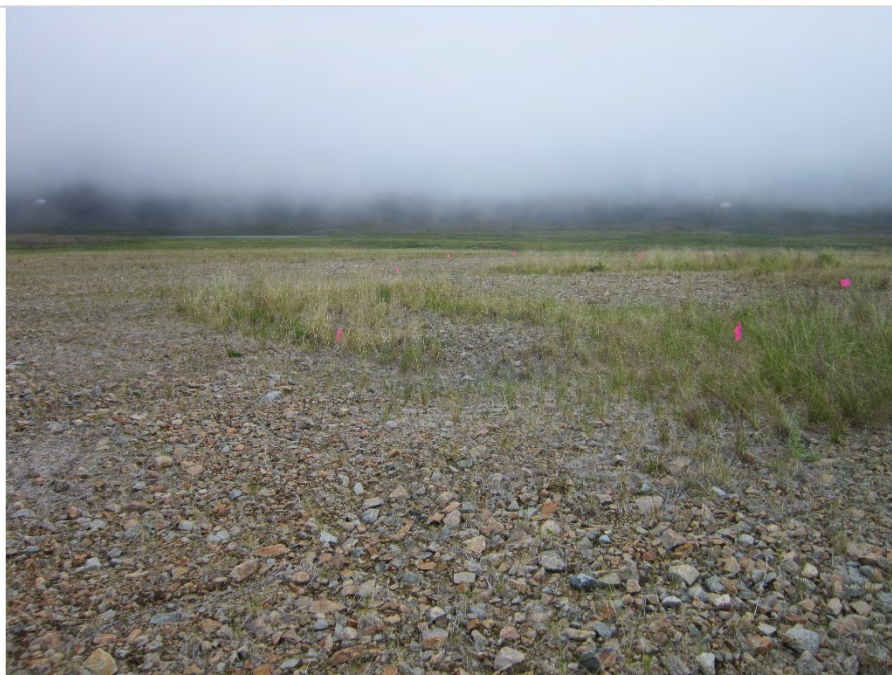
Photo No. 12 – 02 August 2018

Two areas of settlement on the cap were observed near the top of the landfill (Photo Nos. 12, 13, and 14 [Appendix D]). Depressions were approximately 2-feet below surrounding grade. Topography across these areas was surveyed and included on Figure A-4. Three topographic cross sections are presented on Figure A-5.

Low spots near the top of the Site 7 landfill cap. View facing southeast.

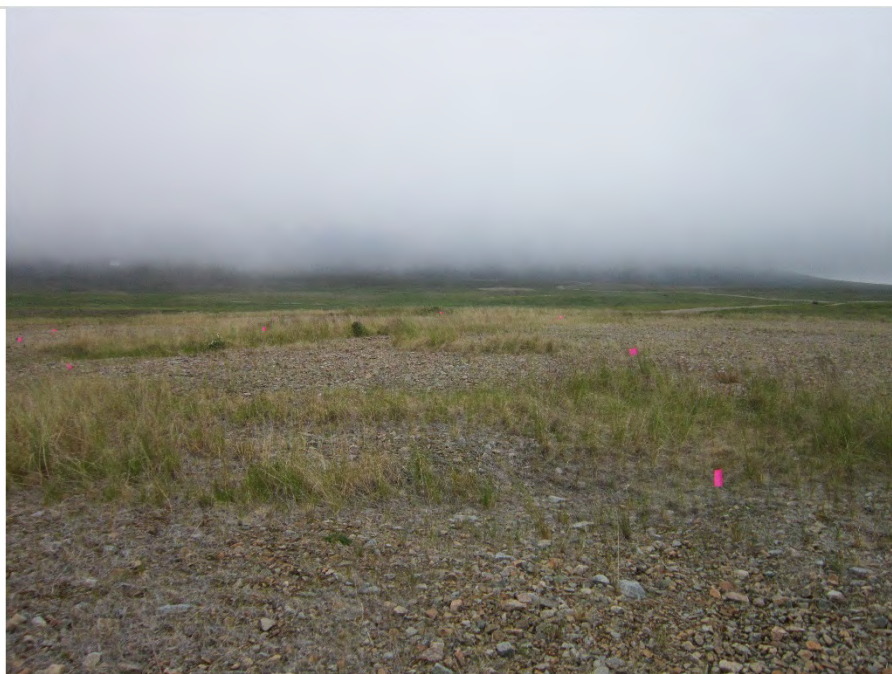
Photo No. 13 – 02 August 2018
Low spots near the top of the Site 7 landfill cap. View facing south.

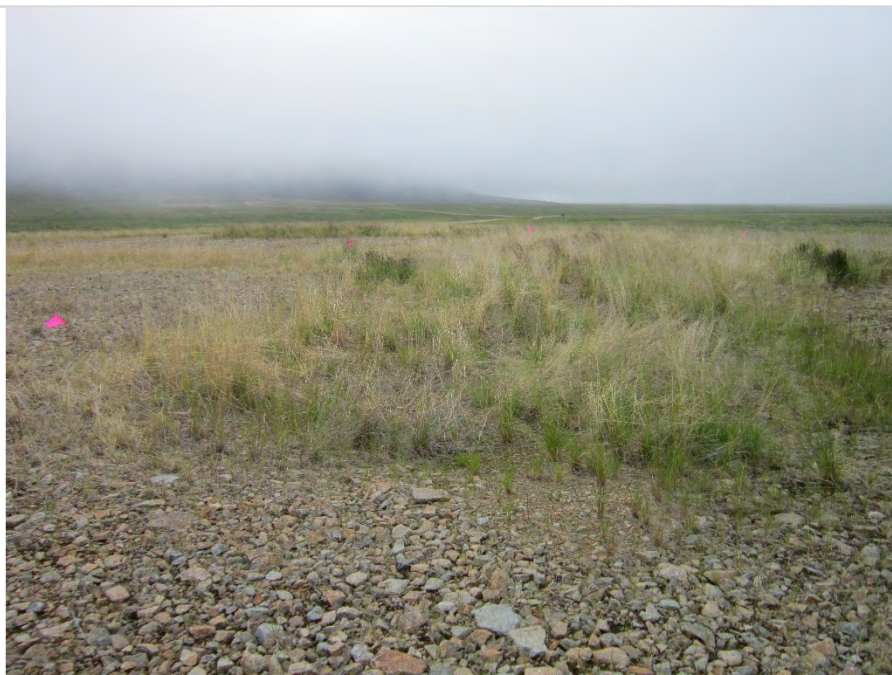
Photo No. 14 – 02 August 2018
Low spot near the top of the Site 7 landfill cap. View facing southwest.

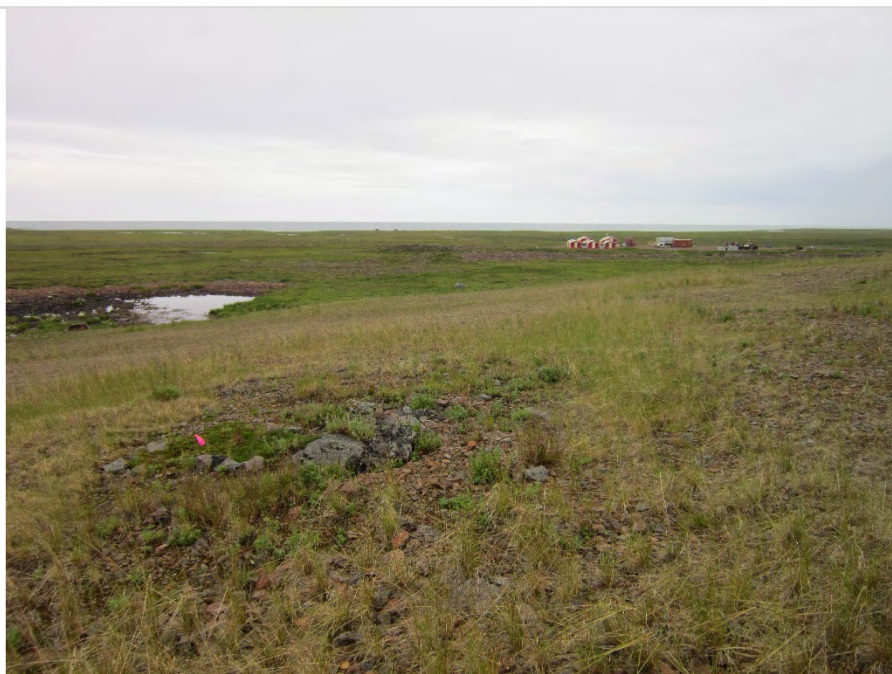
Photo No. 15 – 06 August 2018

Location of historical monument found along the northwestern slope of the Site 7 landfill cap. Monument reads “4469-S GPS-2 2001.” View facing north.
