PRELIMINARY ASSESSMENT REPORT

NAVAL OCEAN SYSTEMS CENTER  
SPECIAL AREAS, ALASKA

NEESA 13-205  
JULY 1991

1. WHITE ALICE SITE, TIN CITY, AK.
2. NAVY FIELD STATION WALES, AK.
3. WHITE ALICE SITE, NE CAPE, ST LAWRENCE IS.  
AK

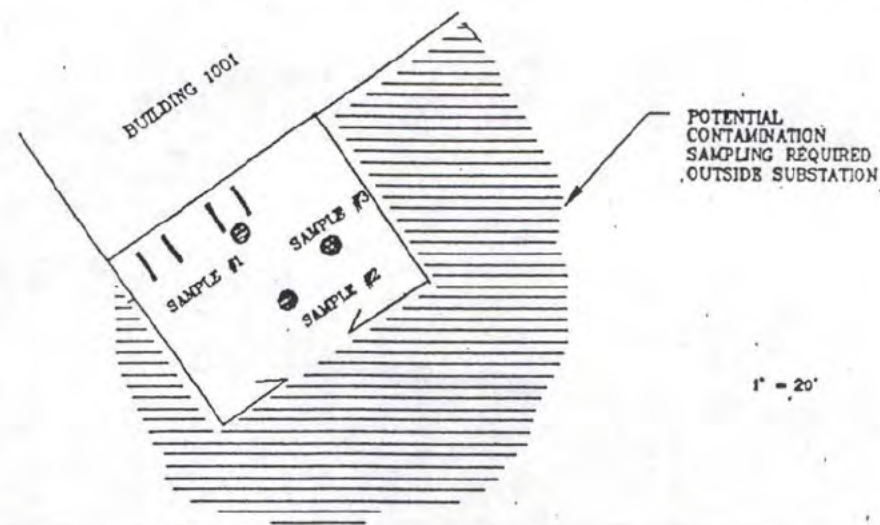
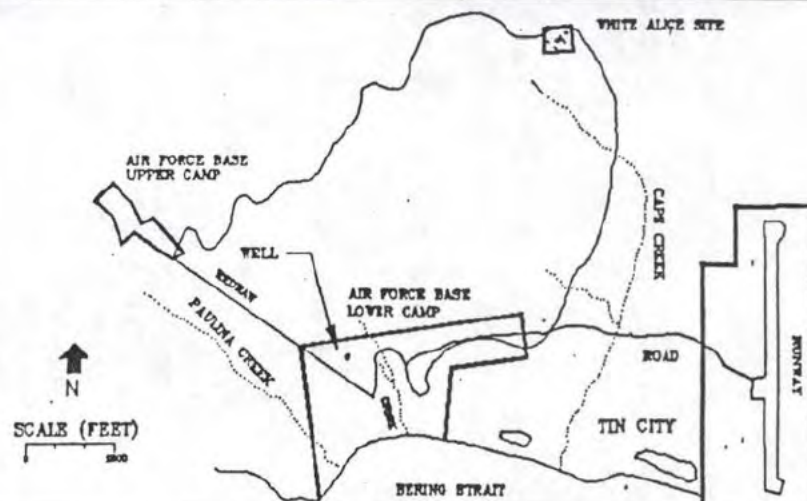
FIGURE 9  
SITE 1, BUILDING 1001  
PCB CONTAMINATION

During the site visit three samples were taken inside the substation of Building 1001 along with a field blank for quality control. The samples were taken in the locations shown on Figure 9. An area of 10 square centimeters was taped off and a

wipe sample was collected and analyzed for total extractable PCBs. Sample #1 was taken next to the location of marks indicating the location of the transformer. Sample #2 was taken from the exposed cable post. Sample #3 was taken towards the corner of the room nearest the doorway. Sample #4 was the field blank. The results revealed PCB 1260 in all samples except for the field blank. The results are shown below in Table 4 and Appendix B.

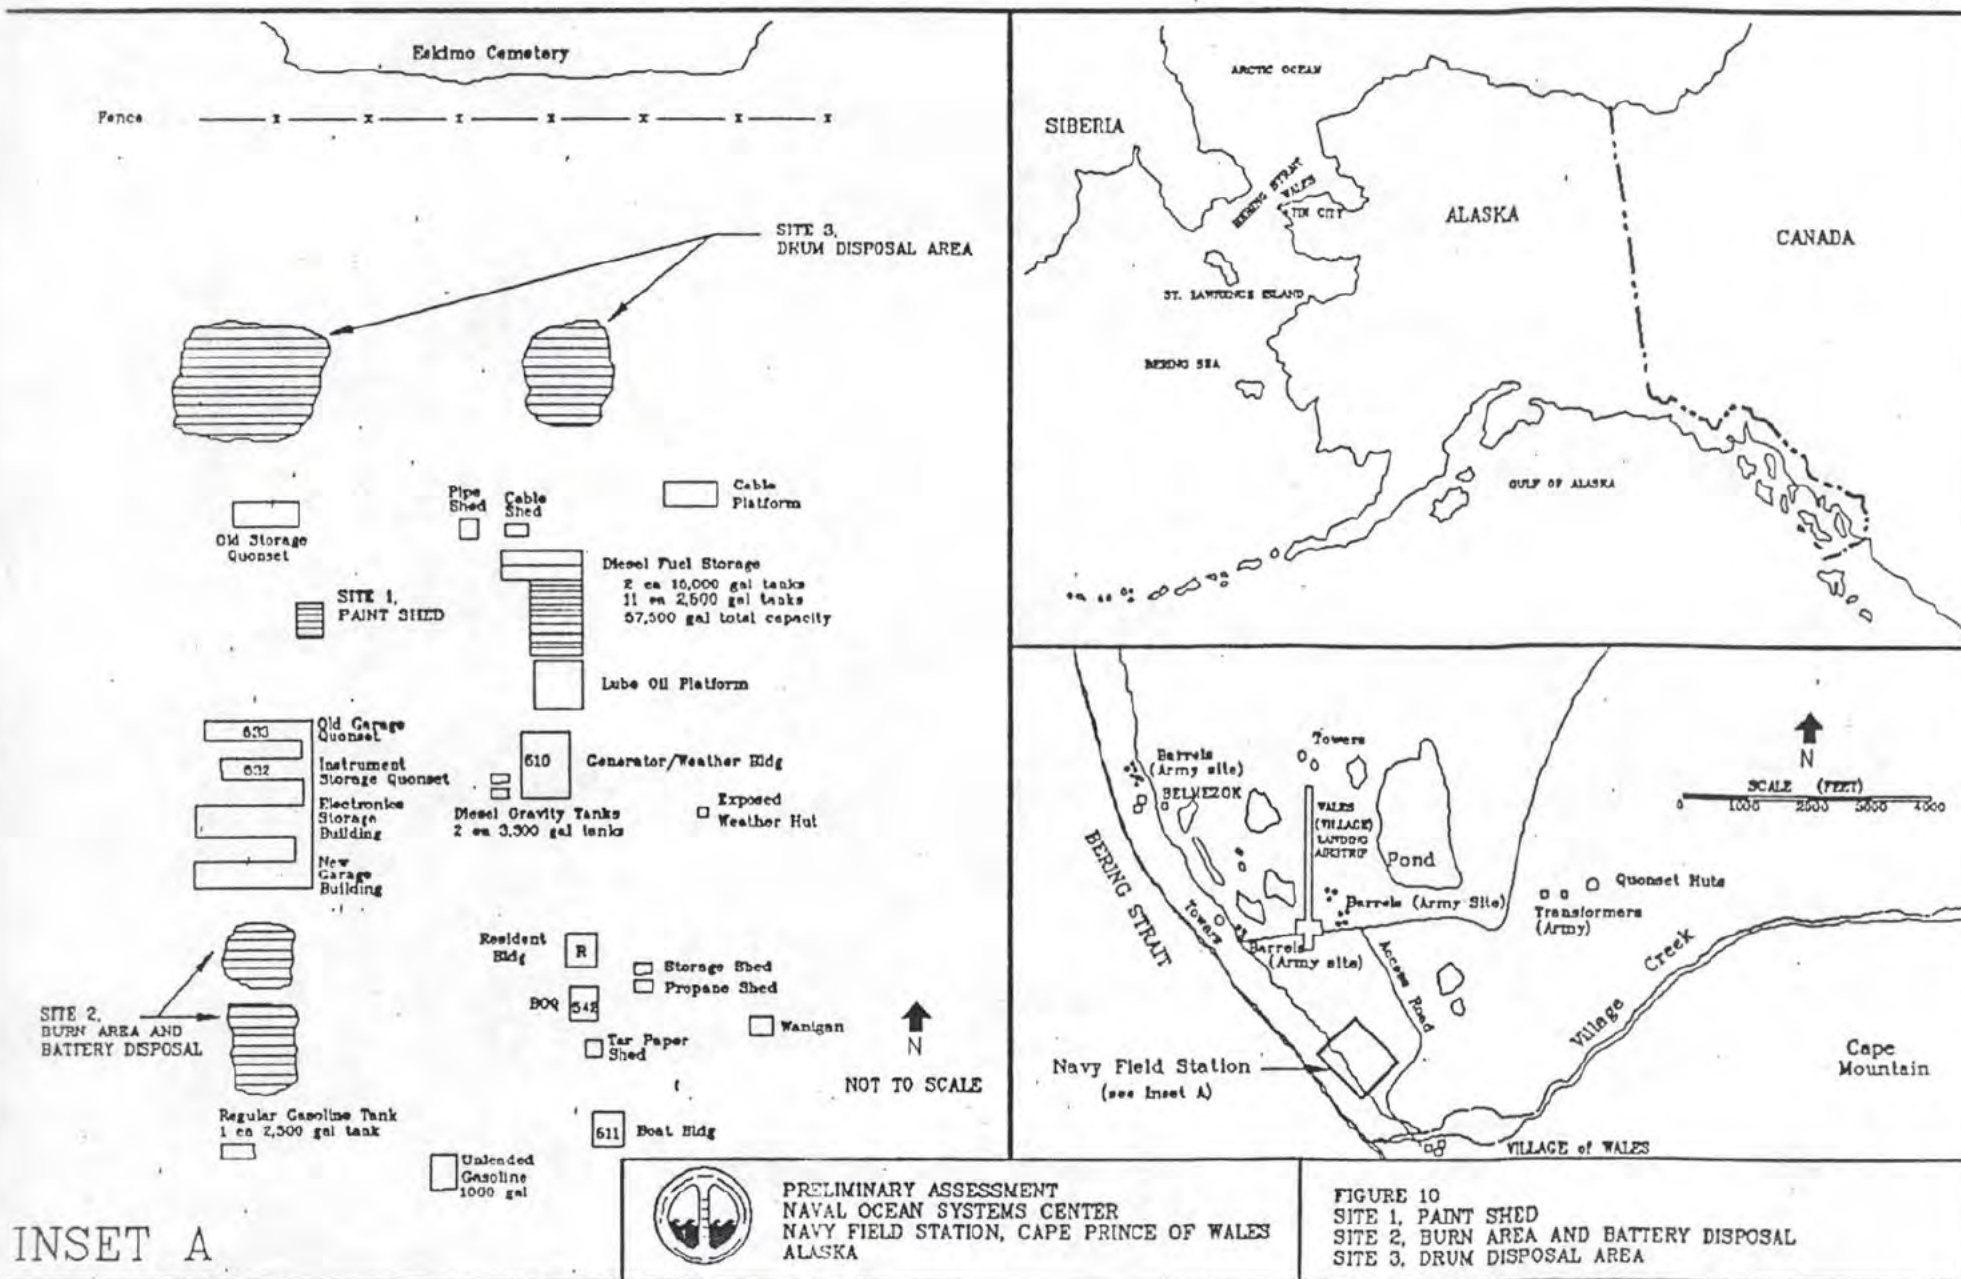
**3.5.2.1 Findings.** Since the 1940s, household trash has been

burned with waste oil in two small areas in the sand dunes in between the new garage building and the gasoline tank as shown in Figure 10. There were also empty paint cans, batteries and an empty acetylene cylinder in the burn areas. There are two burn areas. The north burn area is approximately 20 feet by 20 feet and the south burn area is about 50 feet by 50 feet.

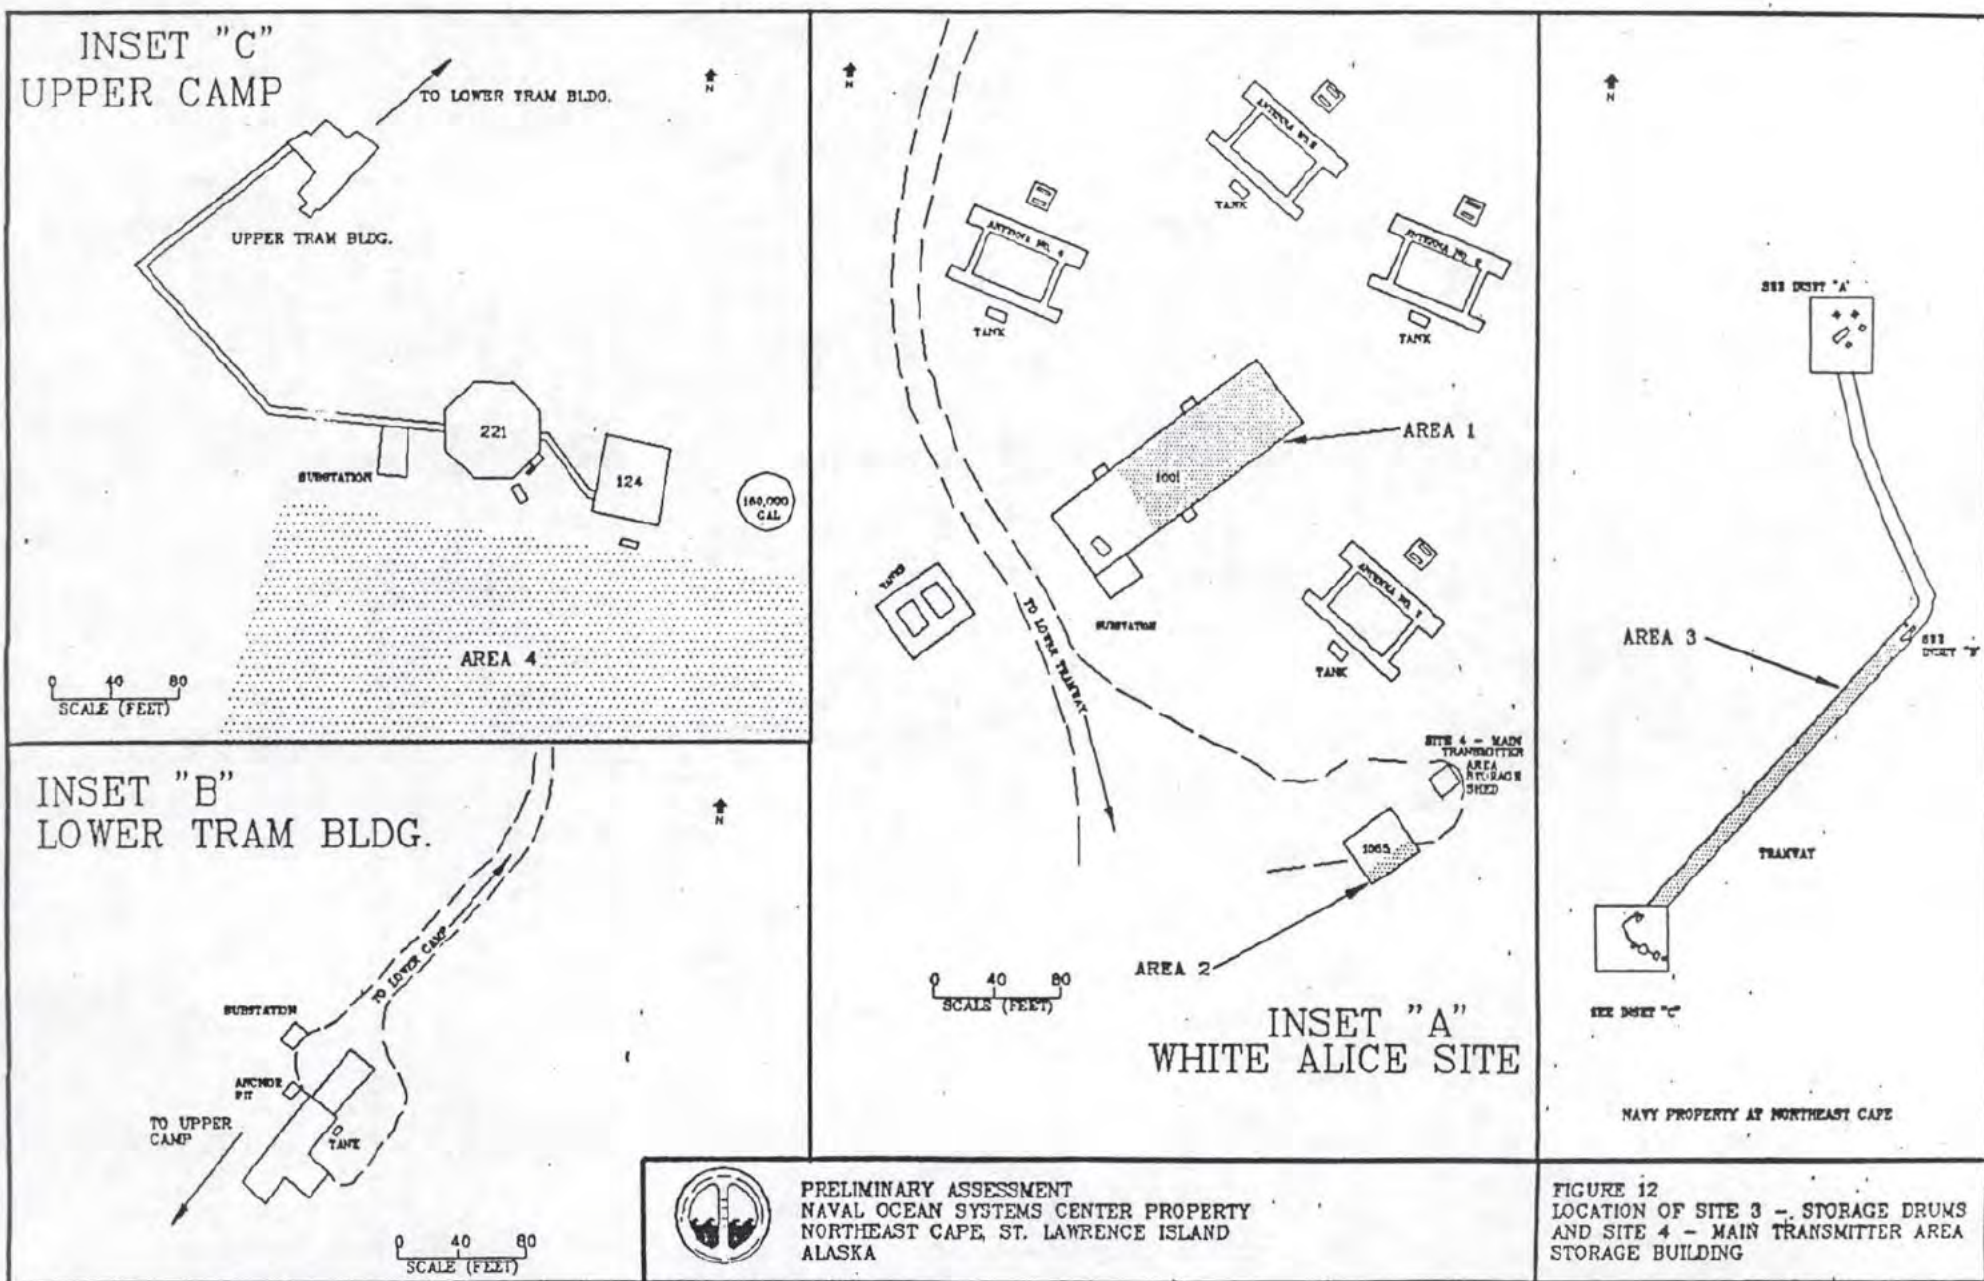
FIGURE 12  
LOCATION OF SITE 3 - STORAGE DRUMS  
AND SITE 4 - MAIN TRANSMITTER AREA  
STORAGE BUILDING

In addition to the above mentioned chemicals, the station also reportedly handled PCB dielectric fluids, dibenzofuran, carbon tetrachloride, DDT, Trichlorophenoxy acetic acid (2,4,5-T), alcohols, and sulfuric acid. No drums or containers were noted

that were labeled as such. However, with the exception of Area 1, a majority (greater than ninety percent) of the drums were too rusted to read their labels and determine the contents.

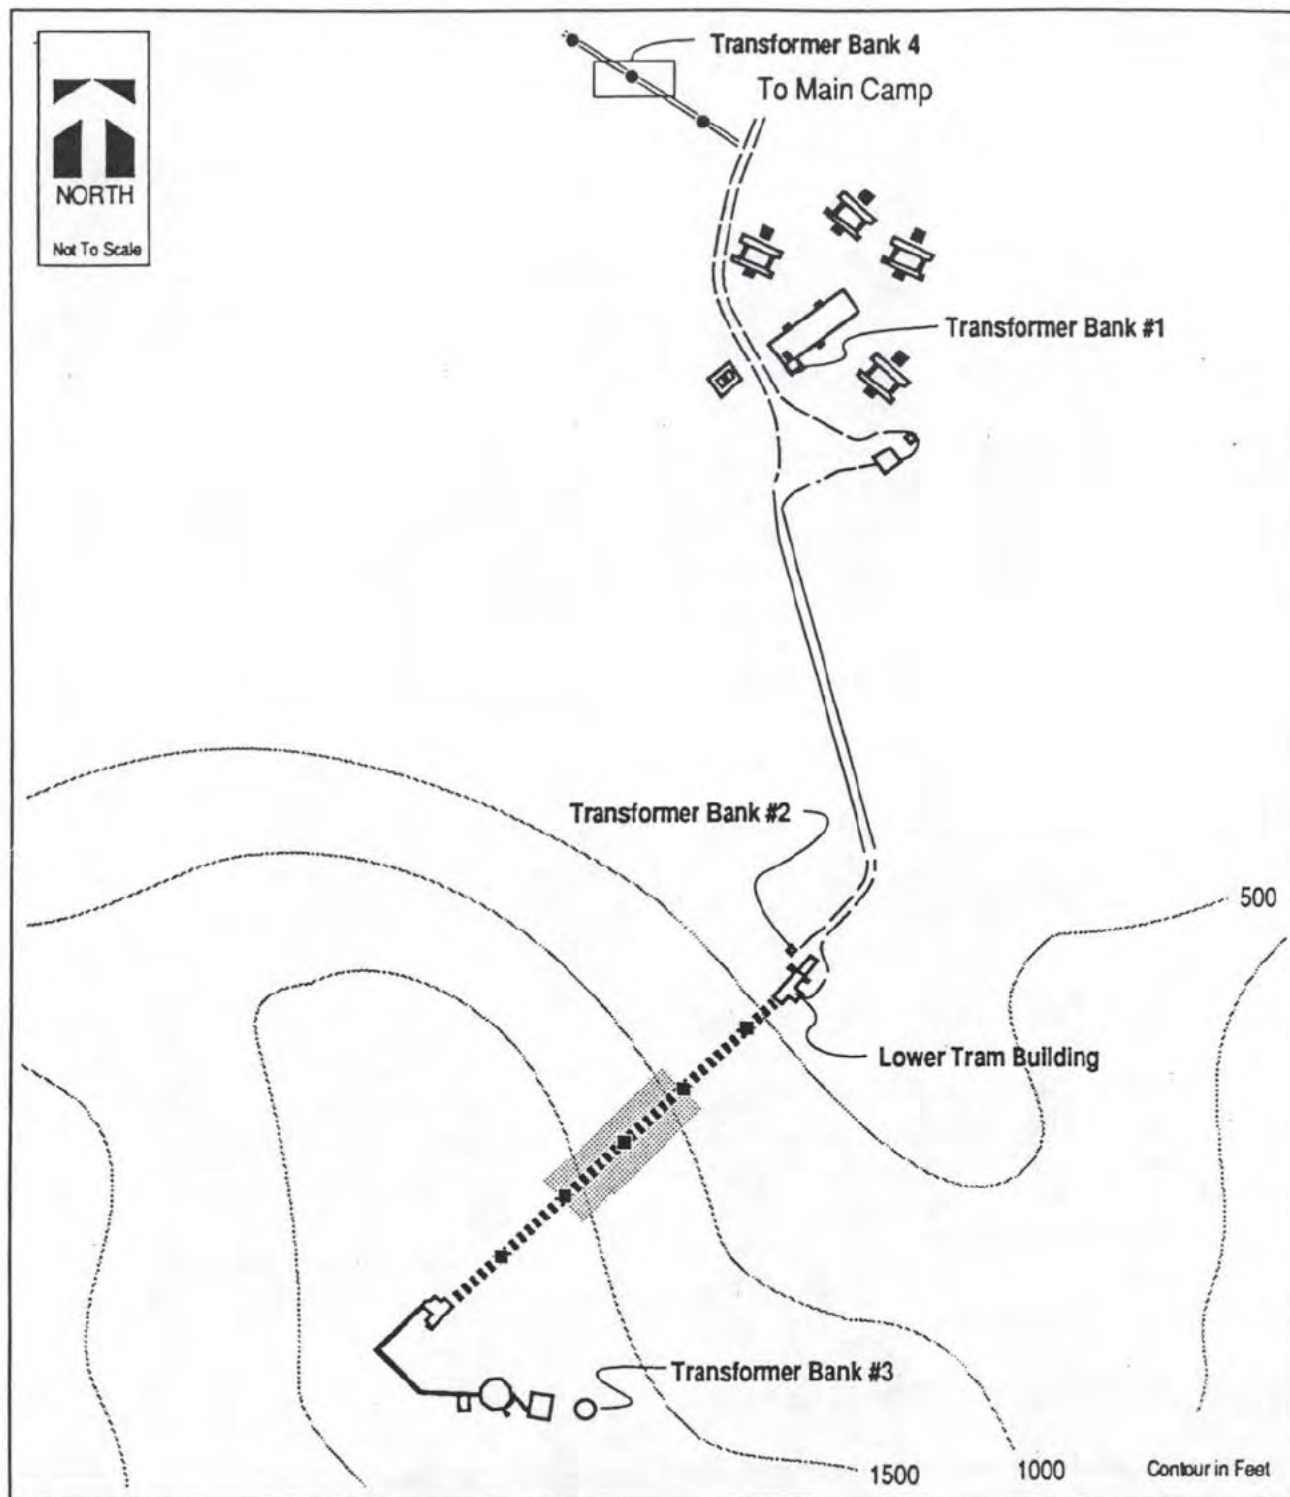
**Figure 6-1**  
**Tram Slope and Abandoned**  
**Electrical System**

The substations of Building 1001, the Lower Tram Transformer Building, and the Upper Camp Transformer Building, as shown in Figure 6-1, revealed three separate large size transformer banks. Midway between the White Alice transmitter facilities and the abandoned AFB facility, under the main electric power line (Figure 5-1), a fourth bank of transformers was located on an unprotected platform. Details of each transformer bank are found in Appendix A and the following text:

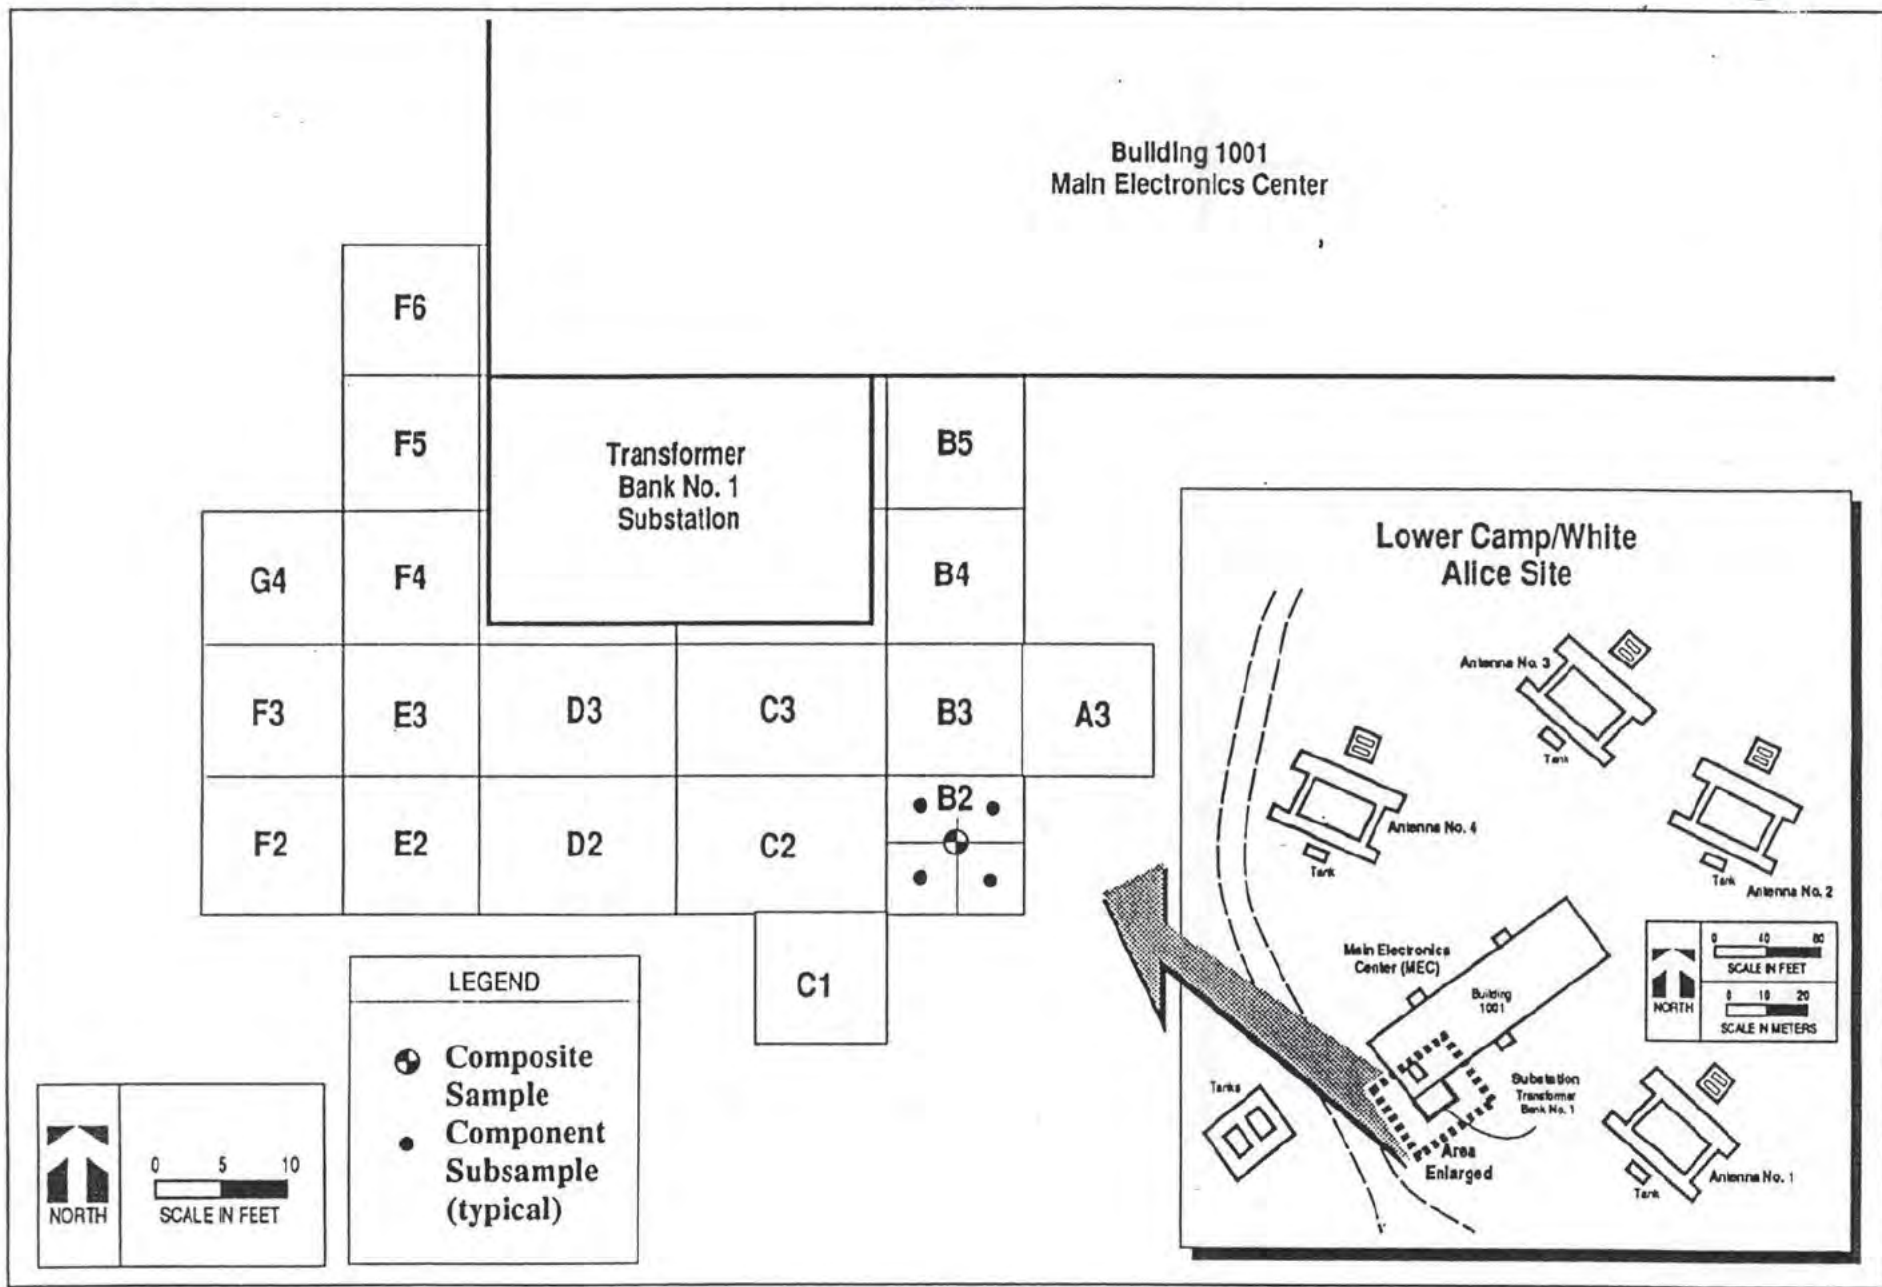
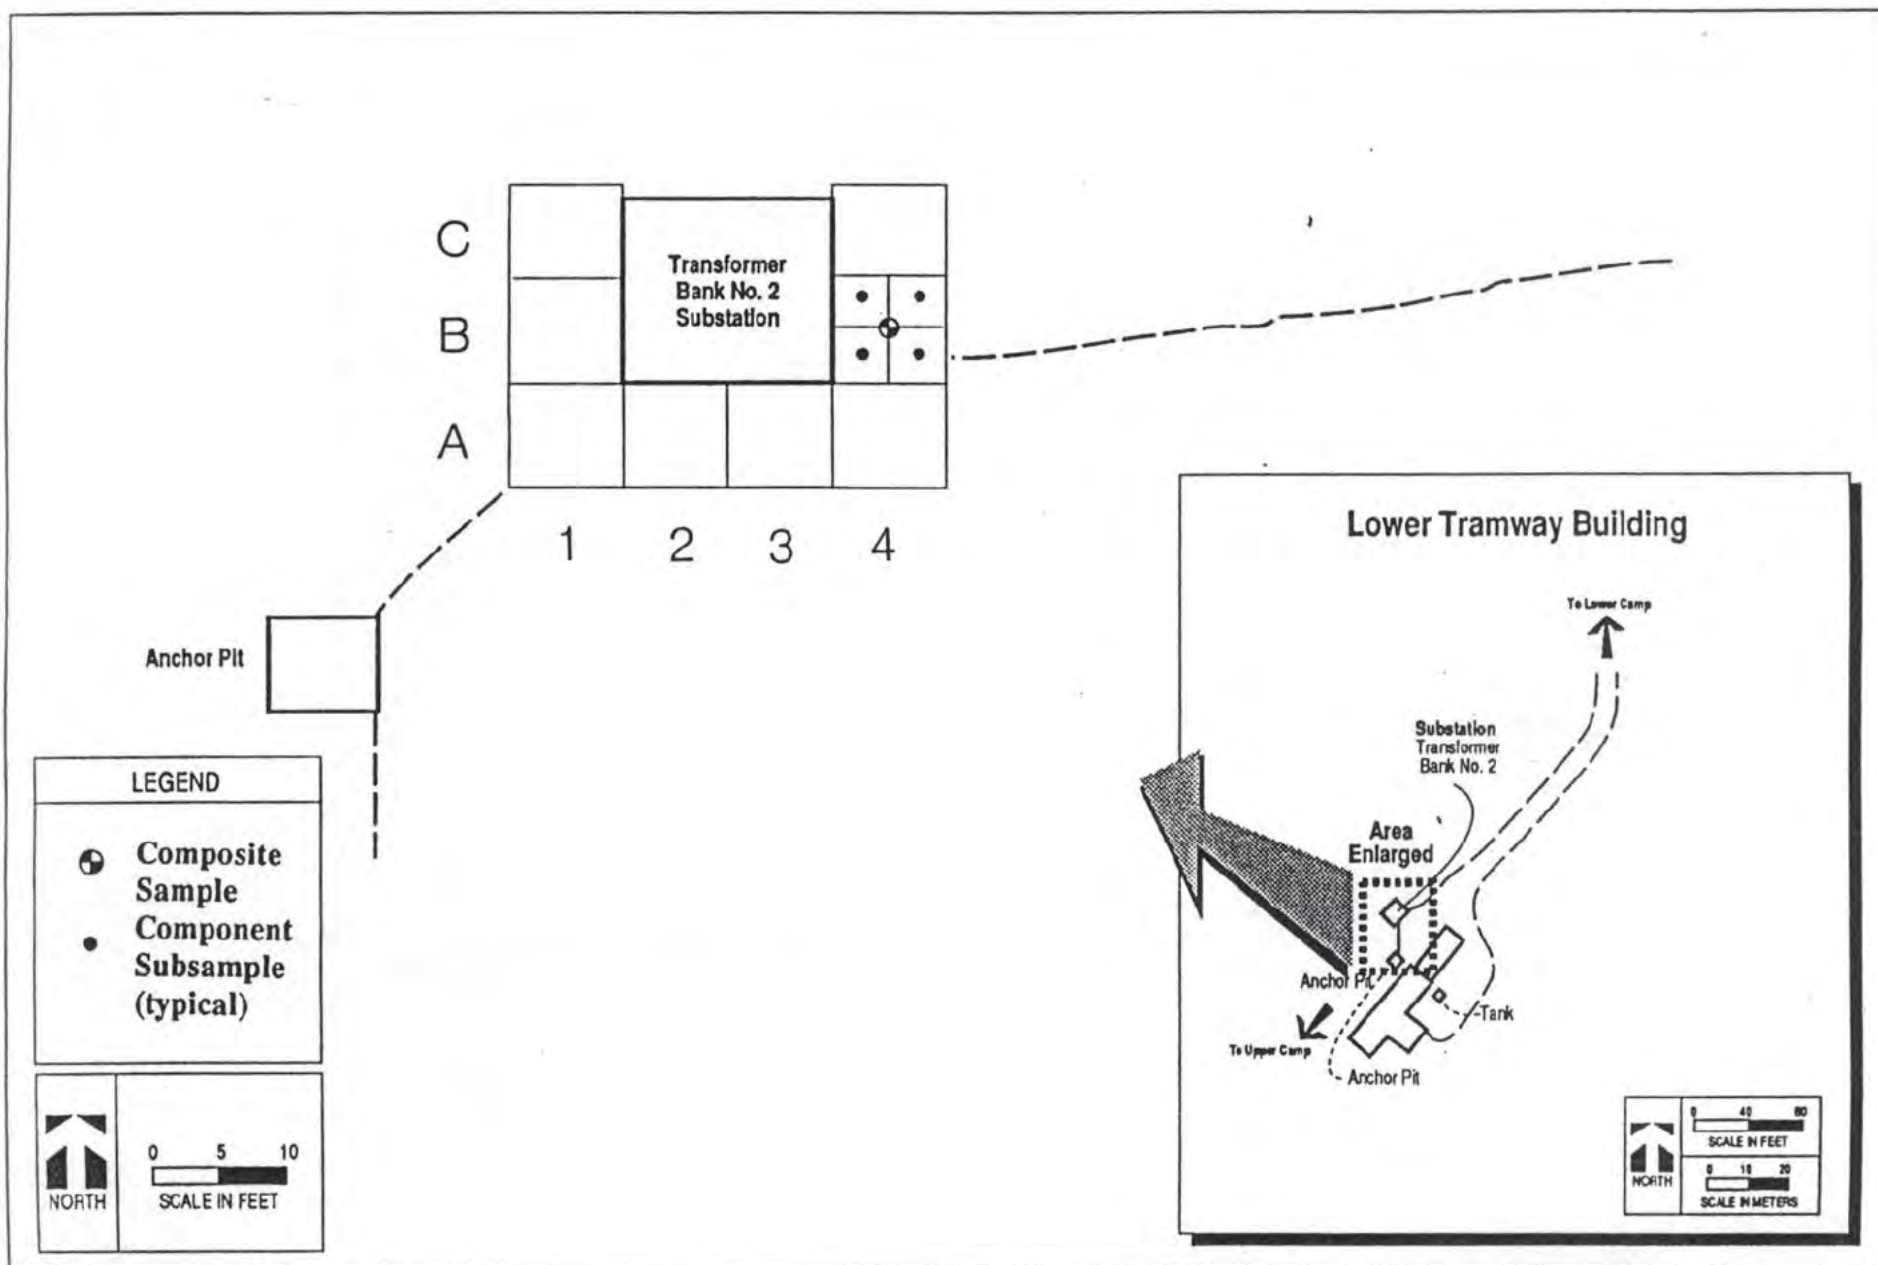
The grid layout for the soil-sampling effort of Site 1 was identical to the grid established during the previous SI Sampling Plan (URS 1990E) with the exception of three additional sample-point locations shown as shaded boxes in Figure 4-1. The sample grid was extended to add one composite sample each to the southwest, southeast, and east sides of the grid where previous sampling efforts had indicated the presence of contamination (URS 1991). This extension was intended to identify whether the contamination limit was immediately adjacent to the prior grid boundary, or if the contamination was more widespread.

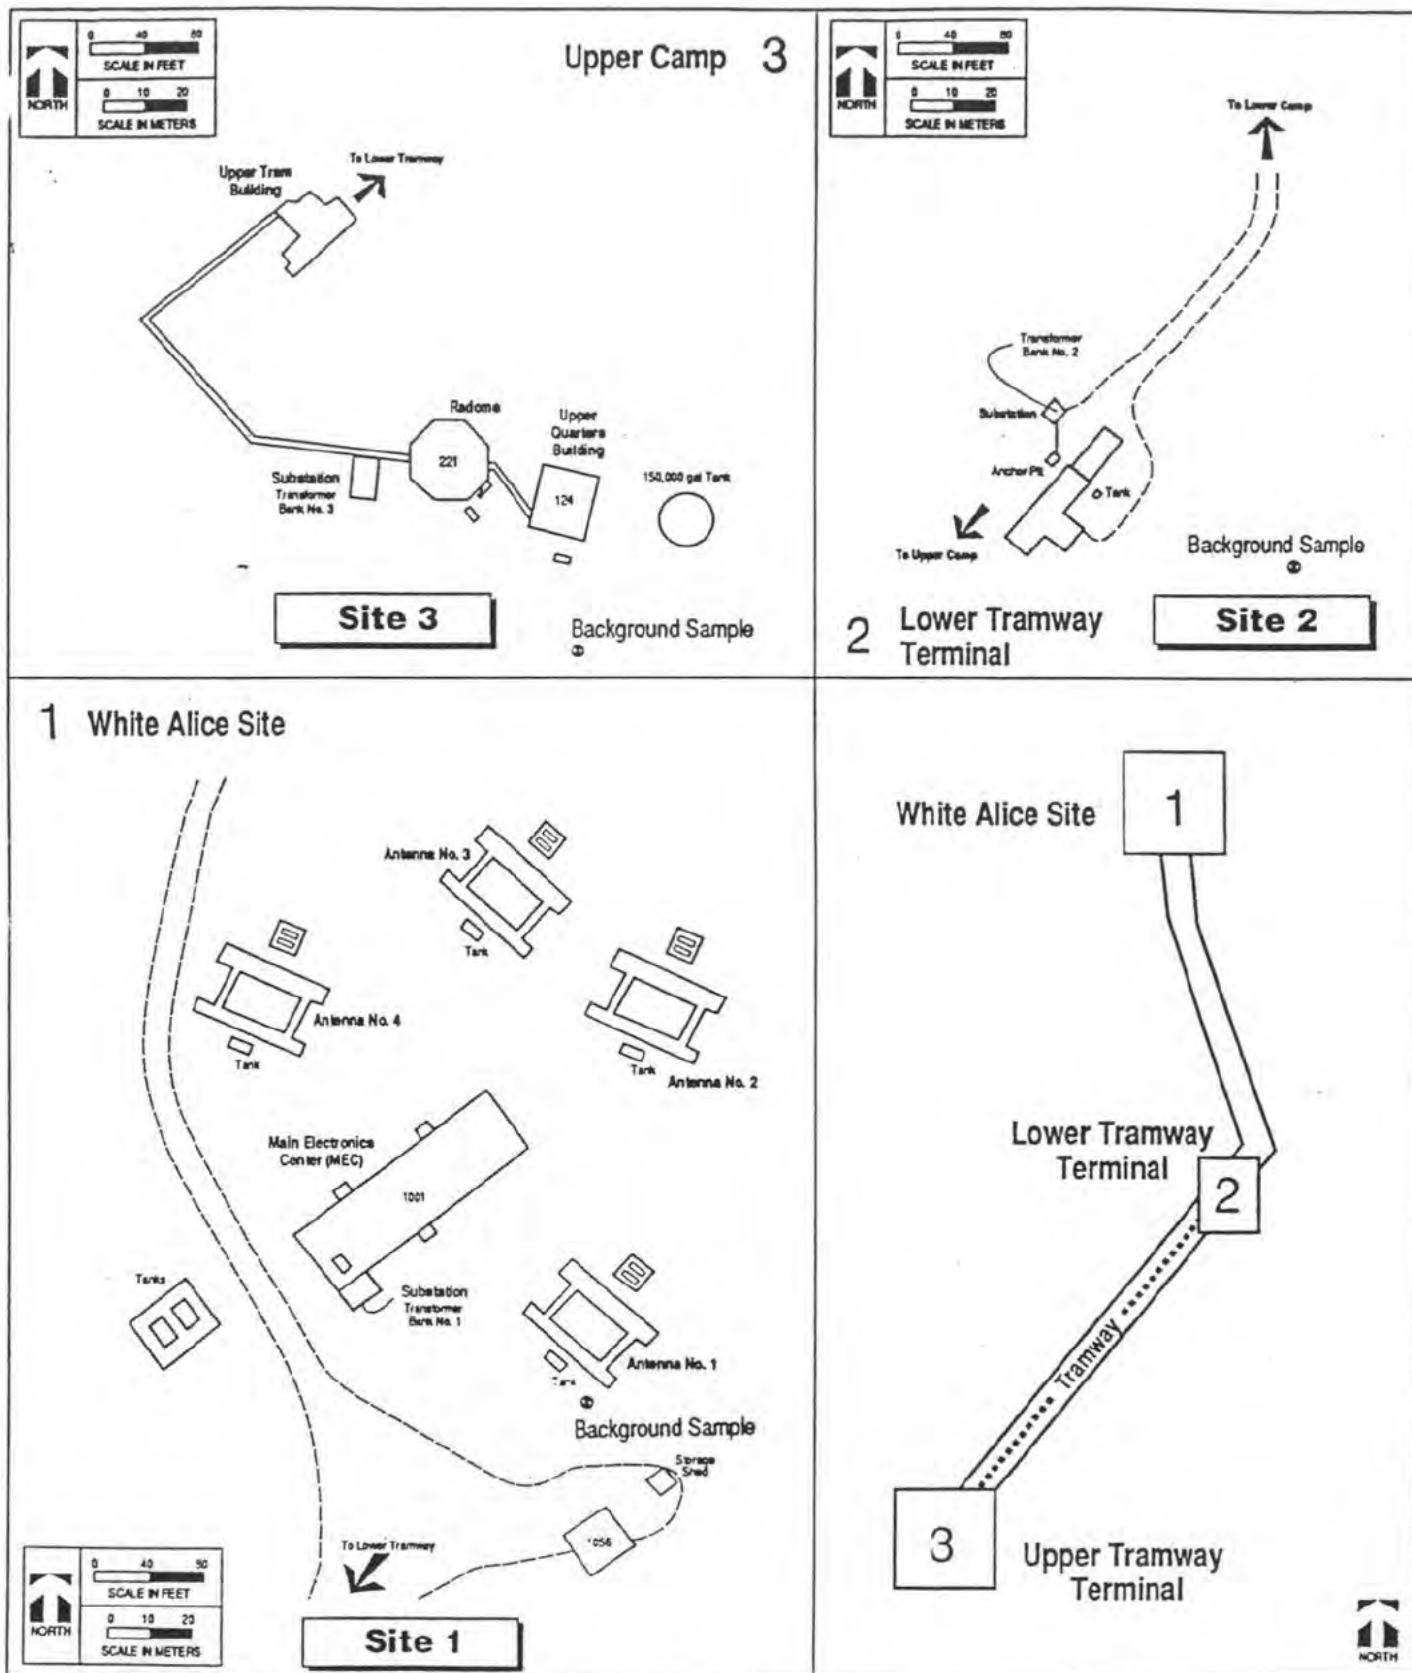
**Figure 4-4**  
**Background Sample Location Map**

- Site 1 (Sample #8427) - approximately 100 feet south and slightly upgradient from the site. Background contaminants detected consisted of Aroclor 1260 at 90 ppb and a tentatively identified compound (TIC) at 7 ppb.
- Site 2 (Sample #8447) - approximately 150 feet south and upgradient of the site. No contaminants were detected in Sample 8447.
- Site 3 (Sample #8482) - approximately 75 feet south and across a flat, rocky field. Background contaminants detected consisted of Aroclor 1254 at 140 ppb, concentrations of benzene at 12 ppb, and naphthalene at 20 ppb.
