# NORTHEAST CAPE HTRW REMEDIAL ACTIONS

## FINAL REMOVAL ACTION REPORT

Northeast Cape, Saint Lawrence Island, Alaska

June 2012

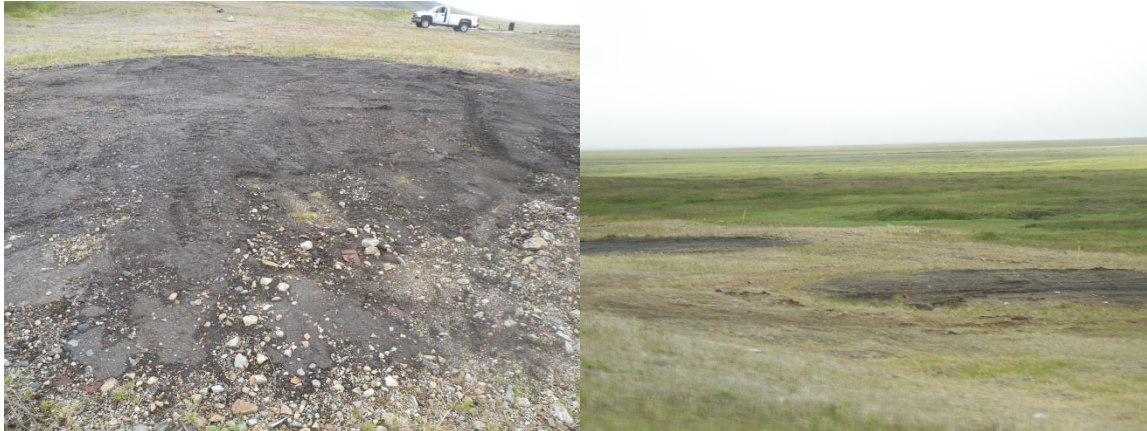
This site will require a mechanical implement, such as ripper to fracture the soil.

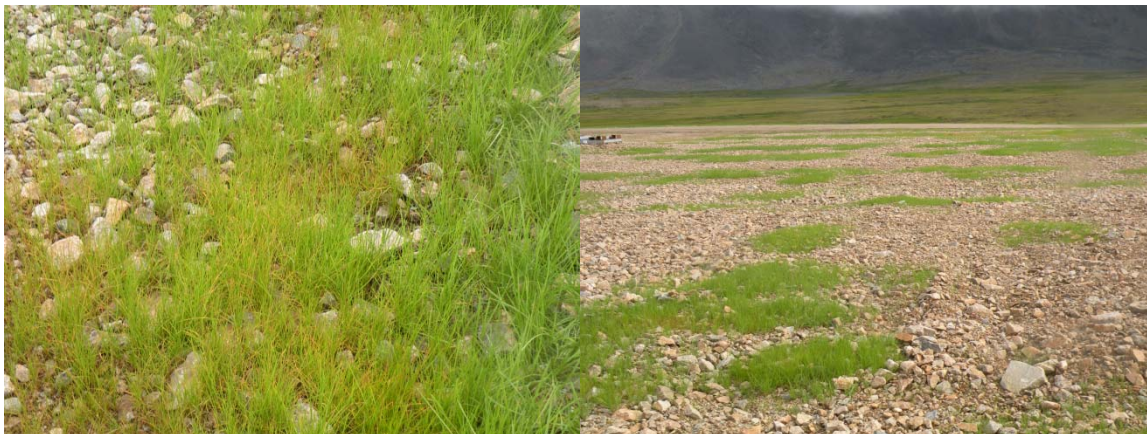
I recommend reseeding this site with 70% Tufted hairgrass and 30% Red fescue. Fertilize with 20-20-10 at 500 pounds per acre. Yellowing of the grasses is probably due to fertilizer deficiency.

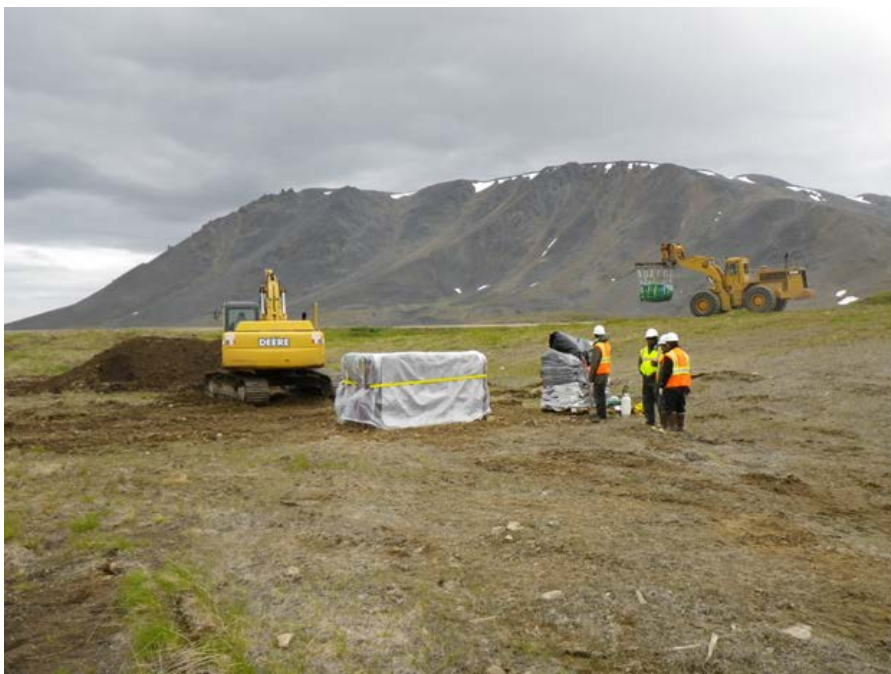
Photograph 1 Bulk bag loading at eastern tank footprint in Main Operations Complex (MOC)  
July 16, 2011

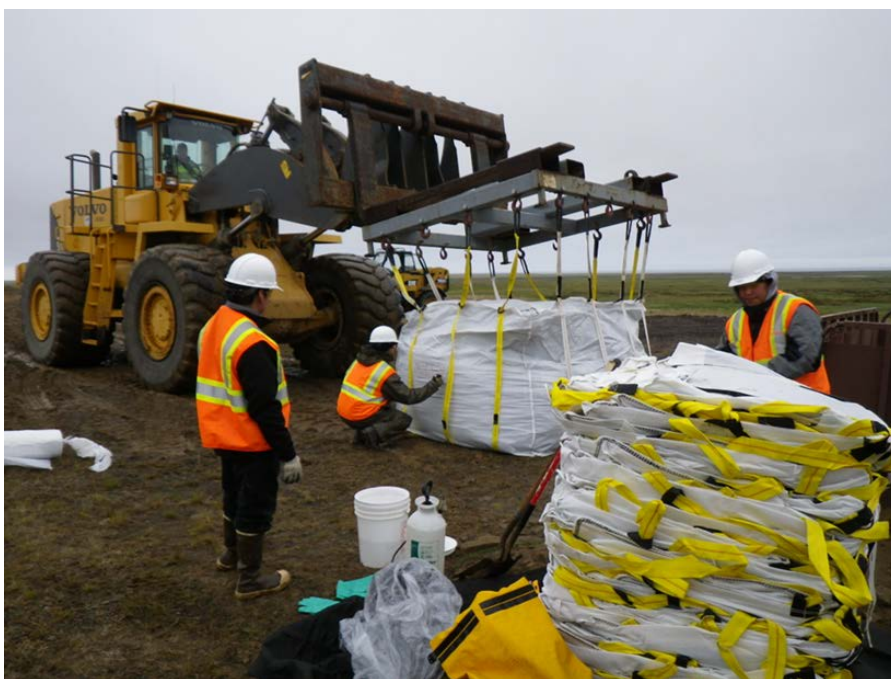
Photograph 2 Bag loading and marking in MOC tank footprint area  
July 17, 2011

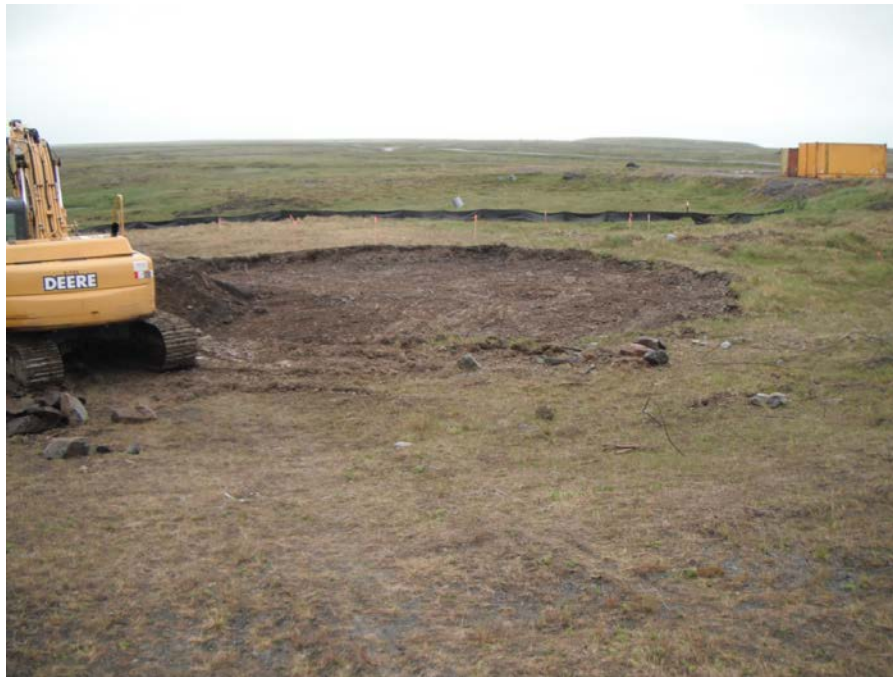
Photograph 3 Excavating eastern tank footprint  
at the MOC  
July 18, 2011

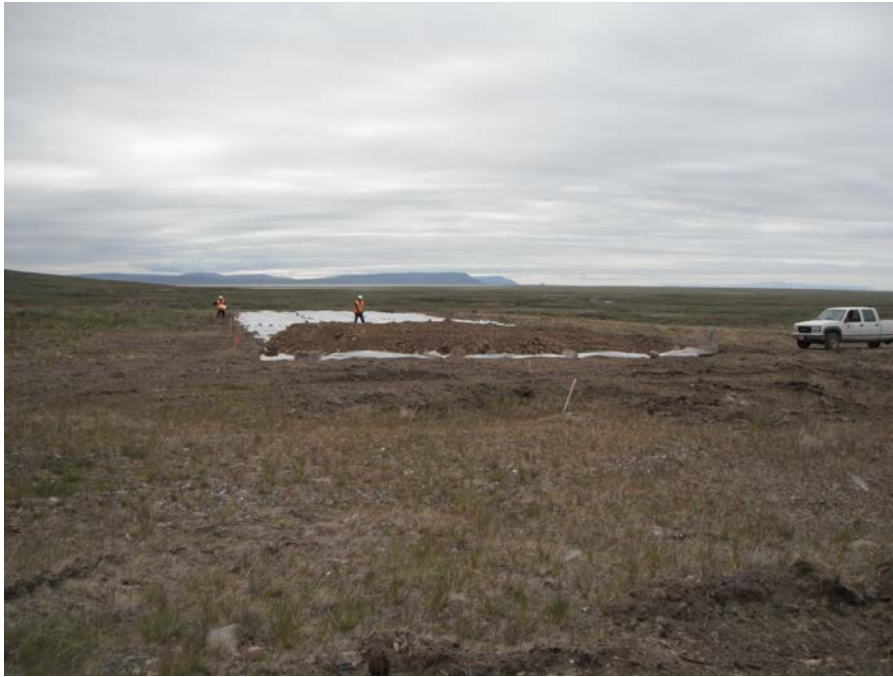
Photograph 7 Initial POL stockpile  
July 20, 2011

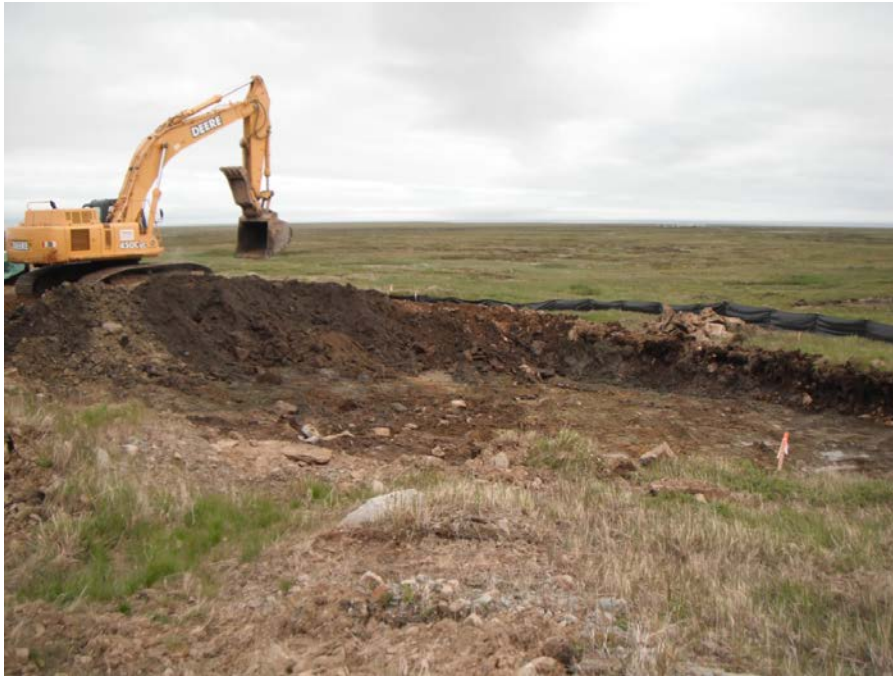
Photograph 9 Excavation of contaminated material  
2-4 feet below ground surface (bgs) at J1A  
July 21, 2011

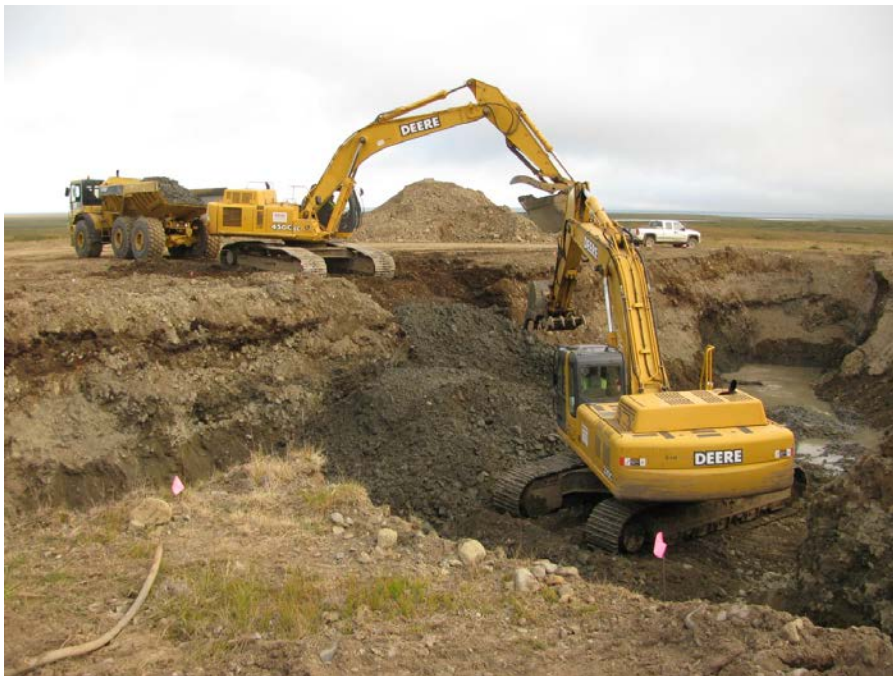
Photograph 16 Excavation of POL-contaminated  
soil at A1  
August 5, 2011

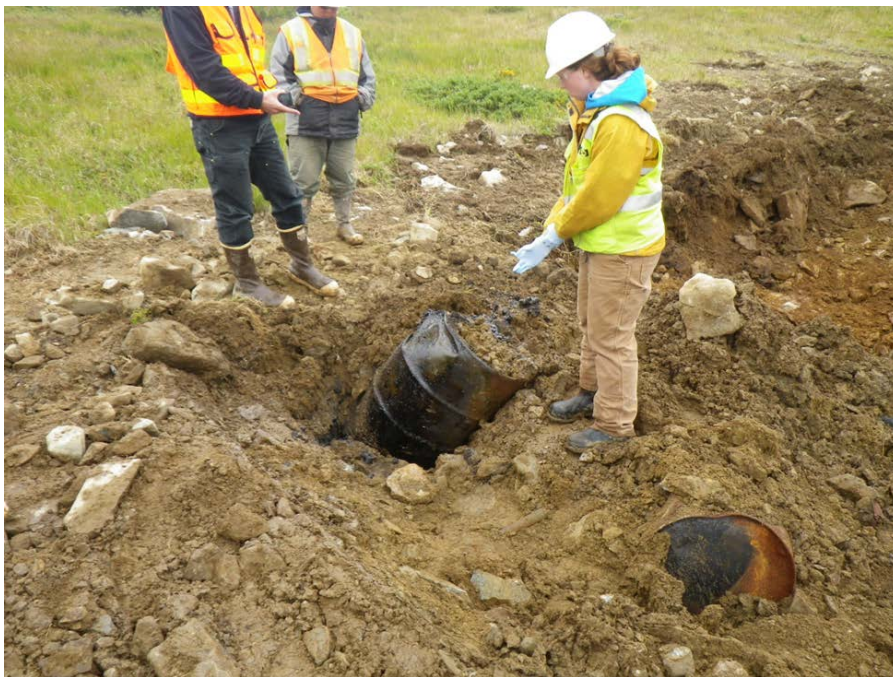
Photograph 20 An oil-containing drum uncovered  
In the southeast corner of the J1A excavation  
August 15, 2011

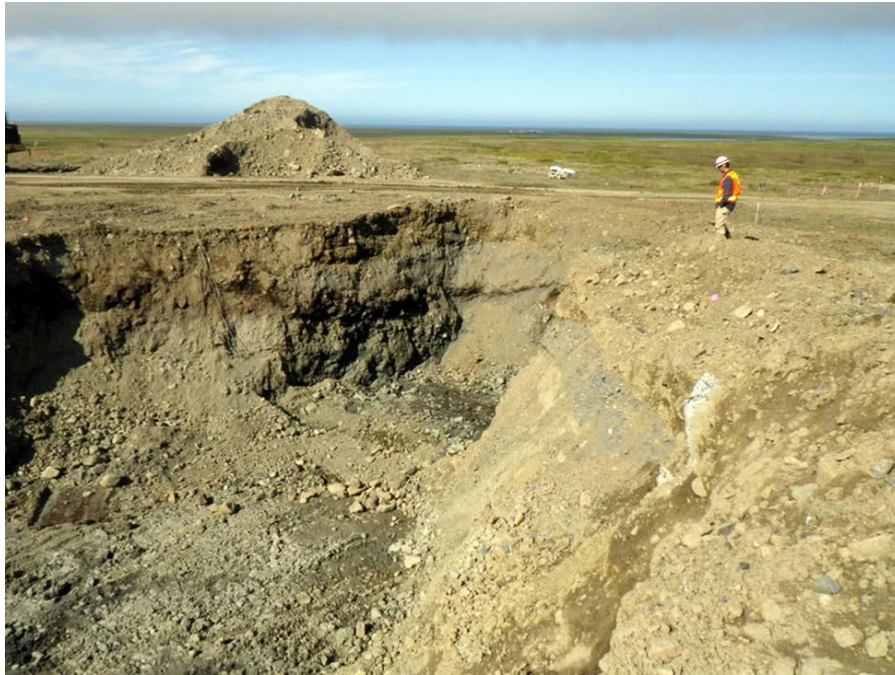
Photograph 21 Northwest sidewall of A1 showing  
newly excavated area  
August 19, 2011

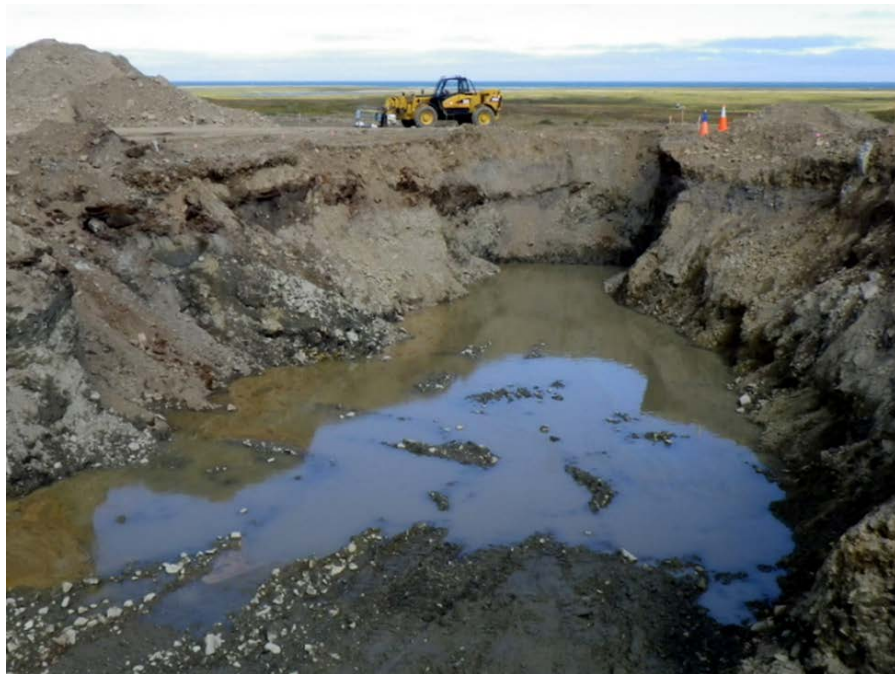
Photograph 22 Groundwater flowing into  
deepened A1 excavation  
August 20, 2011

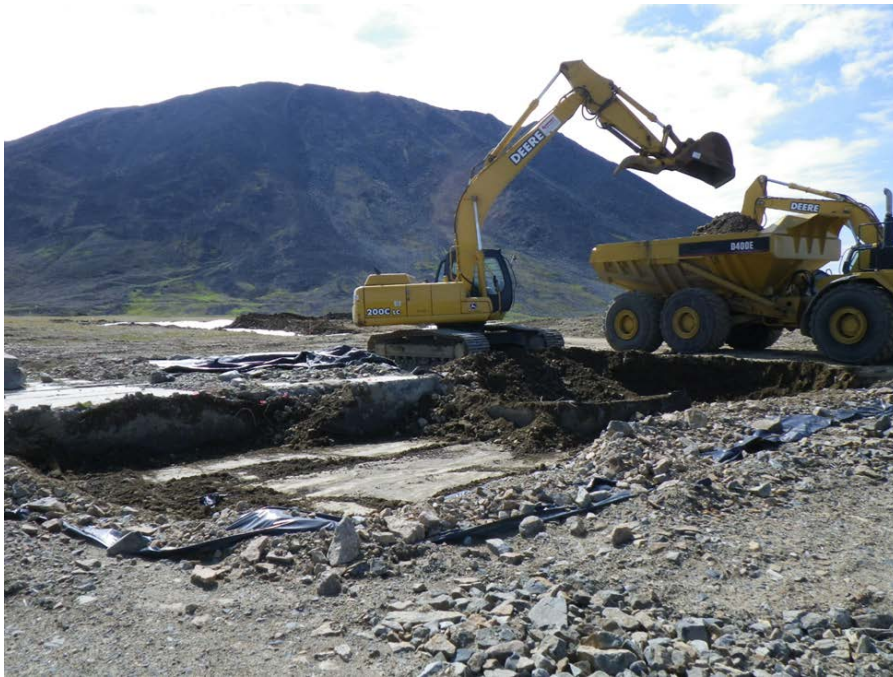
Photograph 27 Removing clean overburden  
from Site 13  
July 20, 2011

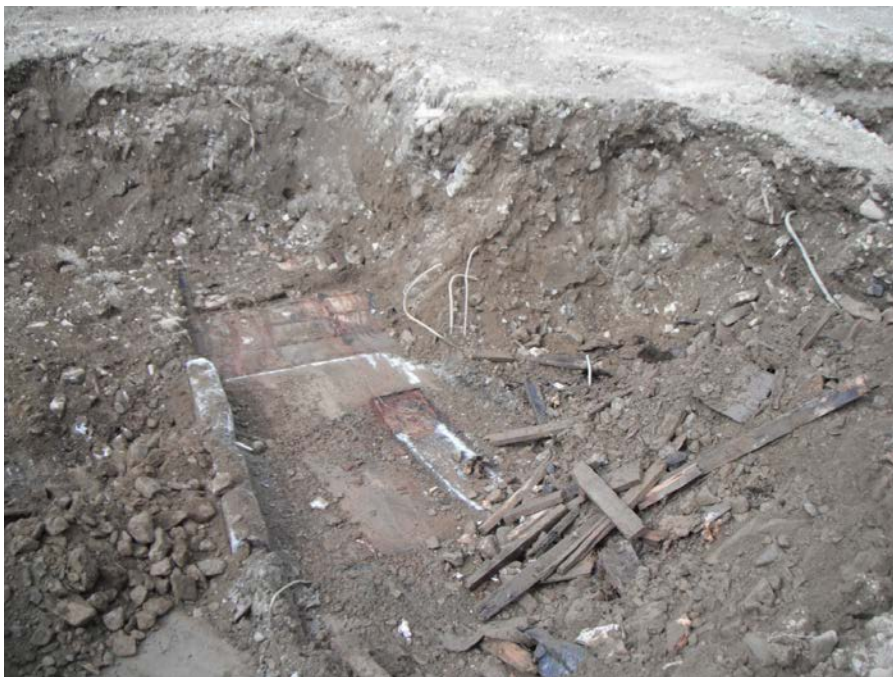
Photograph 32 A concrete slab and wood frame  
in the bottom of Site 13 excavation  
July 27 2011

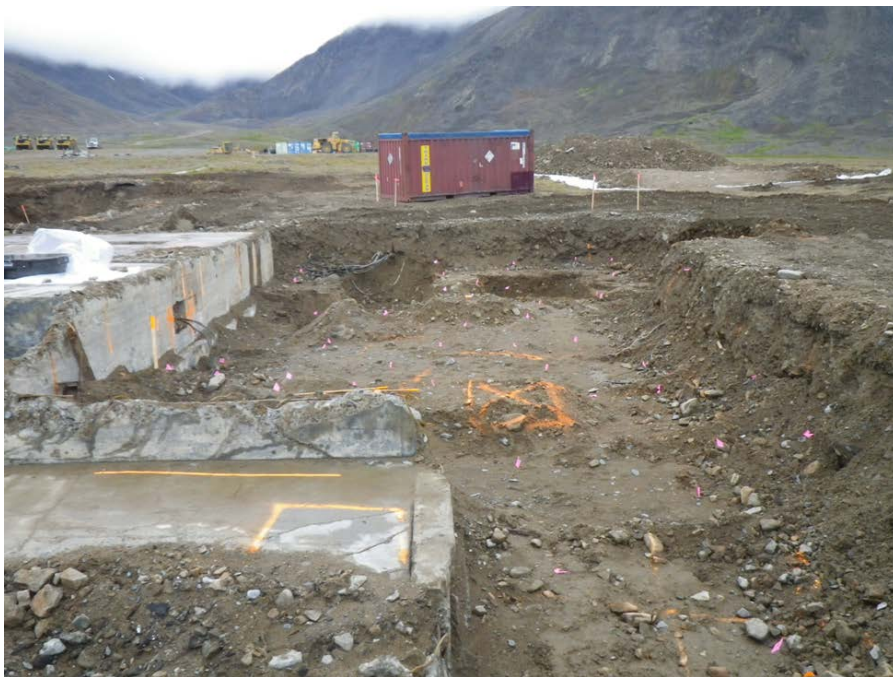
Photograph 34    Site 13 excavation    Northeast Cape  
August 10, 2011    Direction: South

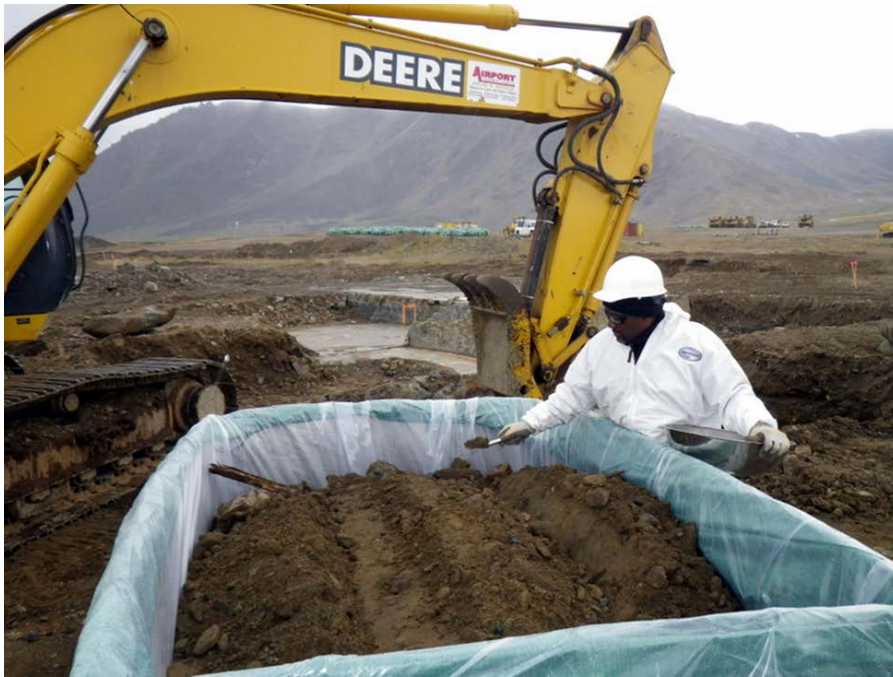
Photograph 35 Collecting samples from  
bulk bags from Site 13  
August 22, 2011

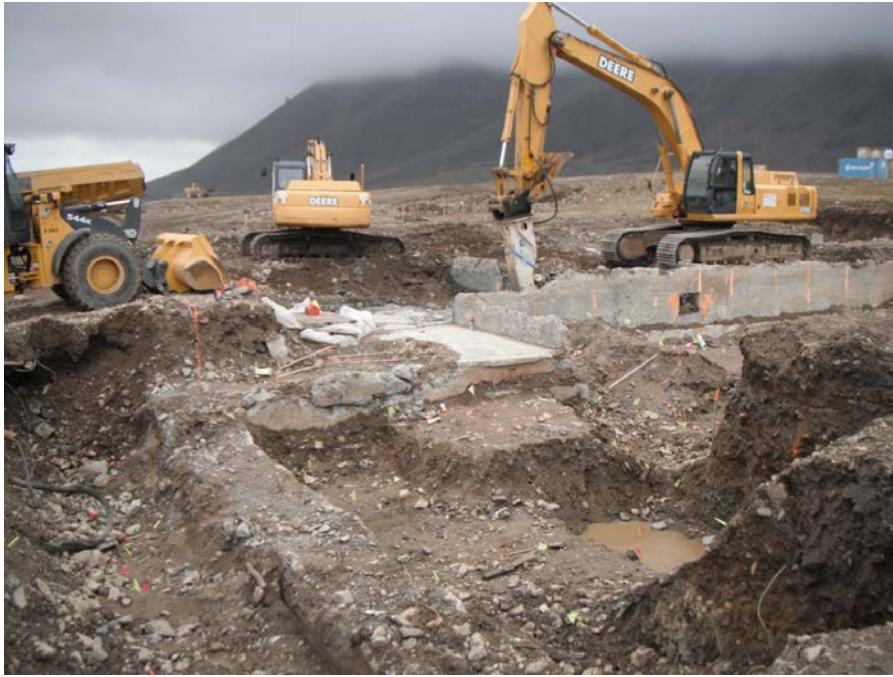
Photograph 37 Concrete removal, material  
to be used as backfill at A1 excavation  
September 11, 2011

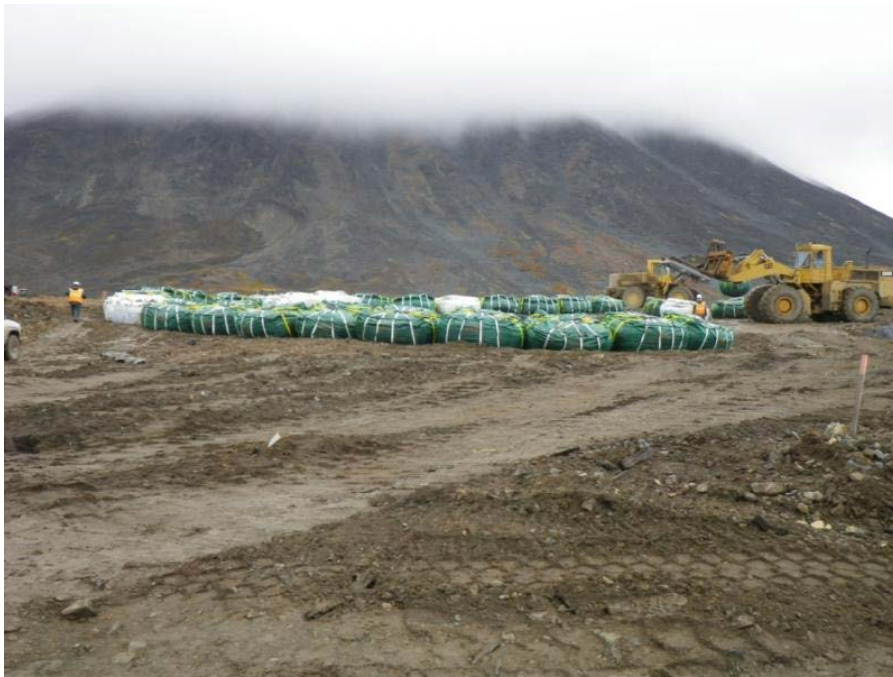
Photograph 39 Site 13 excavation during  
bag-armoring operations  
September 26, 2011

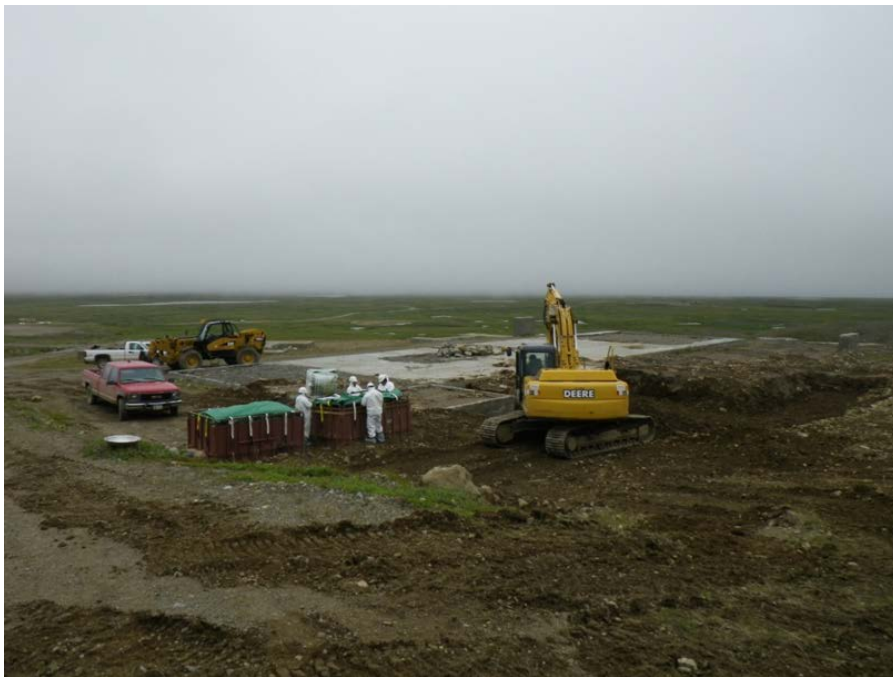
Photograph 42 Excavation of Site 31  
July 23, 2011

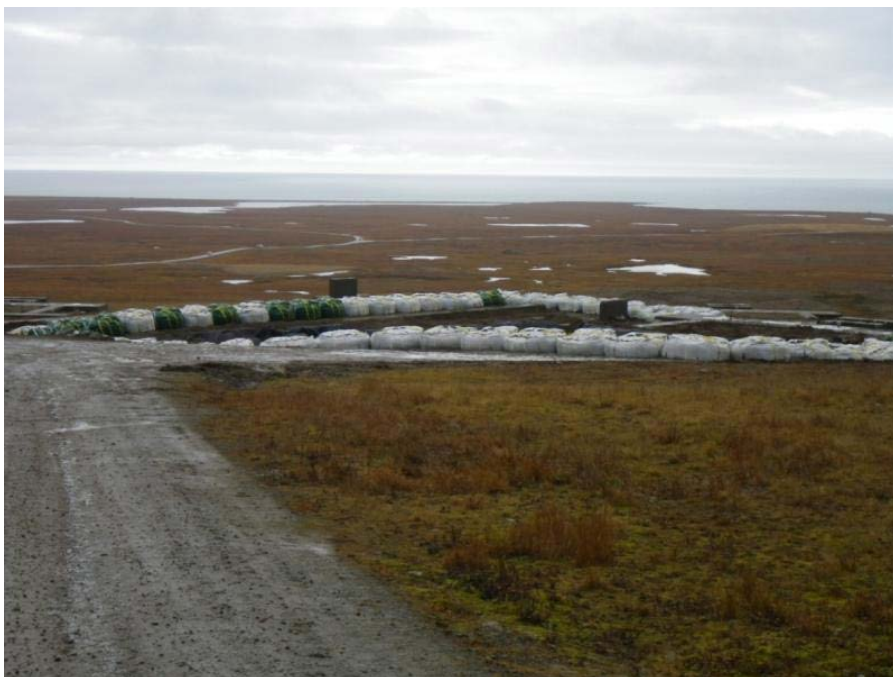
Photograph 50 Site 31 excavation rimmed Northeast Cape  
with bulk bags September 26, 2011 Direction: North

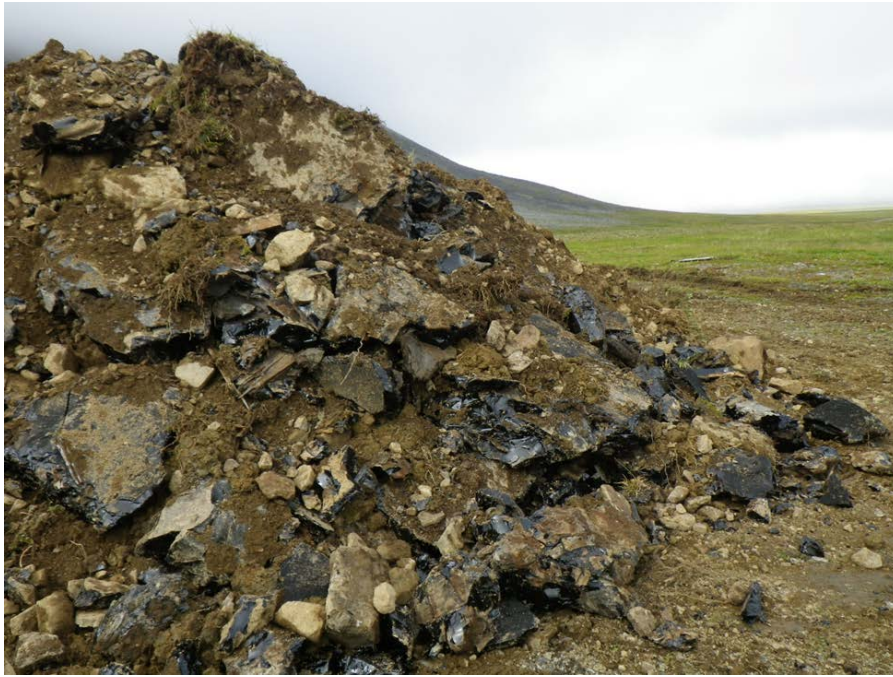
Photograph 53 Roofing tar stockpile  
July 18, 2011

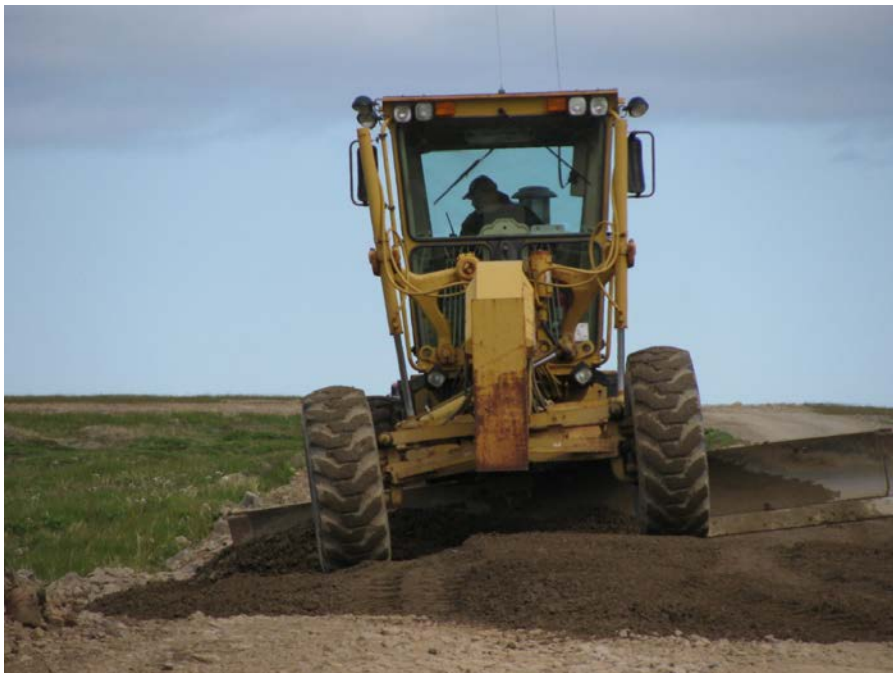
Photograph 76 Road regrading and repair Northeast Cape  
July 3, 2011 Direction: North
