**NATIVE VILLAGE OF NORTHEAST CAPE
REMOVAL ACTION/
SITE INVESTIGATION REPORT
REVISION 1**

Northeast Cape, St. Lawrence Island, Alaska

August 2013

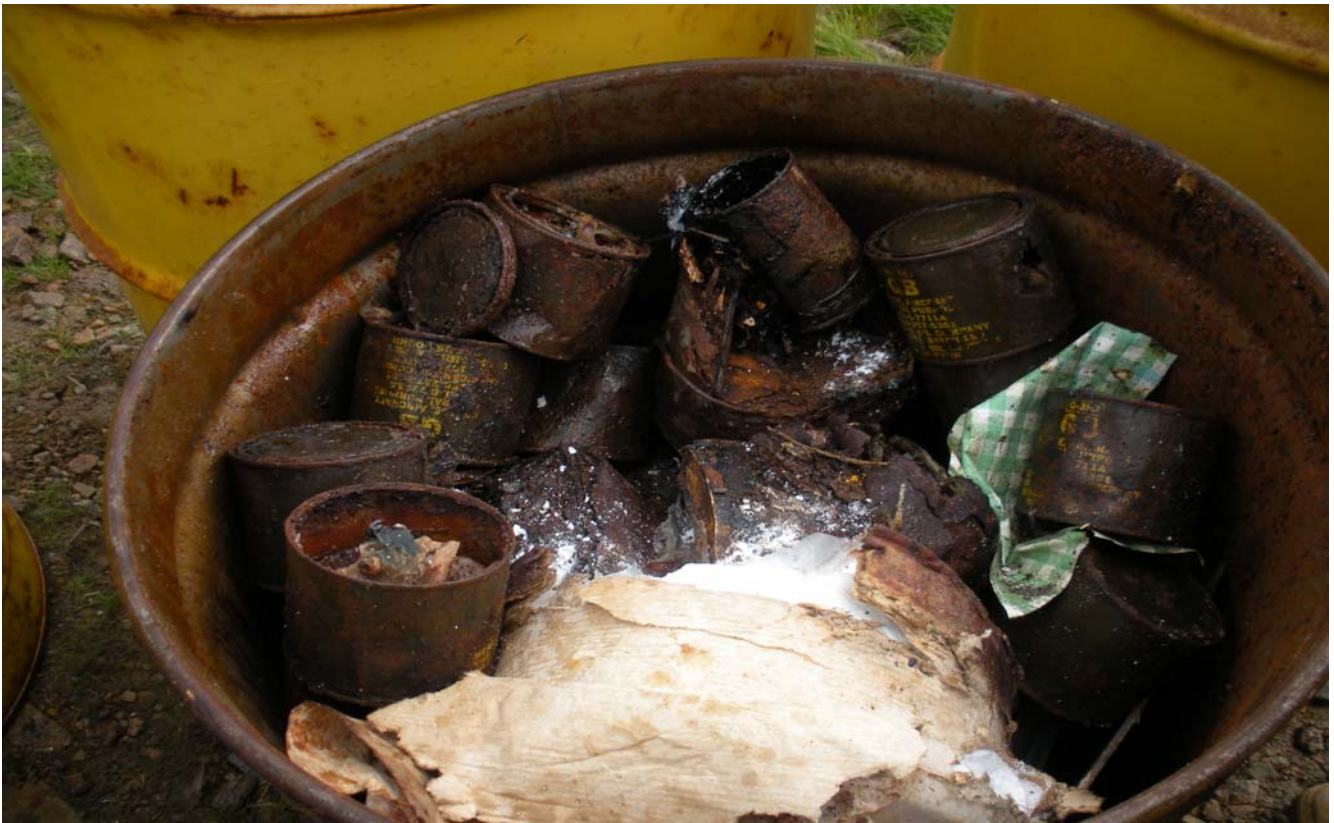
Photograph 1: Drum Containing Cans of Grease
Direction: N/A

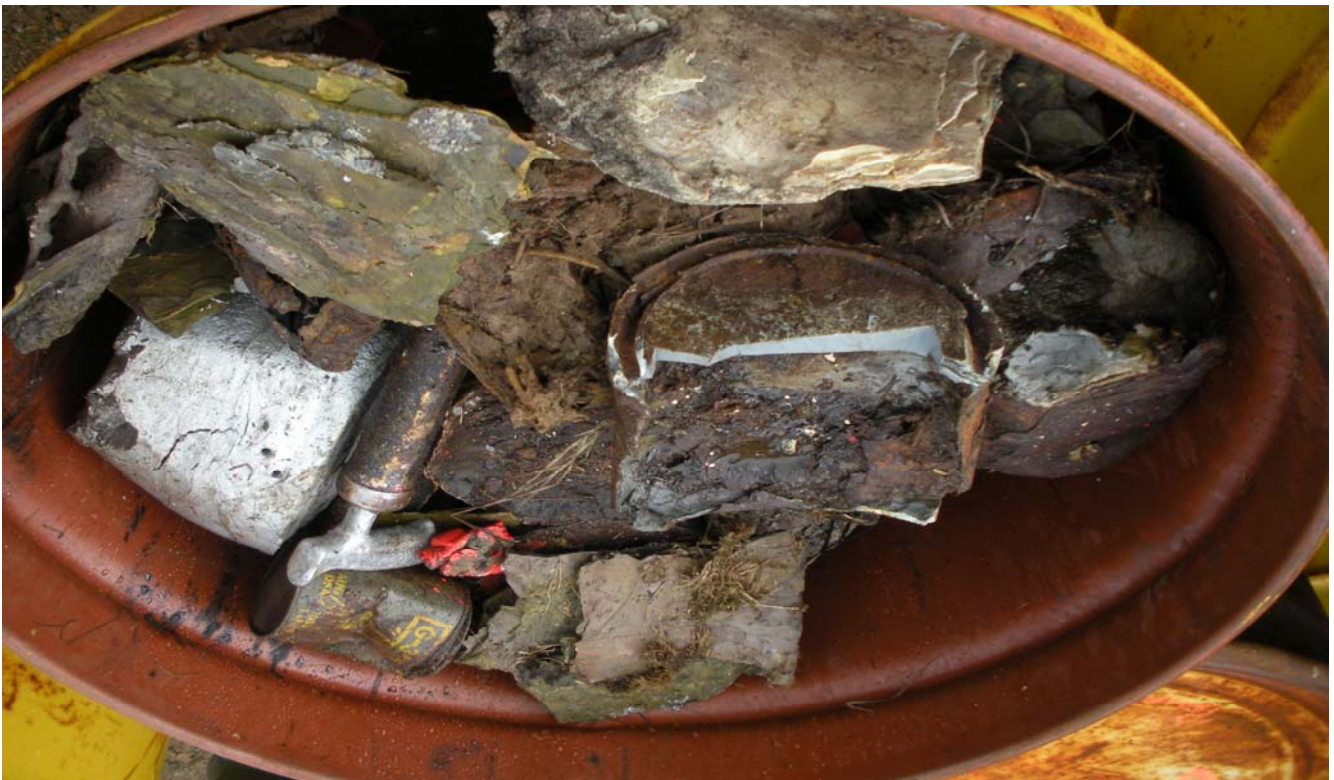
Photograph #2: Drum Containing Dried Paint
Direction: N/A

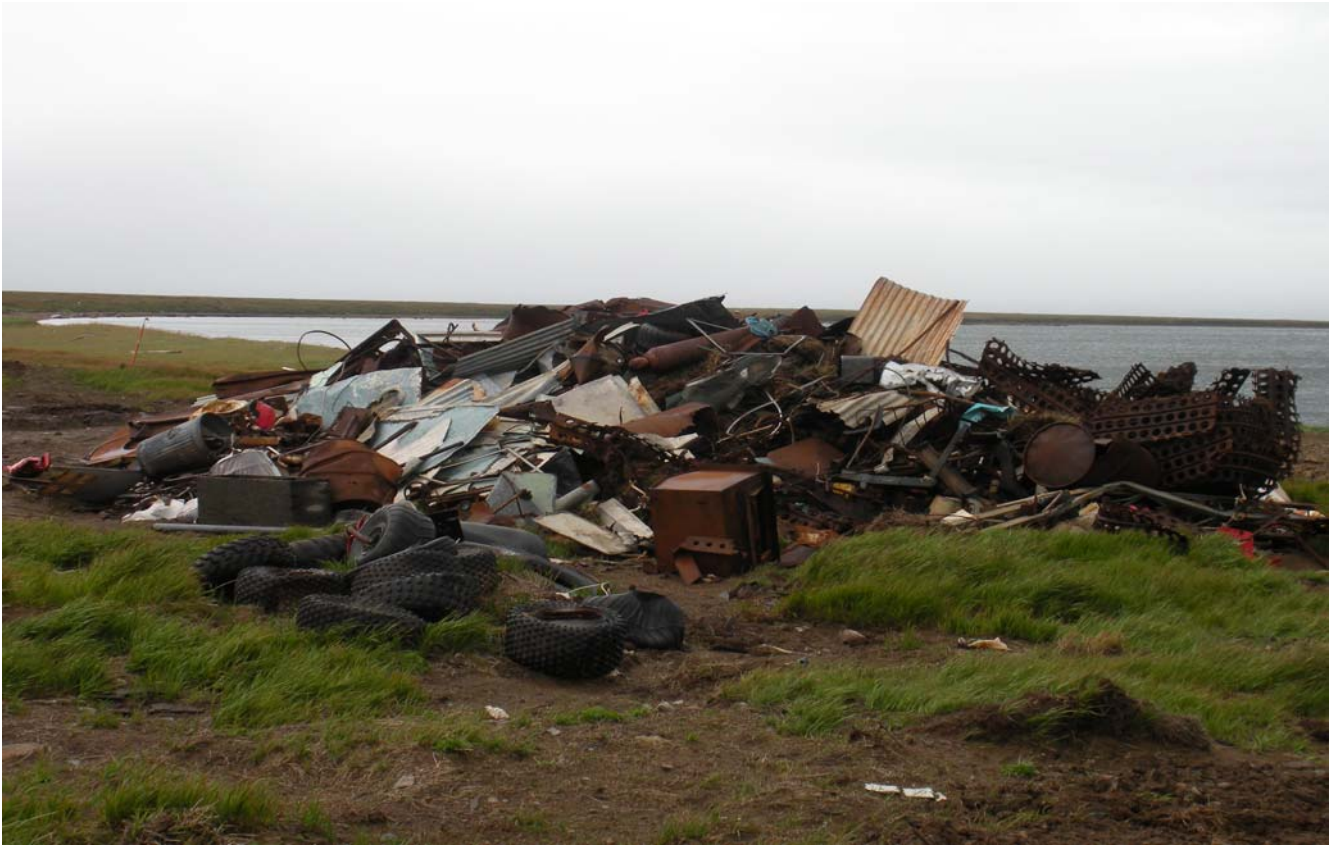
Photograph 3: Scrap Metal and Non-Burnable Debris Staged for Removal
Direction: Northwest

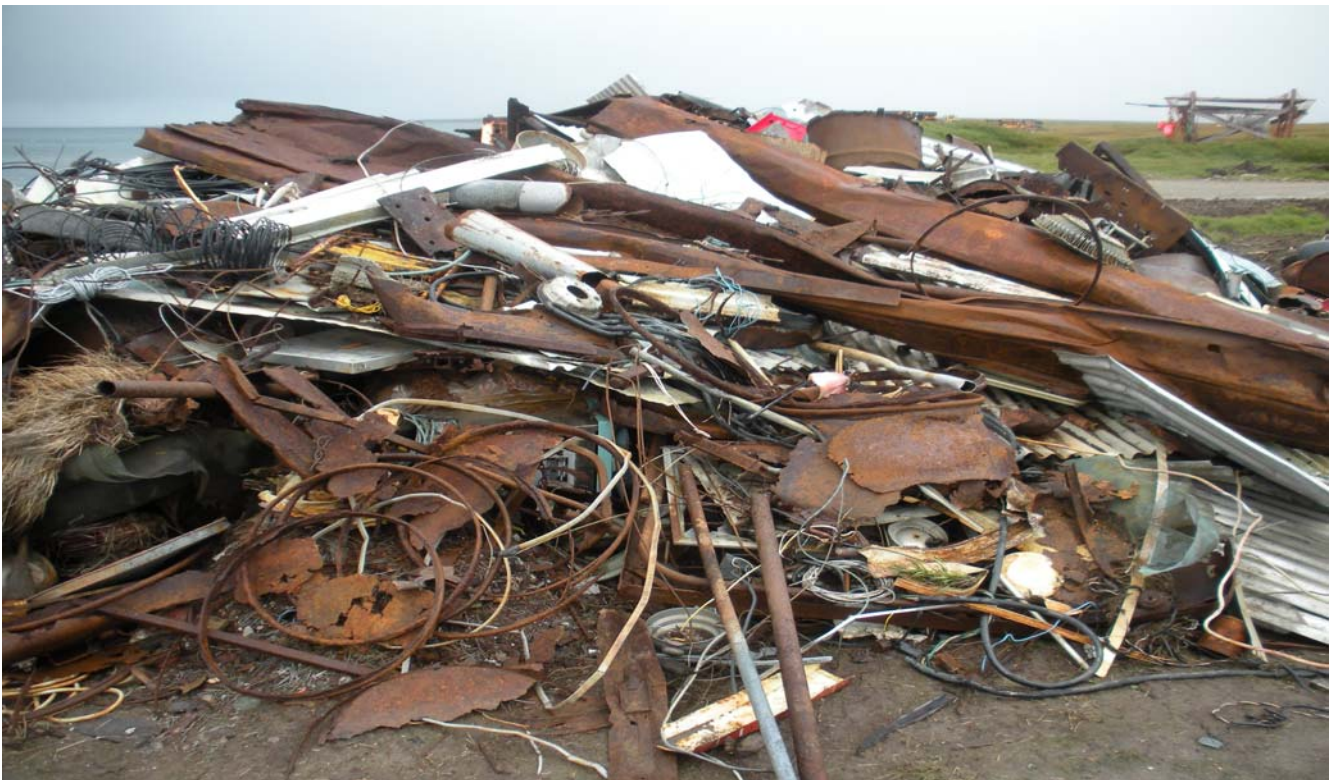
Photograph 4: Scrap Metal and Non-Burnable Debris Staged for Removal
Direction: East

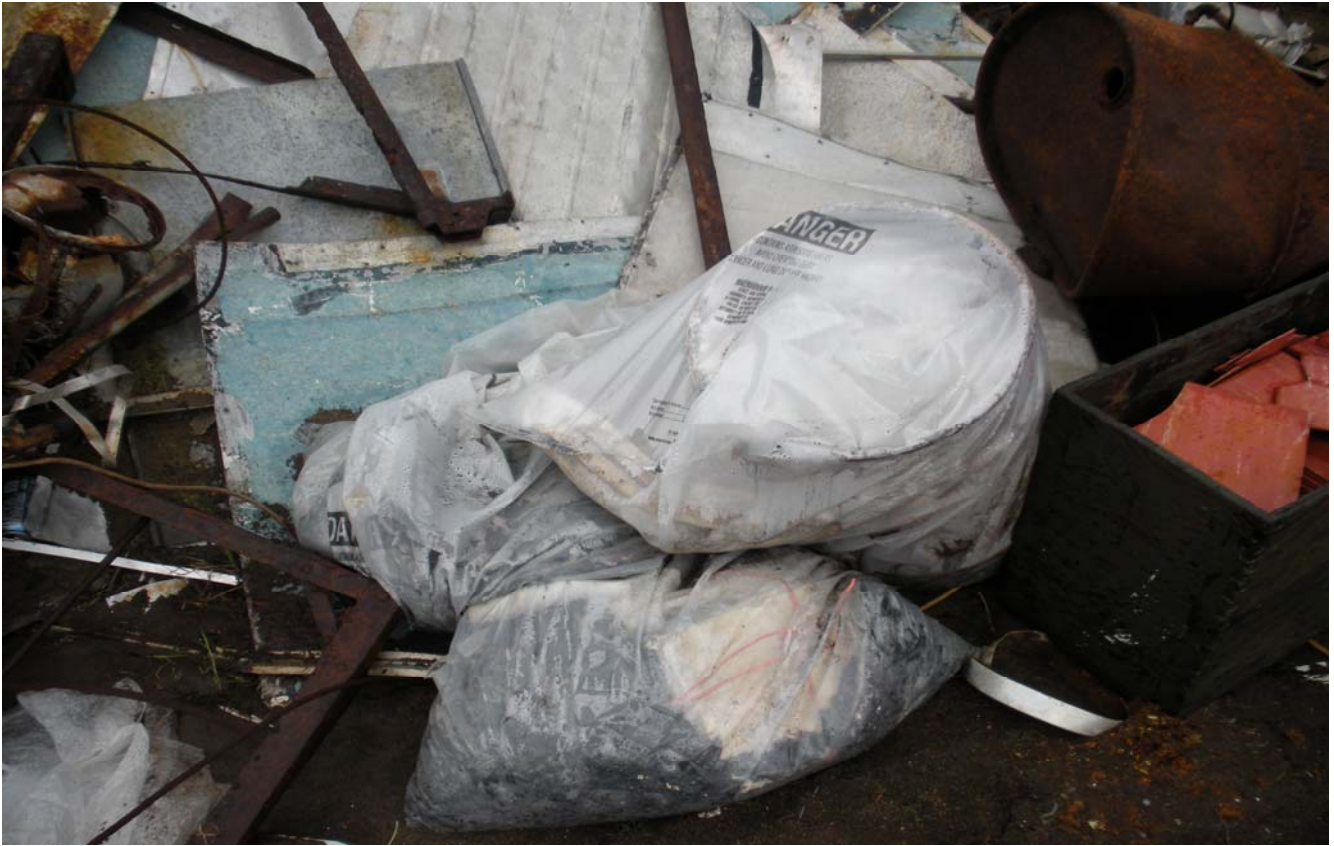
Photograph 5: Suspected Asbestos Containing Material
Direction: N/A

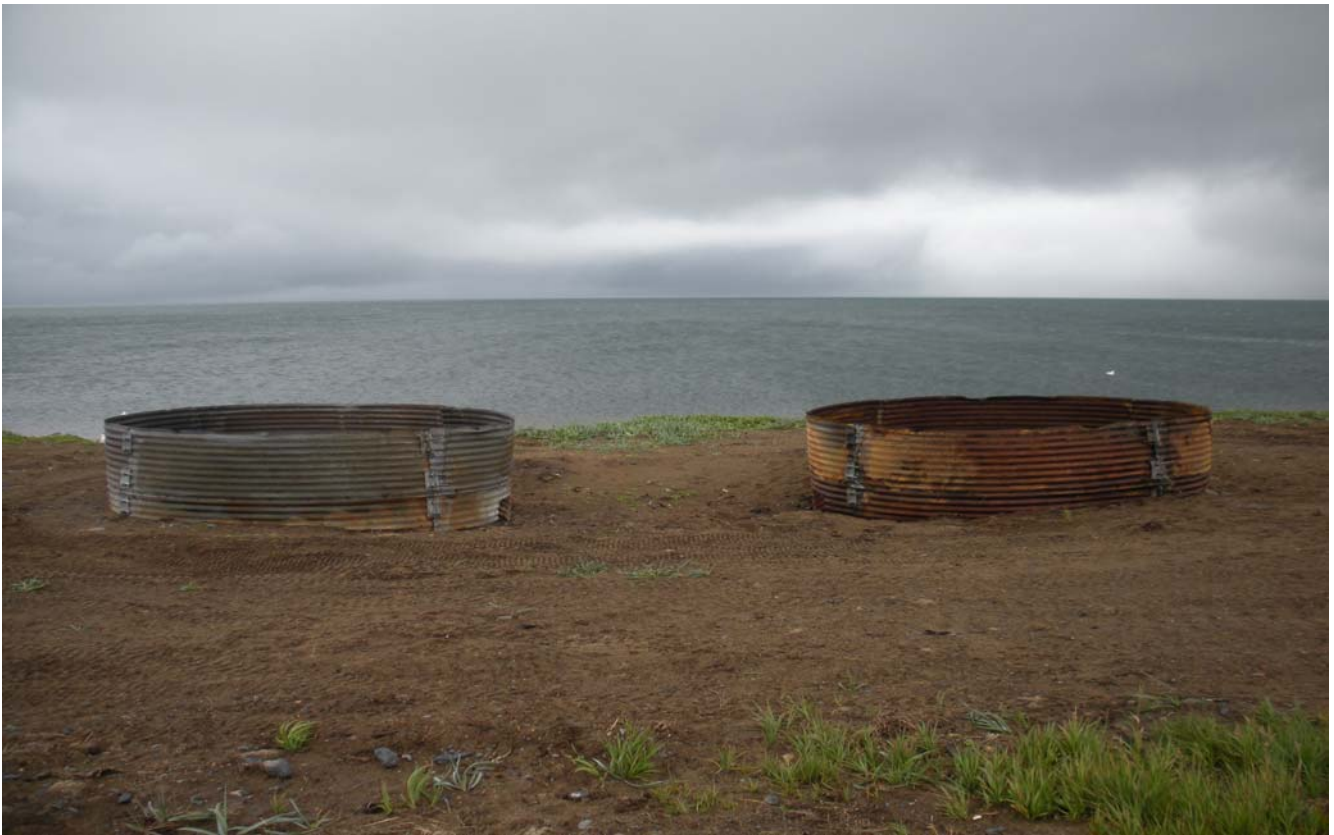
Photograph 7: Non-Painted Wood Burning Units
Direction: North

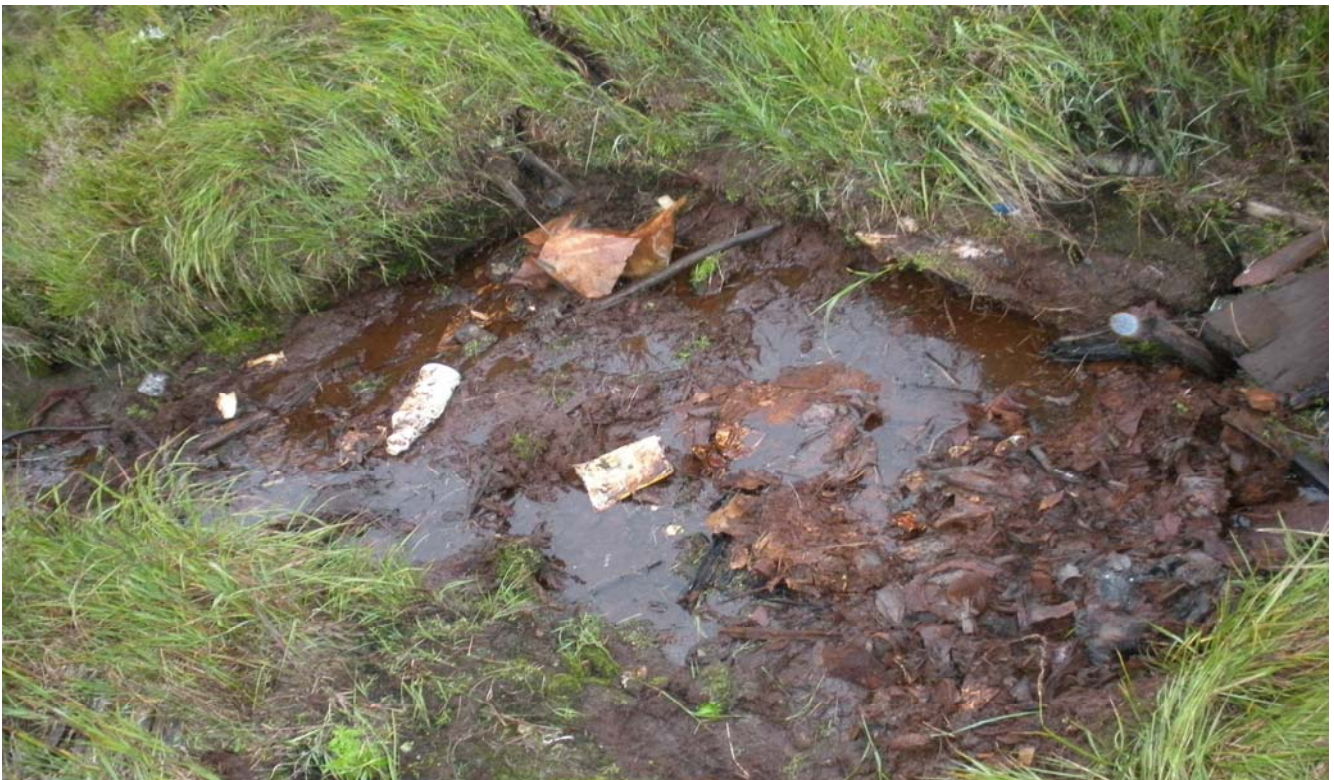
Photograph 8: Debris Along Creek Drainage
Direction: N/A

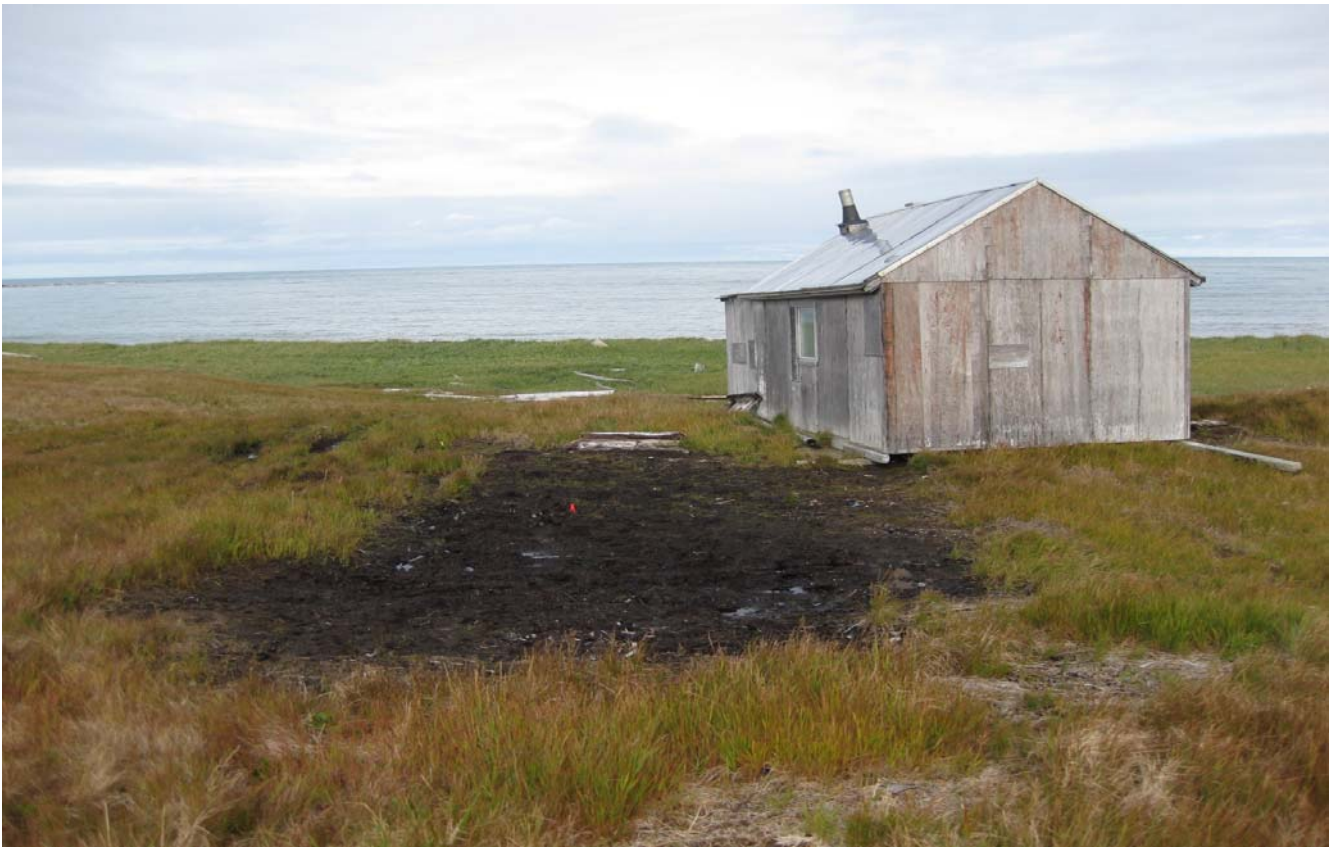
Photograph 9: Soil Sample Location 12NVNCSL01 Collected from Debris Pile Location #16
Date: September 6, 2012 Direction: North-Northwest Photographer: L. Nelson

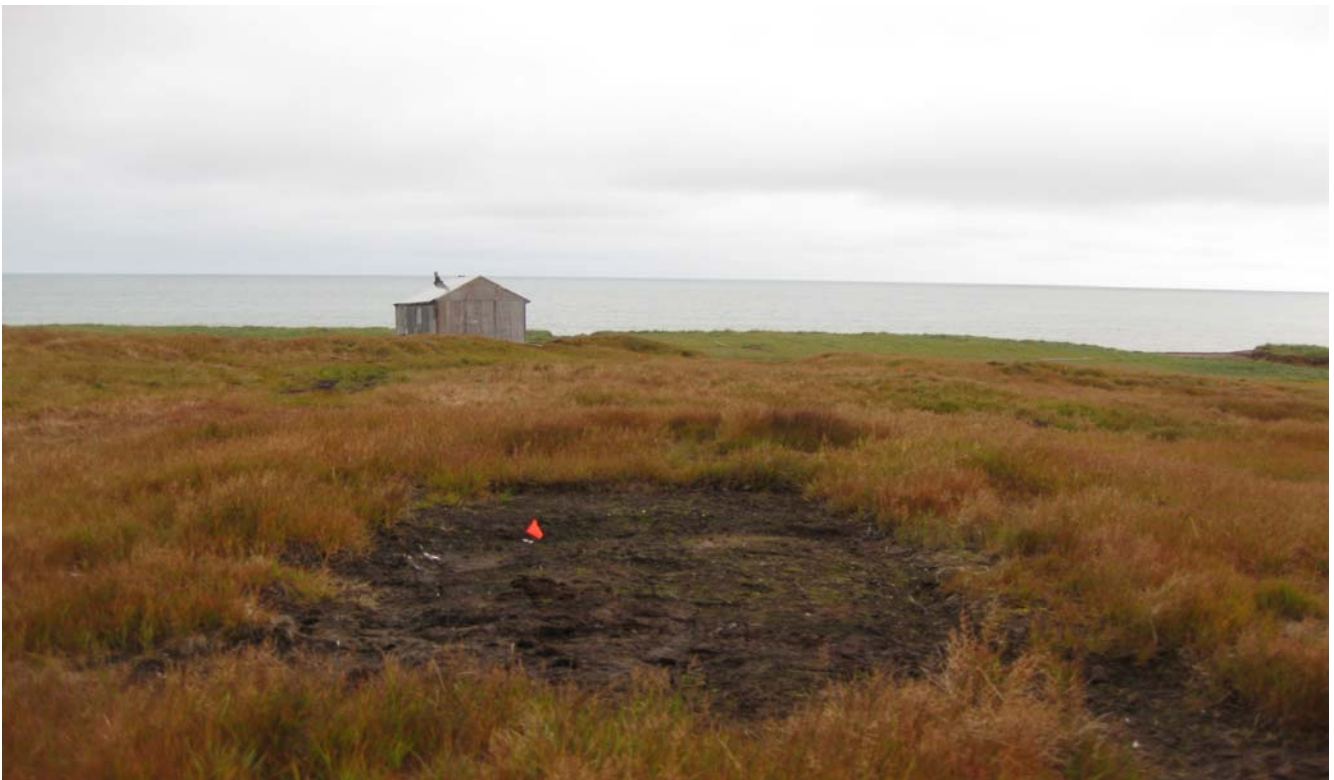
Photograph 10: Soil Sample Location 12NVNCSL06 Collected from Debris Pile Location #13
Date: September 7, 2012 Direction: North Photographer: L. Nelson

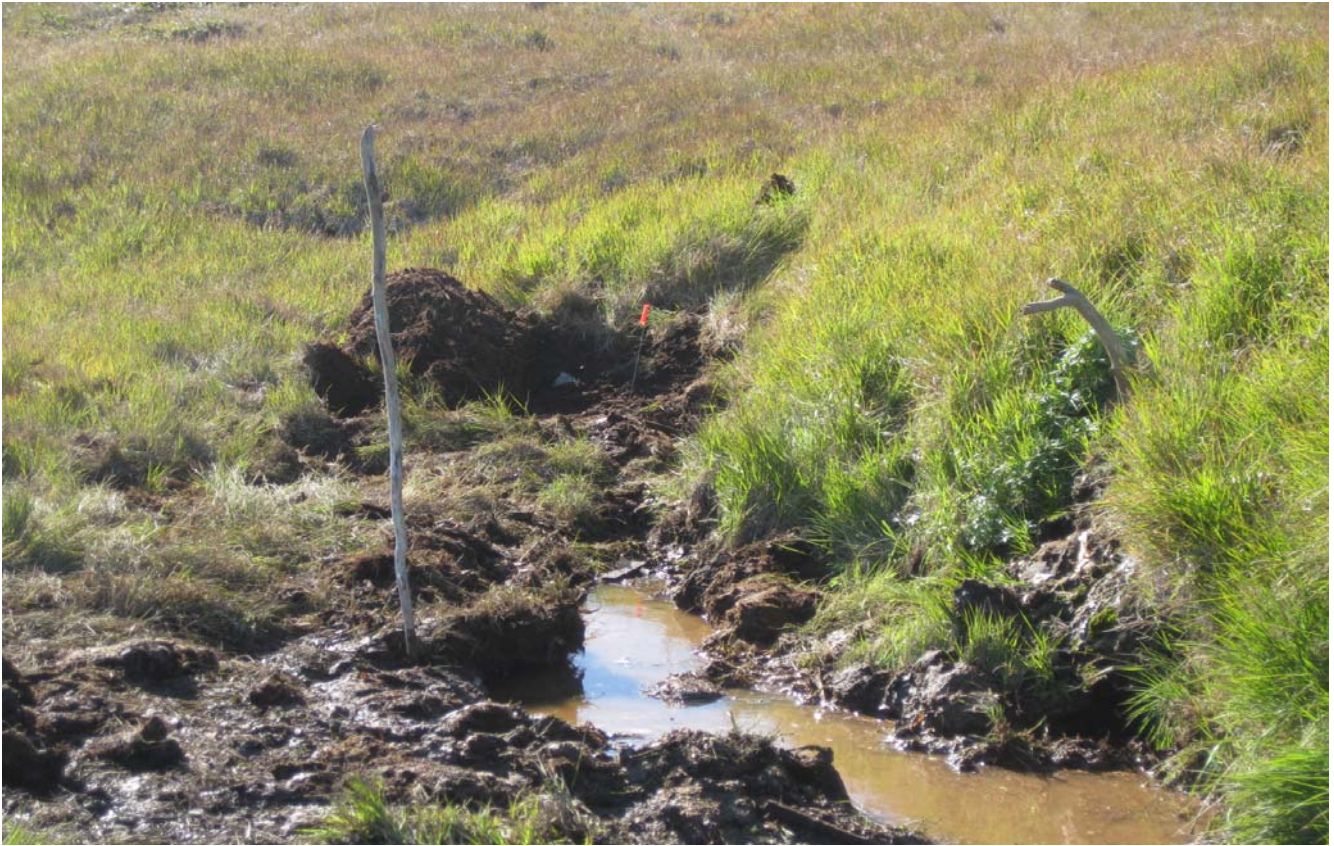
Photograph 13: Soil Sample Location 12NVNCSL40 Collected from Trash/CON/HTRW Removal Site AA01
Date: September 8, 2012 Direction: North-Northeast Photographer: L. Nelson

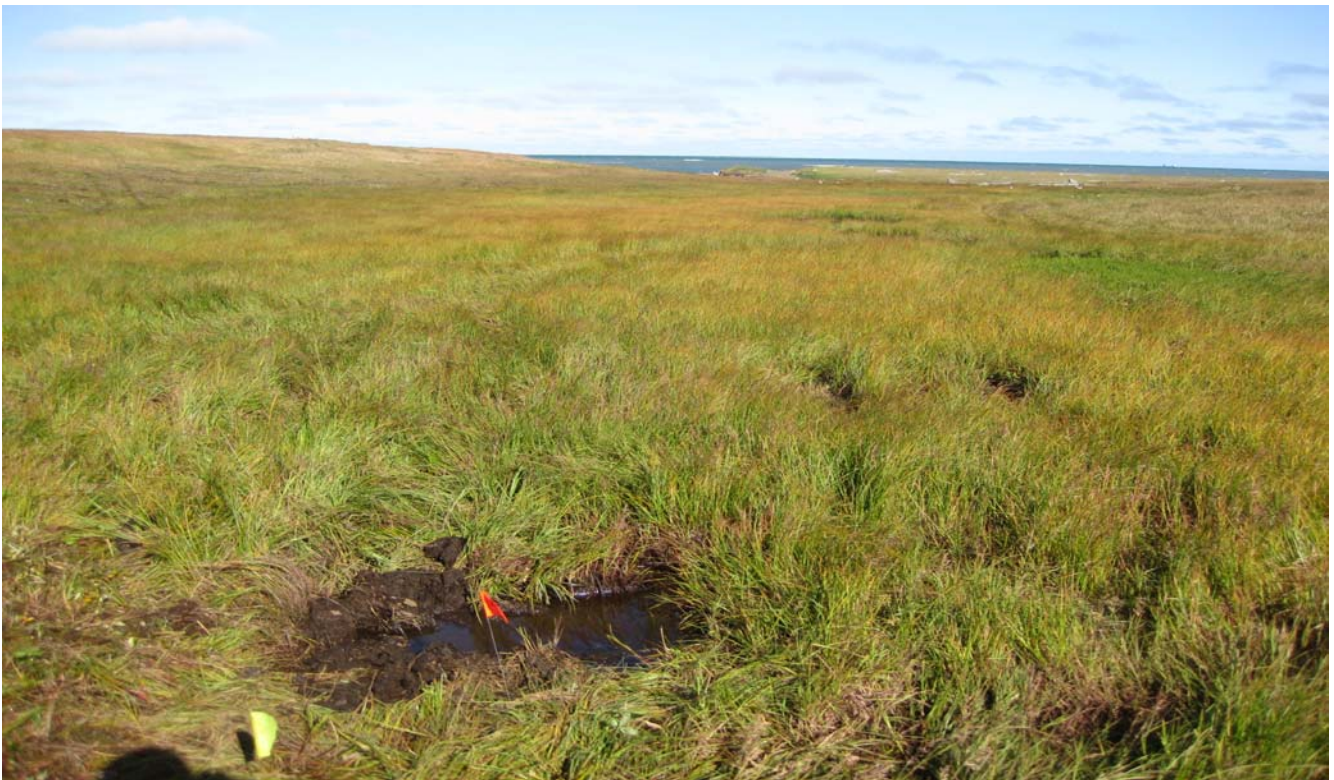
Photograph 14: Soil Sample Location 12NVNCSL44 Collected from Trash/CON/HTRW Removal Site AA05
Date: September 8, 2012 Direction: North Photographer: L. Nelson

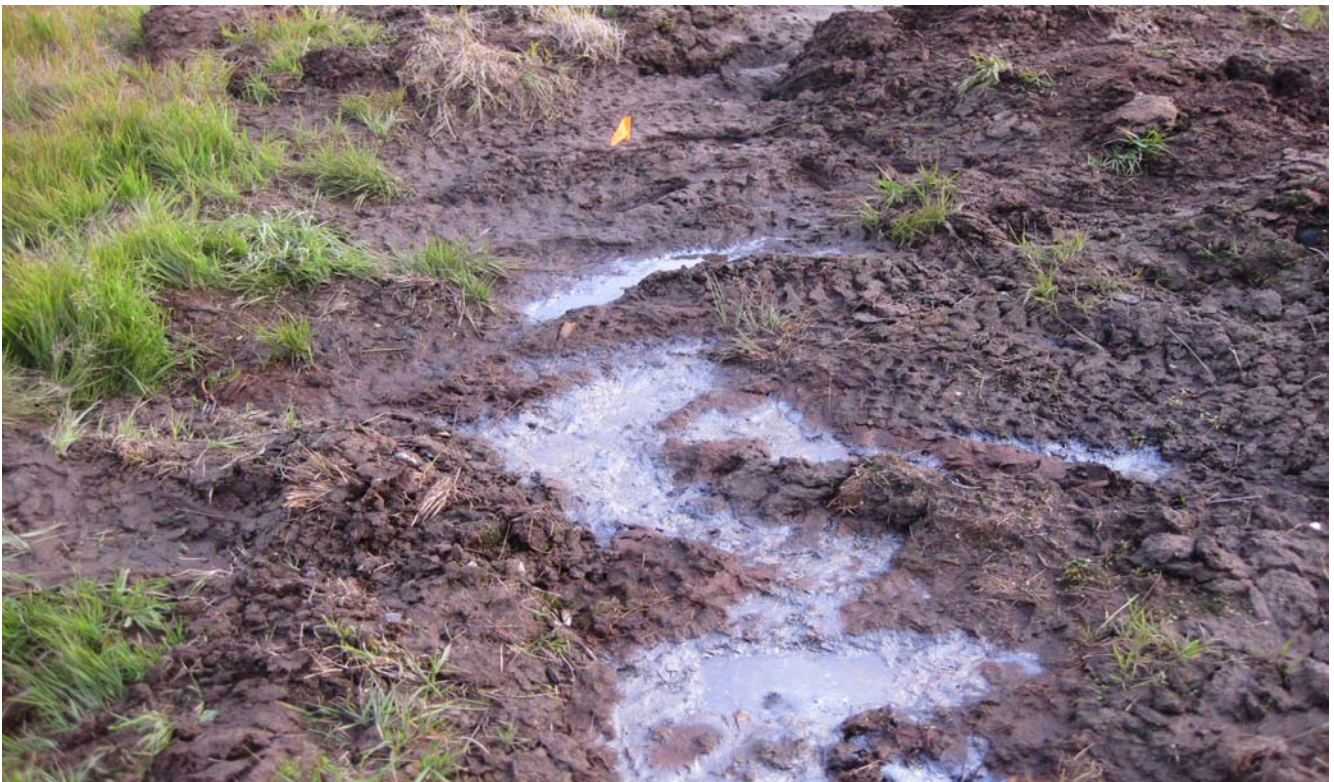
Photograph 16: Soil Sample Location 12NVNCSL54 Collected from Additional Area AA15
Date: September 9, 2012 Direction: N/A Photographer: L. Nelson

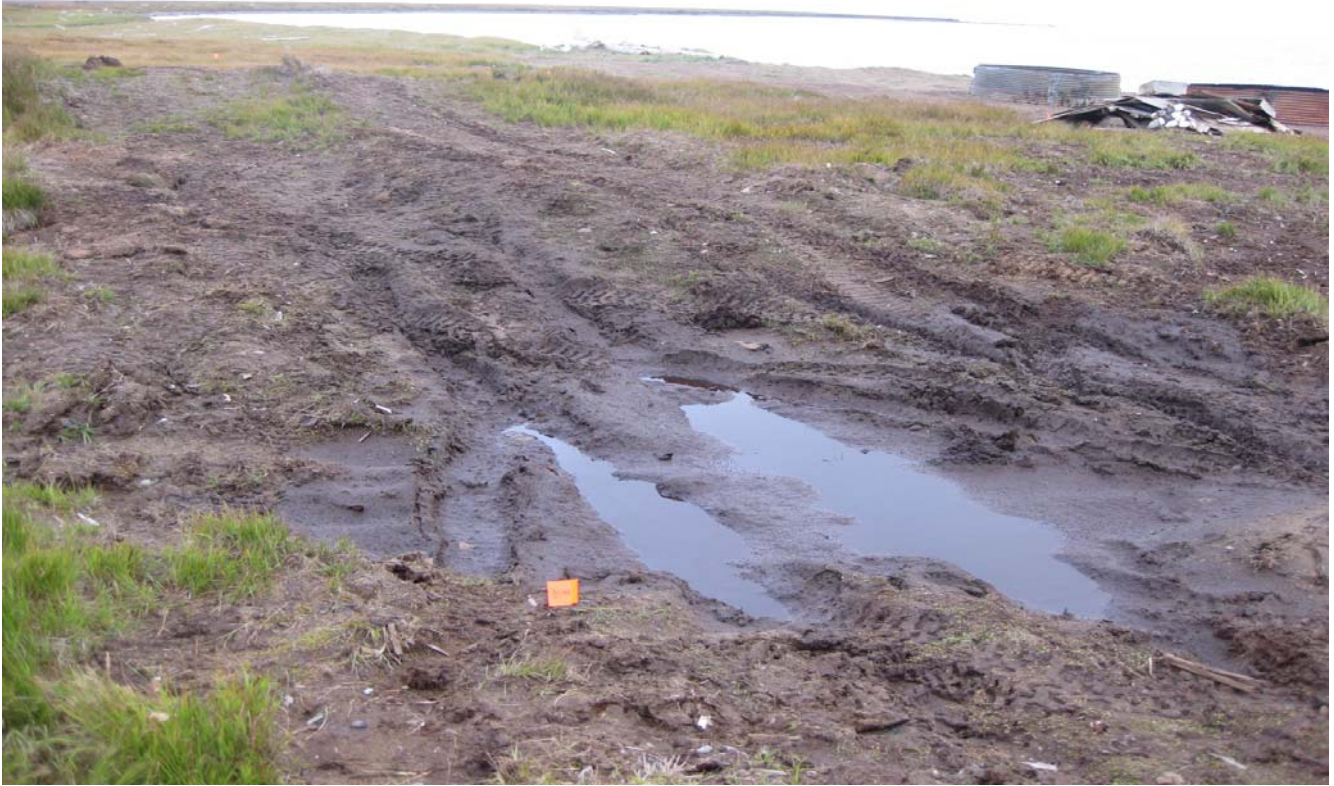
Photograph 17: Soil Sample Location 12NVNCSL56 Collected from Soil removal Location AA17
Date: September 9, 2012 Direction: Northwest Photographer: L. Nelson

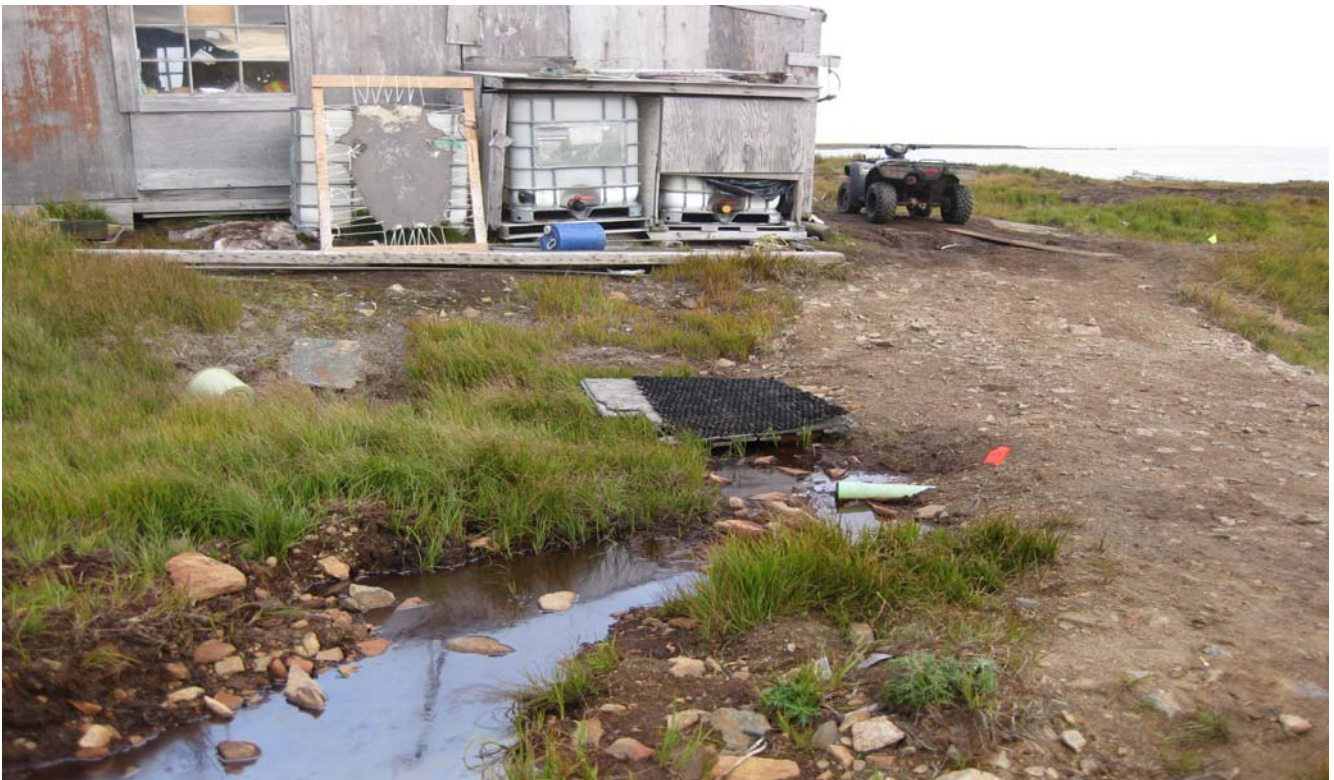
Photograph 18: Soil Sample 12NVNCSL58 Collected from Drum Removal Area near E. Toolie Cabin (AA19)
(no visible sheen was present on the surface water)
Date: September 9, 2012 Direction: Northwest Photographer: L. Nelson

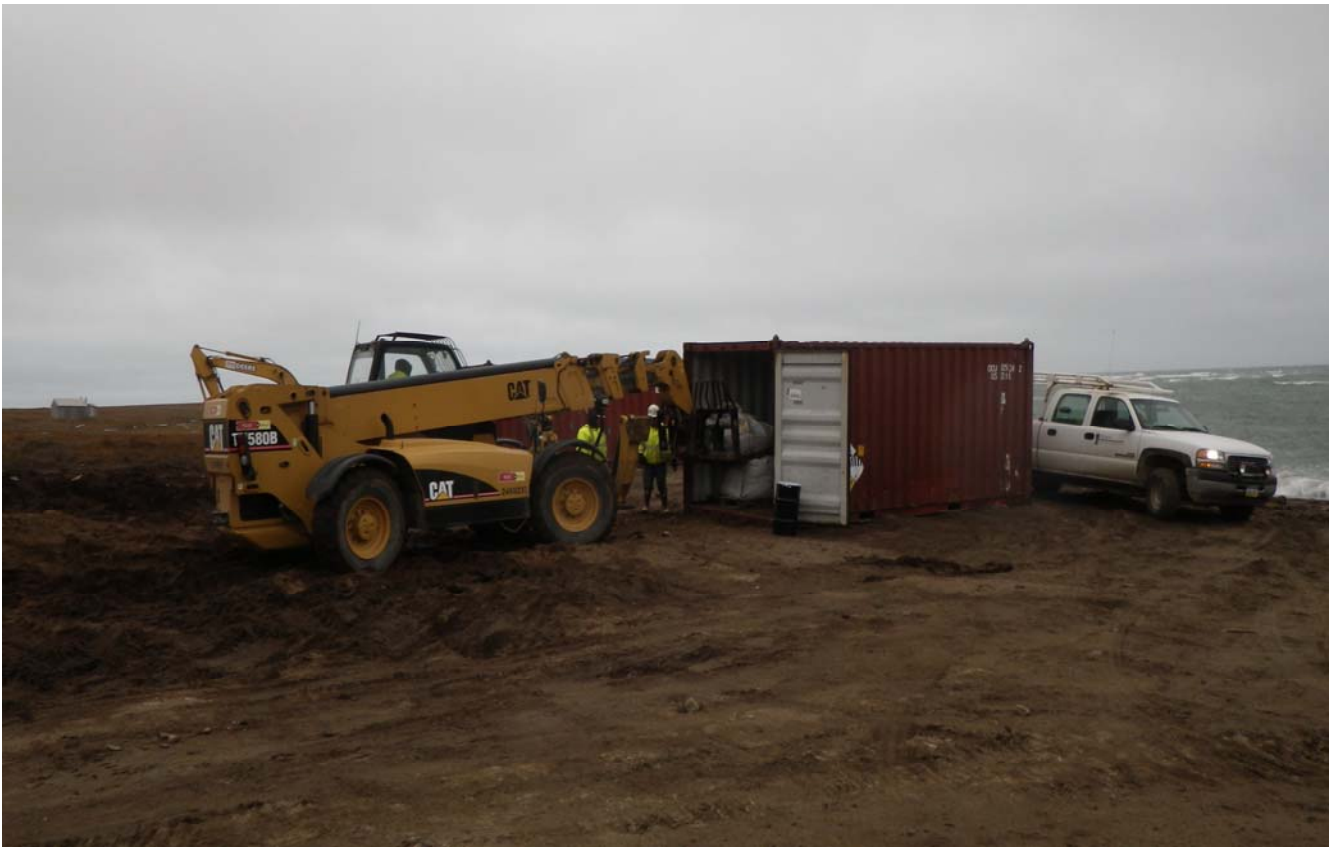
Photograph 21: Loading of CON/HTRW for Transportation and Disposal
Direction: Northwest

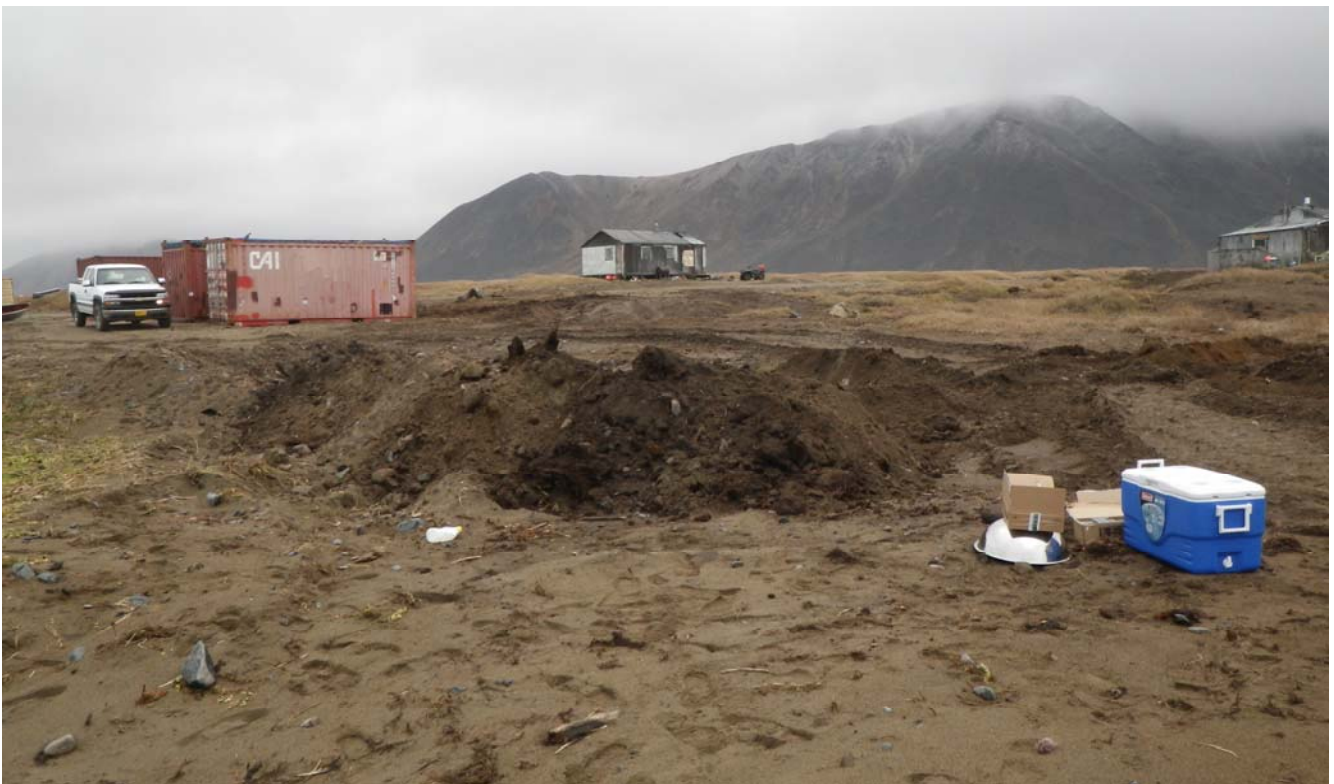
Photograph 22: Confirmation Sampling of Burn Pit Area
Direction: Southeast

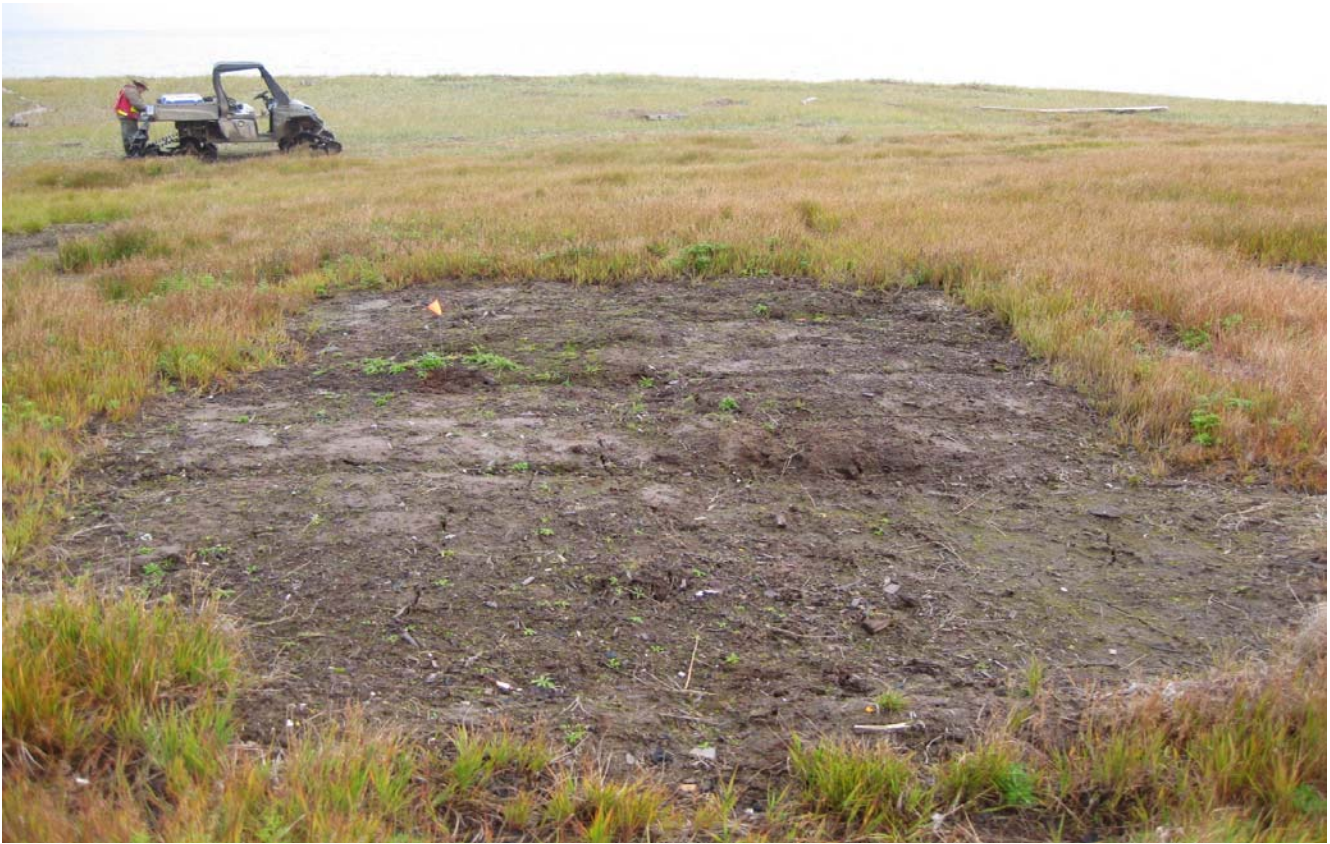
Photograph 23: Soil Sample Location 12NVNCSL08 Collected from Debris Pile #11
Date: September 7, 2012

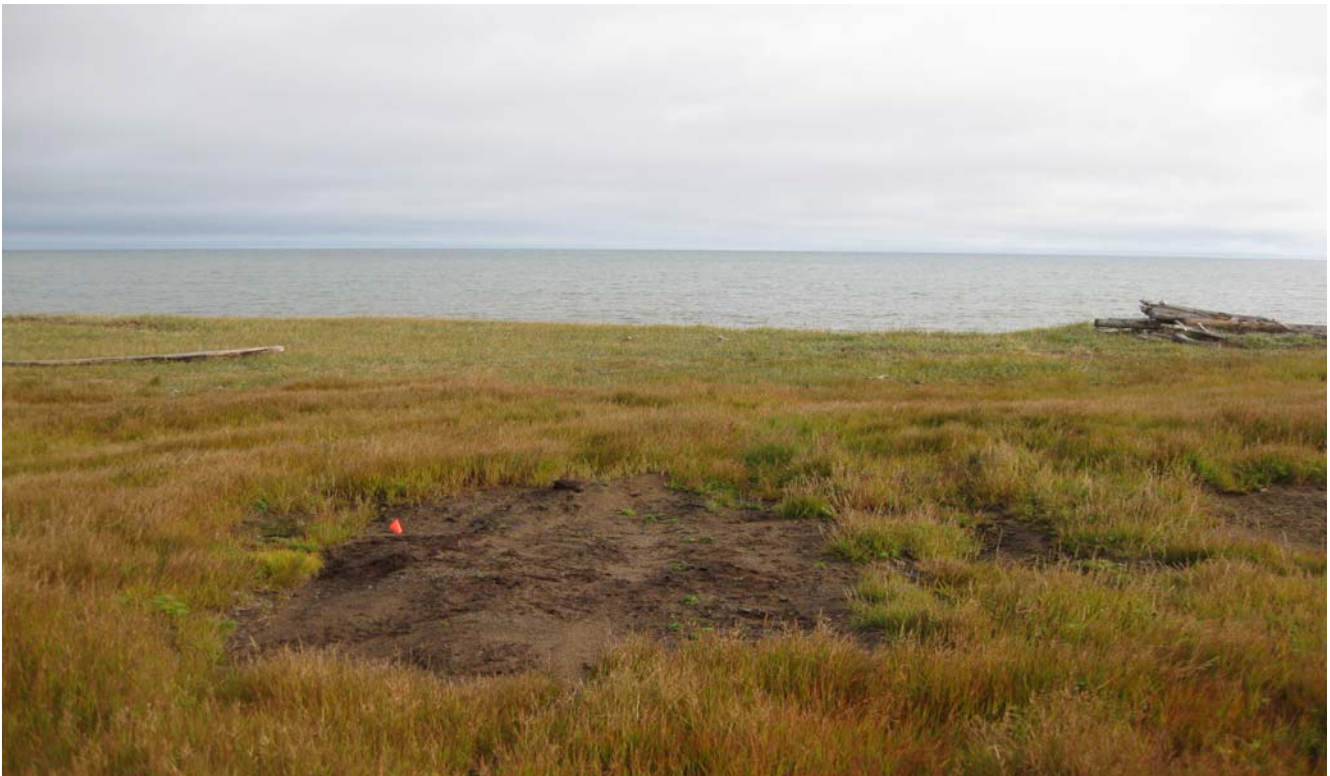
Photograph 24: Soil Sample Location 12NVNCSL09 Collected from location of Former Structure #7
Date: September 7, 2012

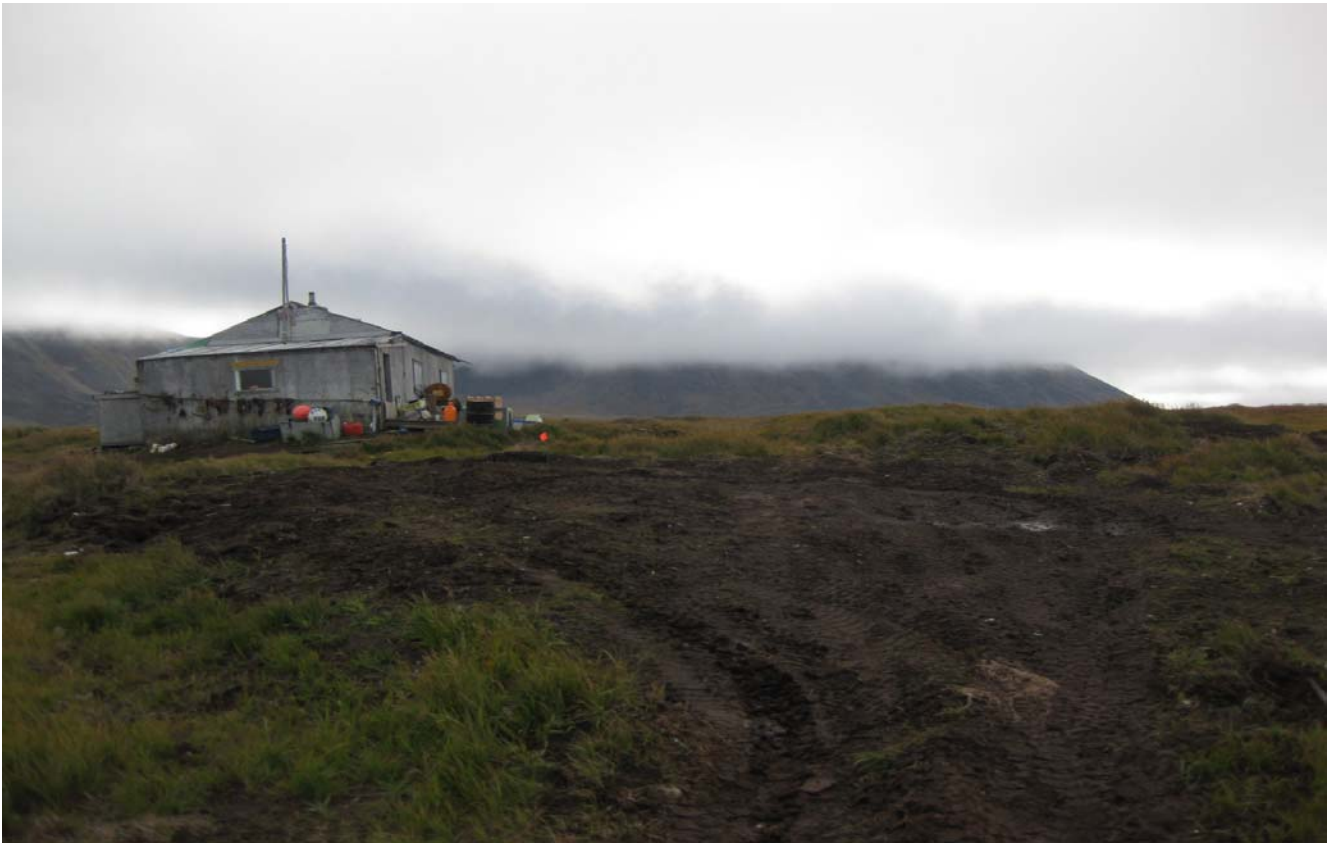
Photograph 27: Soil Sample Location 12NVNCSL24 Collected from Location of Former Structure #4
Date: September 7, 2012 Direction: Southeast Photographer: L. Nelson

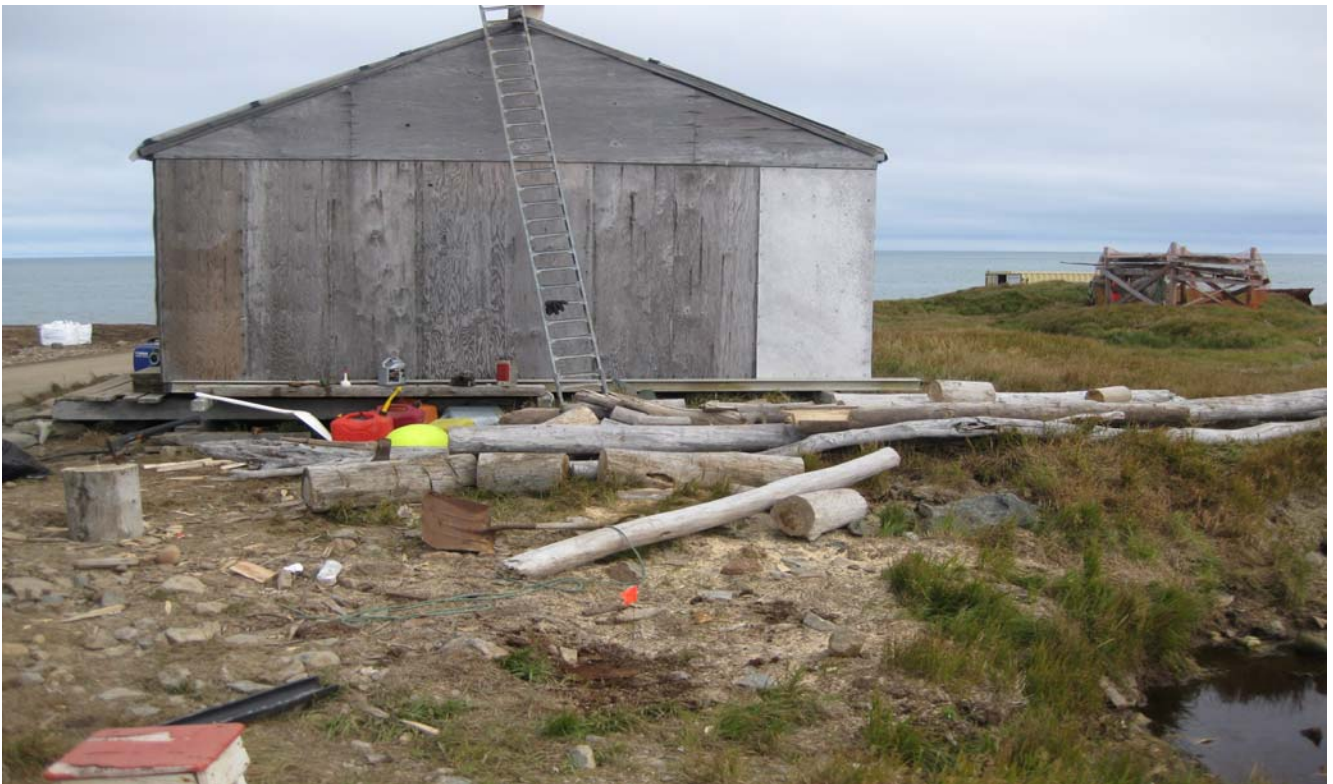
Photograph 28: Soil Sample Location 12NVNCSL28 Collected from Location of Debris Pile #23
Date: September 8, 2012 Direction: North Photographer: L. Nelson

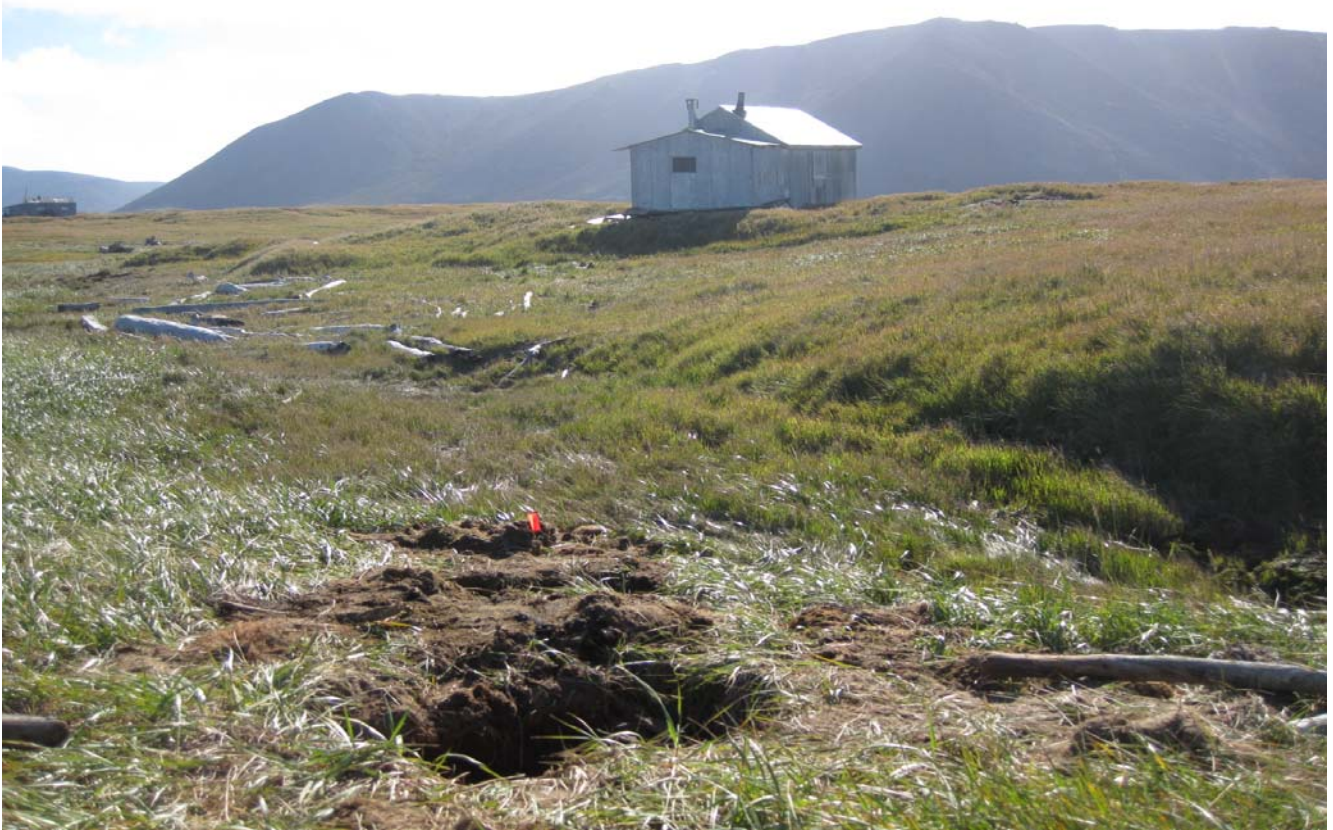
Photograph 29: Soil Sample Location 12NVNCSL43 Collected from Additional Area of Concern AA04
Date: September 8, 2012 Direction: East Southeast Photographer: L. Nelson
