**NATIVE VILLAGE OF NORTHEAST CAPE
REMOVAL ACTION/
SITE INVESTIGATION REPORT
REVISION 1**

Northeast Cape, St. Lawrence Island, Alaska

August 2013

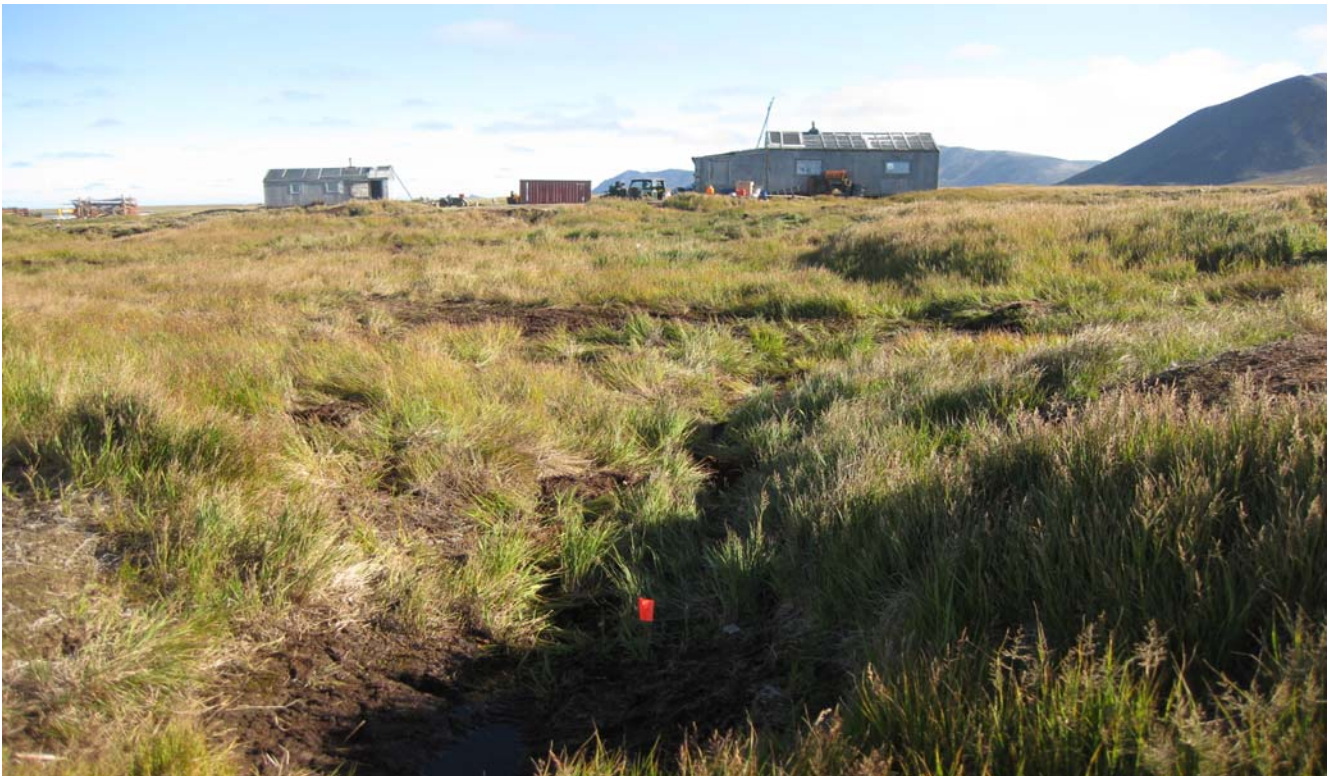
Photograph 30: Soil Sample Location 12NVNCSL51 Collected from Additional Area of Concern AA12
Date: September 8, 2012 Direction: East Photographer: L. Nelson

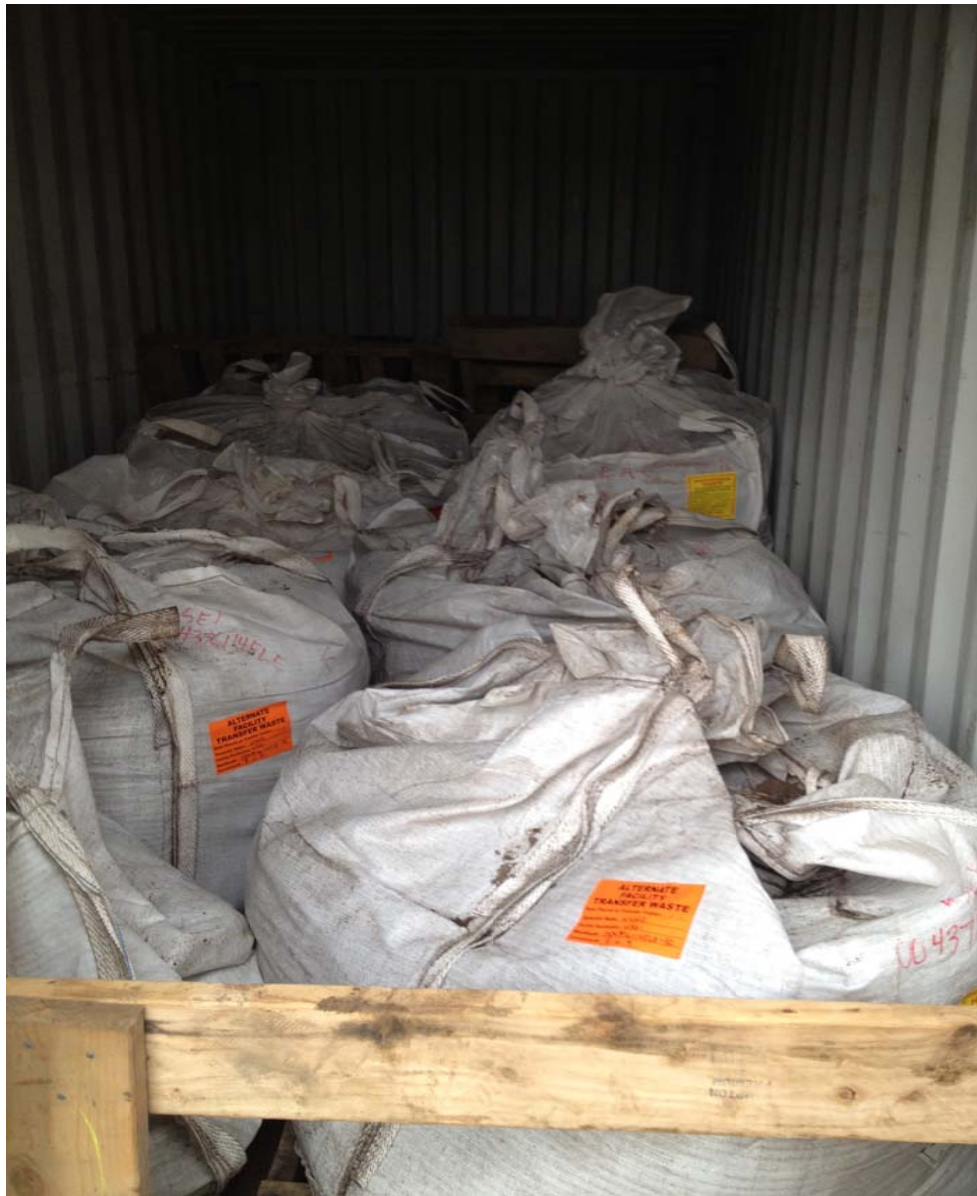
Photograph 33: Photograph of Shipping Containers After Arrival At Port of Seattle Date: November 16, 2012
Direction: N/A Photographer: T. Ellingboe
