U.S. Army Corps of Engineers, Alaska District
In-Situ Chemical Oxidation (Phase I) and Intrusive Drum
Removal/Landfill Cap

Northeast Cape, St. Lawrence Island, Alaska
Contract No. W911KB-09-C-0013
FIIP No. F10AK096905_07.08_0500_p

SITE 7 LANDFILL CAP
CONSTRUCTION COMPLETION REPORT

FINAL
MAY 2010

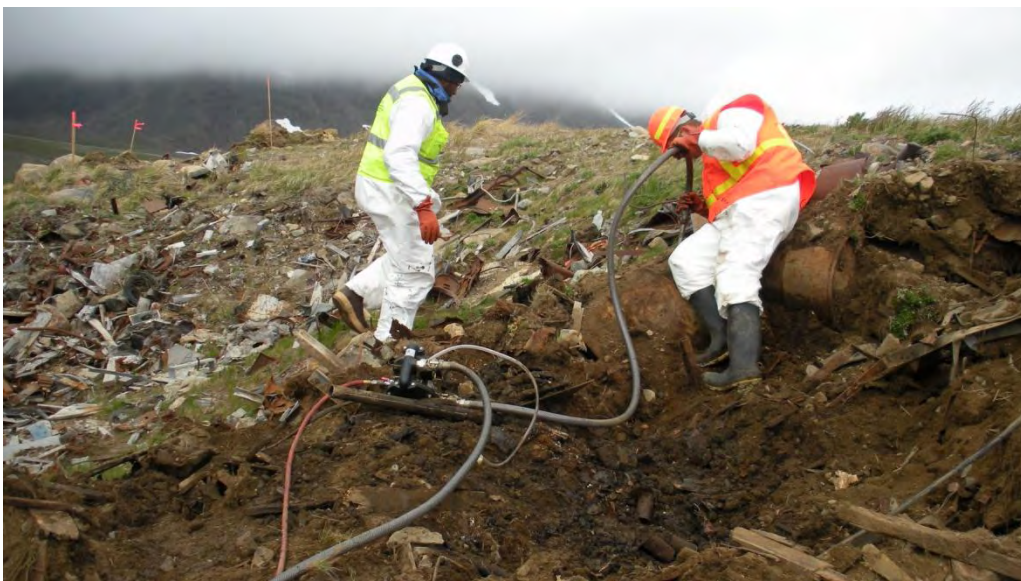
Drum found with oil. In-situ pumping process at landfill.

- 14 • **Drum Waste Accumulation** – The WP stated that some drums in poor condition
15 would be pumped in situ into a new drum before transport to the HWAP. In the field,
16 it was discovered that the consistency of the product contained in these drums was
17 very thick. Due to this high viscosity, pumping was slow and prone to complications.
18 A few drums were pumped in situ during the early removal stages, but the method was
19 eventually abandoned and all waste accumulation occurred at the HWAP.

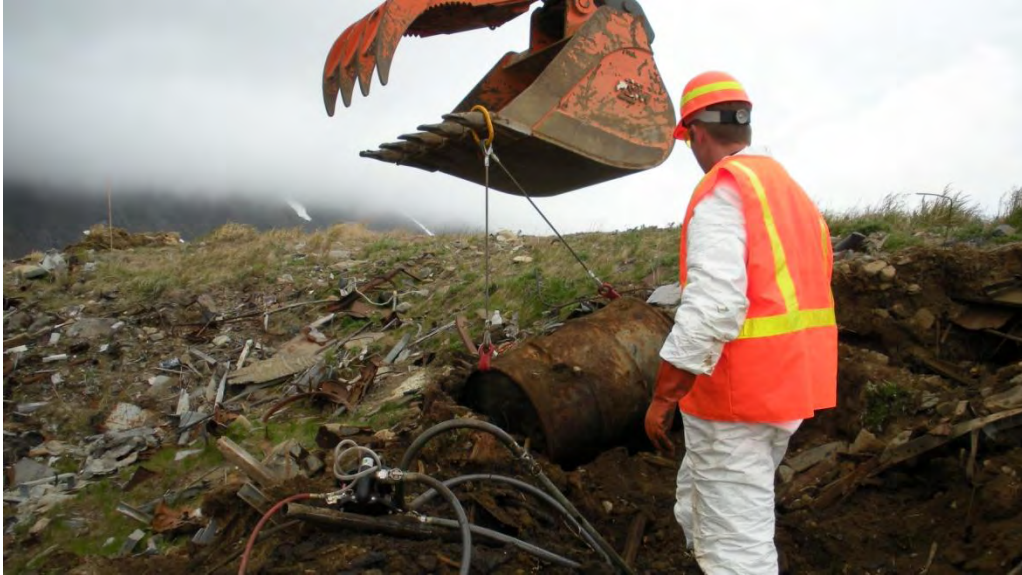
Removing pumped drum with drum lifter and excavator.

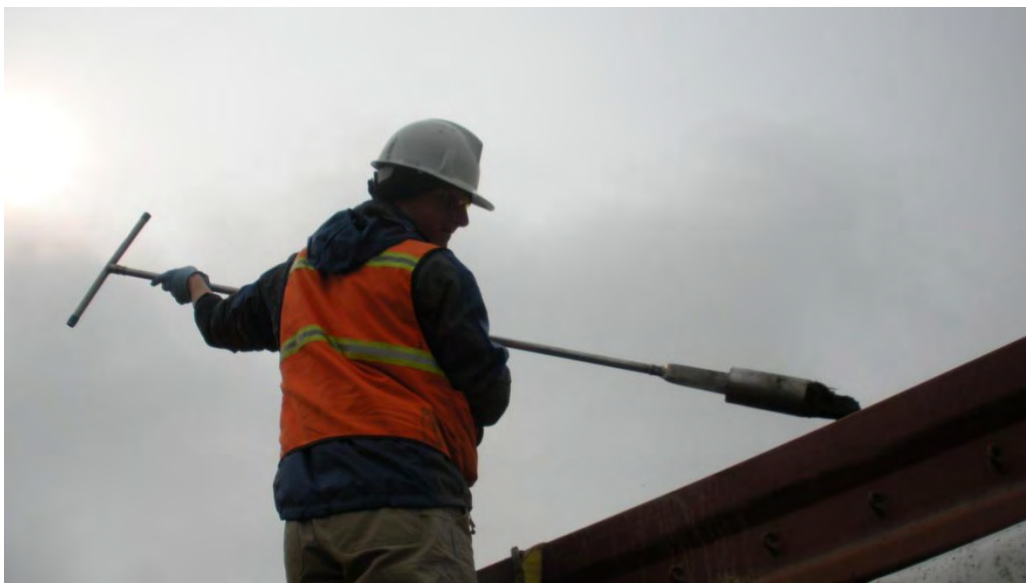
Sampling grossly stained bulk soils.

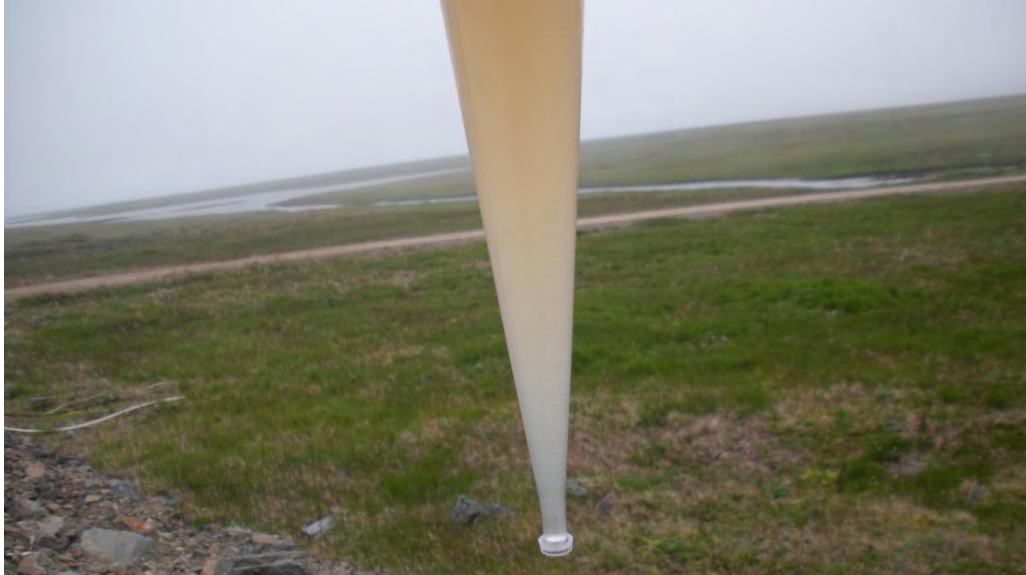
Water from final containment area shown in Imhoff cone,
no settleable solids were observed.

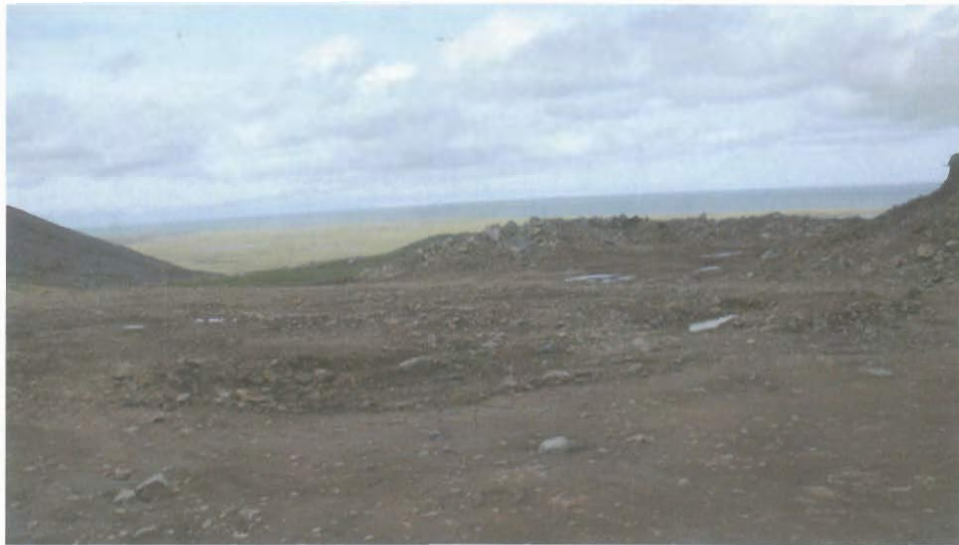
After the cleanup activity was finished and the vehicle was fixed and moved Bristol personnel took soil samples from spots along the length of the excavation. There was no odor or visual evidence of petroleum product observed. Six samples were taken from various spots along the spill area including sidewalls and excavation bottom. The soil samples were placed in sealed Ziploc bags and were allowed to volatilize in the sun for a period of approximately twenty minutes. At the end of twenty minutes PID readings were taken of all of the samples. All samples had a PID reading of zero.

Hydraulic Spill Site after Cleanup

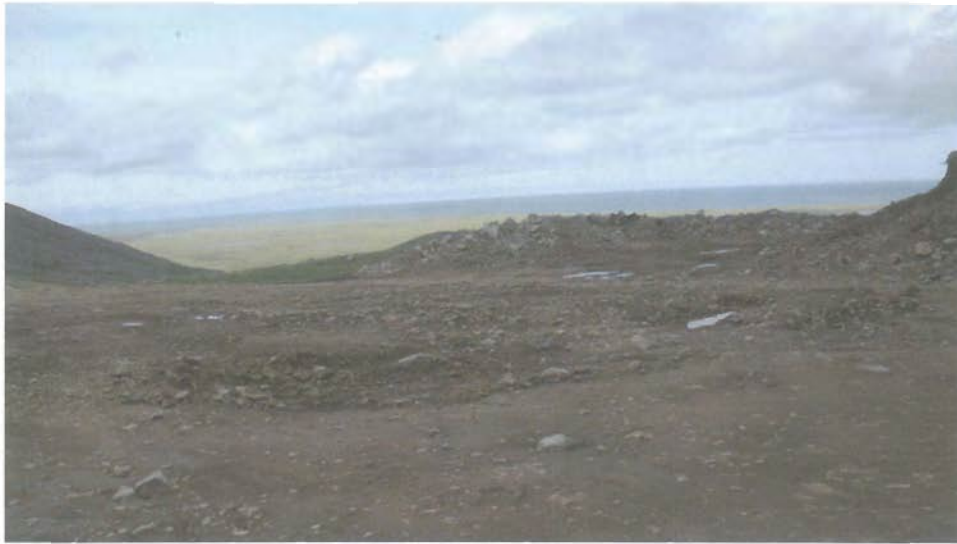
After the cleanup activity was finished and the vehicle was fixed and moved Bristol personnel took soil samples from spots along the length of the excavation. There was no odor or visual evidence of petroleum product observed. Six samples were taken from various spots along the spill area including sidewalls and excavation bottom. The soil samples were placed in sealed Ziploc bags and were allowed to volatilize in the sun for a period of approximately twenty minutes. At the end of twenty minutes PID readings were taken of all of the samples. All samples had a PID reading of zero.

Hydraulic Spill Site after Cleanup

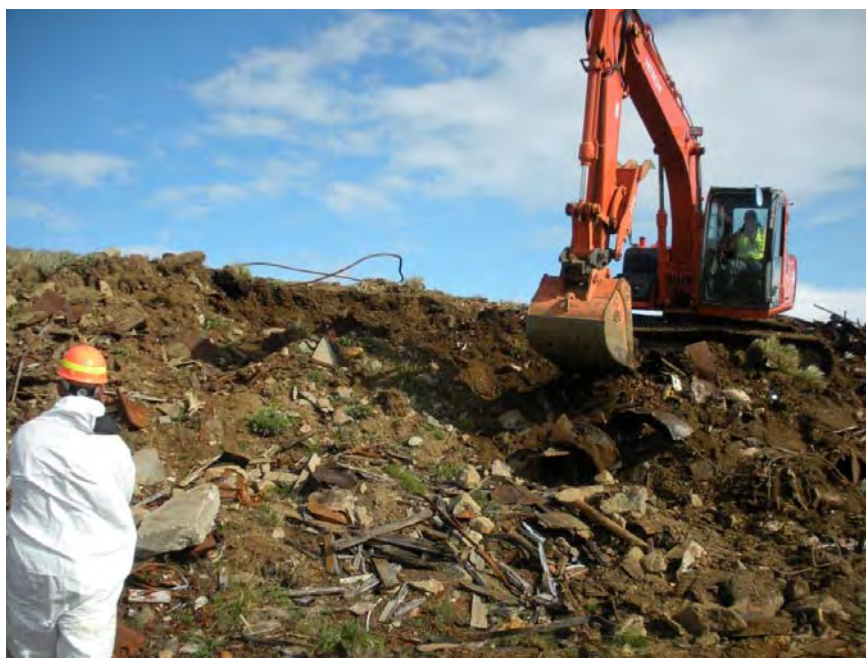
The excavation areas were chosen based on the metallic anomalies and the information yielded from test pits and trenching. Surface material was excavated and staged along the section of landfill being worked on. Debris was moved and piled until a drum was found. Upon discovery, the drum was checked with the aid of a drum thief. Drums found to have retrievable petroleum product, or residue determined to not be water, were moved to the Hazardous Waste Accumulation Point (HWAP) or were pumped in place into empty barrels and moved to the HWAP (Photograph 3).

Photograph 2. Excavation of soil and drums from the Site 7 Landfill.

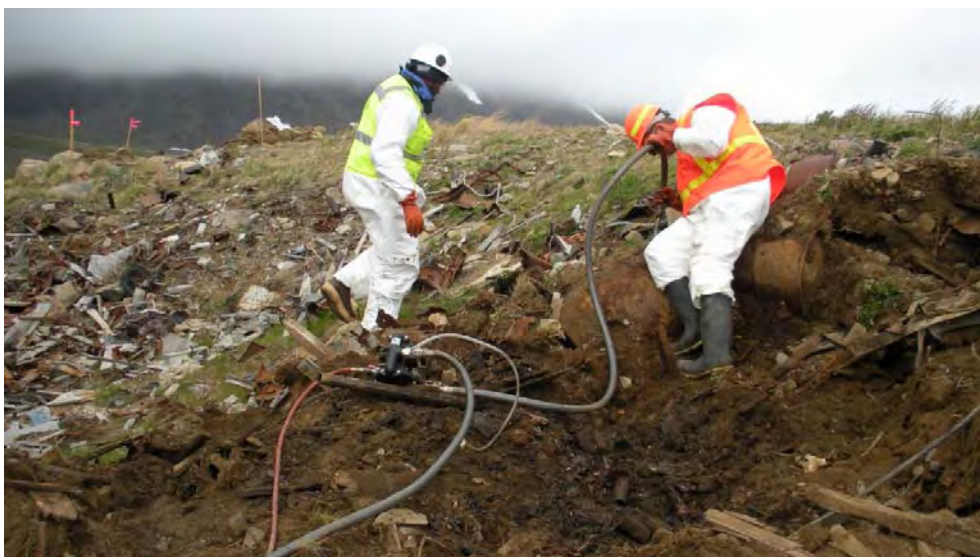
Photograph 3. Field crew pumping liquid out of a corroded drum in the landfill.

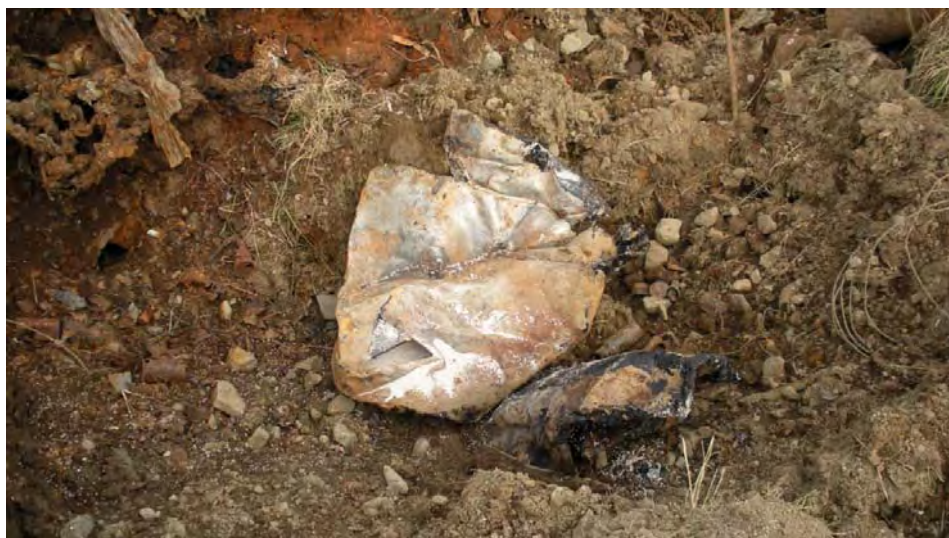
Oil found in drums was drained and put in new containers for eventual petroleum recycling. Fifty drums were shipped off-island for disposal, and the rest of the drums were cleaned and returned to the landfill prior to capping. Drums that were extremely corroded or crushed were thoroughly cleaned on the outside and filled with Oil-Dri[®] absorbent, before being returned to the landfill (Photograph 4).

Photograph 4. Crushed drum that was cleaned, coated with Oil-Dri[®] absorbent, and returned to landfill.

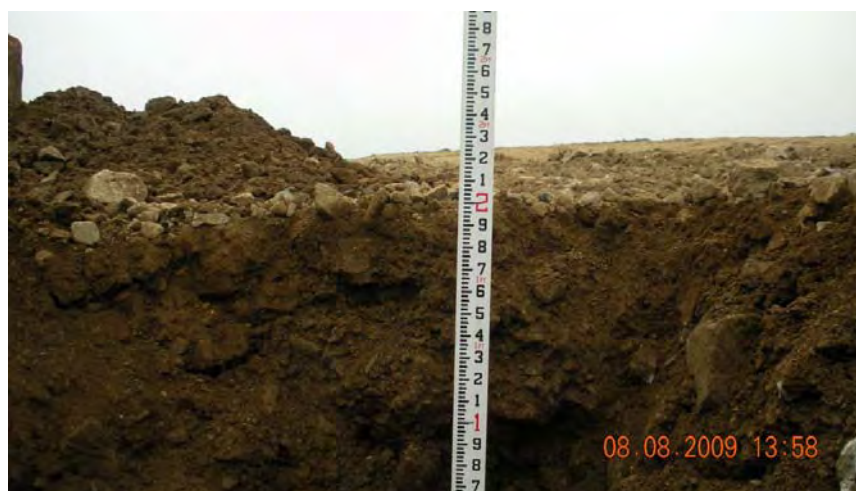
Quality control measures taken in the field to ensure appropriate cap thickness consisted of excavating test pits through the capping material to its interface with the debris. The thickness of the material was noted, and fill stakes were placed at all locations that required additional material (Photograph 6).

Photograph 6. Measurement showing a 2-foot-thick cap in a test pit in the landfill.
