NORTHEAST CAPE HTRW REMEDIAL ACTIONS

FINAL REMOVAL ACTION REPORT

Northeast Cape, Saint Lawrence Island, Alaska

February 2012

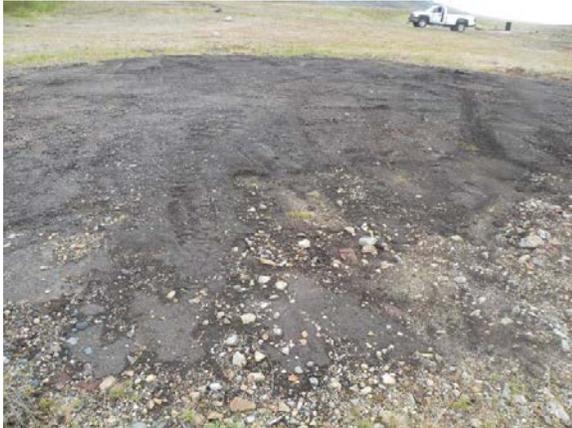
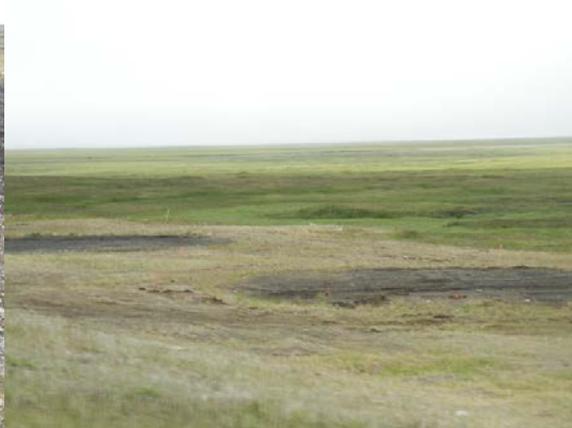
This site will require a mechanical implement, such as ripper to fracture the soil.

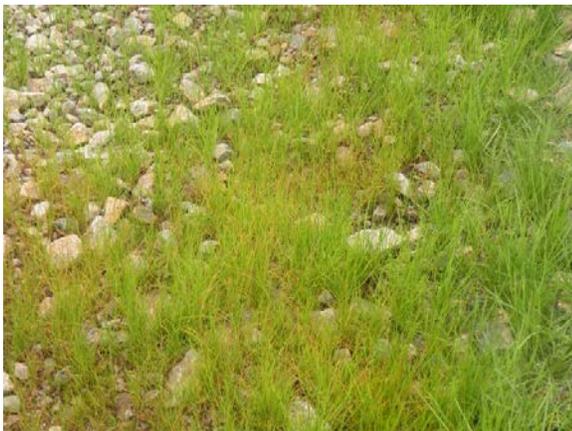
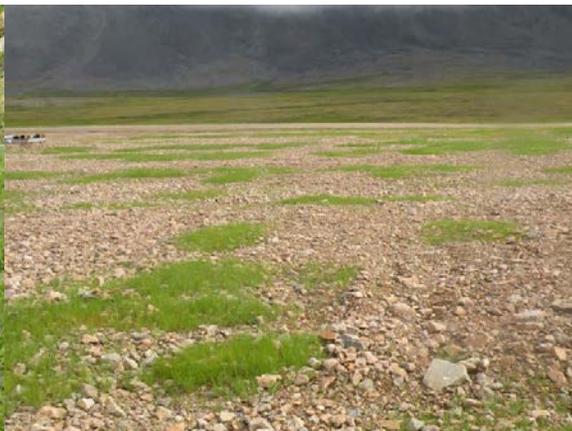
I recommend reseeding this site with 70% Tufted hairgrass and 30% Red fescue. Fertilize with 20-20-10 at 500 pounds per acre. Yellowing of the grasses is probably due to fertilizer deficiency.

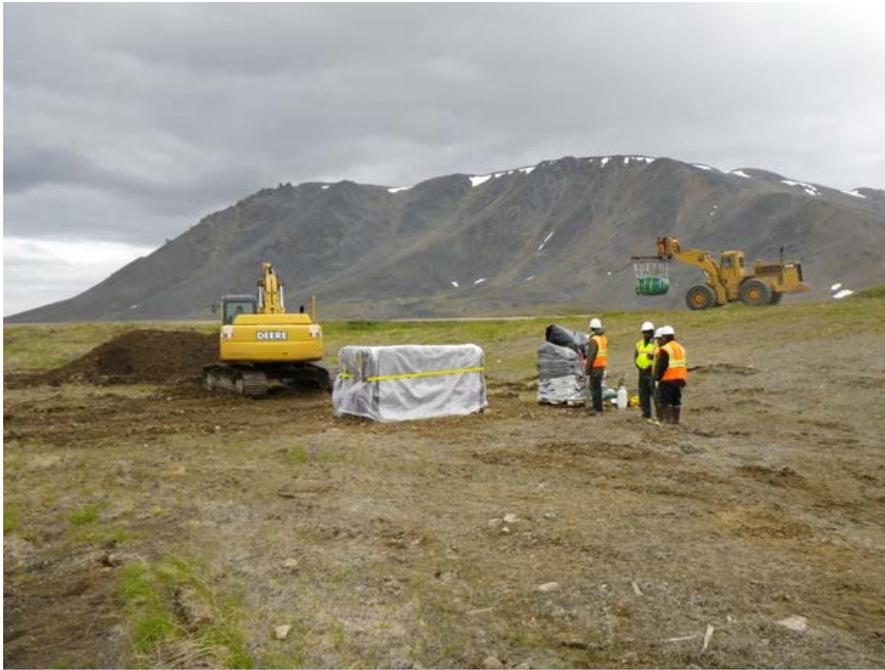
Photograph 1 Bulk bag loading at eastern tank footprint in Main Operations Complex (MOC)
July 16, 2011

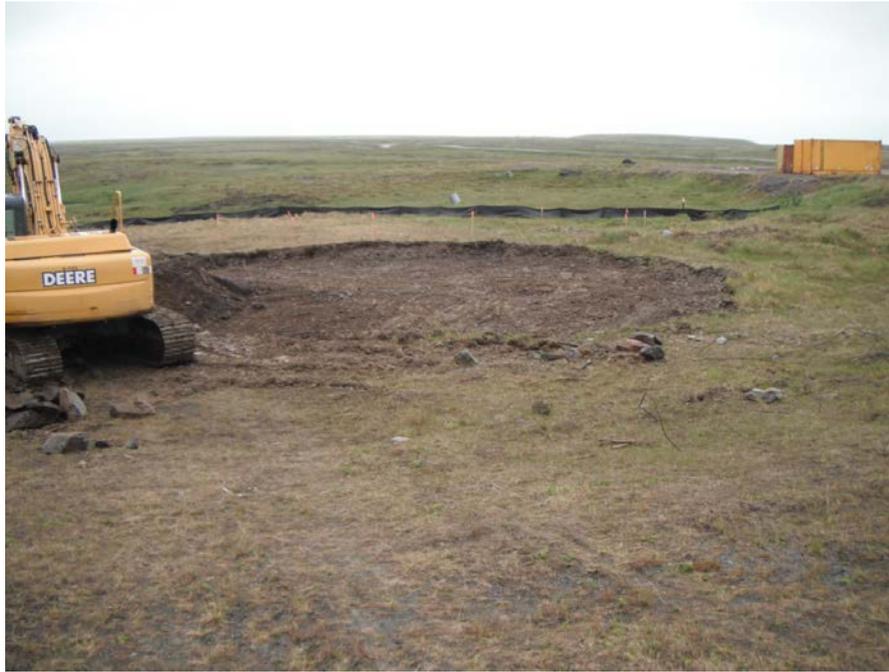
Photograph 3 Excavating eastern tank footprint
at the MOC
July 18, 2011

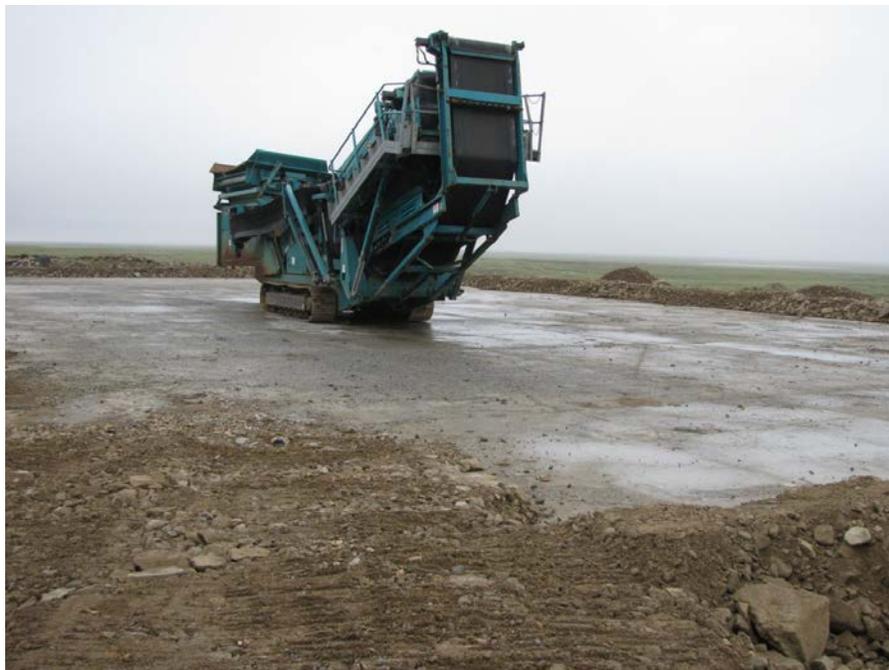
Photograph 4 Building pad 98 where bulk bags were
stored overwinter, with rock screener parked on it
July 18, 2011

- **Stockpiled Soil at Pad 98** – The WP stated that Bristol would place liner underneath soils stockpiled on the concrete foundation of former Building 98. No liner was placed on the concrete where machinery was operating, but instead

berms were constructed along the edges of the concrete foundation. Liner was placed on top of these outer berms.

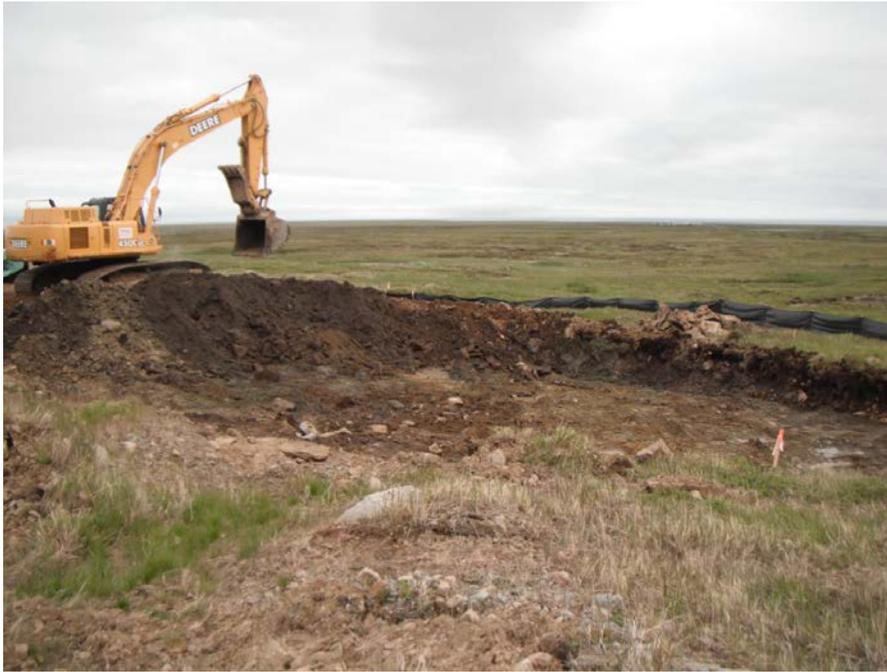
Photograph 9 Excavation of contaminated material
2-4 feet below ground surface (bgs) at J1A
July 21, 2011

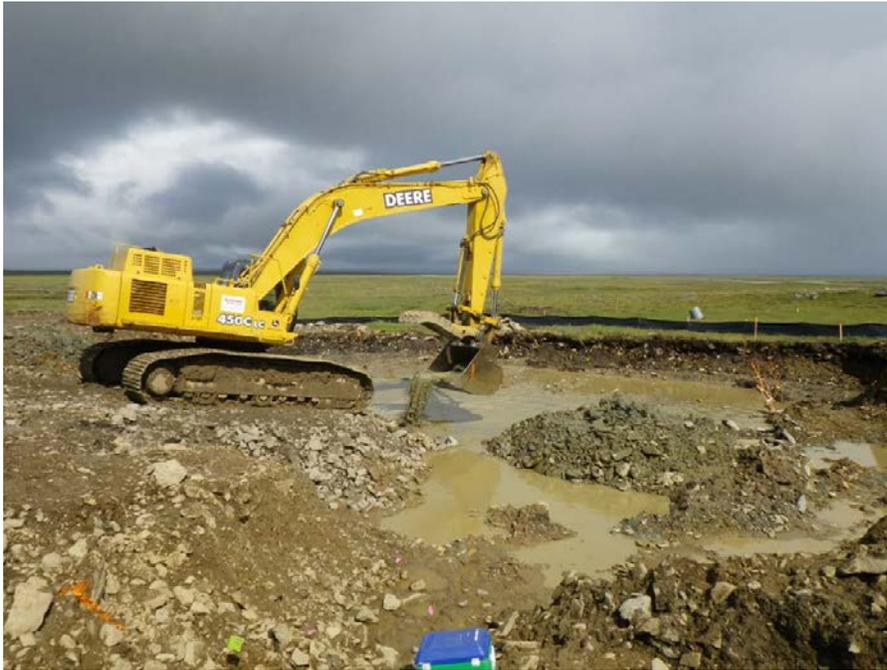
Photograph 15 Removing soil from
2 feet below water at J1A
August 3, 2011

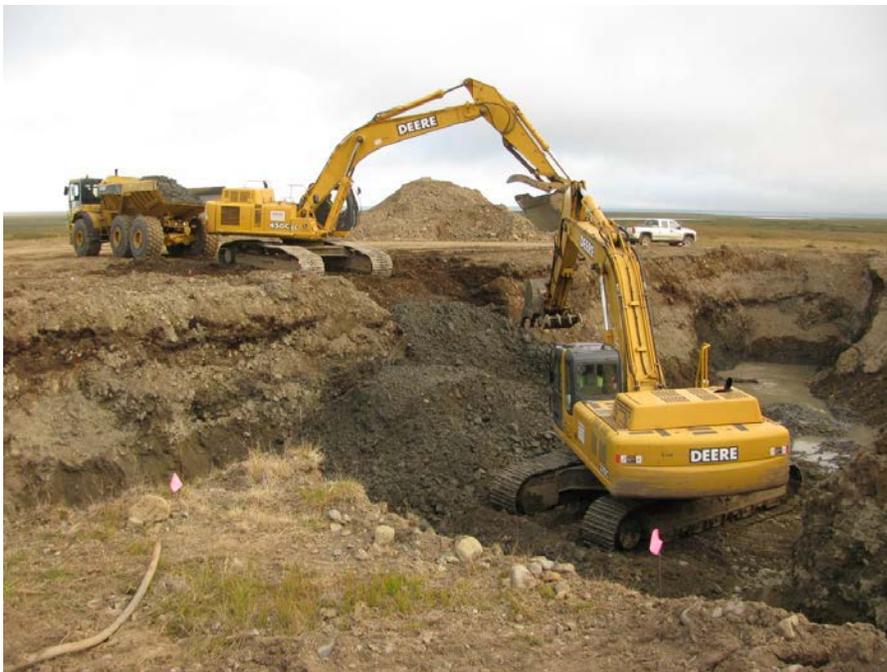
Photograph 16 Excavation of POL-contaminated
soil at A1
August 5, 2011

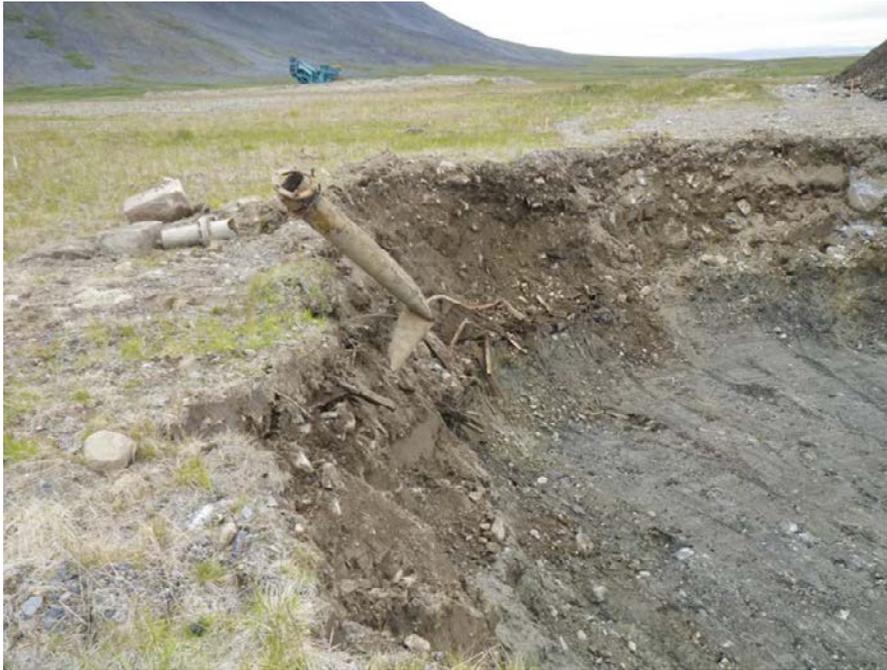
Photograph 17 Buried debris and underground piping Northeast Cape
exposed at southern extent of A1 excavation
August 6, 2011 Direction: Southwest

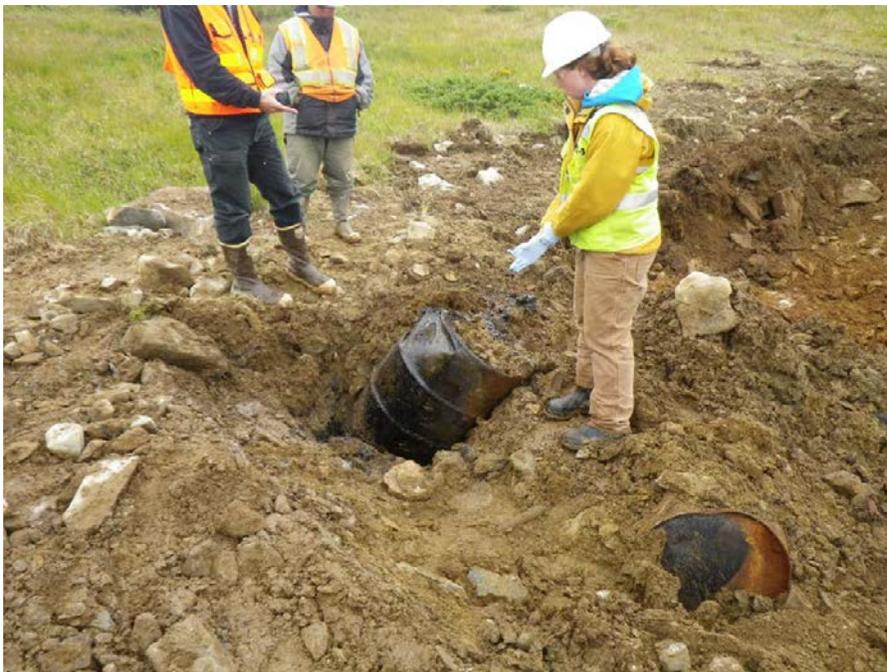
Photograph 20 An oil-containing drum uncovered
In the southeast corner of the J1A excavation
August 15, 2011

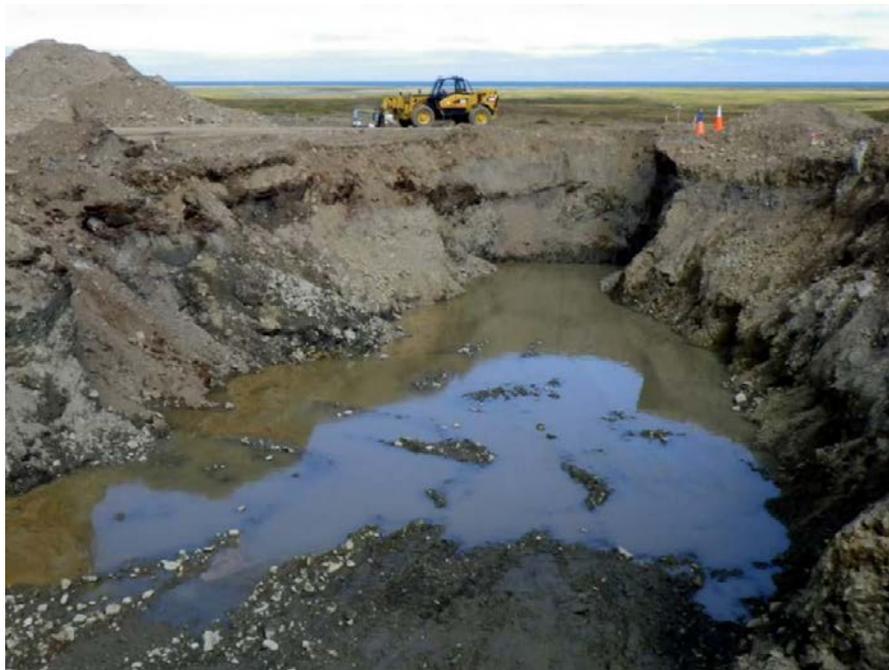
Photograph 22 Groundwater flowing into deepened A1 excavation
August 20, 2011

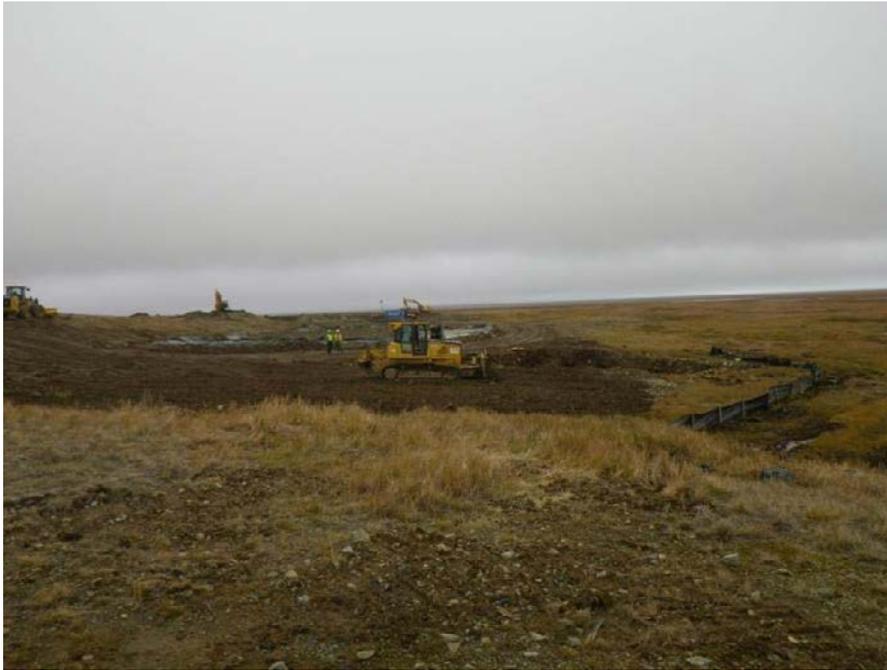
Photograph 25 Backfilling the J1A excavation
September 14, 2011

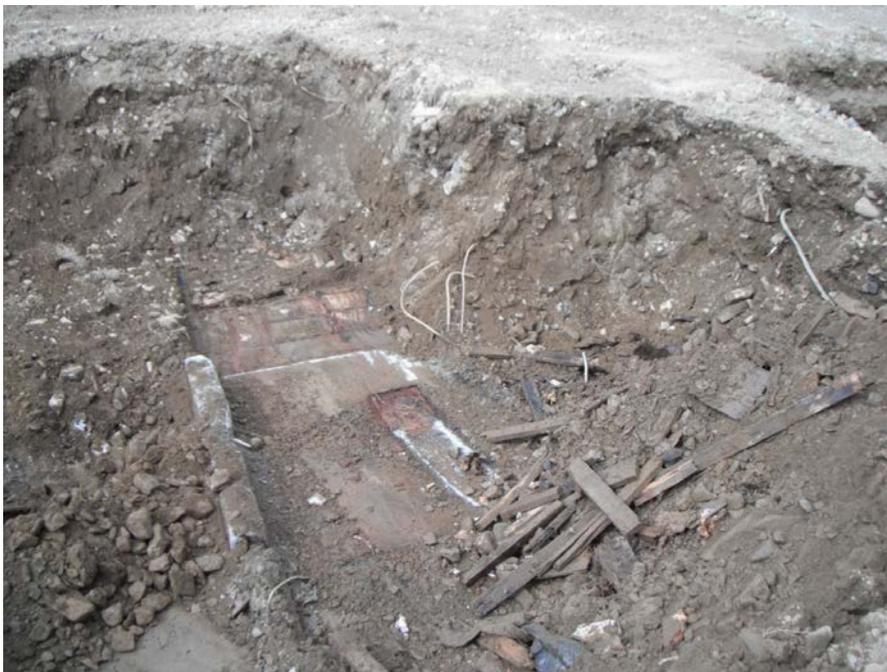
Photograph 32 A concrete slab and wood frame Northeast Cape
in the bottom of Site 13 excavation Direction: West
July 27 2011

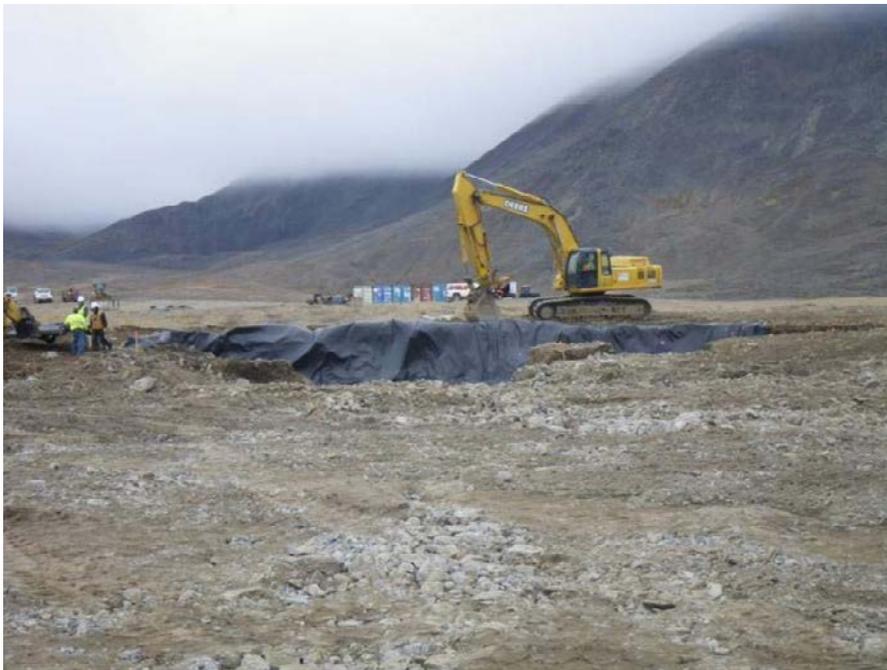
Photograph 38 Liner installations at Site 13
September 24, 2011

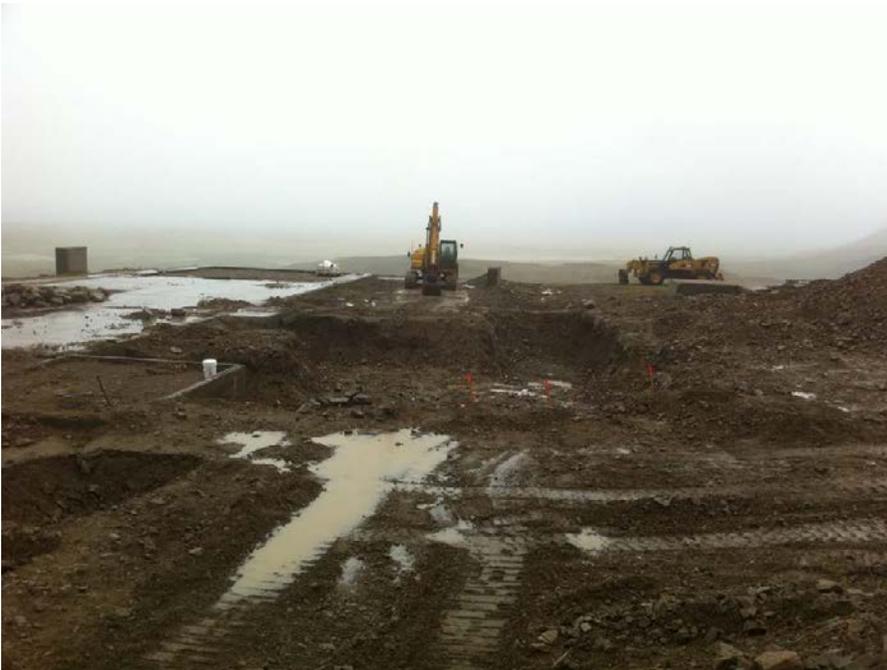
Photograph 44 Water pooling behind berm at Site 31
July 29, 2011

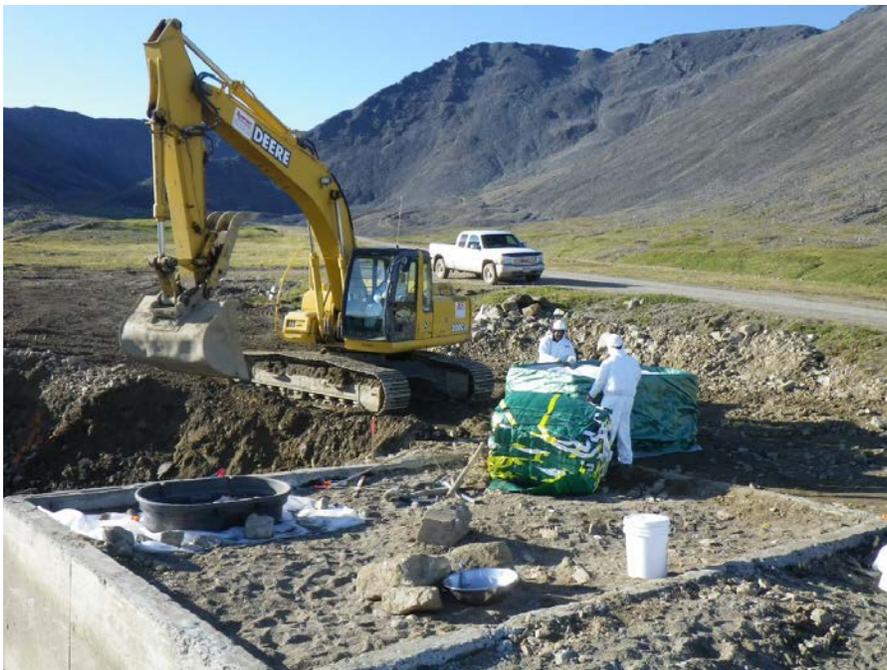
Photograph 46 Excavating and bulk bagging polychlorinated biphenyls- (PCB-) contaminated soil
August 18, 2011

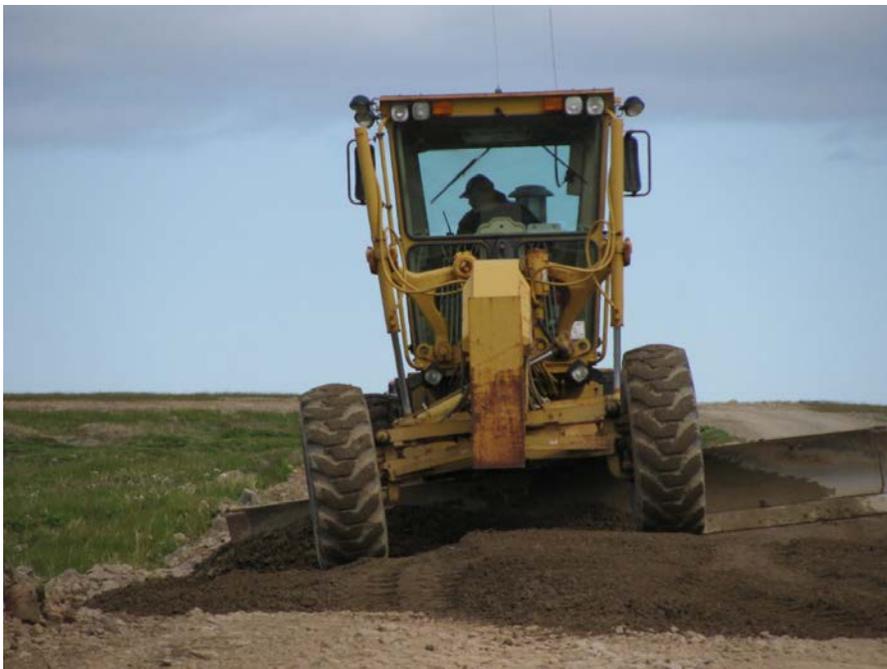
Photograph 74 Road regrading and repair Northeast Cape
July 3, 2011 Direction: North
