**Final Strategic Project Implementation Plan**

**Gambell, St. Lawrence Island, Alaska  
Contract No. DACA85-98-D-0007  
Delivery Order No. 18, Task 1**

December 2000

Montgomery Watson  
4100 Spenard Road  
Anchorage, Alaska 99517

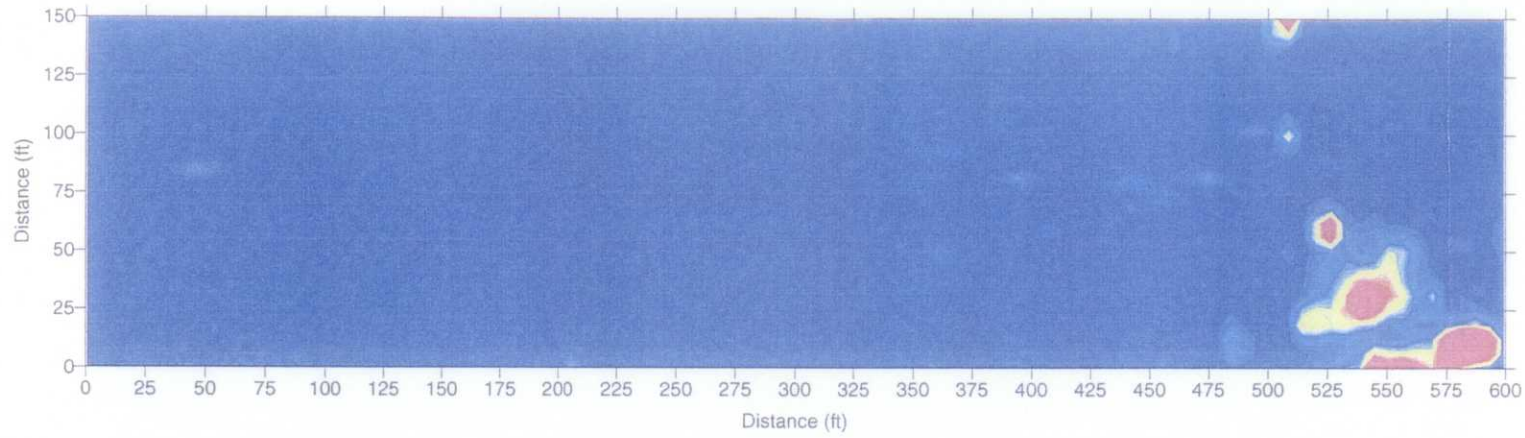
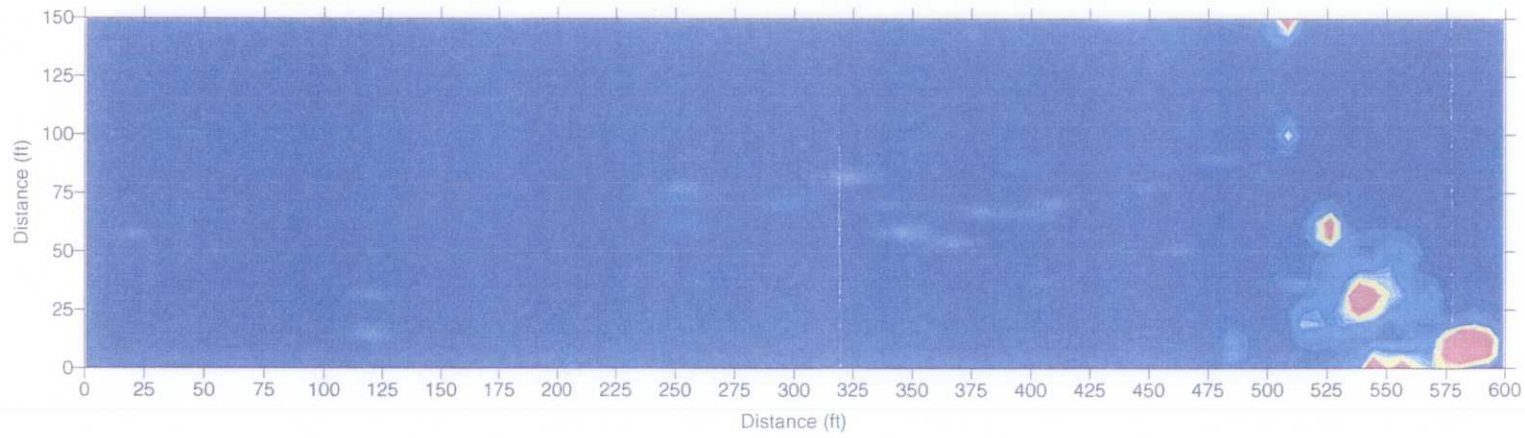
SITE H MAGNETOMETRY SURVEY Mag 858 GRADIENT		
GEOPHYSICAL ASSESSMENT GAMBELL, ST. LAWRENCE ISLAND, AK MONTGOMERY WATSON		
<b>GOLDER ASSOCIATES, INC.</b> REDMOND, WA		
August 15, 2000	003-5435 task 000	Fig. 7

The only region with anomalous magnetic data is located in the south-east corner of the grid (Station 510E to 600E and 0N to 80N). This region is outlined in red in Figures 7 and 9. The EM data also indicates that the south-east corner of the site contains conductive material. The anomalous region in the EM-61 differential dataset, however, is not as broad as that indicated by the magnetometry data and reveals several isolated anomalies. Two EM anomalies, located at Stations 525E, 60N and 510E, 150N, are significantly reduced in the differential channel. This suggests that these objects are buried immediately beneath

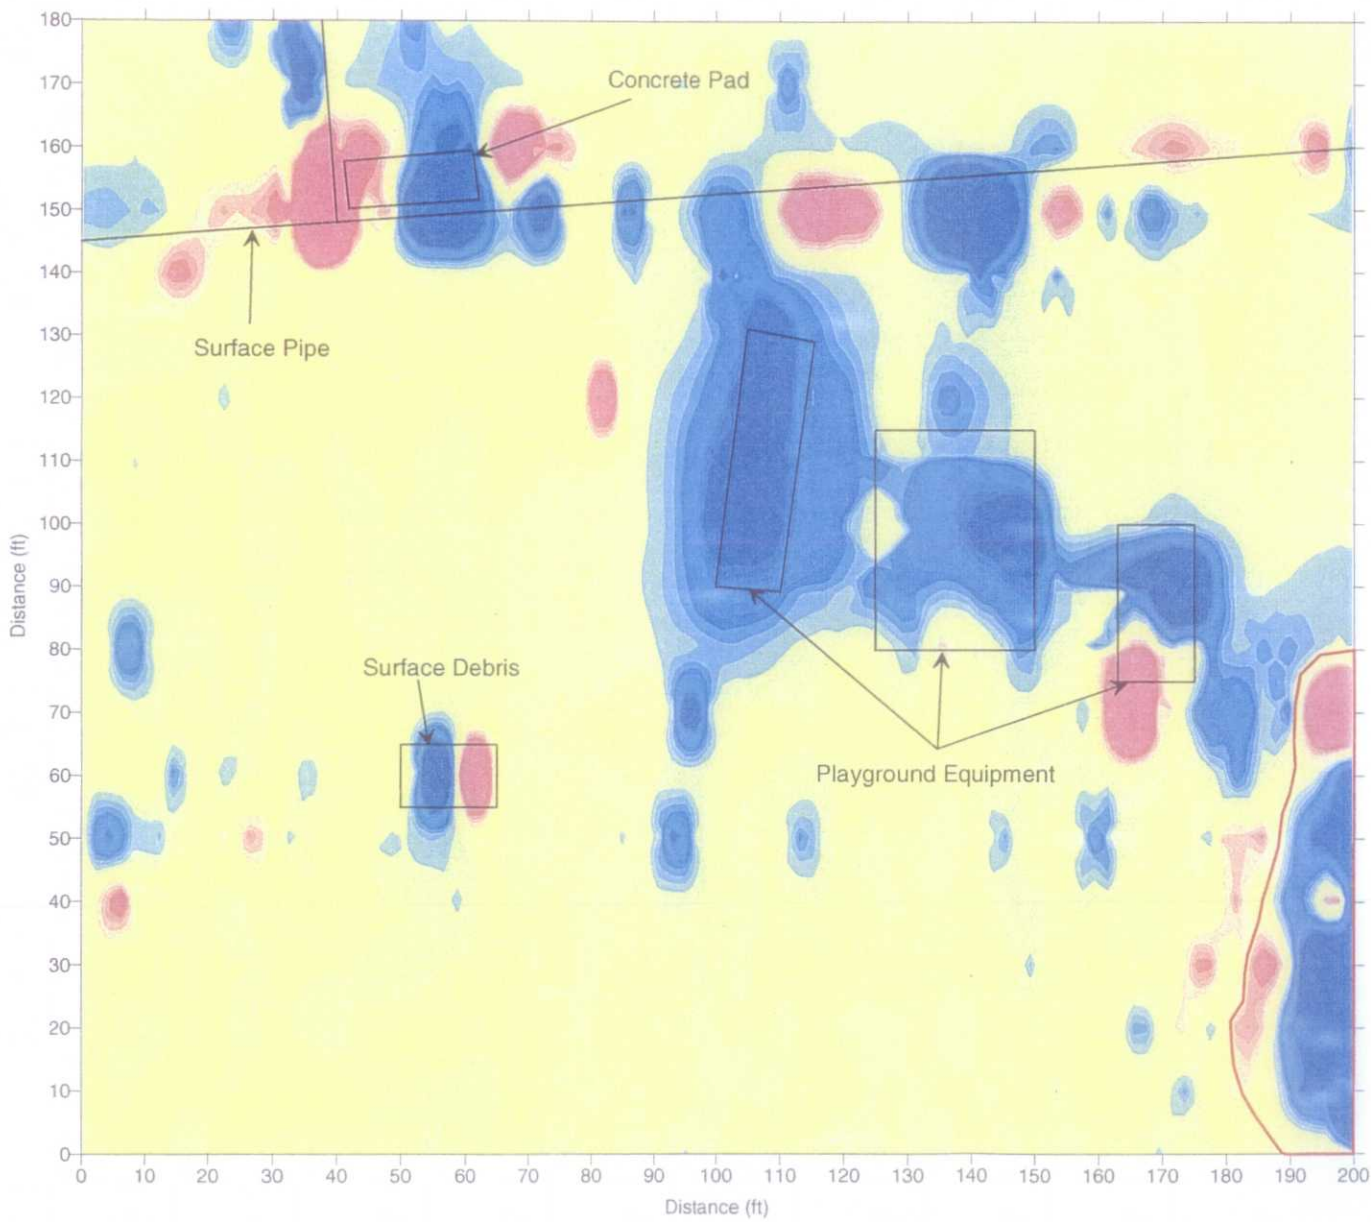
SITE I2 MAGNETOMETRY SURVEY Mag 858 GRADIENT		
GEOPHYSICAL ASSESSMENT GAMBELL, ST. LAWRENCE ISLAND, AK MONTGOMERY WATSON		
GOLDER ASSOCIATES, INC. REDMOND, WA		
August 15, 2000	003-5435 task 000	Fig. 15

There were many metallic features on the surface that influenced both the magnetic and EM data. These features, annotated on Figures 15 and 17, included various playground structures, an iron pipe, a concrete pad and a large metal gate. The only region within the site where the magnetometer data did not correlate with surface debris is in the south-east corner between Stations 185E and 200E and south of Station 80N. The extent of the magnetometer anomaly is outlined in red in Figures 15 and 17.

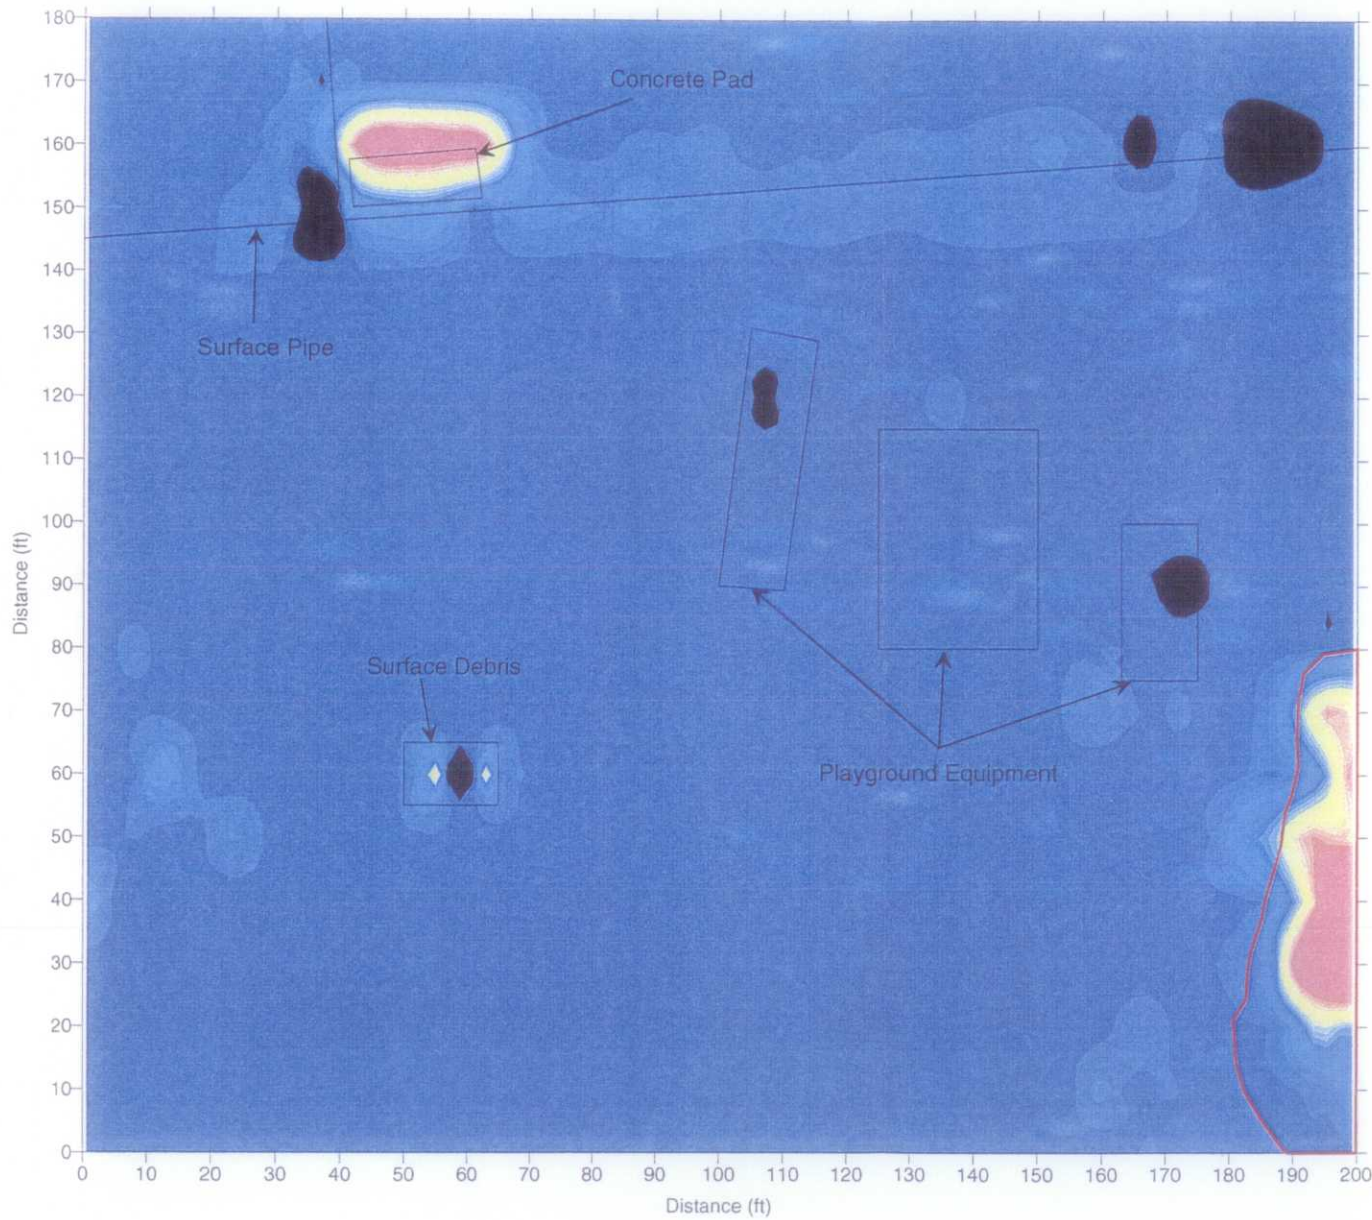
SITE I2 TIME DOMAIN EM EM-61 DIFFERENTIAL CHANNEL	
GEOPHYSICAL ASSESSMENT GAMBELL, ST. LAWRENCE ISLAND, AK MONTGOMERY WATSON	
GOLDR ASSOCIATES, INC. REDMOND, WA	
August 15, 2000	003-5435 task 000
	Fig. 17

The differential channel data supports the magnetometer data and indicates that the debris is located along the eastern site boundary between Stations 20N and 75N. The regions that are negative in this data (plotted in black, Figure 17) correspond to locations of metallic objects at the surface or extending slightly above the surface. The strong response in the differential channel data in the region of the concrete pad suggests that there is possibly a large metal object located beneath the pad.

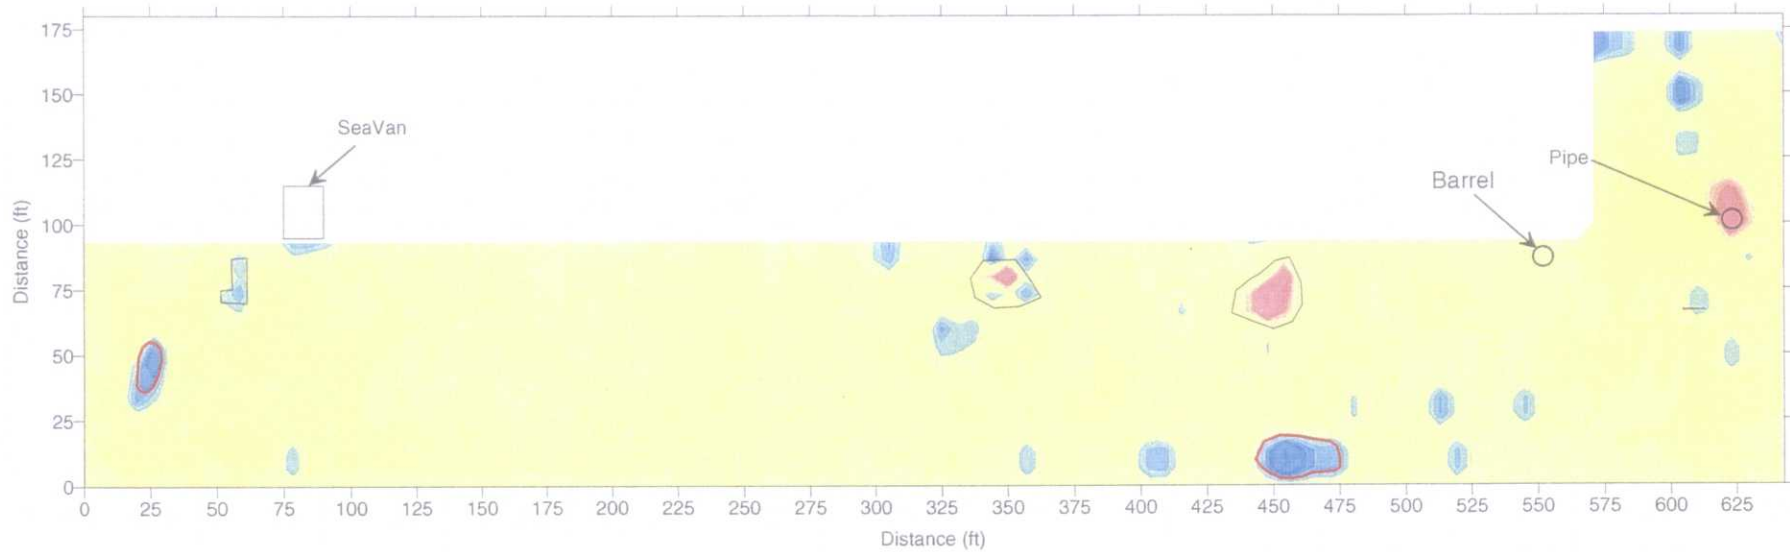
SITE J MAGNETOMETRY SURVEY Mag 858 GRADIENT		
GEOPHYSICAL ASSESSMENT GAMBELL, ST. LAWRENCE ISLAND, AK MONTGOMERY WATSON		
GOLDER ASSOCIATES, INC. REDMOND, WA		
August 15, 2000	003-5435 task 000	Fig. 19

Region 1 did not contain any surface metallic debris, and did not have either magnetic or electromagnetic anomalies. Region 2 contained frequent piles of surface metallic debris and other objects that affected the magnetometer and the EM-61 readings. These surface features are noted in Figures 19 and 21.

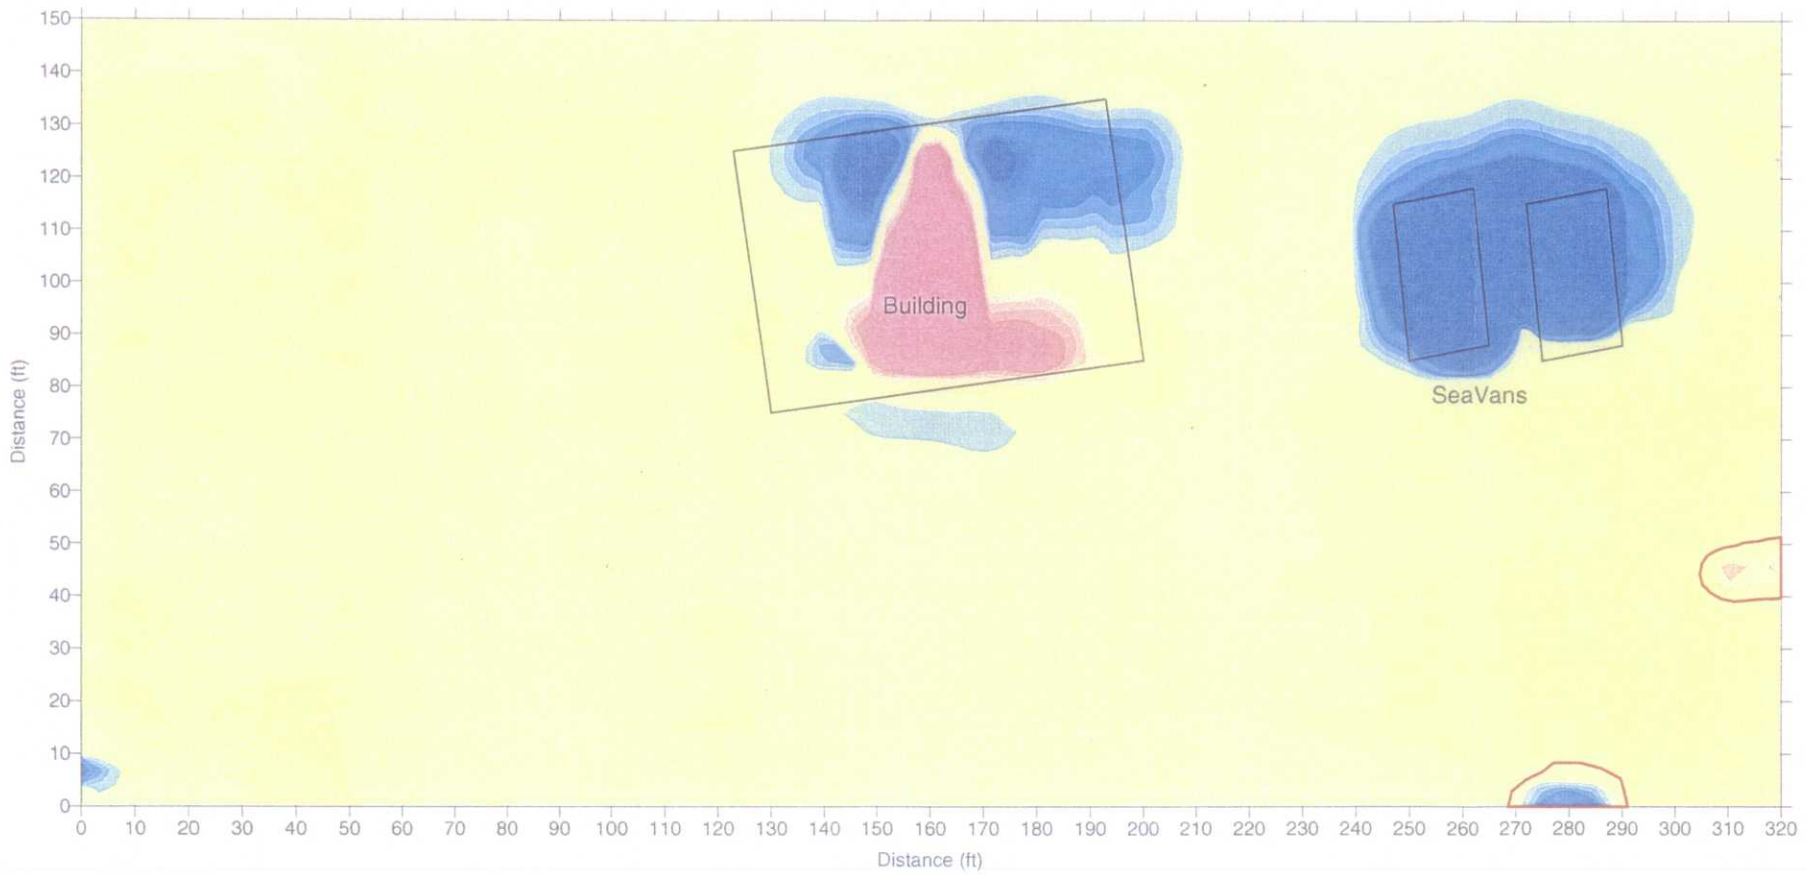
SITE L MAGNETOMETRY SURVEY Mag 858 GRADIENT		
GEOPHYSICAL ASSESSMENT GAMBELL, ST. LAWRENCE ISLAND, AK MONTGOMERY WATSON		
GOLDER ASSOCIATES, INC. REDMOND, WA		
August 15, 2000	003-5435 task 000	Fig. 27

The primary areas with high magnetic values are associated with the building and with the two sea vans to the east of the building. There are two weak anomalies, however, at Station 320E, 50N and Station 280E, 0N. These regions are outlined in red in Figures 27 and 29. Both of these locations had anomalous EM-61 values in differential mode and are interpreted to be small, buried metallic objects.

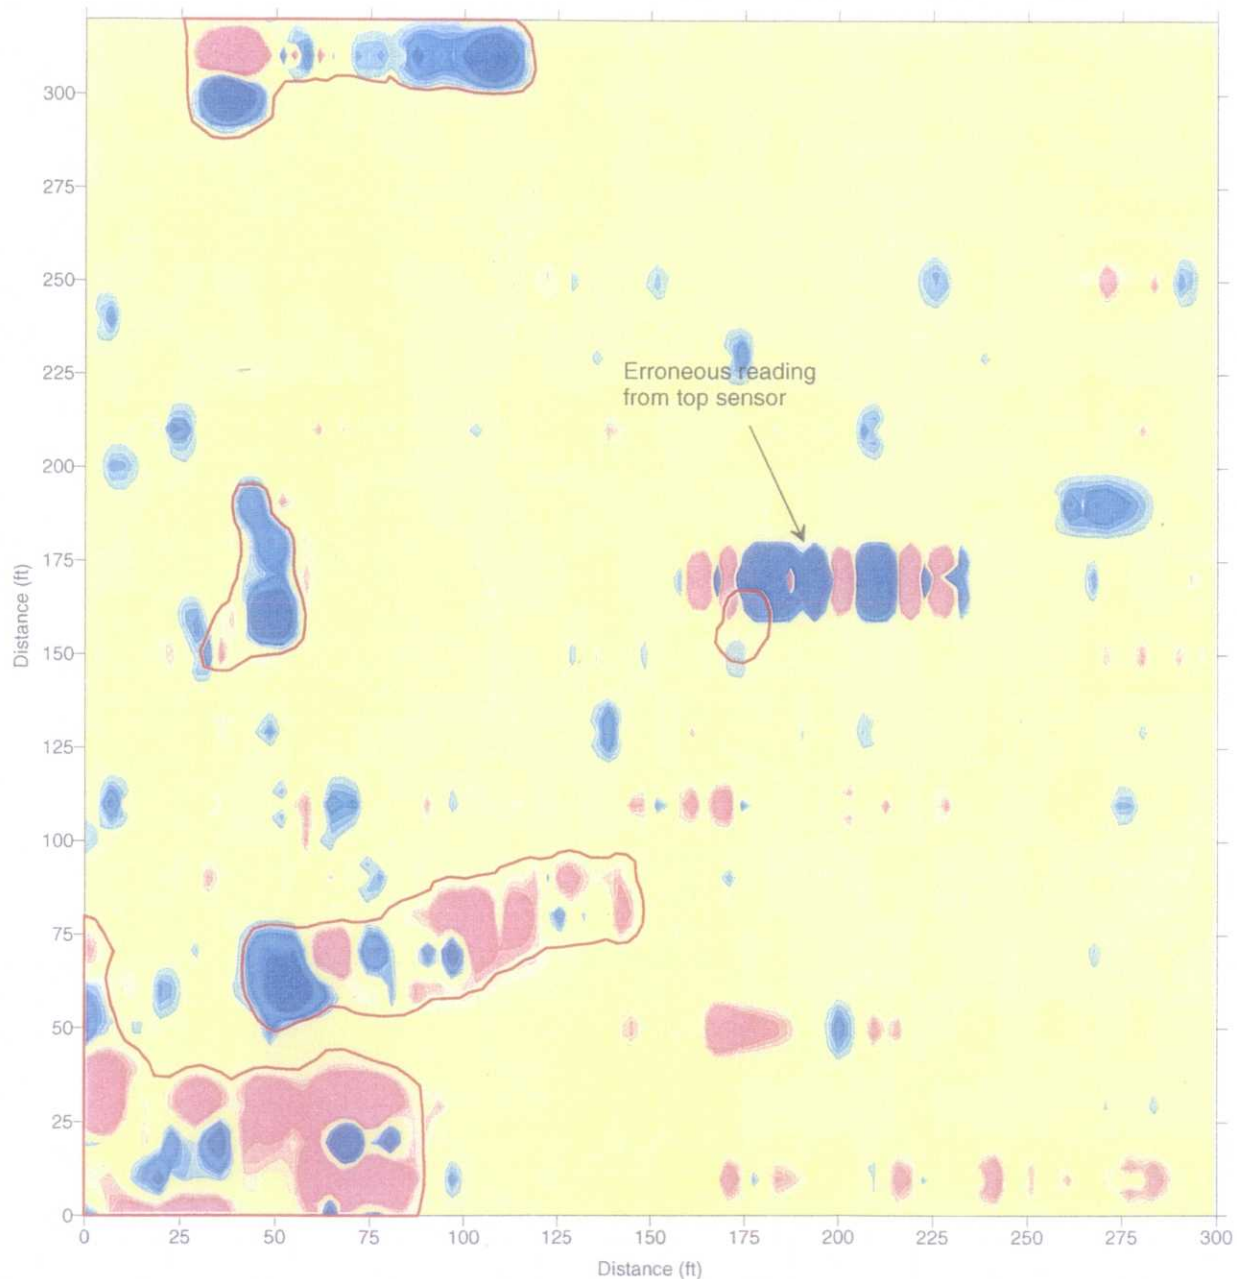
SITE M MAGNETOMETRY SURVEY Mag 858 GRADIENT		
GEOPHYSICAL ASSESSMENT GAMBELL, ST. LAWRENCE ISLAND, AK MONTGOMERY WATSON		
GOLDER ASSOCIATES, INC. REDMOND, WA		
August 15, 2000	003-5435 task 000	Fig. 31

The data from the top sensor contains some faulty readings along the Line 160N between Stations 160E and 240E. These readings are interpreted to be erroneous for the same reason as described above. Magnetic field anomalies were found primarily in the south-east corner of the site. In addition, there are anomalous readings at Station 30E, 160N and between Stations 20E and 90E along the Line 310N. The magnetic field anomalies are outlined in red in Figures 31 and 33.

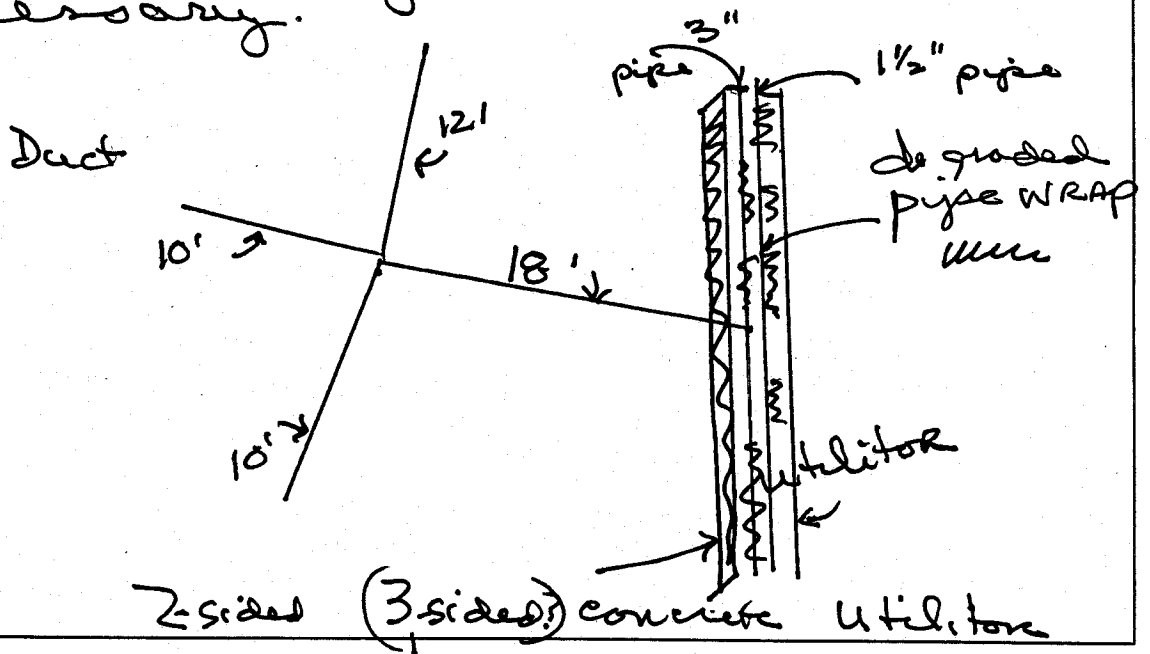
① Heating WRAP remaining in concrete Utilitons running within 34' basements; seems to be fiberglass wrapped with cloth material. No mag observed.

This should be removed as a whole component, using wet methods, should bag & dispose of off island.

Replacement of the duct will not be necessary.

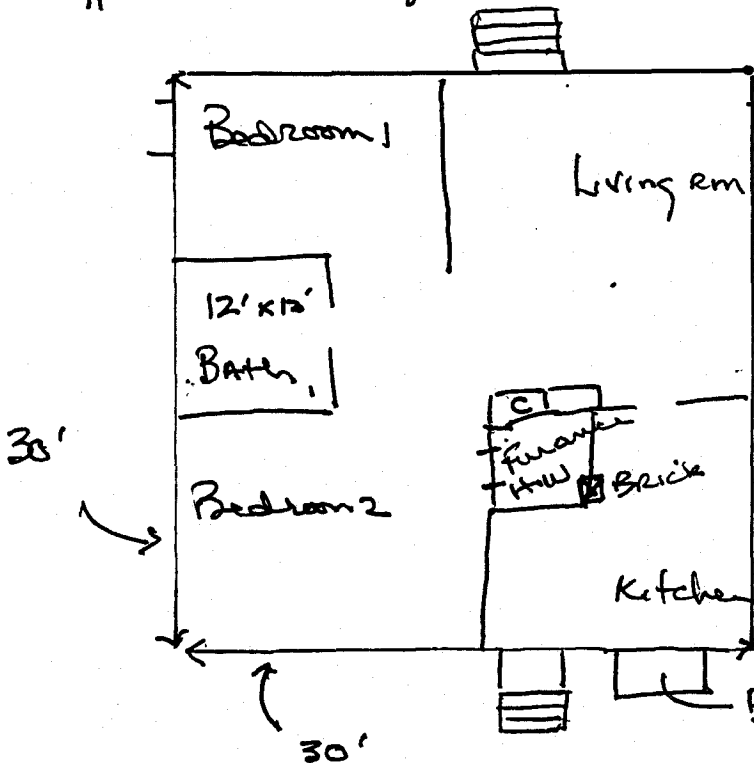
Former CAA Housing

Former  
util. door into basement

Exterior - Wood  
Roofing - wood  
Shingle  
Floor - hardwood  
Flooring Kitchen =  
rolled Lio  
walls & ceiling =  
insul/Tape sheetrock  
panel board

$\frac{3}{4}$   
Basement access  
open floor  
concrete foundation  
2nd floor - one room  
some have been  
finished

shed - heating plant  
on steel  
removed by VSW, '97.

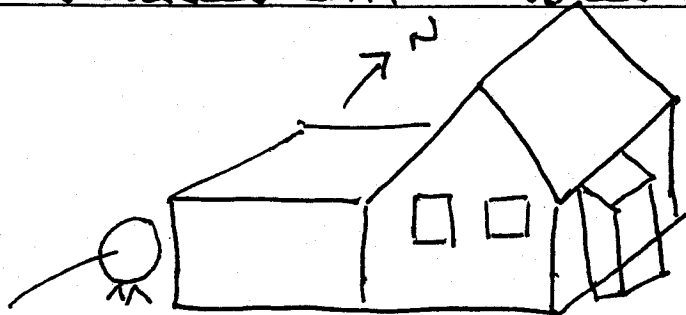
"Jones Hotel"

1000 gal TANK  
foam over fiberglass

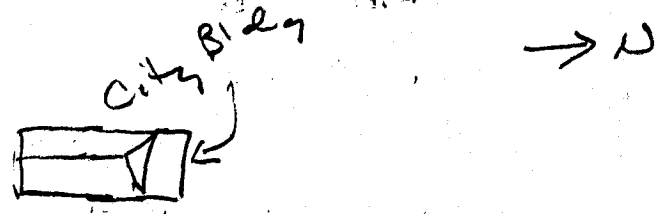
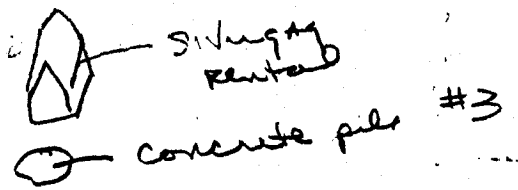
Gambell 6-27-00 TASK 2  
 Concrete Removal  
 3-areas around school.

- #1 SLAB 25' x 12' x 8"  
NOT REINFORCED
- #2 2 pc 4 x 3 x 1.5'  
3 x 2 x 1.5'
- #3 pile - reinforced  
1/2" rebar  
13' x 14' x 3'

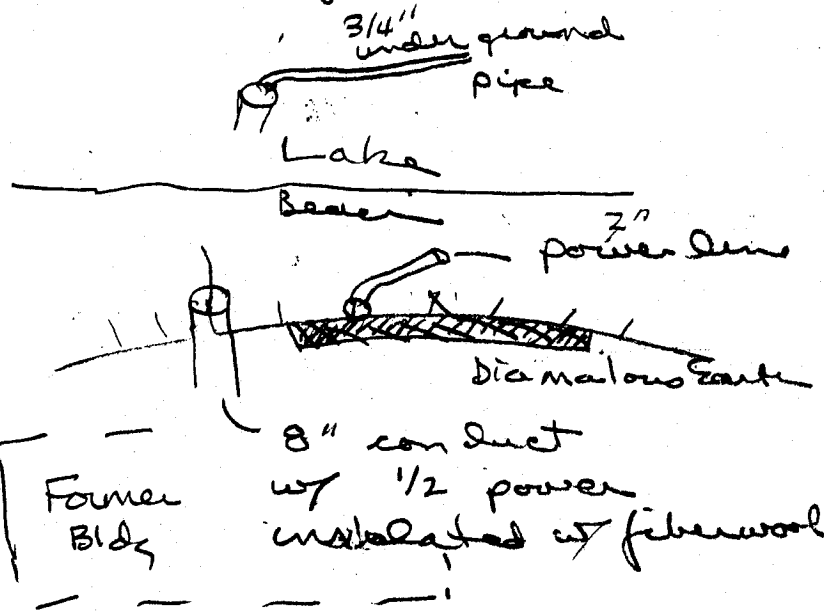
TASK 2 6-27-00 Gambell AK  
Military Water  
pump station

Revised Diamatous Earth in building  
Bags 30' x 3' x 4'

Dia Earth exposed on  
lake side berm cut  
away at beach.

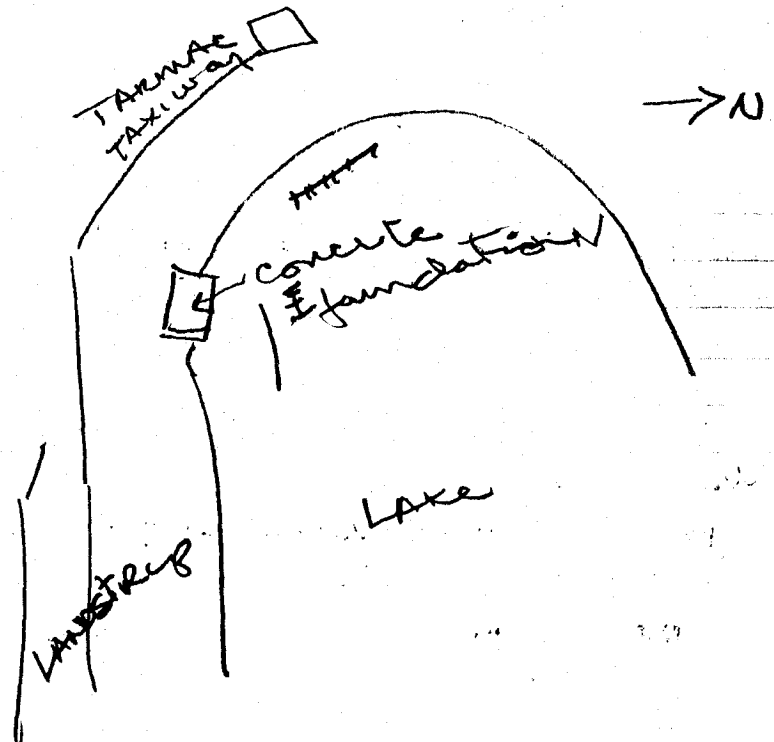
6-27-00 SP1P 15  
 Gamble Geophysical TASK 2  
 Troutman Lake - in water  
 N. End  
 marster matting  
 & piping seen

Est. quantity -  
 pull up w/ hooks & boots

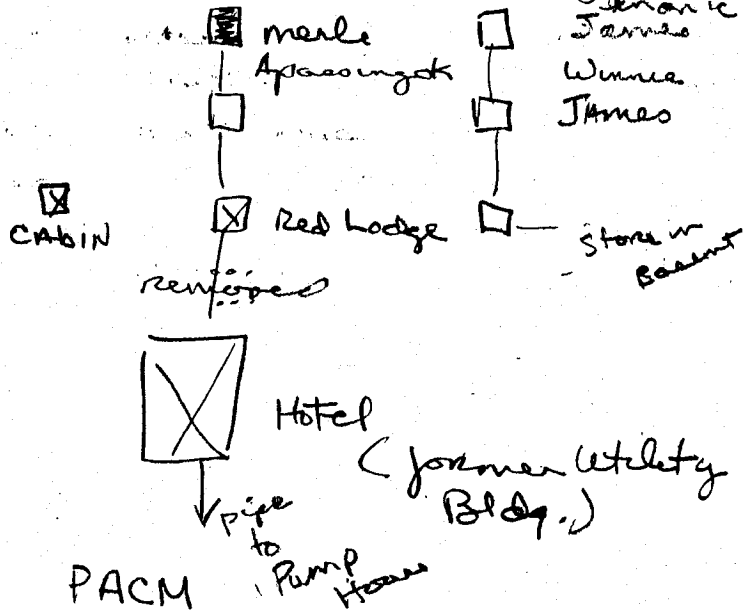
VSW MOVED  
former heating plant

Heating duct has thin insulate applied to venting  
Each Bldg (homes)  
8" x 4" four runs from common area
