## Northeast Cape HTRW Remedial Actions

Northeast Cape, St. Lawrence Island, Alaska

## Remedial Action Report

May 2013

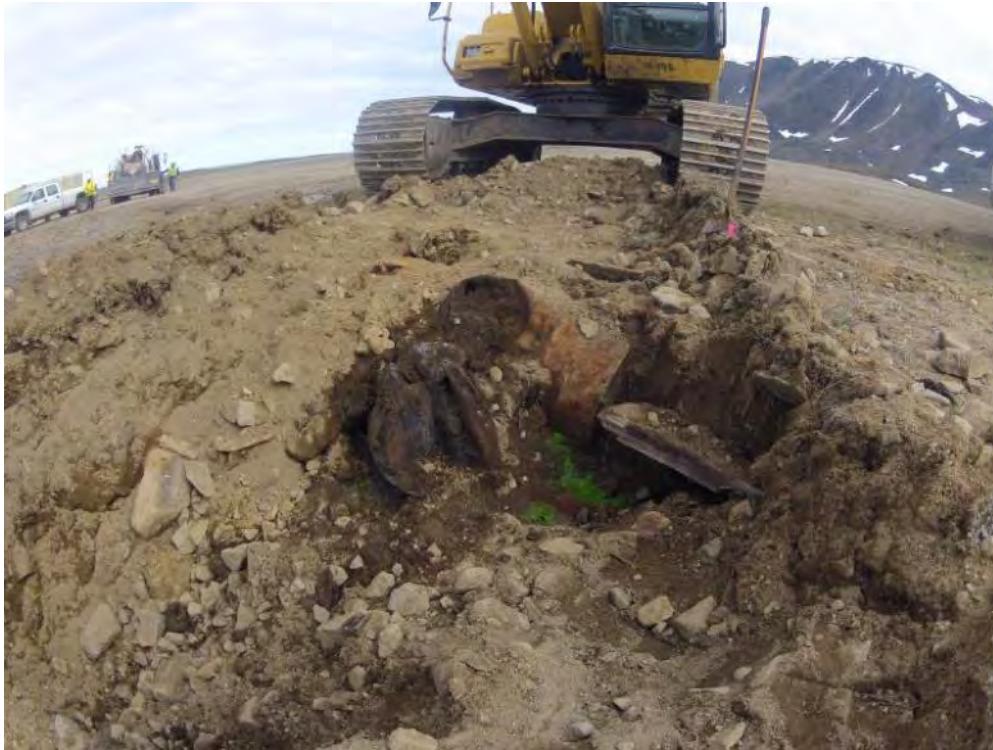
Photograph 9 Antifreeze leaking from exposed drums at Site 10.  
July 12, 2012

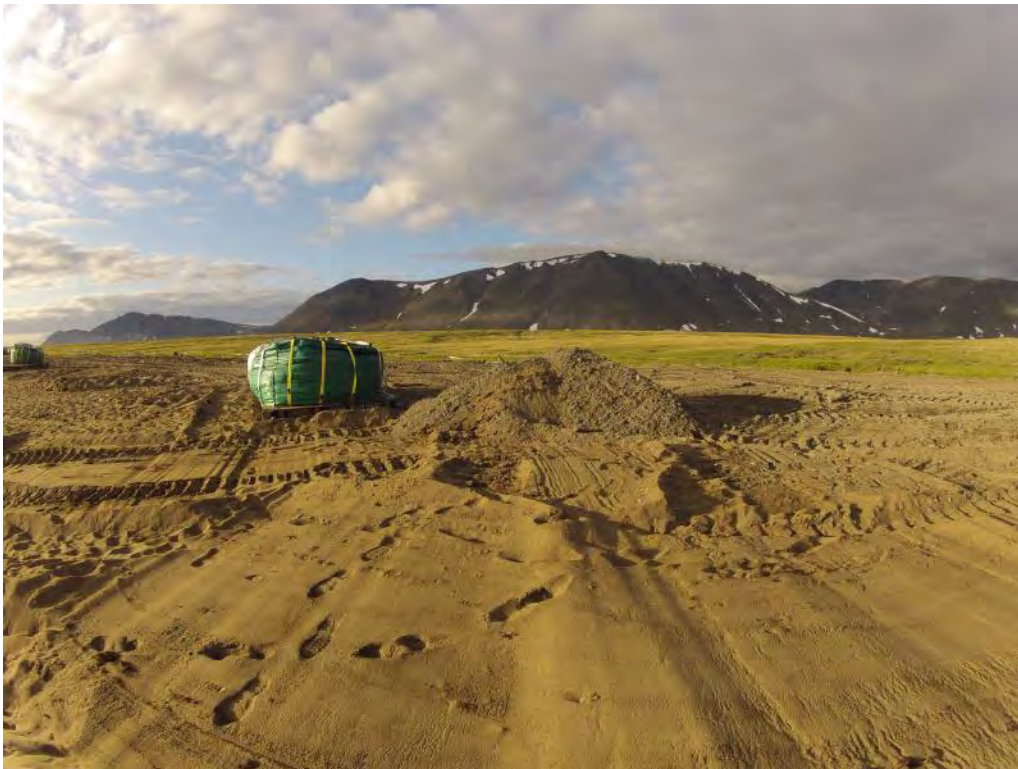
Photograph 10 The hydraulic spill area at Cargo Beach.  
The sand in the center contains the spilled oil.  
July 13, 2012

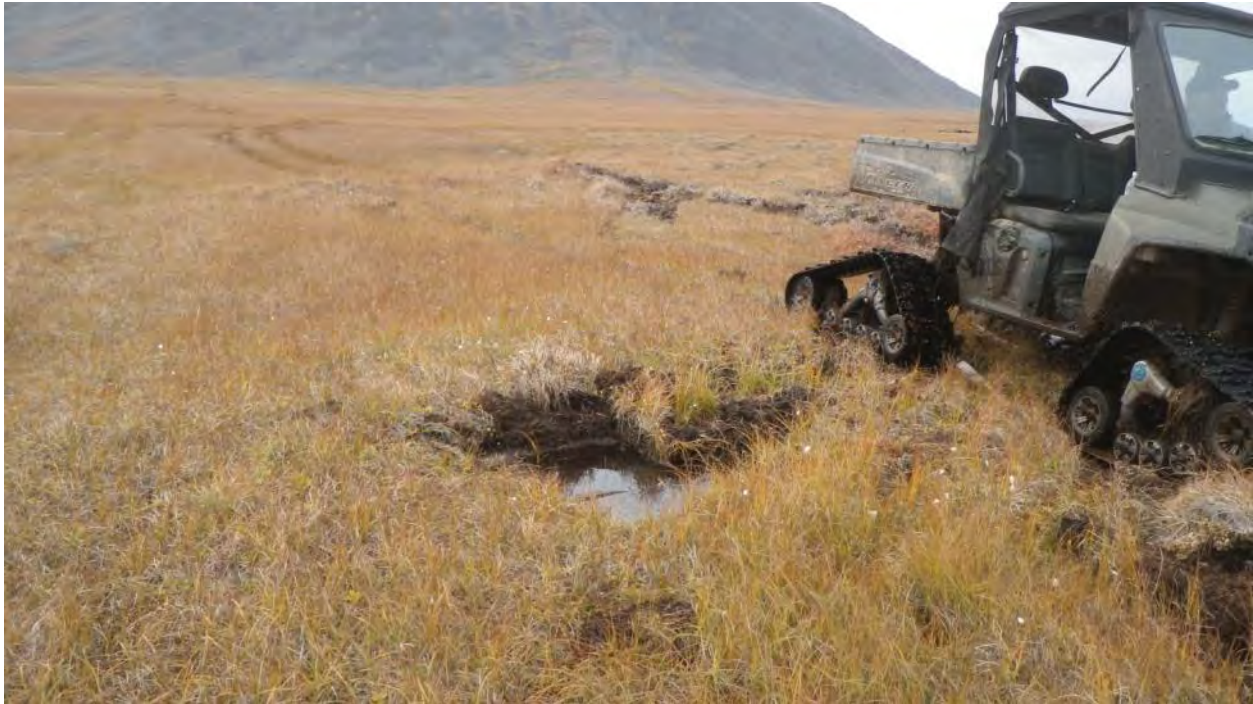
Photograph 79 A pole removal location.  
September 21, 2012

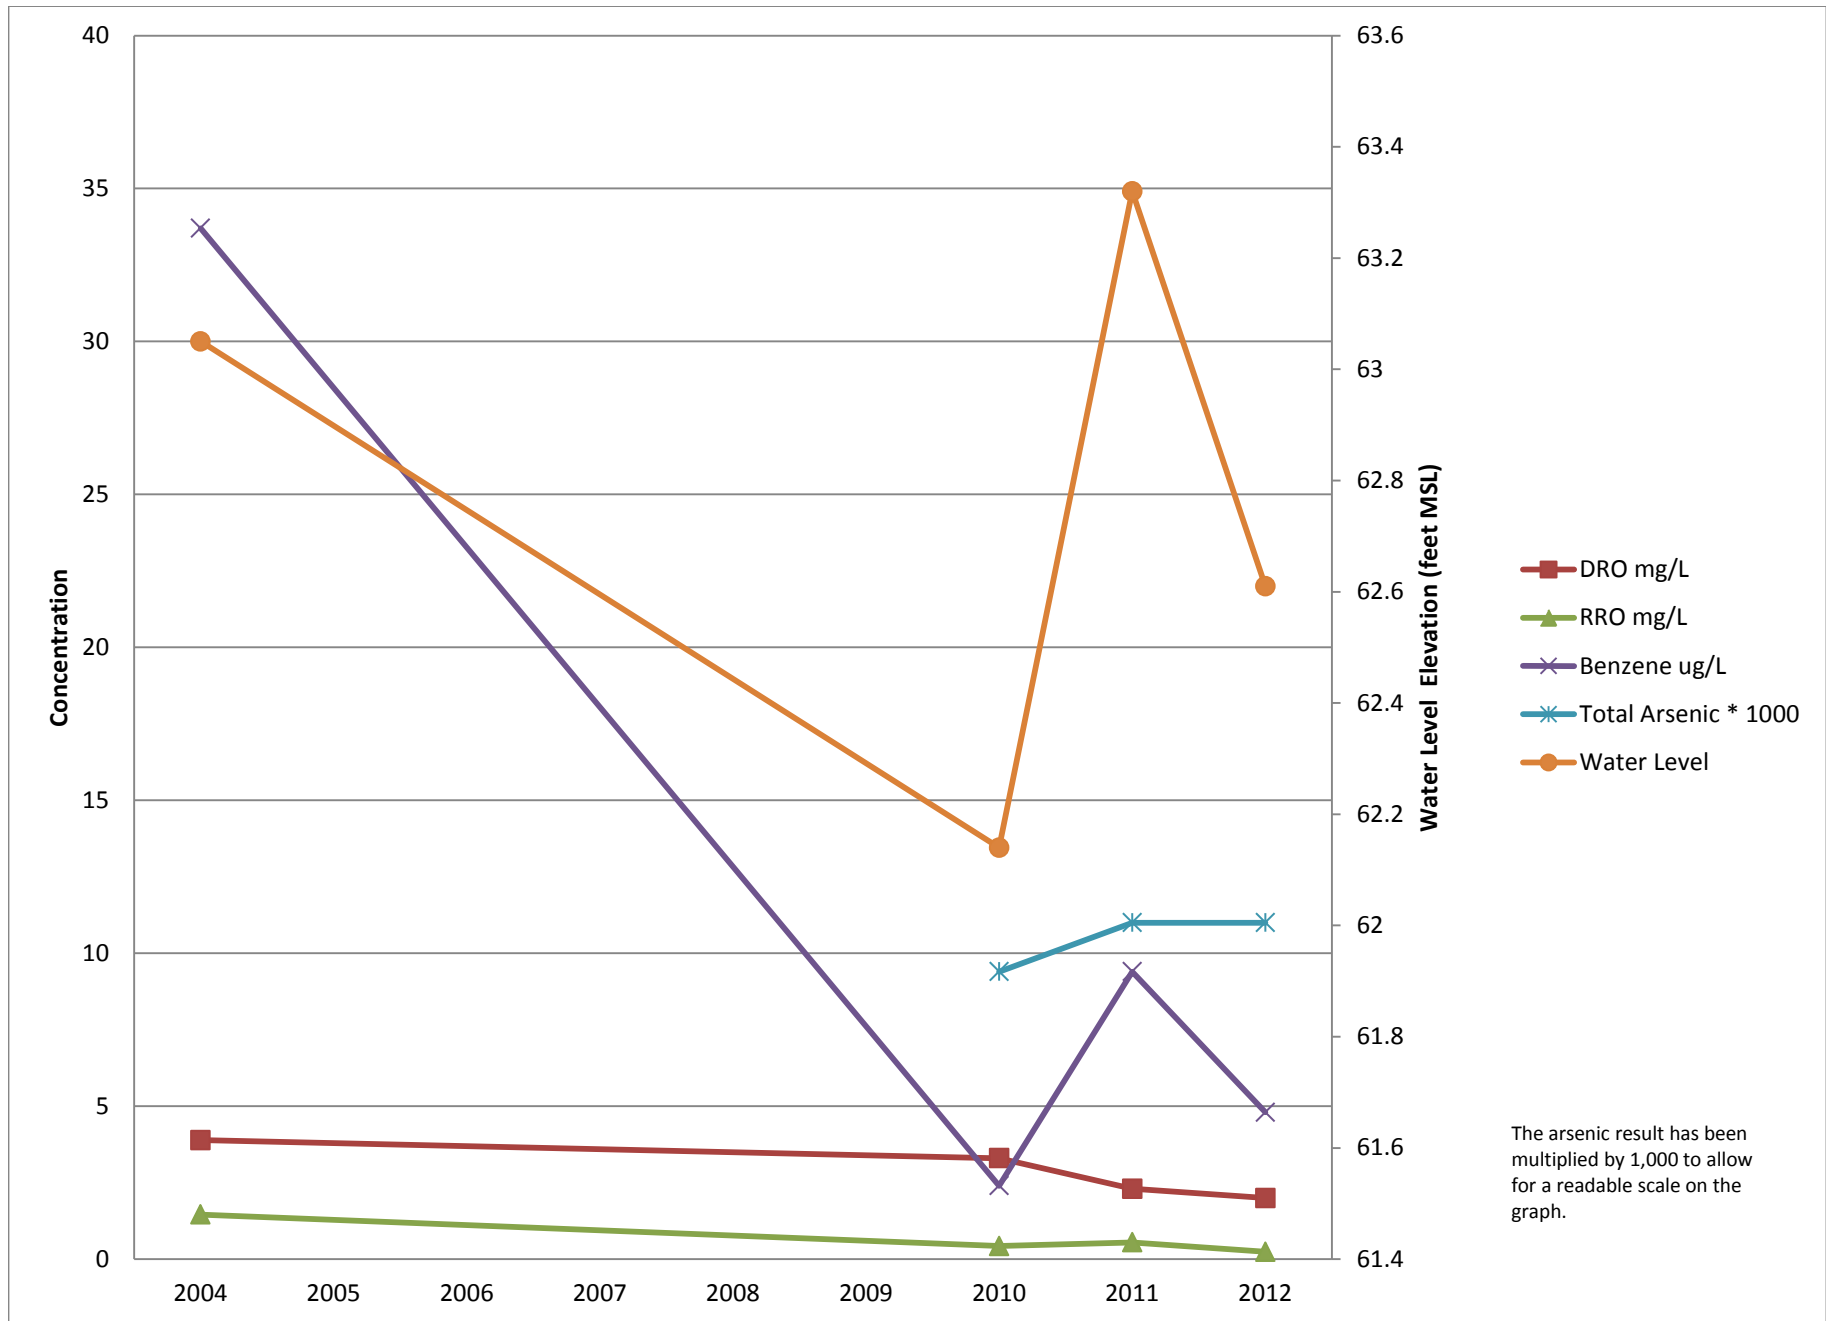
Graph 3 Analyte Concentrations in MOC Well 88-4

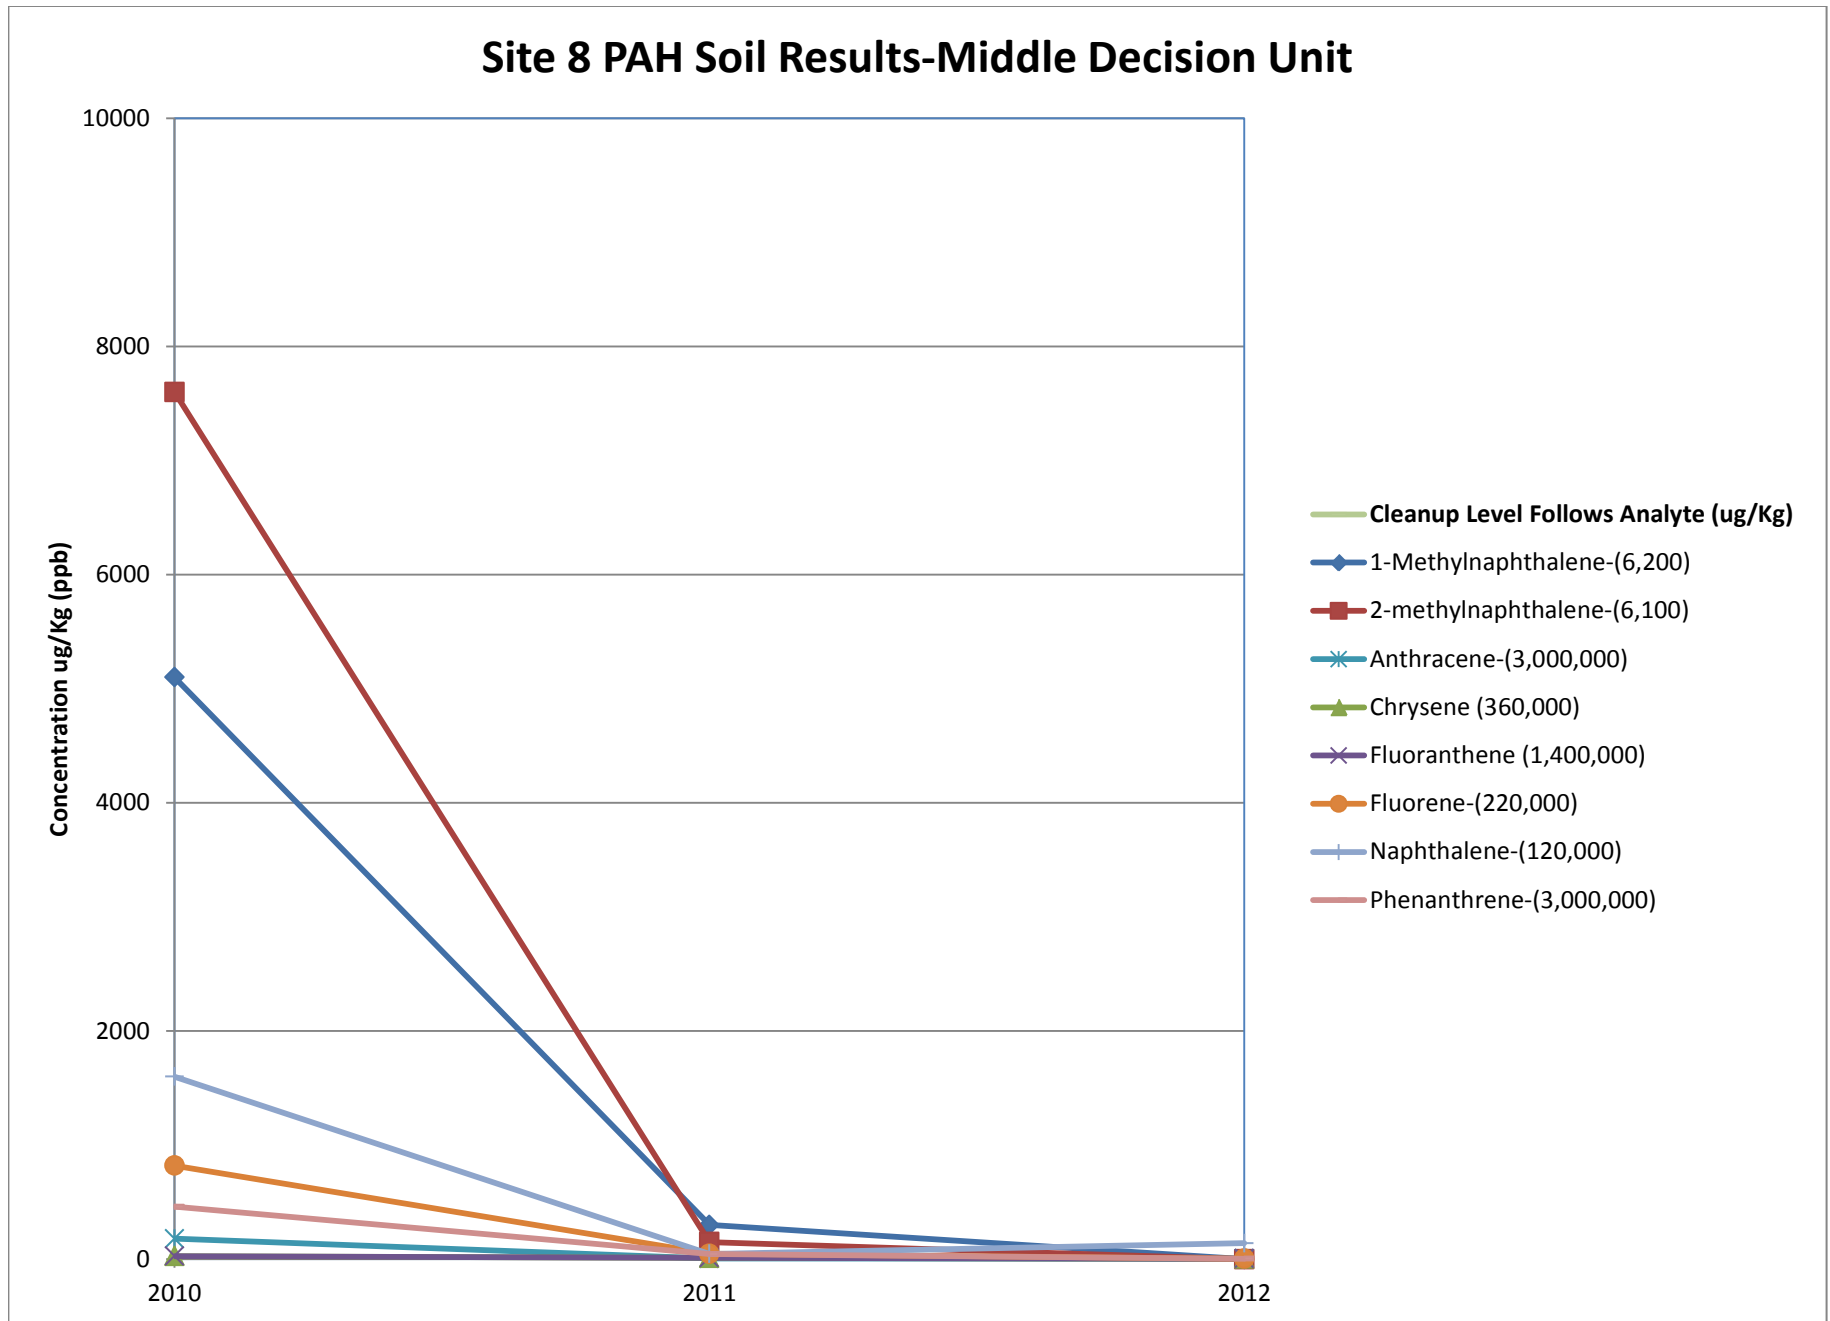
Graph 6 Site 8 PAH Soil Results-Middle Decision Unit

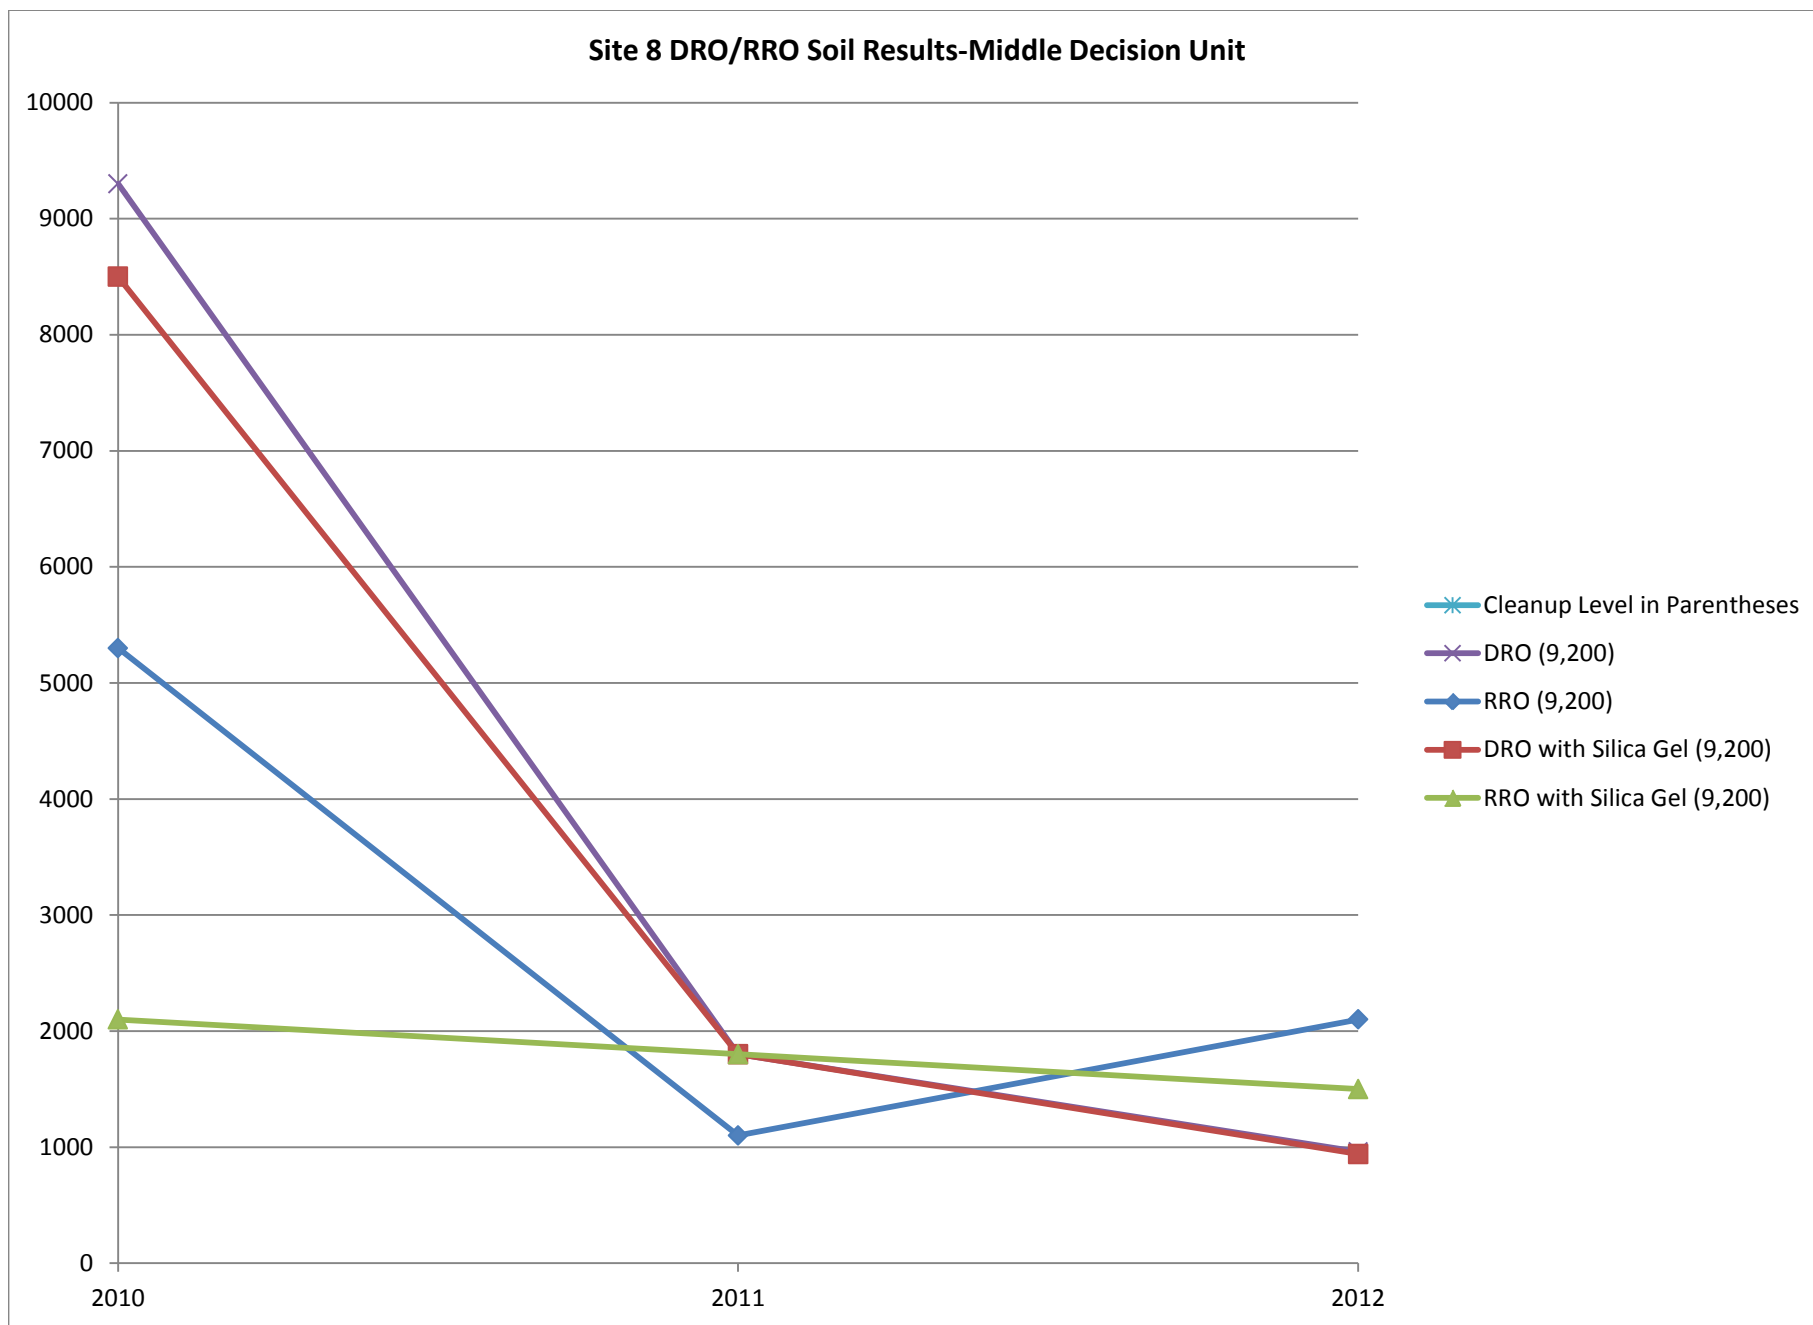
Graph 7 Site 8 DRO/RRO Soil Results-Middle Decision Unit

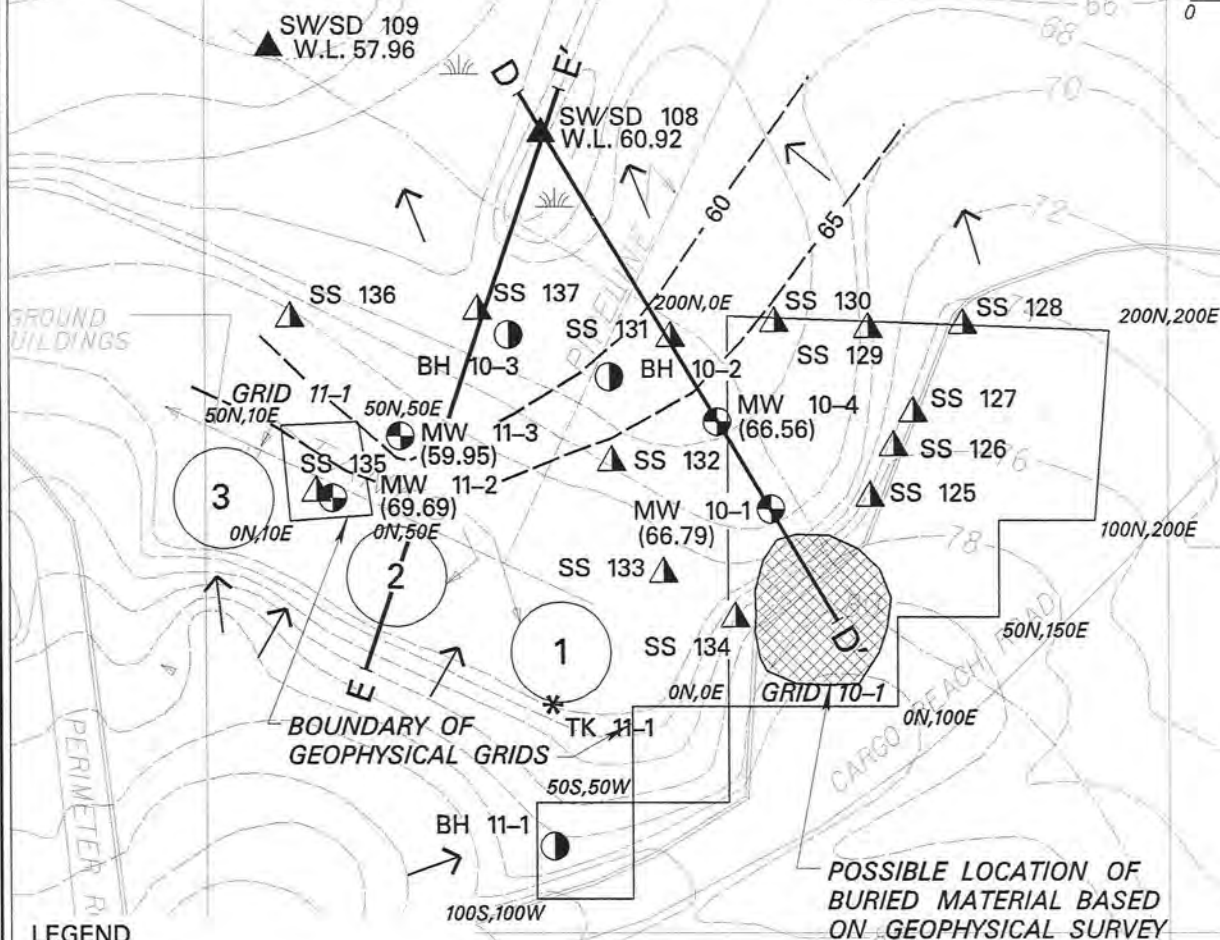
Geophysical surveys were performed on Sites 10 and 11 to delineate the extent of a reported buried drum field and to identify any underground piping associated with the tank area so as to avoid it while drilling. The geophysical grid boundaries are shown in Figure 4-7-1. A very important finding of the geophysical survey at Site 10 is the apparent absence of 29,500 buried drums as reported by E&E (1993). The relatively few magnetic and conductive anomalies noted are attributed to surface debris or the adjacent large diesel storage tanks, although a smaller area of buried debris was noted east of Tank No. 1. No underground piping was noted at Site 11.
