U.S. Army Corps of Engineers Alaska District

LONG-TERM MANAGEMENT PLAN NORTHEAST CAPE FUDS

ST. LAWRENCE ISLAND, ALASKA

**FINAL
SEPTEMBER 2016**

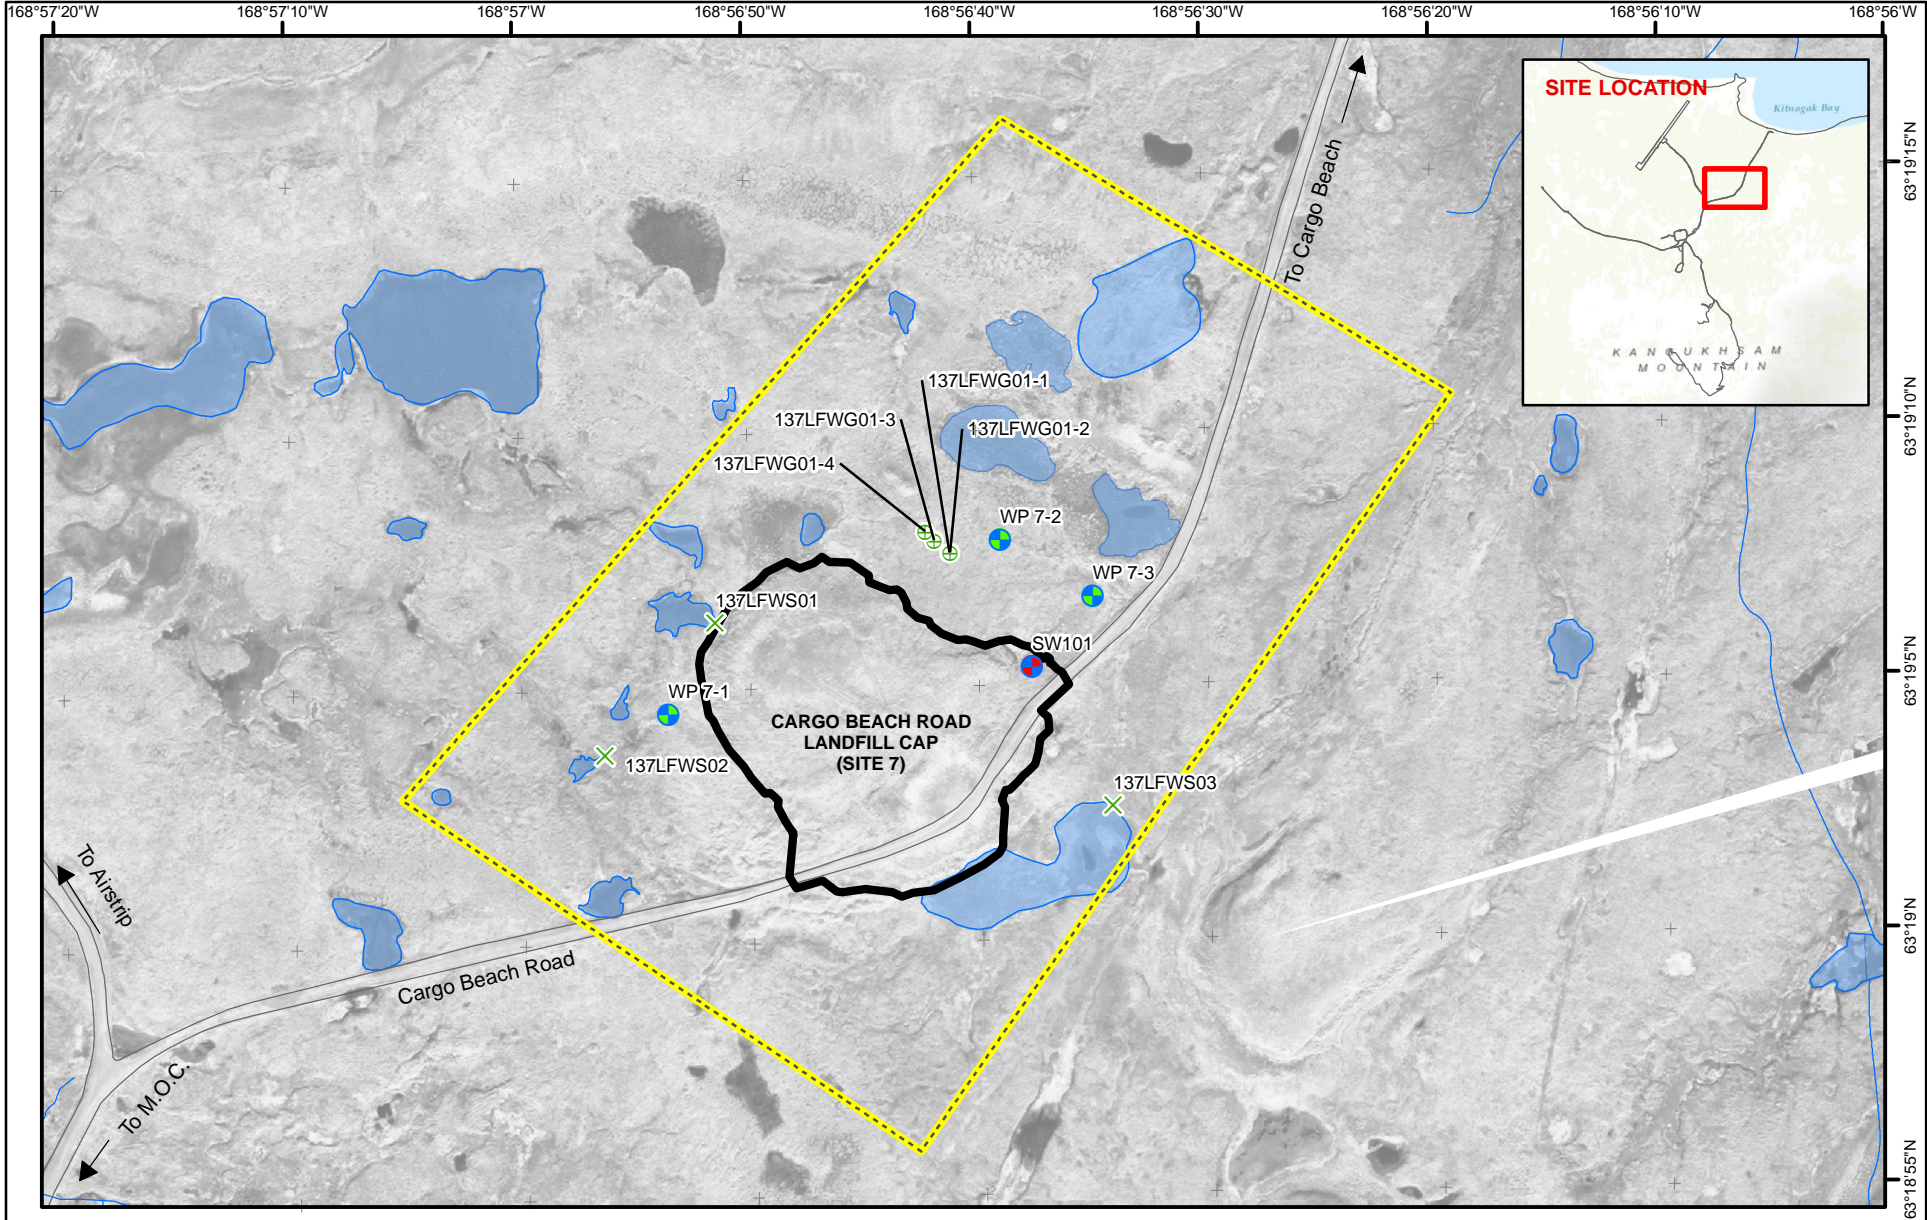
JACOBS	DATE:	06 JAN 2016	PROJECT MANAGER:	K. MAHER	FIGURE NO.:	A-3

- ⊕ 2013 Attempted Groundwater Sample
- ⊕ 2001 Historic Monitoring Well (Approx. Location)
- ✕ 2013 Surface Water Sample
- Non-Drinking Water Area
- ⊕ 1994 Historic Monitoring Well (Approx. Location)
- Landfill Cap Boundary
- 💧 Surface Water

The selected remedy for Site 7 was initiated in 2009. Metallic anomalies identified by geophysical investigation in 2007 were located by survey and re-investigated. The top 1 foot of soil was uncovered to locate drums within the shallow subsurface. Excavation efforts encountered and disposed of approximately 201 pounds of PCB-containing light ballasts, 350 pounds of lead batteries, 4,100 pounds of lead debris, and approximately 10 gallons of antifreeze. Approximately 2,150 gallons of contents recovered from drums and 100 tons of petroleum-stained soil were containerized and shipped offsite for disposal. A landfill gravel cap was constructed to a depth of 2 feet using material from an on-island borrow source south of Site 31. The cap was graded to promote surface runoff and prevent erosion. Locations

The initial three years of annual visual monitoring were completed in 2011 through 2013. In 2014, maintenance was conducted to remove debris protruding from the surface of the cap and to fill select areas that exhibited minor surface subsidence (USACE 2015a). The fifth periodic visual monitoring event was performed in 2015. The First Periodic Review Report for Site 7 recommended an additional periodic review of Site 7 with a milestone date of 2019 (USACE 2015c). The upcoming periodic review scoping process will identify the path forward for any necessary sampling to evaluate remedy performance.

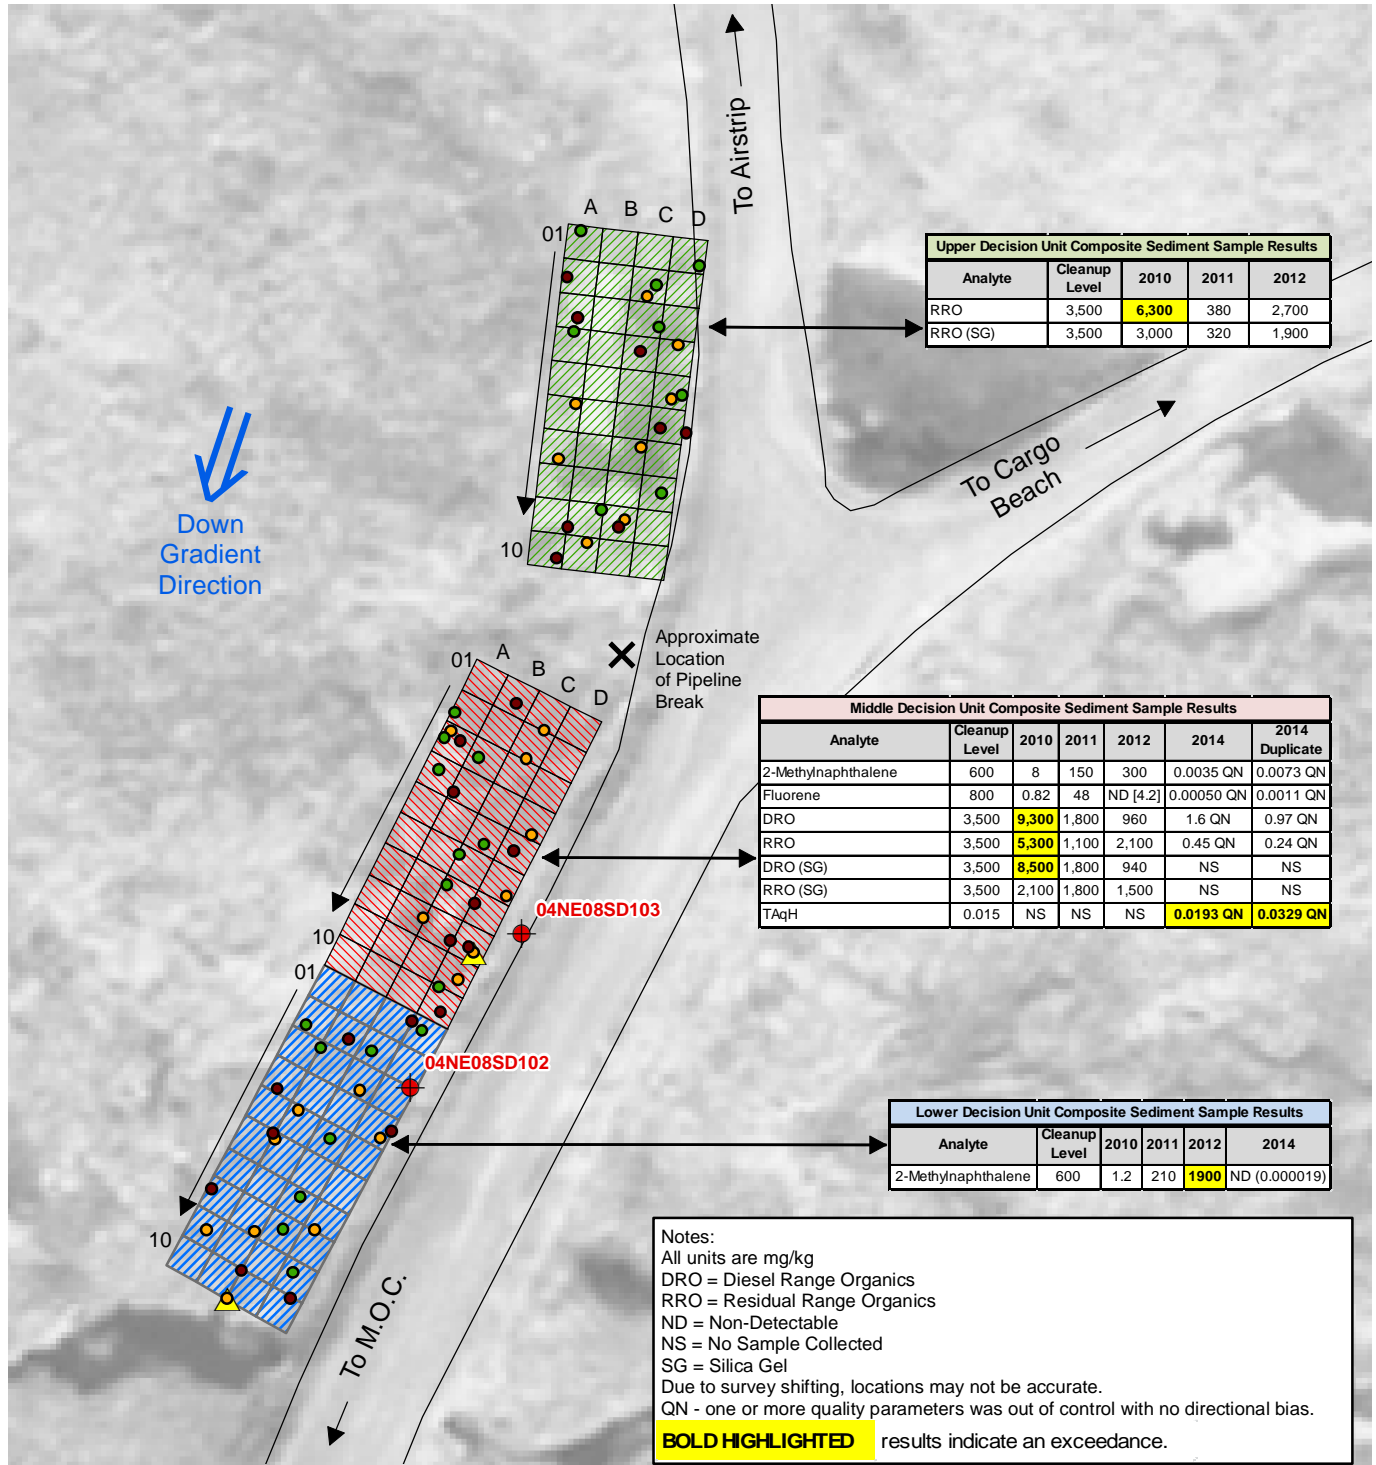
JACOBS	DATE:	PROJECT MANAGER:	FIGURE NO:
	26 MAY 2016	K. MAHER	A-4

- Historical Sediment Sample Exceedance
- 2010 Sediment & Surface Water Sample Location
- 2012 Sediment & Surface Water Sample Location
- 2011 Sediment & Surface Water Sample Location
- 2012 & 2014 Surface Water Sample Location
- Road
- Upper Decision Unit
- Middle Decision Unit
- Lower Decision Unit

**NORTHEAST CAPE
 SITE 8, PETROLEUM, OIL AND LUBRICANT SPILL
 SAINT LAWRENCE ISLAND, ALASKA**

The remedy selected—monitored natural attenuation (MNA) of petroleum-contaminated sediment for a period of three years—was initiated in 2010 (USACE 2011). Three decision units were created based on field observations and the approximate location of the pipeline break. In 2010, 2011, and 2012, composited primary sediment samples were collected from each decision unit, and a composite duplicate sediment sample was collected from one decision unit to establish site trends and possibly degradation rates. During each monitoring event, primary and duplicate sediment samples were composited from eight different locations within each decision unit. MNA sampling conducted in 2011 and 2012 indicated the maximum concentrations of DRO and 2-methylnaphthalene in sediment as 8,500 mg/kg and 7.6 mg/kg, respectively. Figure A-4 presents the locations of composited samples for each decision unit by year.

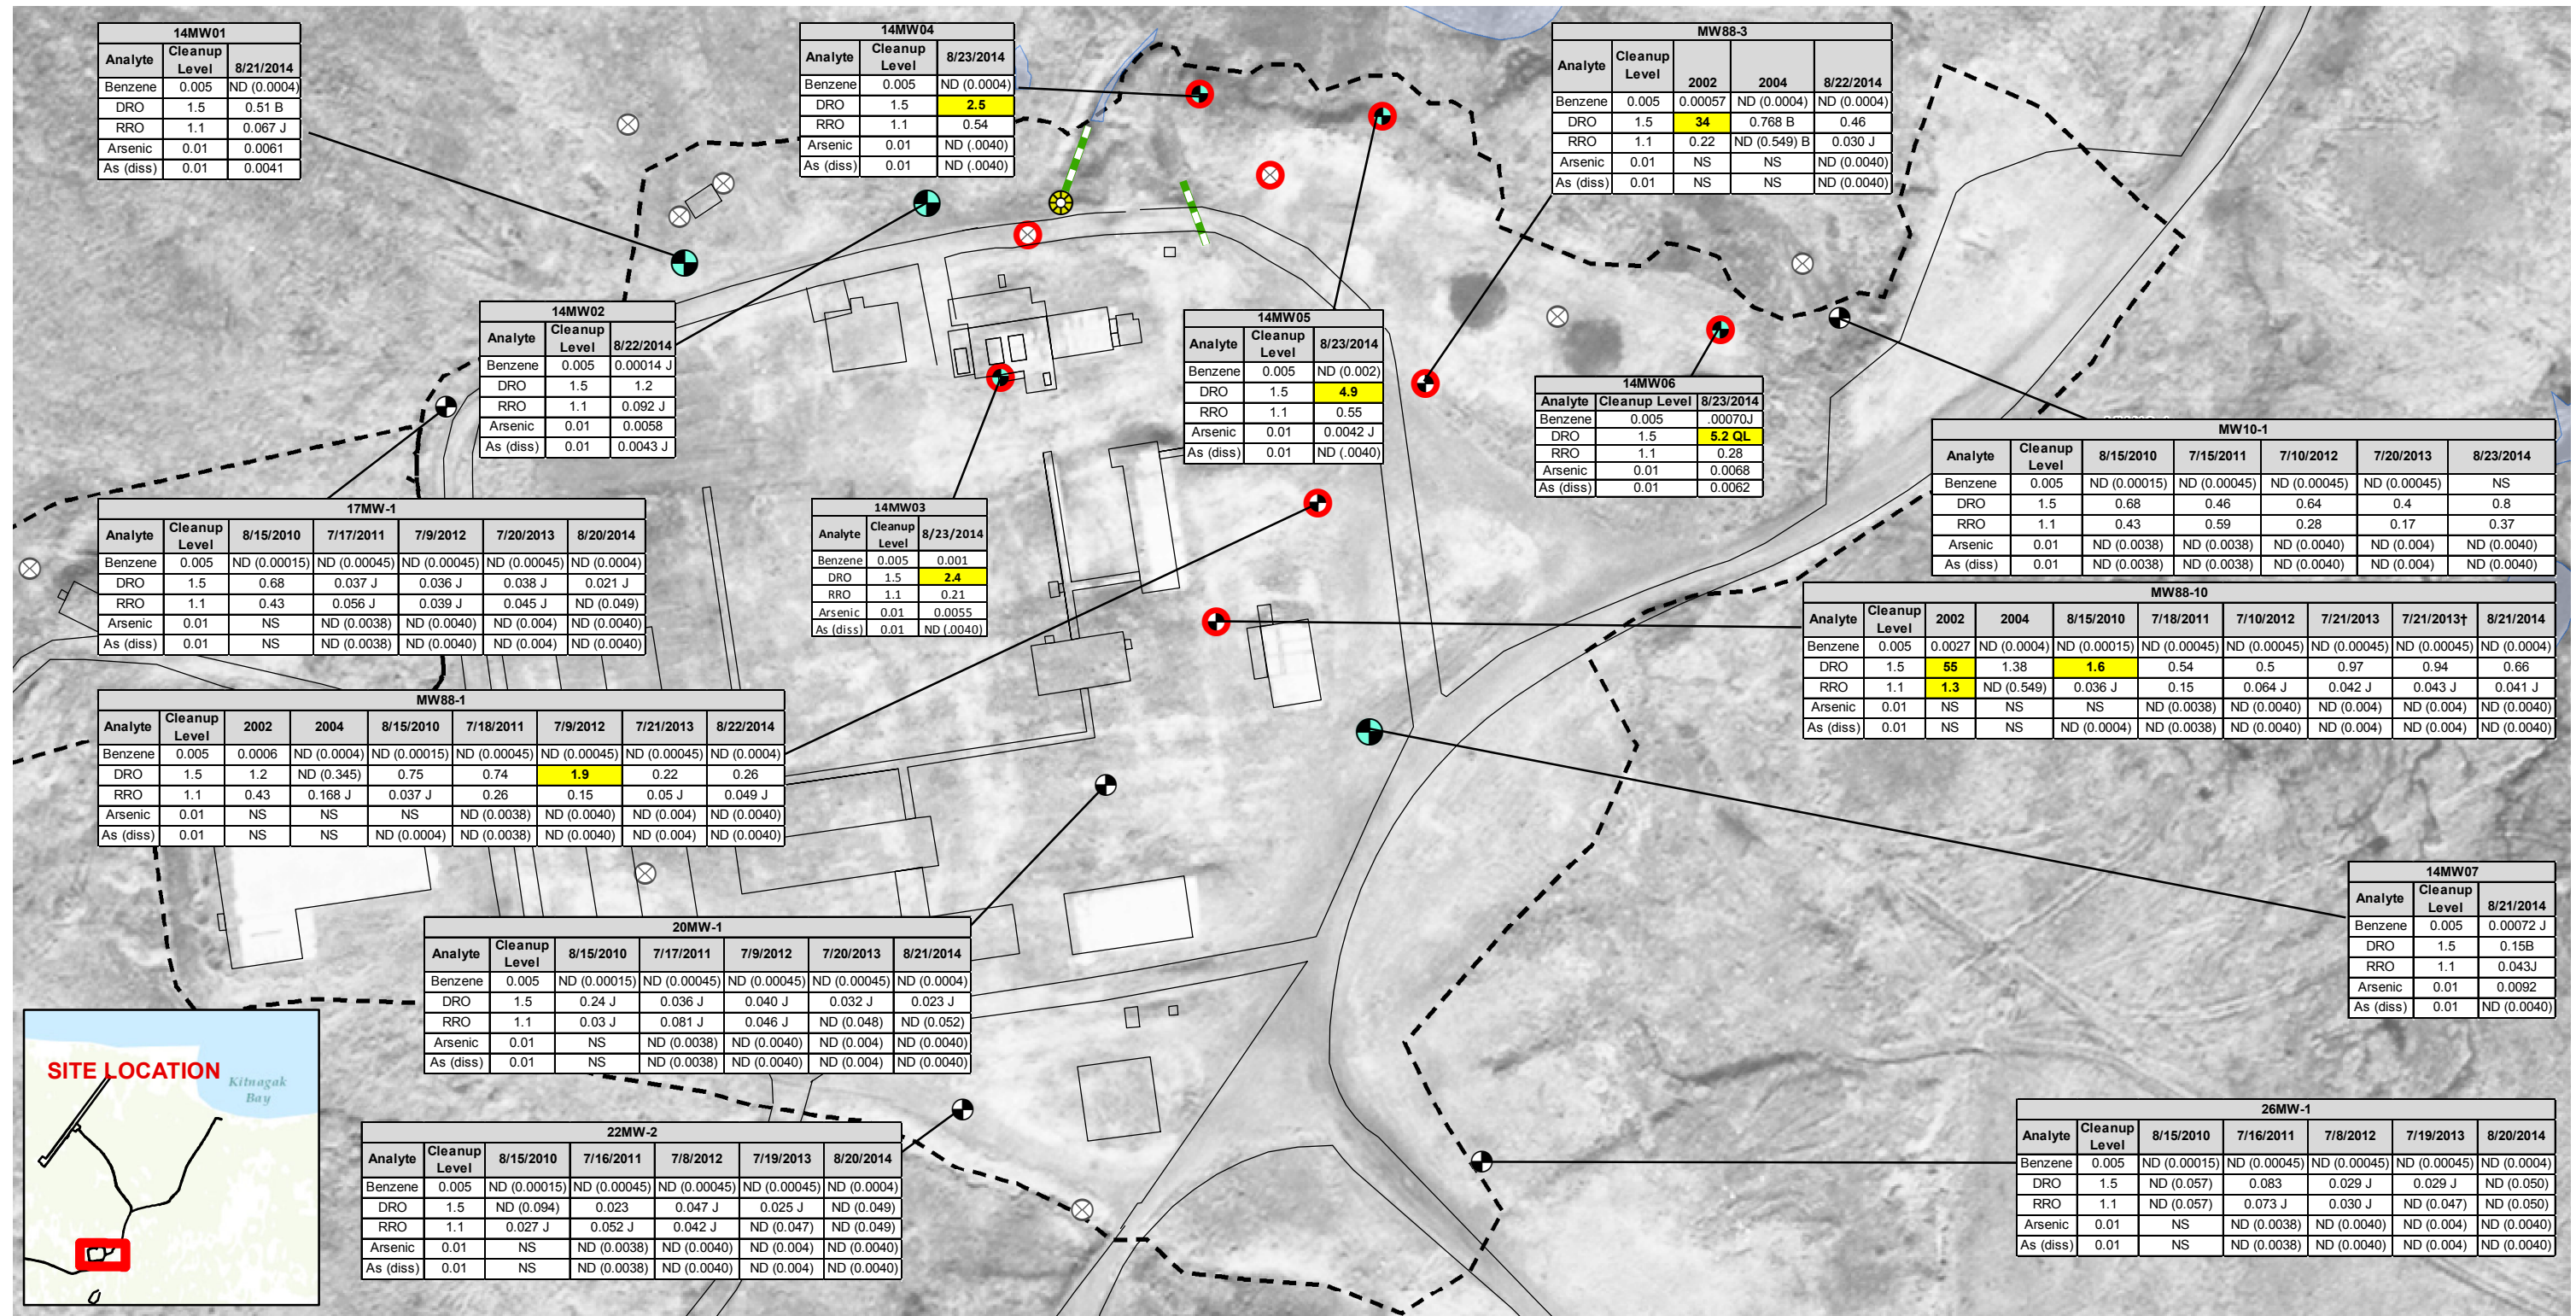
NORTHEAST CAPE MOC MONITORING WELL LOCATIONS AND SELECT SAMPLE RESULTS NORTHEAST CAPE, SAINT LAWRENCE ISLAND, ALASKA			
JACOBS	DATE: 20 JUN 2016	PROJECT MANAGER: K. MAHER	FIGURE NO: A-7

- Wells with Historical or Current Contaminant Concentrations Exceeding Site-Specific Cleanup Levels
- Monitoring Well Installed in 2014
- Monitoring Well Installed Prior to 2014
- ⊗ Abandoned Well
- Former Manhole
- Former Culvert
- Water Feature
- Site Boundaries Surveyed in 2014

NAD 1983 StatePlane Alaska 9 FIPS 5009 Feet
All Locations Are Approximate
Due to survey shifting, well locations may not be accurate.
