United States Army
Corps of Engineers

Project Closeout Report

Hazardous, Toxic, and Radioactive Waste (HTRW)
Project # F10AK069603
Gambell FUDS
St. Lawrence Island, Alaska

September 2008

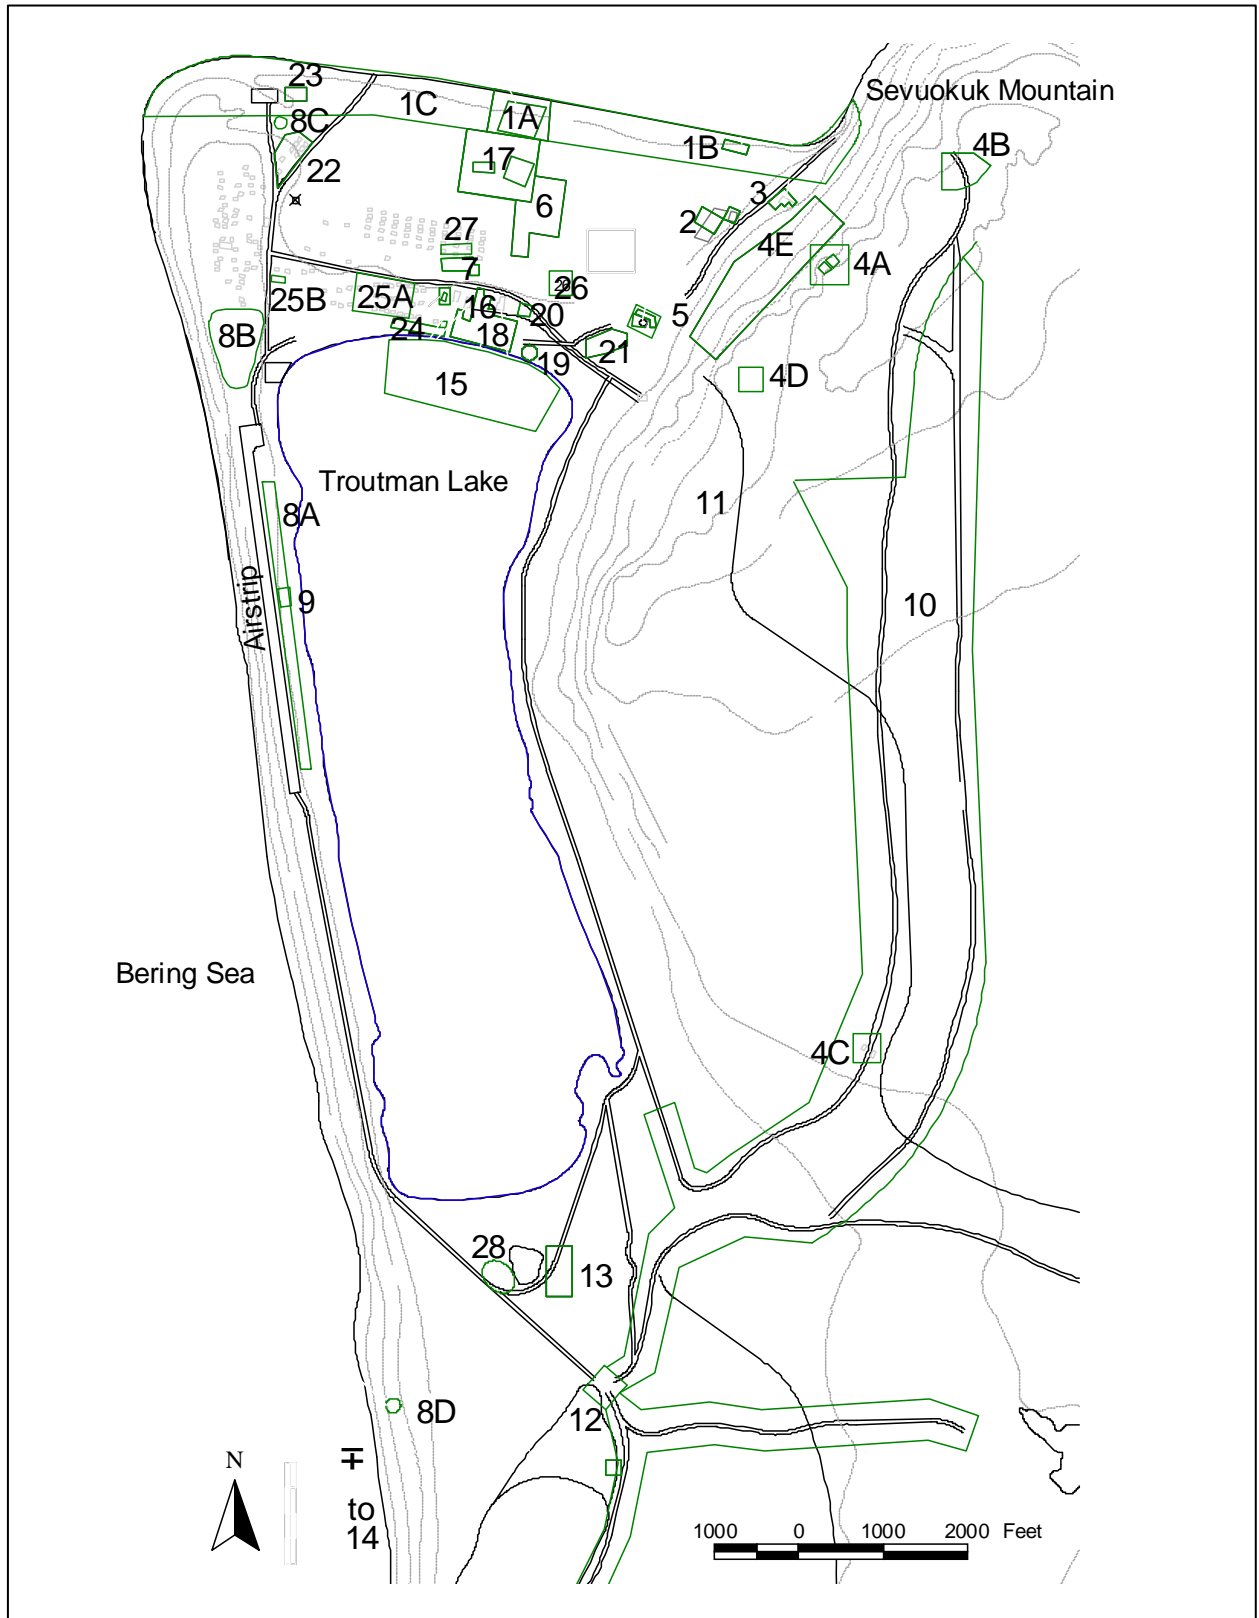
Figure 2. Gambell Sites Overview

This project closure report covers impacts identified as HTRW. A total of 38 sites were identified in Gambell. A remedial response was selected for 37 of these sites under a Decision Document dated June 2005. A decision on Site 5 was postponed until after additional monitoring was conducted in 2005 and 2006. Site 5 was addressed in a Decision Document dated September 2007. No further action was the selected response for 35 of these sites (Table 1). Sites 7 and 12 required excavation of contaminated soil. Site 8A required debris removal. The sites discussed in this document are listed in Table 1 and depicted on Figure 2.

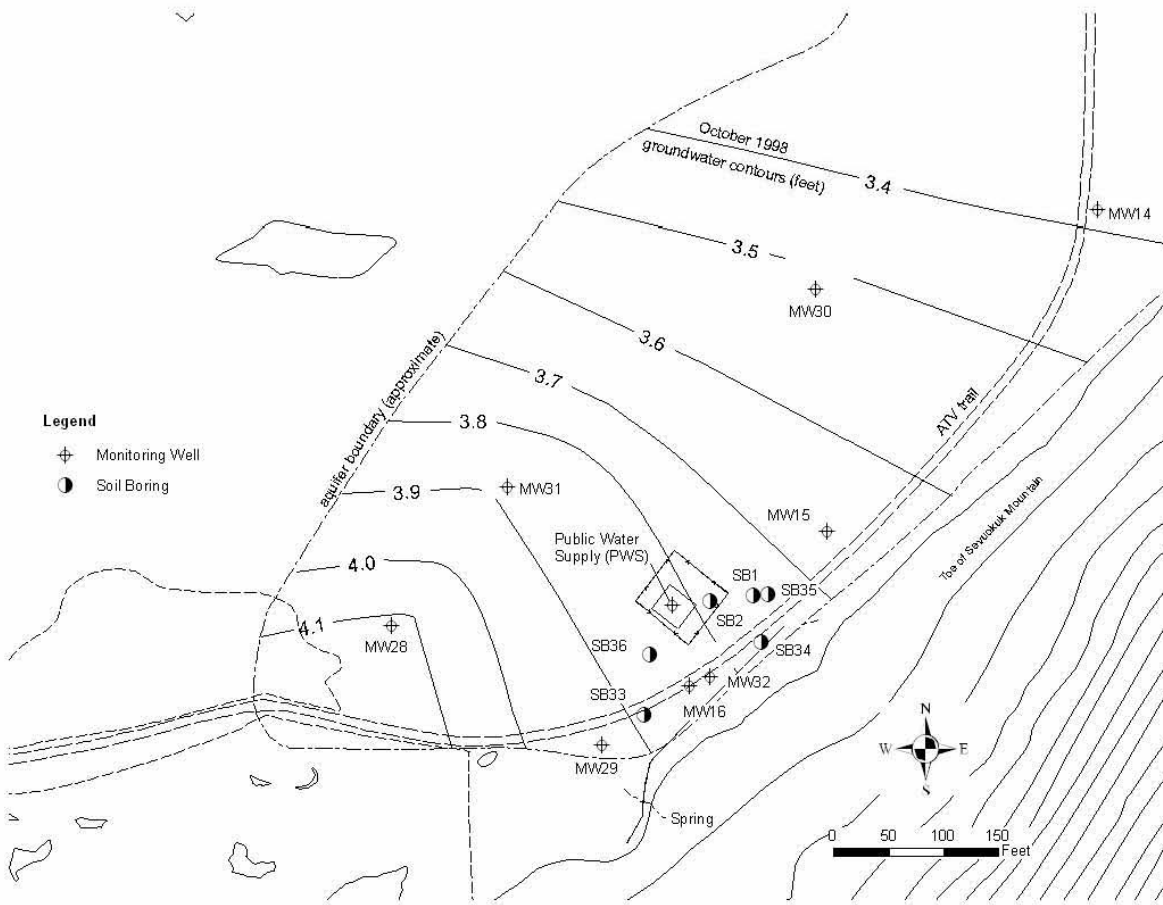
Figure 3. Site 5 Monitoring Well locations

The 7 monitoring wells (MW 14, 15, 28, 29, 30, 31, 32) surrounding Site 5 (see Figure 3) were pulled and decommissioned in October 2007, by personnel with Alaska Village Safe Water Program.

Site 5 is located at the base of Sevuokuk Mountain, northeast of Troutman Lake. Site 5 is the former tramway corridor that provided access to the radar site on top of the mountain. The site also incorporates the current village water supply well at the base of the mountain and an associated groundwater monitoring well array.

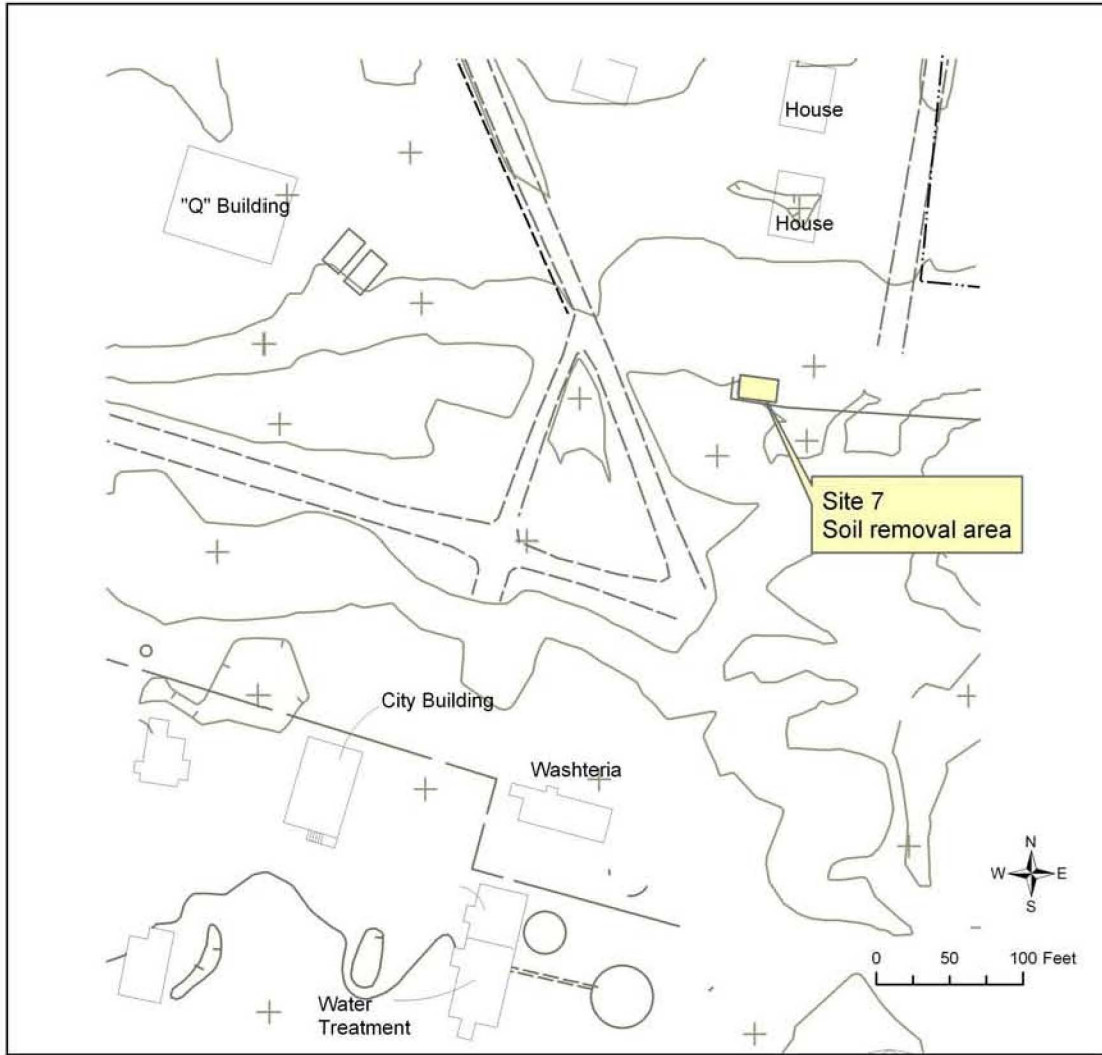
Figure 4. Site 7 Soil Removal Area

A Feasibility Study was completed by USACE in 2004 which evaluated a range of remedial alternatives. A Decision Document (USACE, 2005) selected the final remedy as excavation and off-site disposal of arsenic-contaminated soils at Site 7. During the summer of 2006, Bristol Construction Services (BCS) excavated an area approximately 10 by 20 feet and removed 6.93

tons of arsenic-contaminated soils from Site 7 (see Figure 4). The soil was transported to a permitted disposal facility in Arlington, Oregon. Soil confirmation samples were collected from the base of the excavation and all the results were below the site-specific cleanup level. Additional details regarding the removal action are presented in the Soil and Debris Removal Action Report (BCS 2007b).

Site 7 is located north of the Gambell Municipal Building, and west of the Gambell School. A military power facility was reportedly demolished and buried in this location. A military motor pool building was also believed to be located in this vicinity. Montgomery Watson removed all exposed surface debris in 1996. During 2003, MWH removed the concrete pad, underlying support timbers, a buried 55-gallon drum, and 1 cubic yard of incidental contaminated soils (MWH, 2004). Soil confirmation samples collected from beneath the removed concrete pad and support materials indicated arsenic contamination was still present.

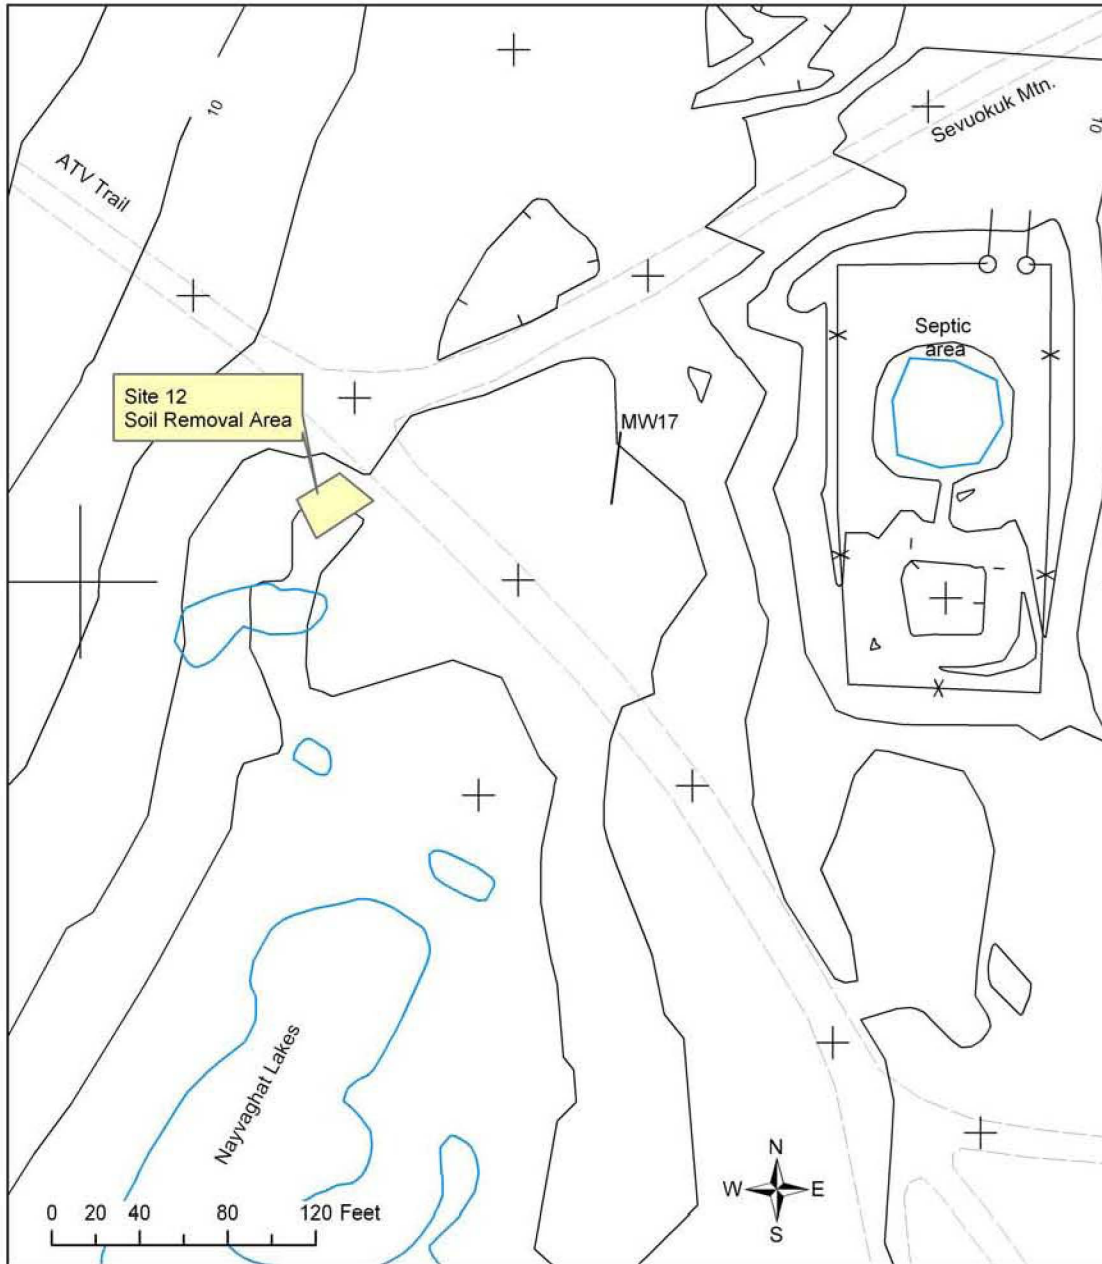
Figure 5. Site 12 Soil Removal Area

Soil confirmation samples and a supplemental remedial investigation conducted in 2001 (MWH, 2002) indicated soils remained with chromium and lead contamination. A Feasibility Study was completed by USACE in 2004 which evaluated a range of remedial alternatives. A Decision Document (USACE, 2005) selected the final remedy as excavation and off-site disposal of chromium and lead contaminated soils at Site 12. During the summer of 2006, Bristol Construction Services (BCS) excavated an area approximately 10 by 20 feet and removed 7.0 tons of chromium and lead contaminated soils from Site 12 (see Figure 5). The soil was transported to a permitted disposal facility in Arlington, Oregon. Soil confirmation samples were collected from the base of the excavation and all the results were below the site-specific cleanup level. Additional details regarding the removal action are presented in the Soil and Debris Removal Action Report (BCS, 2007b).

Site 12 is located north of Nayvaghat Lakes on the southwest side of an ATV trail. The site is divided into a north and a south area. The area south of Troutman Lake is within the City of Gambell boundary. The area is currently used primarily for recreation, subsistence food gathering, and as a gravel borrow source. However, this site has the potential to be developed for residential use in the future, given the flat topography and close proximity to a new drinking water source.
