# **U.S. Army Corps of Engineers Alaska District**

## **FIRST FIVE-YEAR REVIEW REPORT**

### **NORTHEAST CAPE FUDS ST. LAWRENCE ISLAND, ALASKA**

**FINAL  
FEBRUARY 2015**

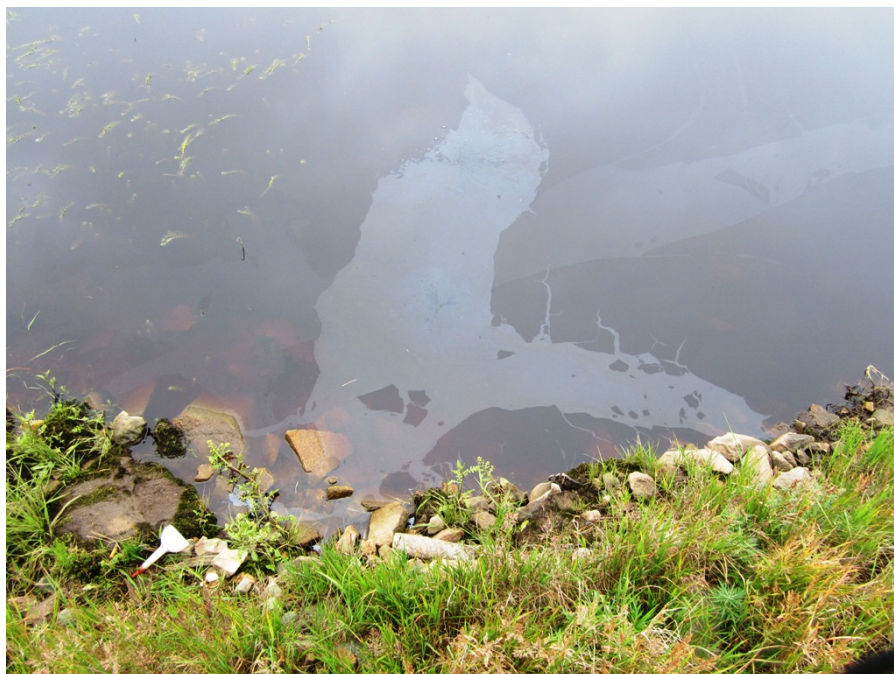
Site 3 is located adjacent to three subsistence hunting camp structures. The area of previous excavation efforts appears to be in good condition and vegetative growth is occurring. A large tracked piece of equipment was temporarily stored onsite and appeared to be prepped for shipment off-island. The DD did not indicate the presence of a surface water body that was observed during the site inspection (Photo No. 11, Appendix D). An apparent petrogenic sheen, limited in size, was observed on the surface water near the seasonal hunting structures. A plastic cap (perhaps to an oil container) was observed onshore adjacent to the sheen (Photo No. 13, Appendix D).

**Photo No. 13 – 14 September 2013  
Potentially petrogenic sheen identified in the large pond at Site 3.**

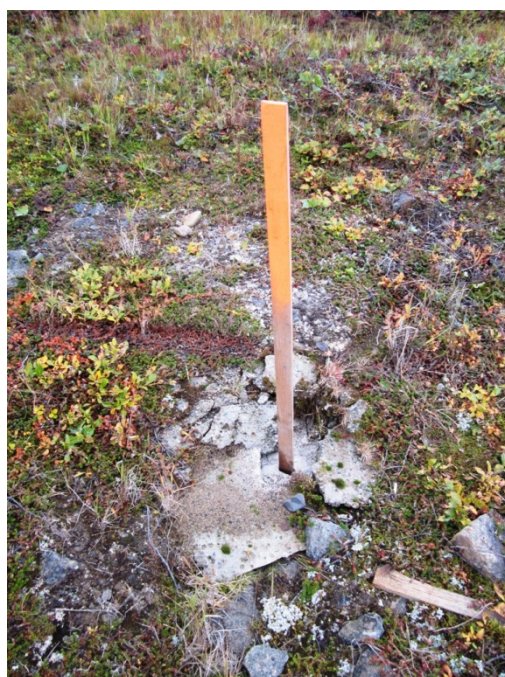
The gravel pad remains at Site 6 and was being used to store shipping CONEXs, six 21,000-liter fuel tanks, and some heavy equipment (Photo No. 17, Appendix D). Excavation areas were graded to promote positive drainage. Adjacent surface water was clear with no debris or observable sheen. Two abandoned monitoring well locations were observed onsite (Photo Nos. 14 and 15, Appendix D).

**Photo No. 14 – 14 September 2013  
Abandoned monitoring well at Site 6.**

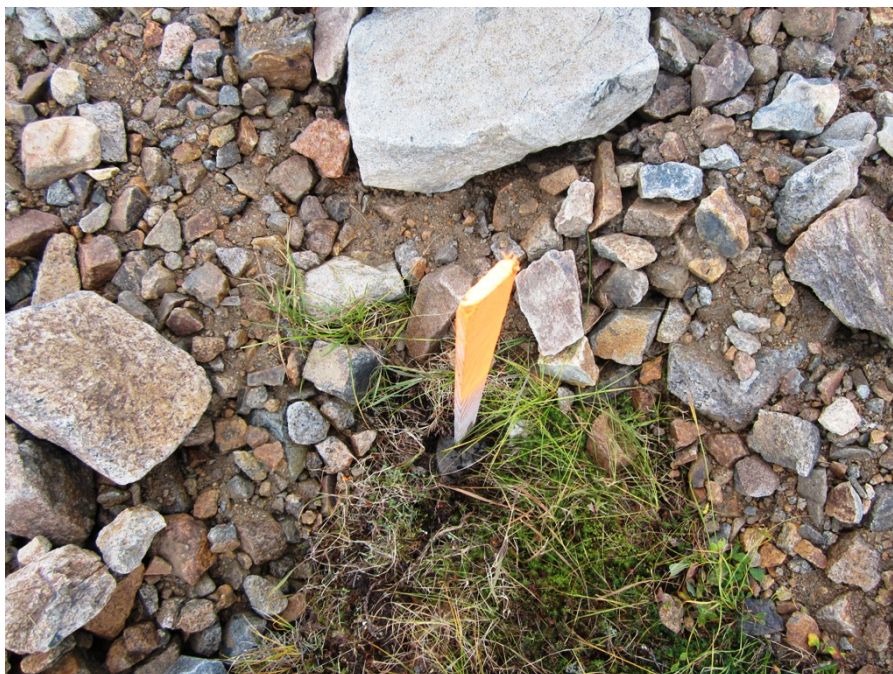
**Photo No. 15 – 14 September 2013  
Abandoned monitoring well at Site 6.**

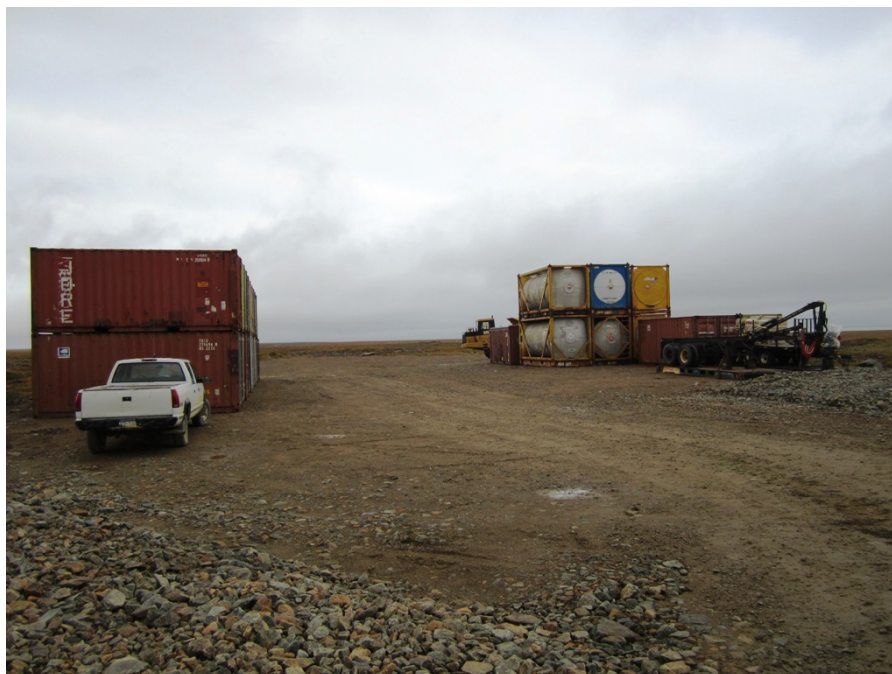
**Photo No. 17 – 14 September 2013  
2013 Staging at Site 6. View facing northwest.**

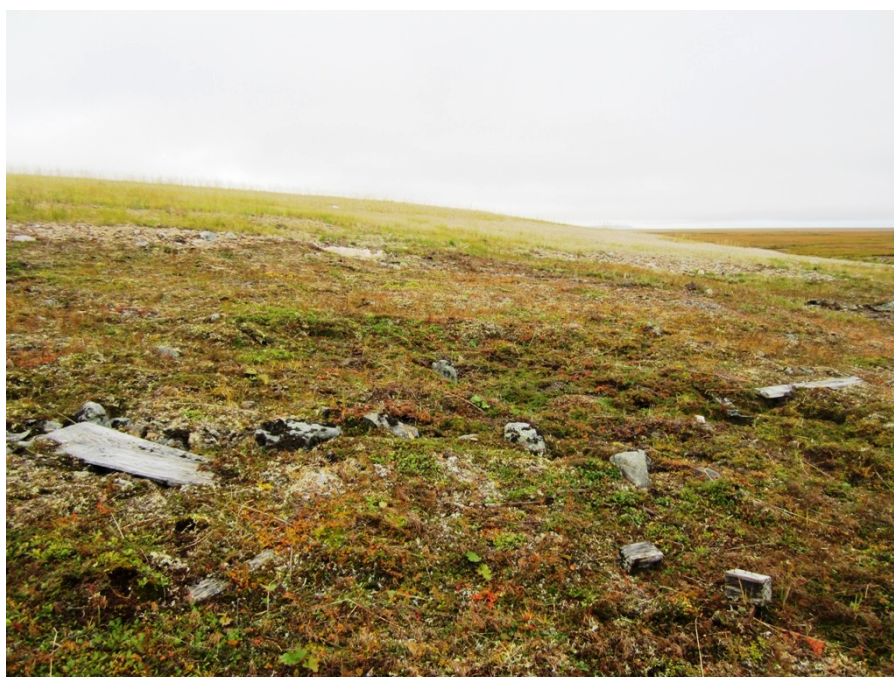
**Photo No. 20 – 13 September 2013  
Wood debris at Site 7. View facing north.**

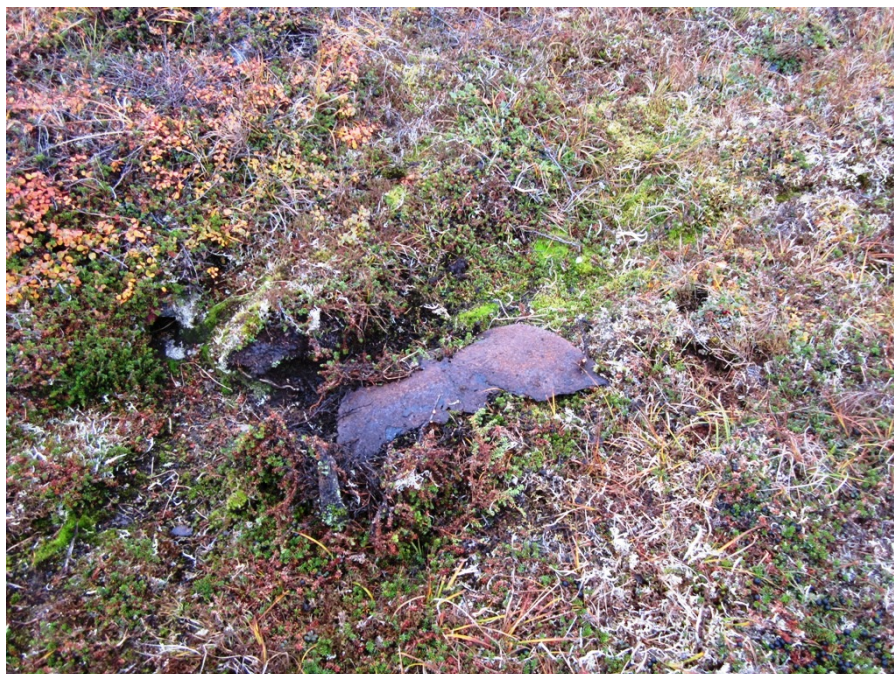
**Photo No. 21 – 13 September 2013  
Metal debris at Site 7.**

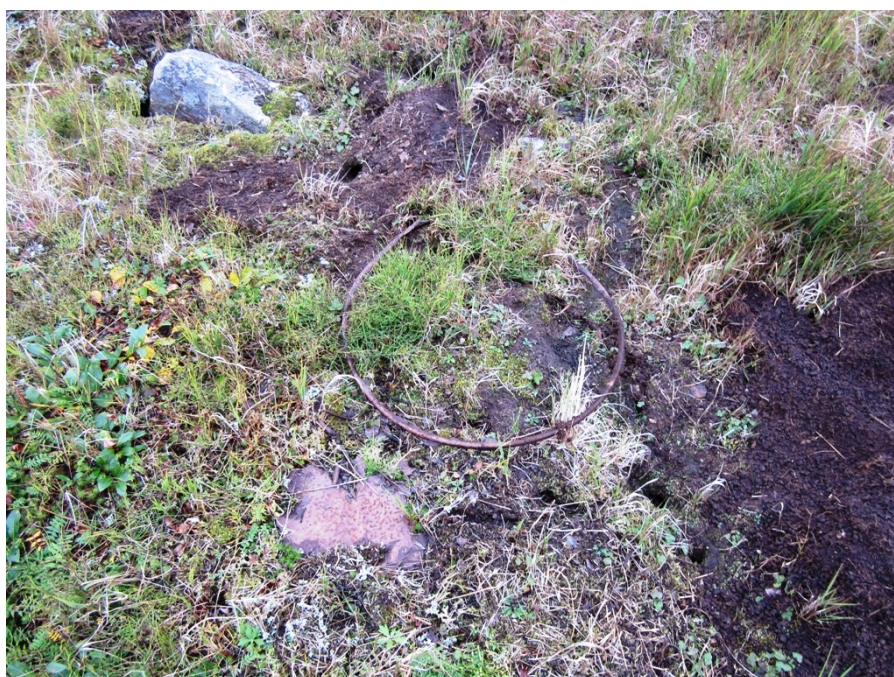
**Photo No. 22 – 13 September 2013  
Metal debris at Site 7.**

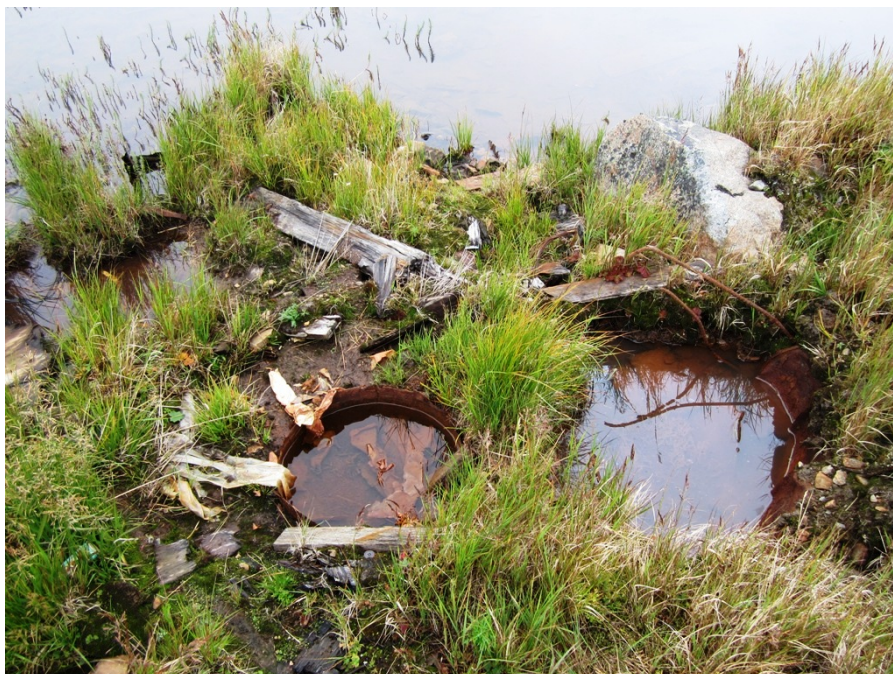
**Photo No. 23 – 13 September 2013  
Drum debris located near a pond at Site 7. View facing north.**

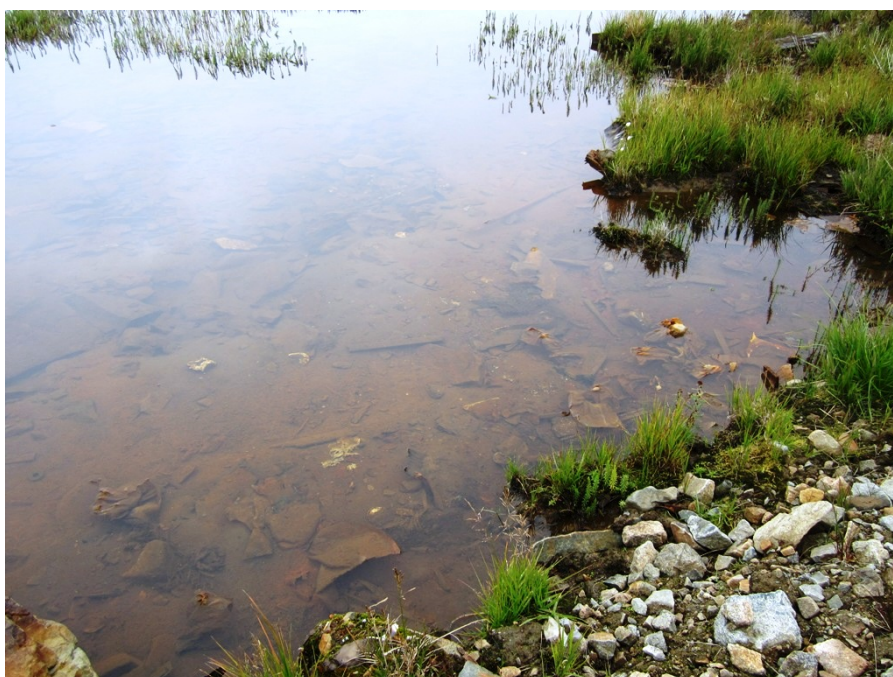
**Photo No. 24 – 13 September 2013  
Debris in pond located adjacent to the landfill cap at Site 7. View facing north.**

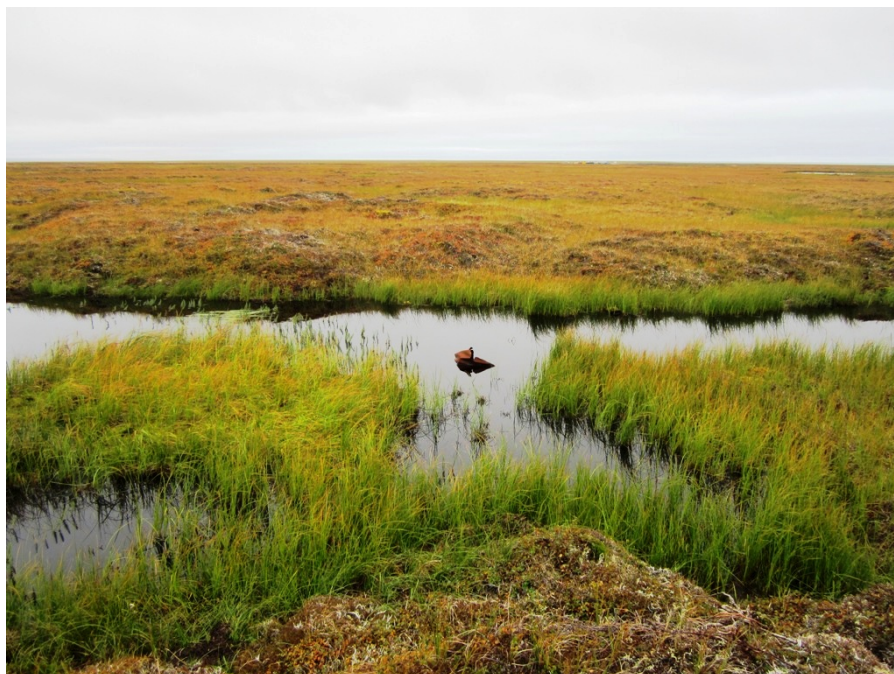
**Photo No. 27 – 13 September 2013**  
**Miscellaneous debris in pond near landfill cap at Site 7. View facing northwest.**

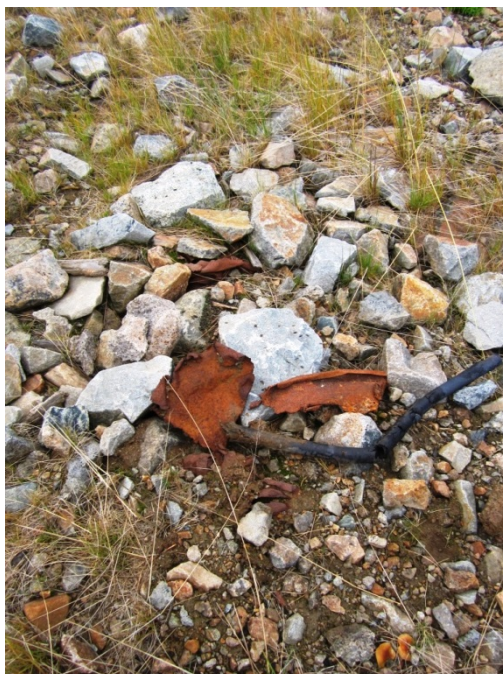
**Photo No. 33 – 13 September 2013**  
**Debris located with the armored rock at Site 7. View facing south.**

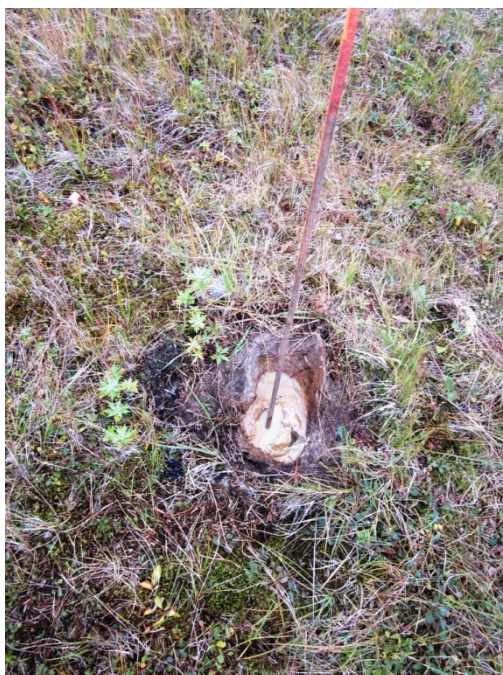
**Photo No. 34 – 13 September 2013**  
**Abandoned monitoring well filled with bentonite at Site 7.**

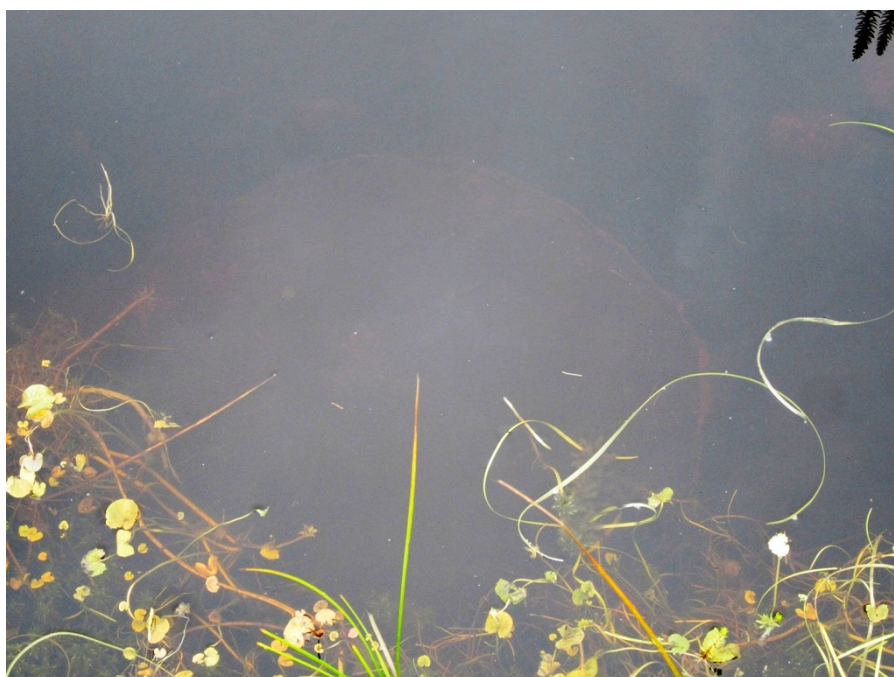
**Photo No. 36 – 13 September 2013  
Apparent drum located in pond south of landfill cap at Site 7.**

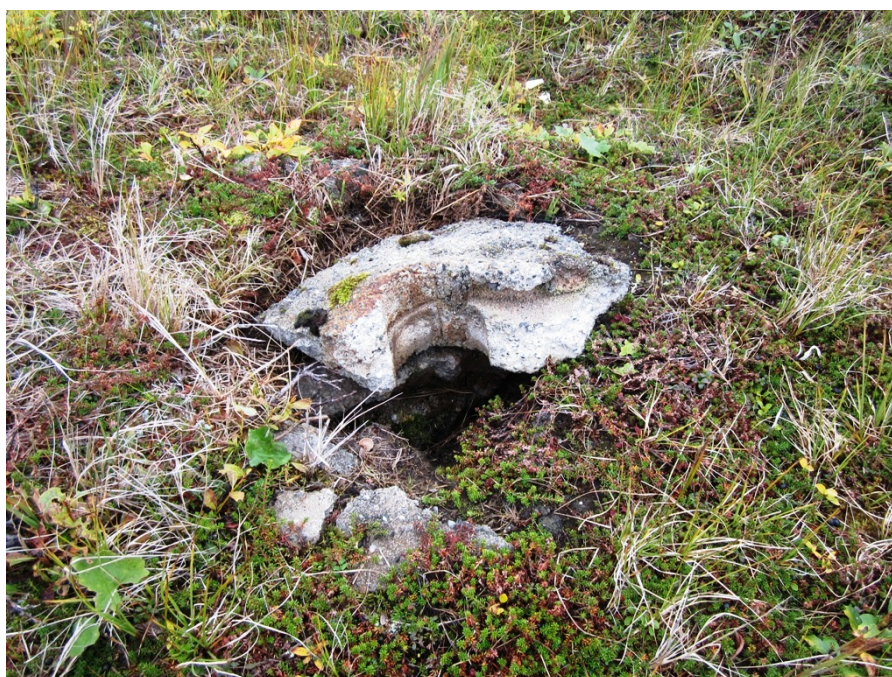
the ground surface in the area believed to previously contain a monitoring well (Photo No. 42, Appendix D).

**Photo No. 42 – 13 September 2013  
Abandoned monitoring well south of landfill cap at Site 9.**

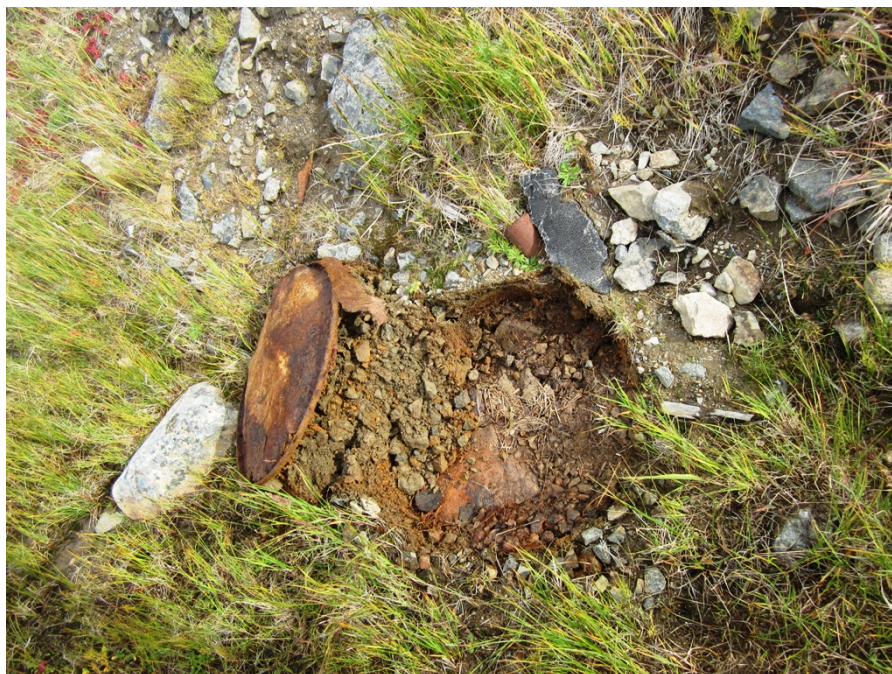
**Photo No. 57 – 14 September 2013  
Drum lid at Site 10.**

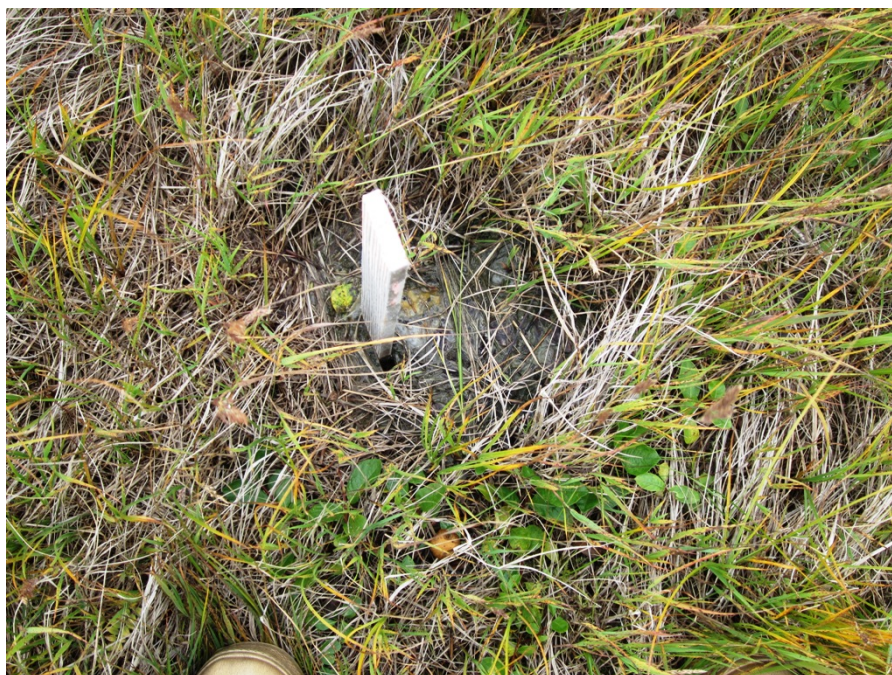
**Photo No. 58 – 14 September 2013  
Abandoned monitoring well at Site 10.**

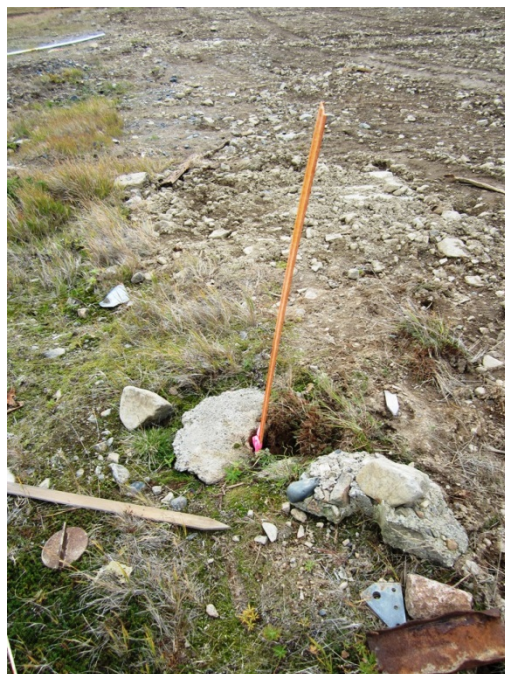
Site 16 was being used as an equipment storage area for ongoing remedial efforts as well as road access for Site 28 (Photo No. 66, Appendix D). The Paint and Dope Storage structure no longer remains onsite. The site had been partially graded to promote positive drainage. A stockpile with approximately 3 cubic yards of soil was observed. Two decommissioned monitoring wells were observed onsite (Photo Nos. 67, 70, and 71, Appendix D).

**Photo No. 67 – 15 September 2013  
Abandoned well at Site 16.**

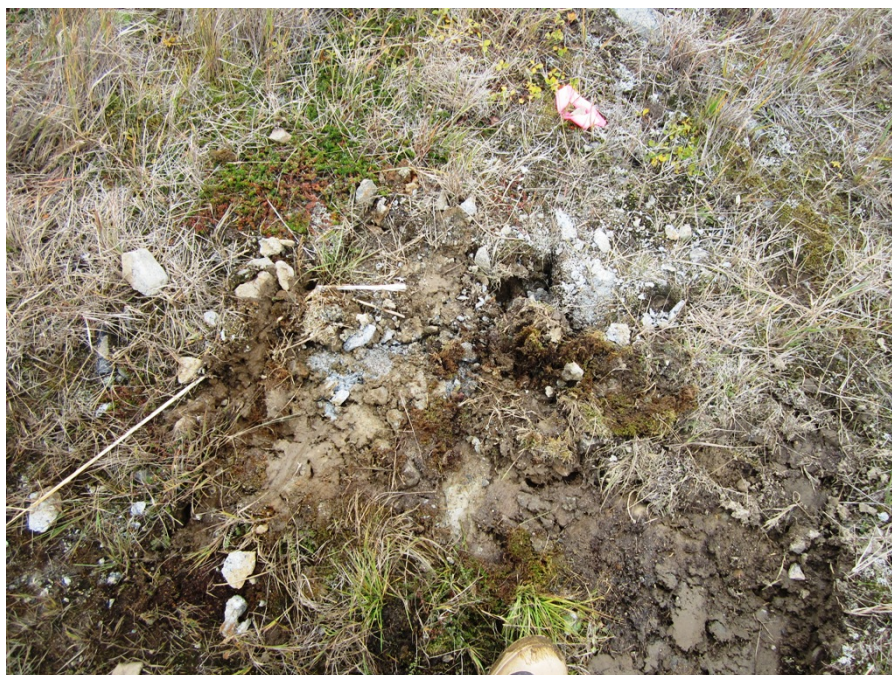
**Photo No. 70 – 15 September 2013  
Abandoned well at Site 16.**

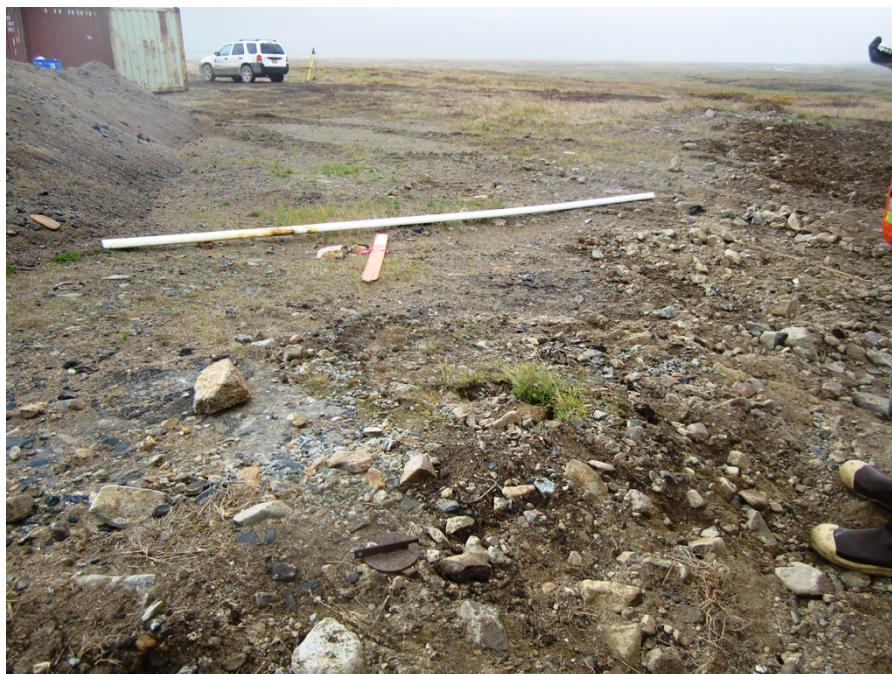
**Photo No. 71 – 15 September 2013  
Abandoned well at Site 16. View facing northeast.**

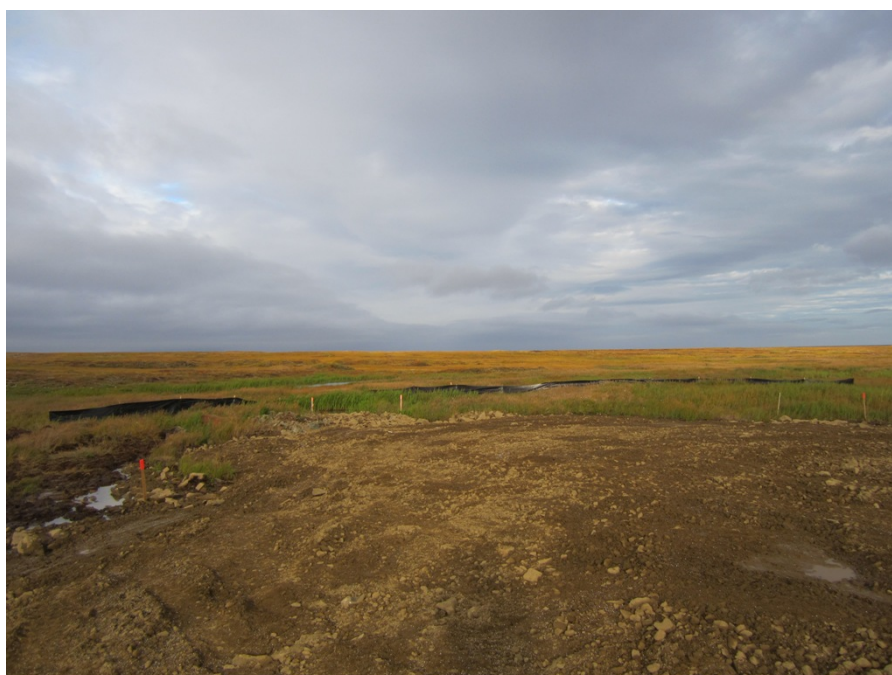
Excavation efforts at Site 21 were performed in September of 2013 and seeding was actively occurring during the site inspection on 15 September 2013. The site appears in good condition with no debris. A sediment wattle was placed to the west of the excavation efforts and a silt fence was installed further downgradient of Site 21 (Photo No. 78, Appendix D). The site was graded to promote drainage.

**Photo No. 78 – 15 September 2013  
Silt fence at Site 21. View facing west.**

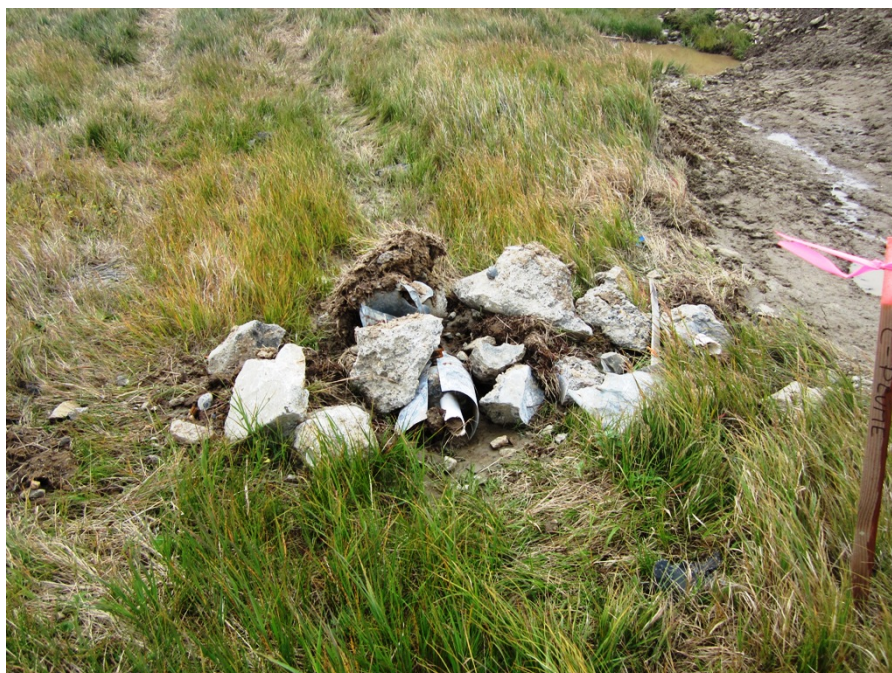
**Photo No. 82 – 15 September 2013  
Well debris identified at Site 27. View facing north.**

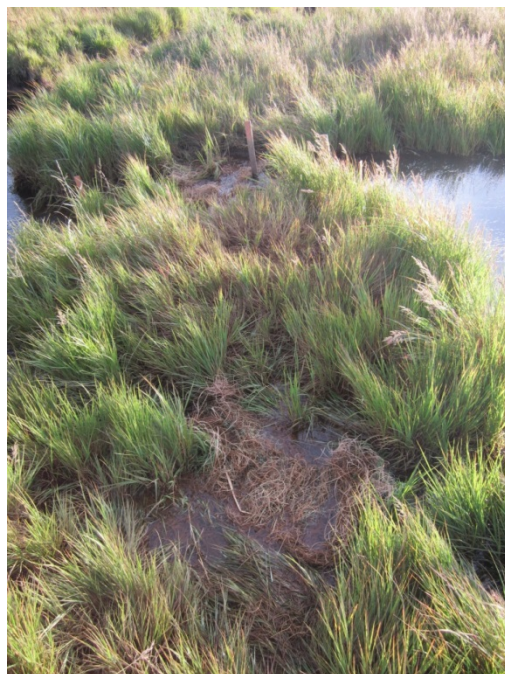
**Photo No. 97 – 15 September 2013**

At the time of the site inspection, the contractor performing remedial actions at Site 28 was initiating demobilization. The site appeared in good condition and had thick vegetation. A sediment trap was placed within the drainage basin to assist in dredging activities. Several water pumps and intermediate ponds were used to pump dredged material upgradient to the flocculation station, water filters, and sediment tubes (Photo Nos. 86, 87, 88, and 91, Appendix D). A sediment trap was observed within the drainage upgradient of recent dredging areas (Photo No. 72, Appendix D). Sediment tubes were located within a constructed temporary containment basin near Site 16 (Photo No. 85, Appendix D). To the north, wattles were placed within the drainage basin at the junction with the Suqitughneq River (Site 29) (Photo No. 97, Appendix D).

**Wattles placed at the junction between the Drainage Basin (Site 28) and the Suqitughneq River (Site 29). View facing east.**

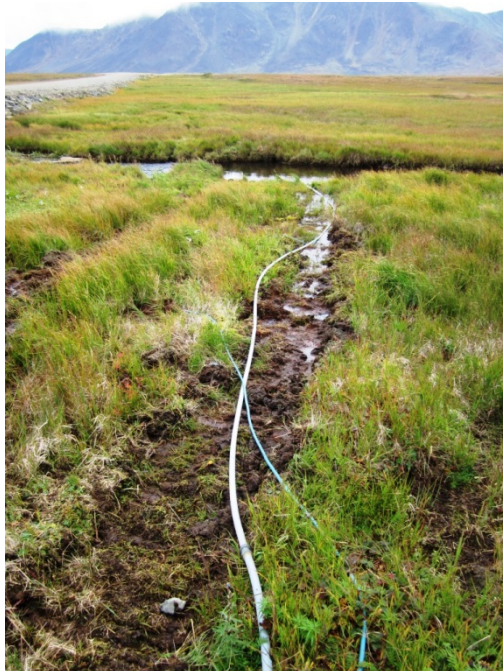
**Photo No. 101 – 14 September 2013  
Water collection at Site 29 for the BERS camp. View facing southeast**

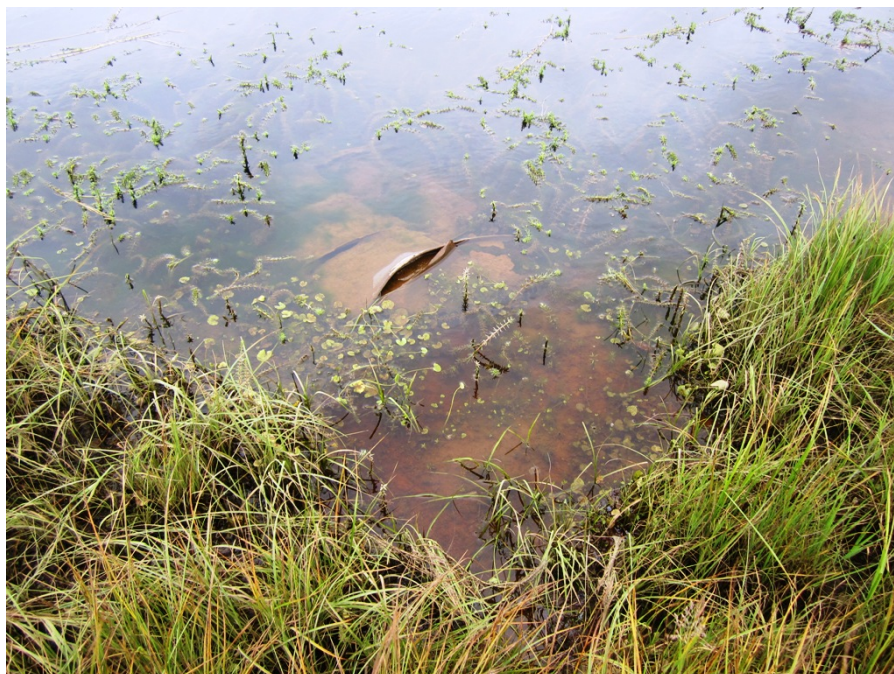
Only one submerged drum was observed as debris in an adjoining pond on the west side of the Suqitughneq River (Photo No. 105, Appendix D, Figure A-14). No sheen was observed to be associated with the drum. No other debris was noted onsite. Water collection from the Suqitughneq River was observed near the temporary camp constructed near the airstrip for use as grey water (Photo No. 101, Appendix D).

**Photo No. 105 – 14 September 2013  
Drum debris located in a pond connected to the Suqitughneq River (Site 29).**

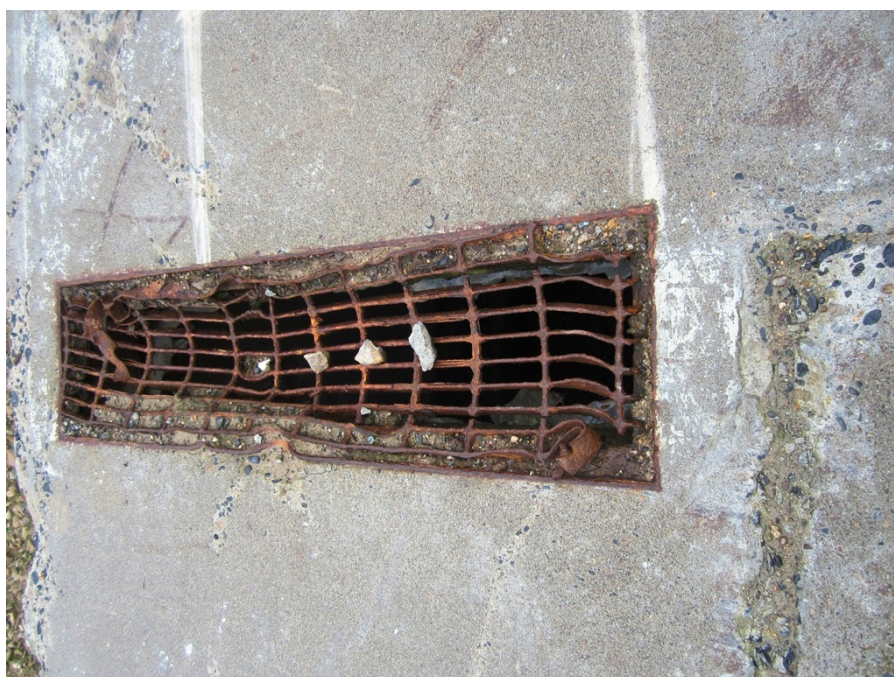
Four former antenna foundations and one building foundation were observed at Site 31. The building foundation contained an approximate 0.5-foot by 4-foot drain (Photo No. 112, Appendix D). The drain appeared to lead to an opening of approximately 5 feet by 9 feet by

**Photo No. 112 – 13 September 2013  
Drain cover at Site 31.**

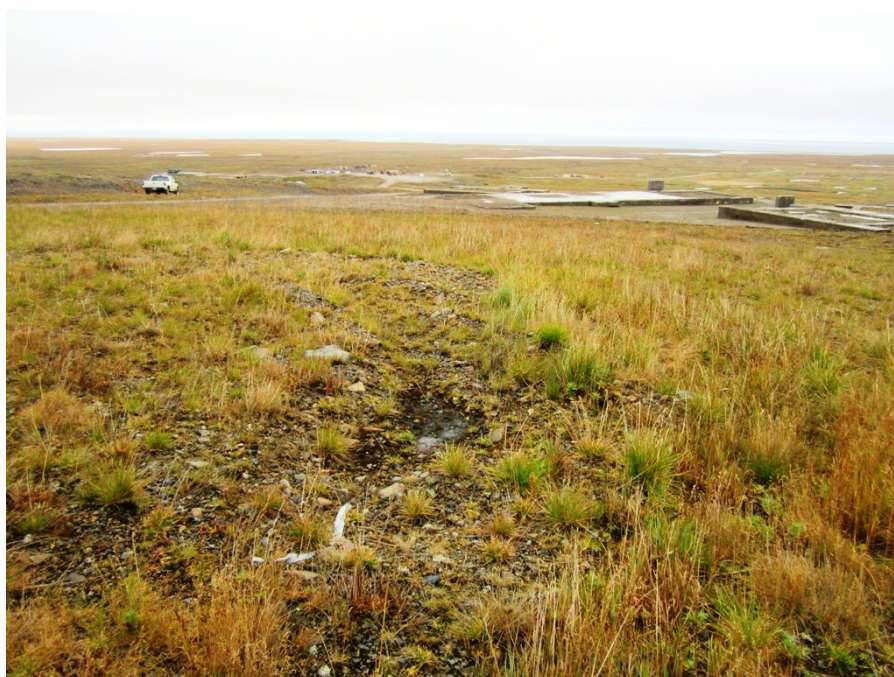
**Photo No. 114 – 13 September 2013  
Slight depression at Site 31. View facing north.**

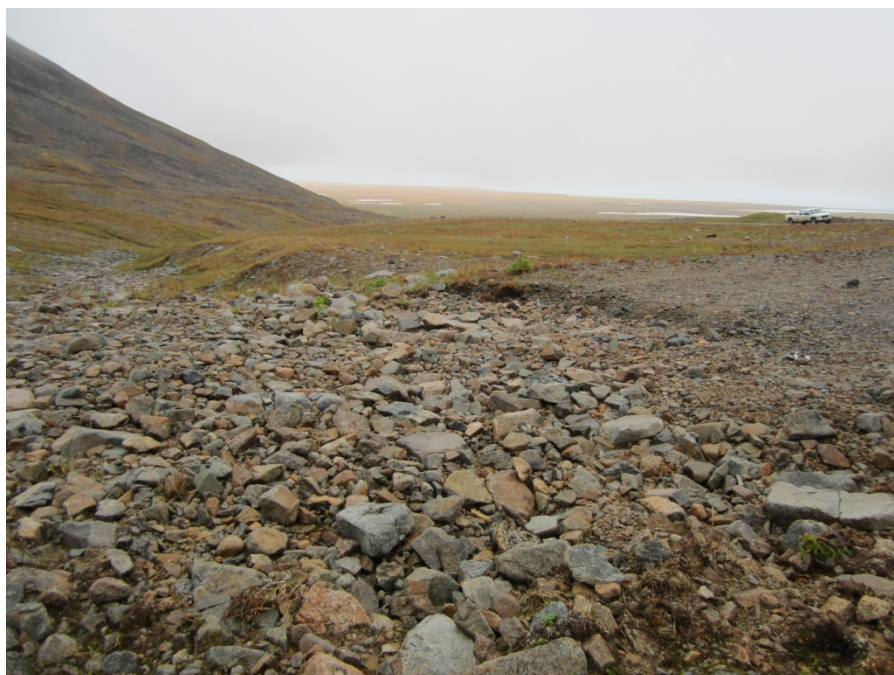
**Photo No. 116 – 13 September 2013  
Condition of the road leading to Site 32. View facing north.**

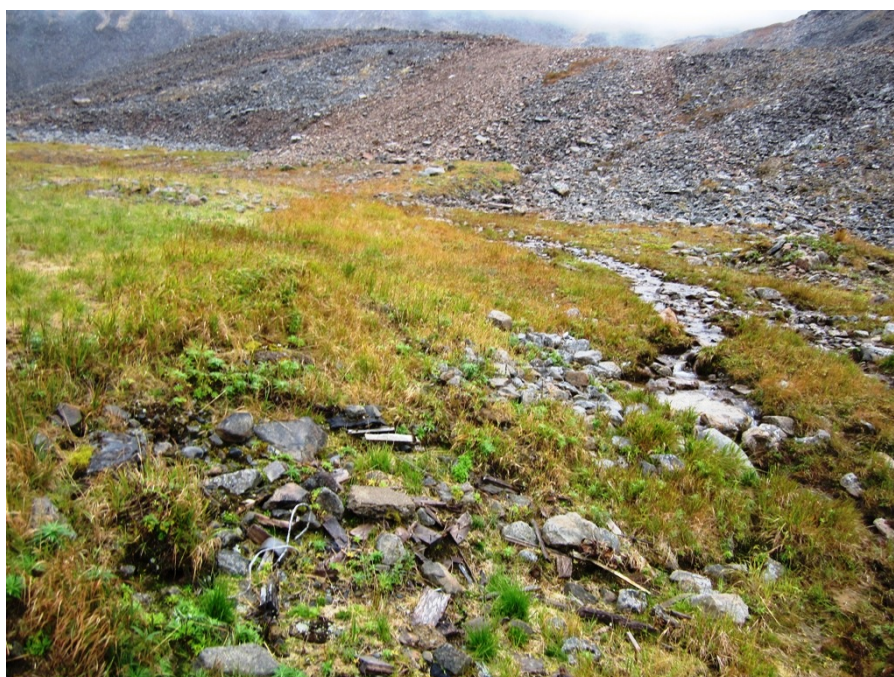
**Photo No. 120 – 13 September 2013  
Miscellaneous debris at Site 32. View facing west.**

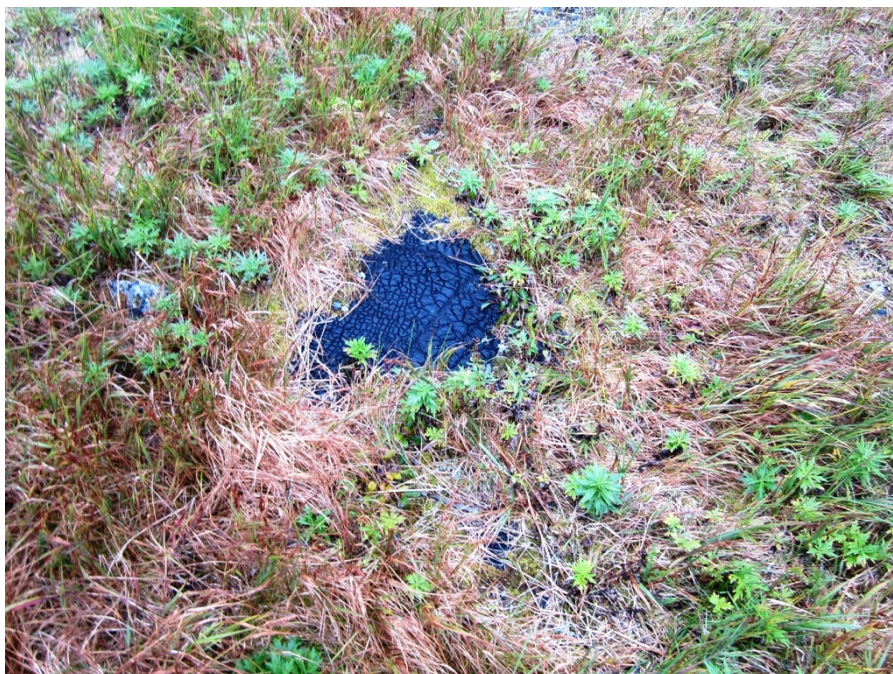
**Photo No. 121 – 13 September 2013  
Asphalt debris at Site 32.**

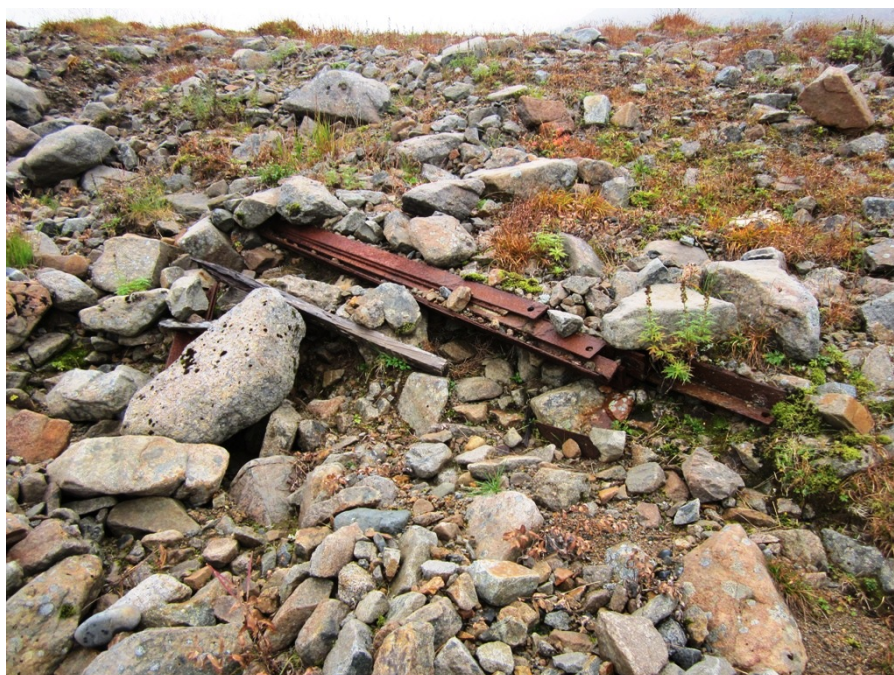
**Photo No. 123 – 13 September 2013**  
**Culvert extending to the north below the roadway at Site 32. View facing east.**

**Photo No. 124 – 13 September 2013**  
**Metal debris at Site 32. View facing south.**
