FIRST FIVE-YEAR REVIEW REPORT

NORTHEAST CAPE FUDS ST. LAWRENCE ISLAND, ALASKA

Formerly Used Defense Site No. F10AK0969-03

**FINAL
FEBRUARY 2015**

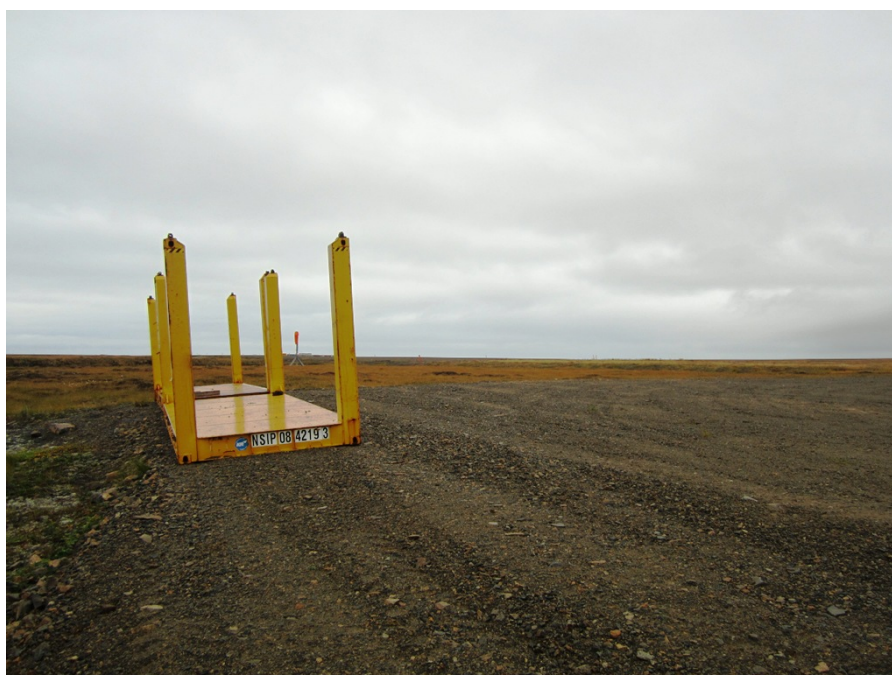
Photo No. 6 – 14 September 2013
Equipment stored at Site 1. View facing east.

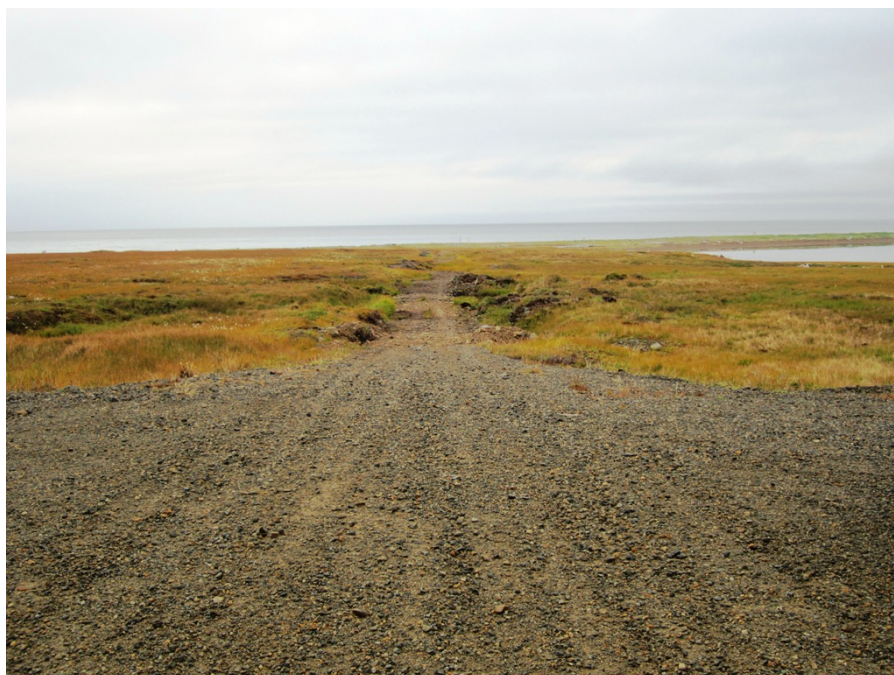
**Photo No. 8 – 14 September 2013
Off-road trail located at the northern end of the runway at Site 1. View facing northeast.**

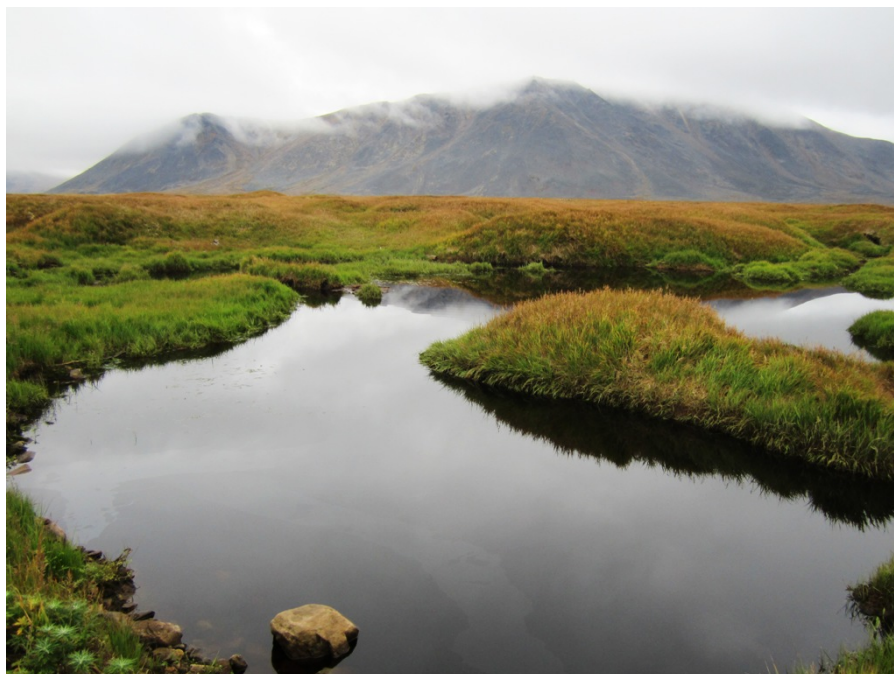
**Photo No. 11 – 14 September 2013
Large pond located at Site 3. View facing south.**

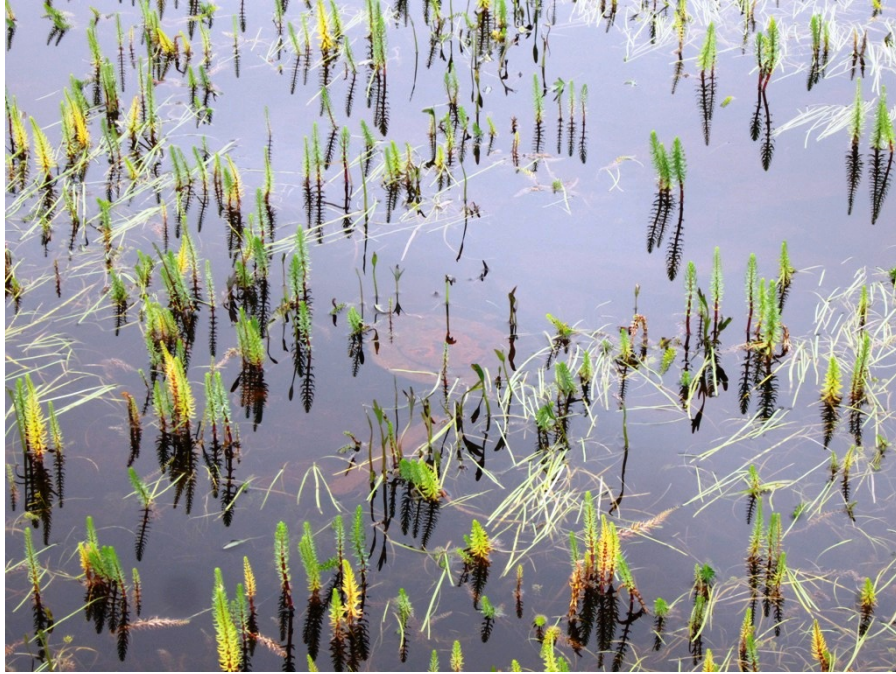
**Photo No. 35 – 13 September 2013
Debris in pond south of landfill cap at Site 7. View facing south.**

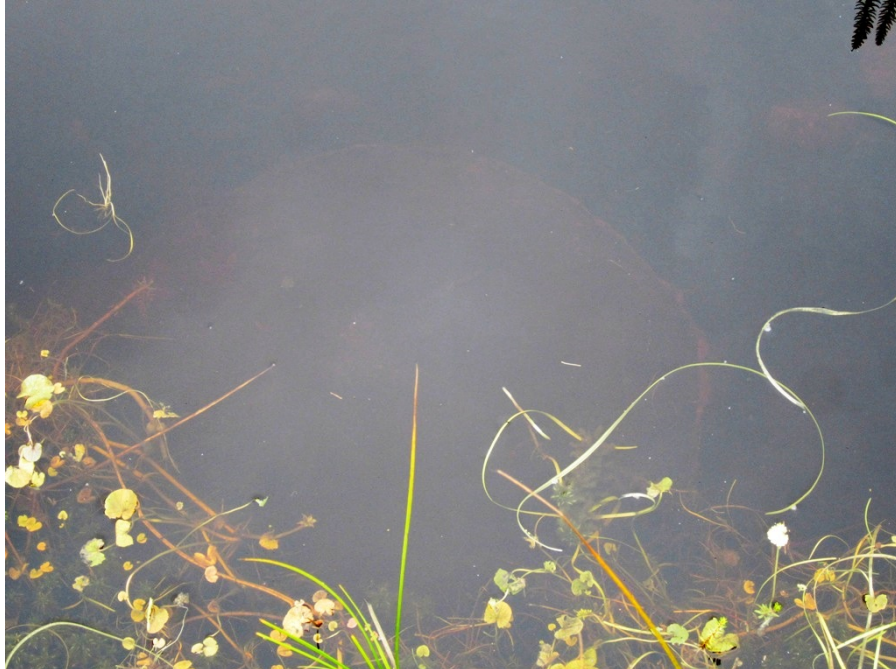
**Photo No. 36 – 13 September 2013
Apparent drum located in pond south of landfill cap at Site 7.**

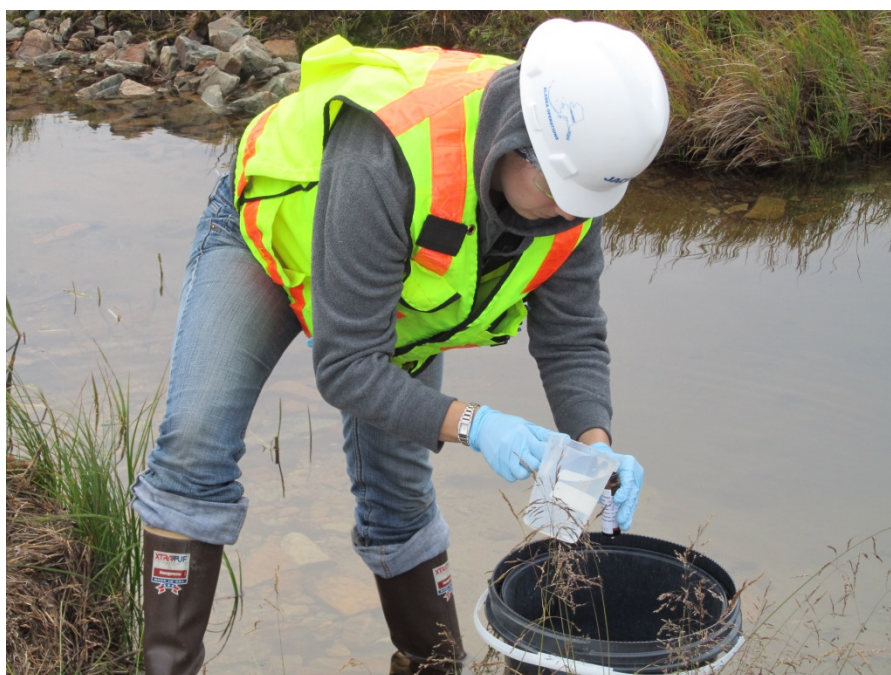
**Photo No. 40 – 12 September 2013
Collecting surface water samples at Site 9. View facing northeast.**

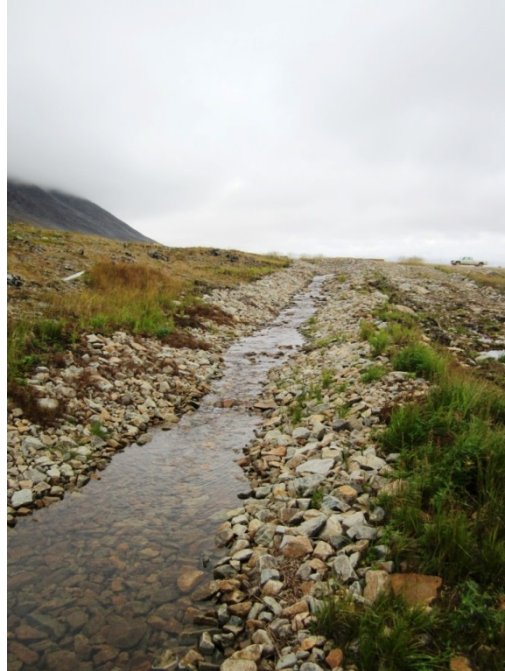
**Photo No. 43 – 13 September 2013
Diversion trench adjacent to landfill cap at Site 9. View facing west.**

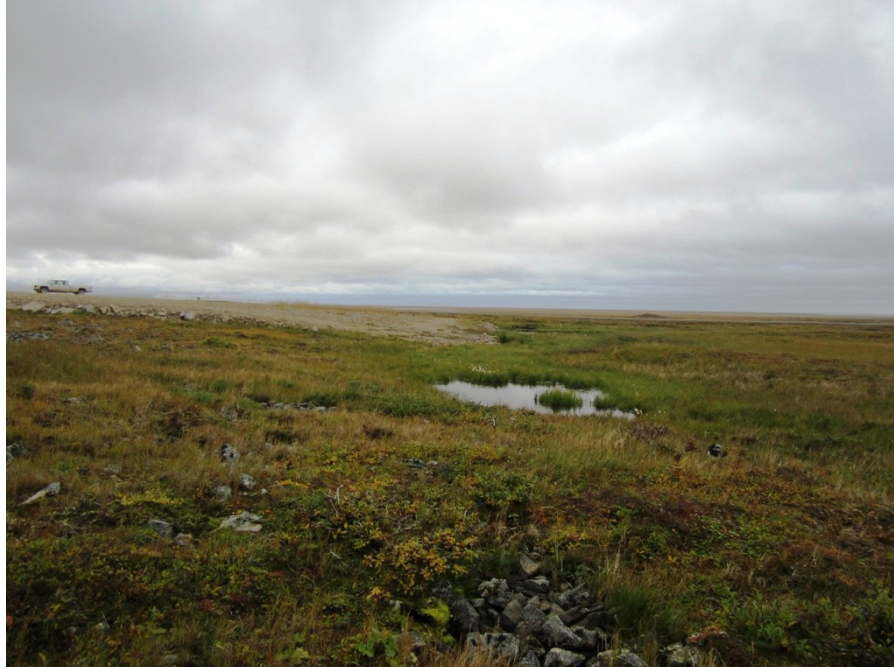
**Photo No. 44 – 13 September 2013
View of landfill cap at Site 9. View facing west.**

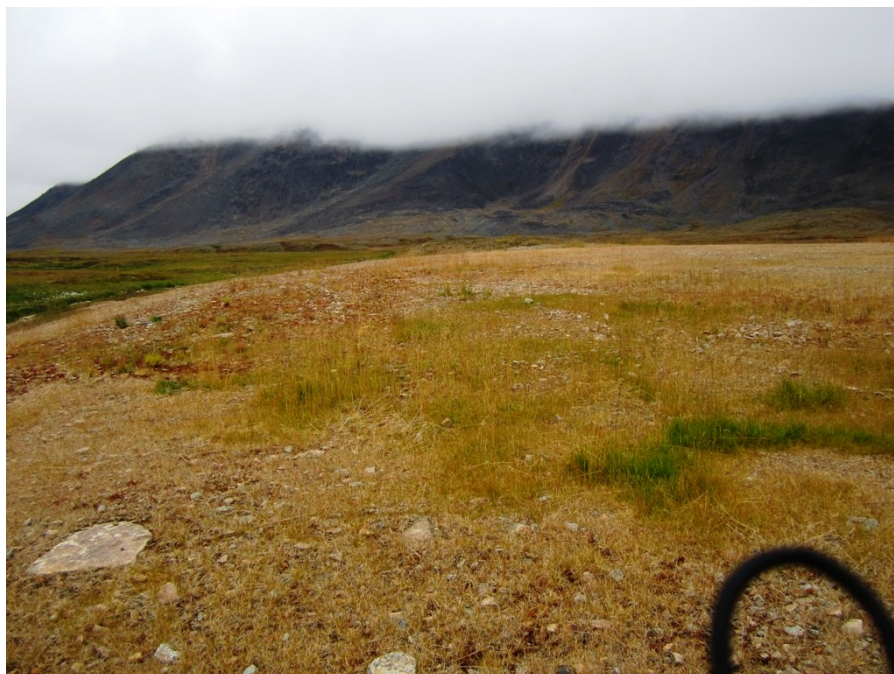
Photo No. 45 – 13 September 2013
Vegetative growth on the surface of the landfill cap at Site 9. View facing east.

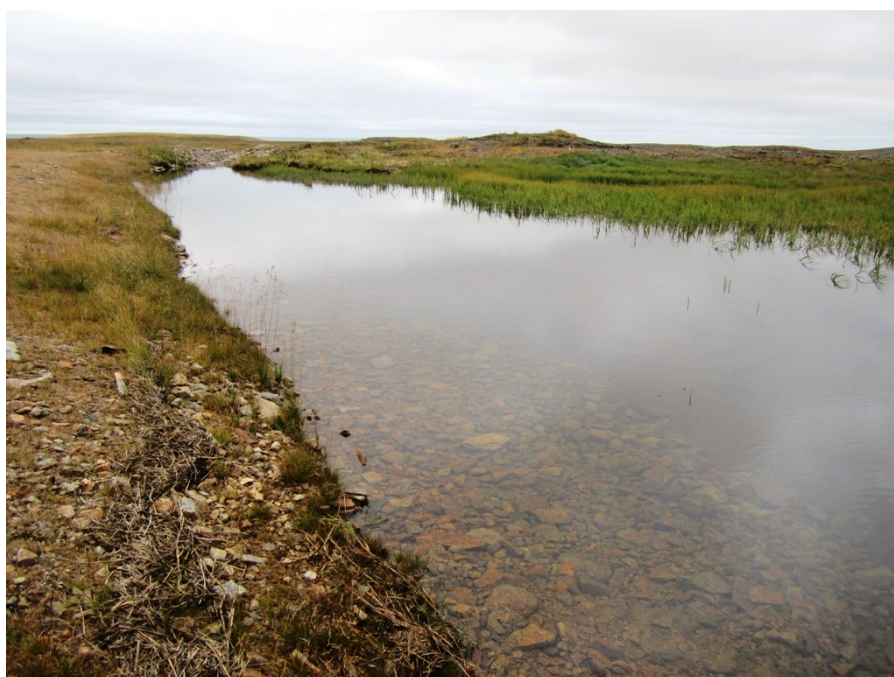
Photo No. 46 – 13 September 2013
Pond located at the southern extent of the diversion trench at Site 9. View facing north.

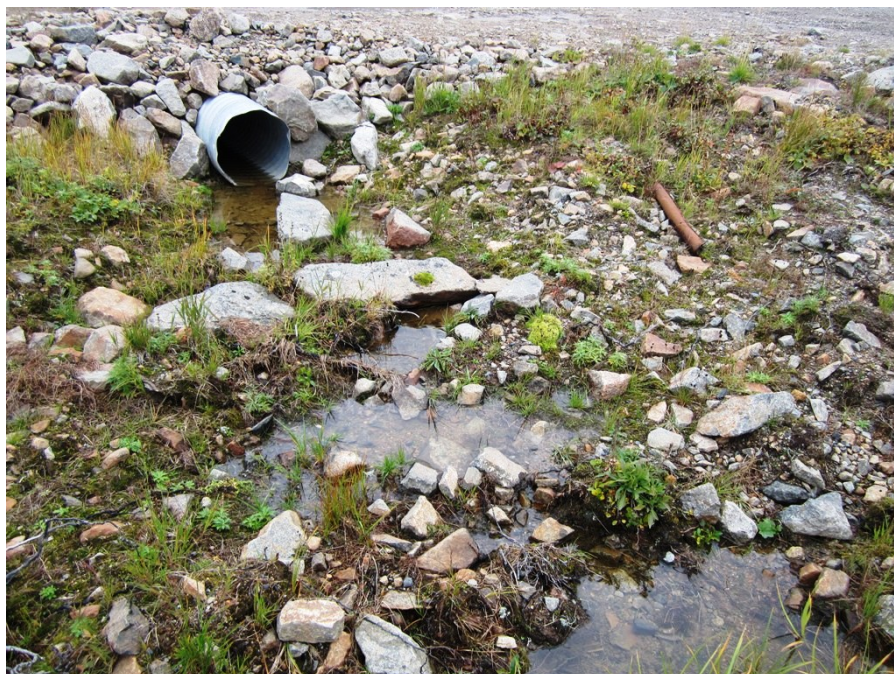
**Photo No. 47 – 13 September 2013
Culvert beneath road access to Site 9 landfill cap. View facing south.**

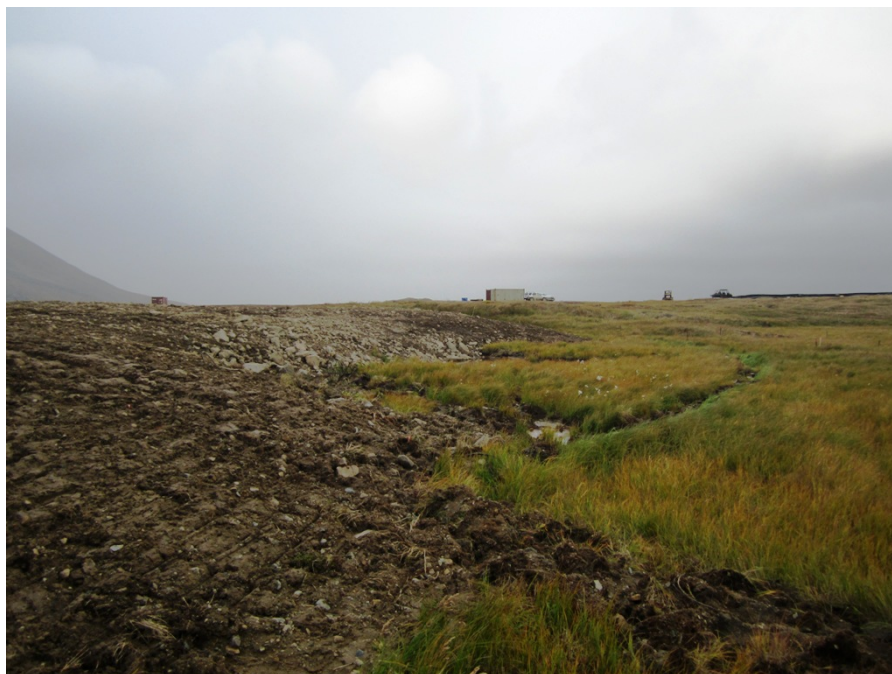
Photo No. 49 – 15 September 2013
Northern edge of excavation MOC Sites 13, 15, 19, 27. View facing west.

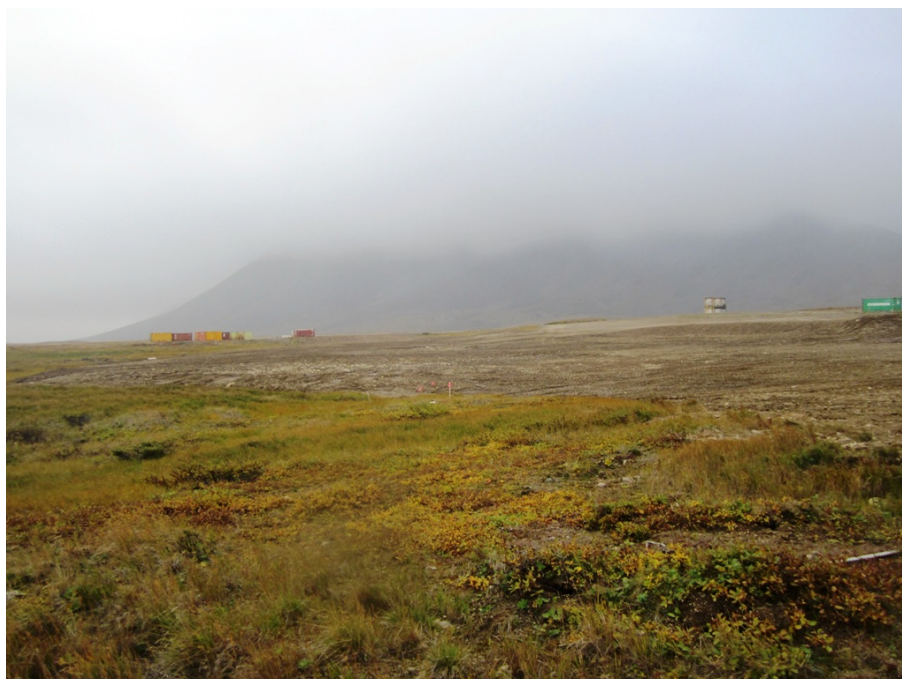
Photo No. 50 – 15 September 2013
Overview of MOC Sites 13, 15, 19, 27. View facing east.

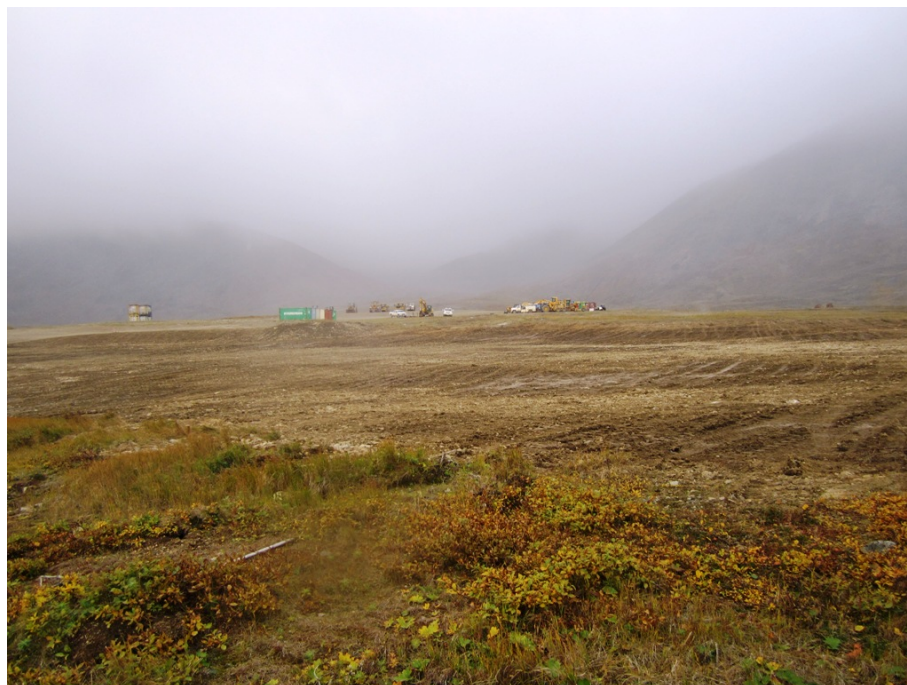
**Photo No. 51 – 15 September 2013
Overview of MOC Sites 13, 15, 19, 27. View facing south.**

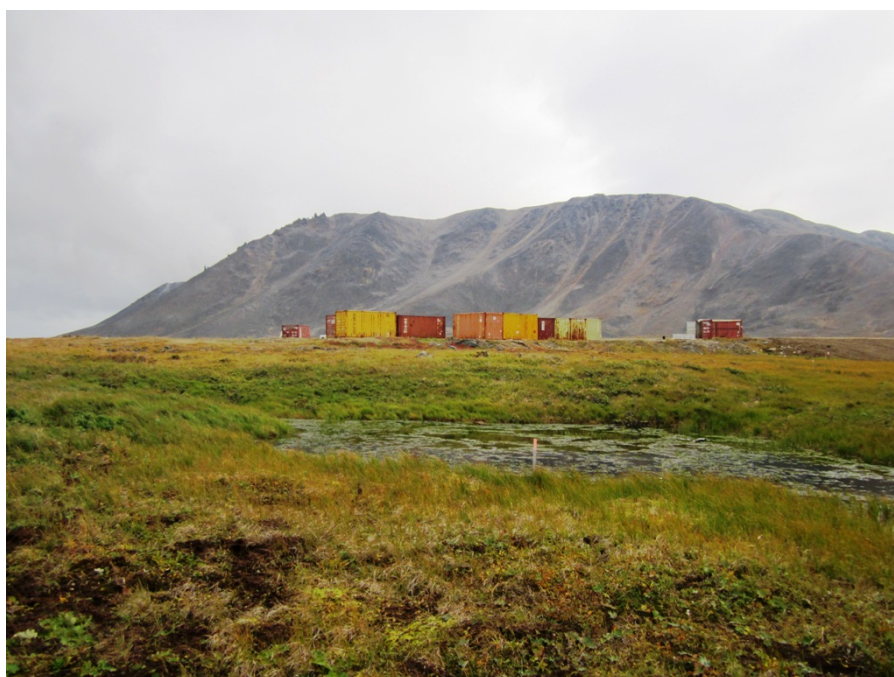
**Photo No. 54 – 14 September 2013
Staging at Site 10. View facing east.**

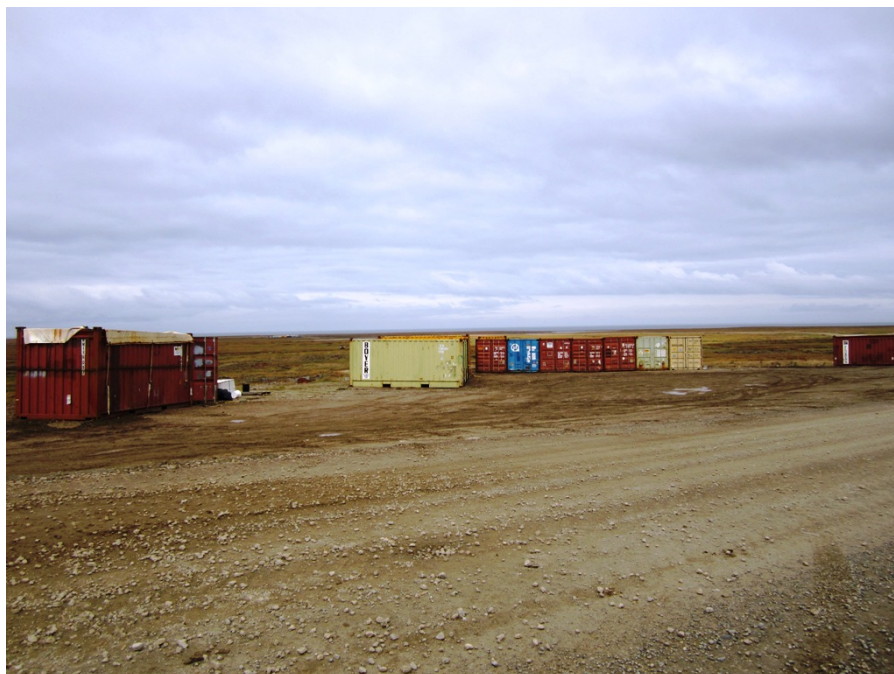
**Photo No. 55 – 14 September 2013
Staging at Site 10. View facing North.**

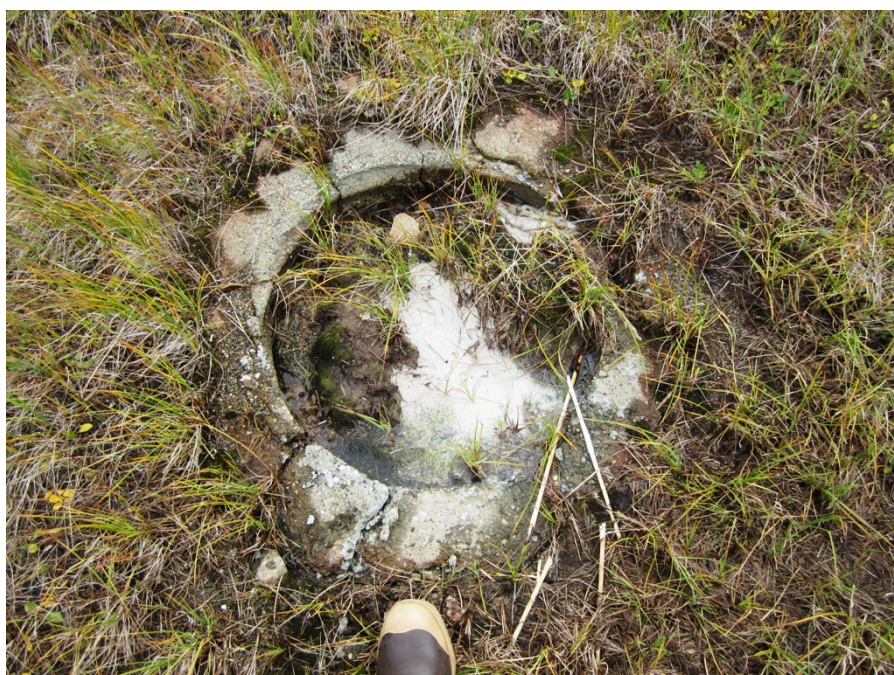
**Photo No. 56 – 14 September 2013
Large concrete ring at Site 10.**

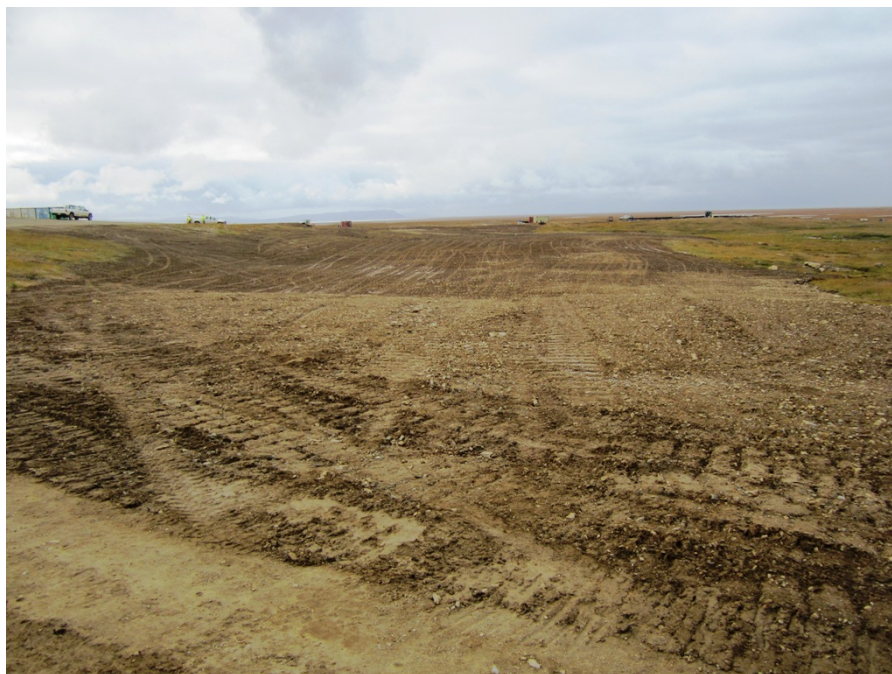
Photo No. 59 – 14 September 2013
Recent grading and seeding at Site 11. View facing southwest.

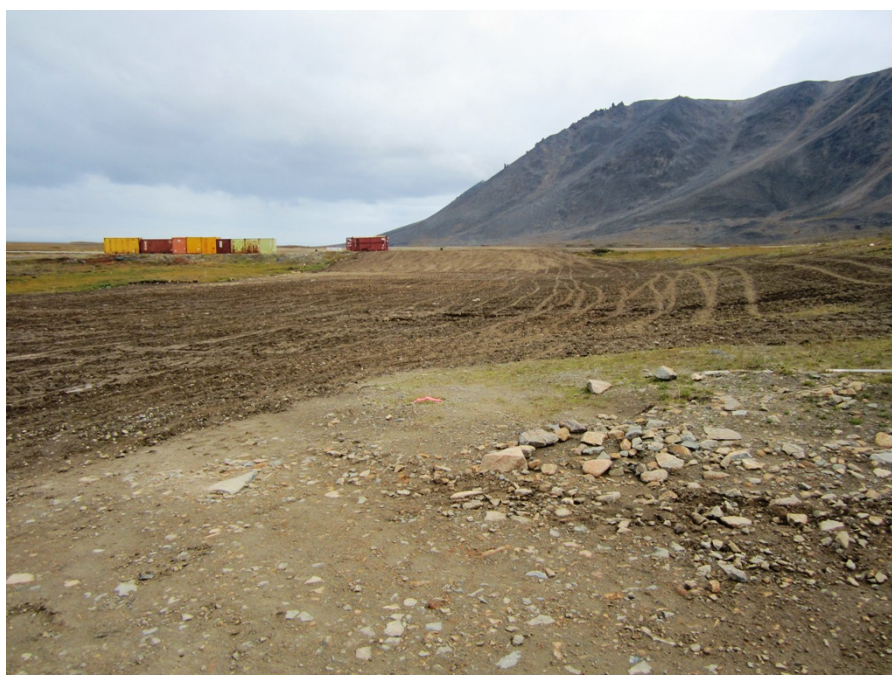
Photo No. 60 – 14 September 2013
Recent grading and seeding at Site 11. View facing northeast.

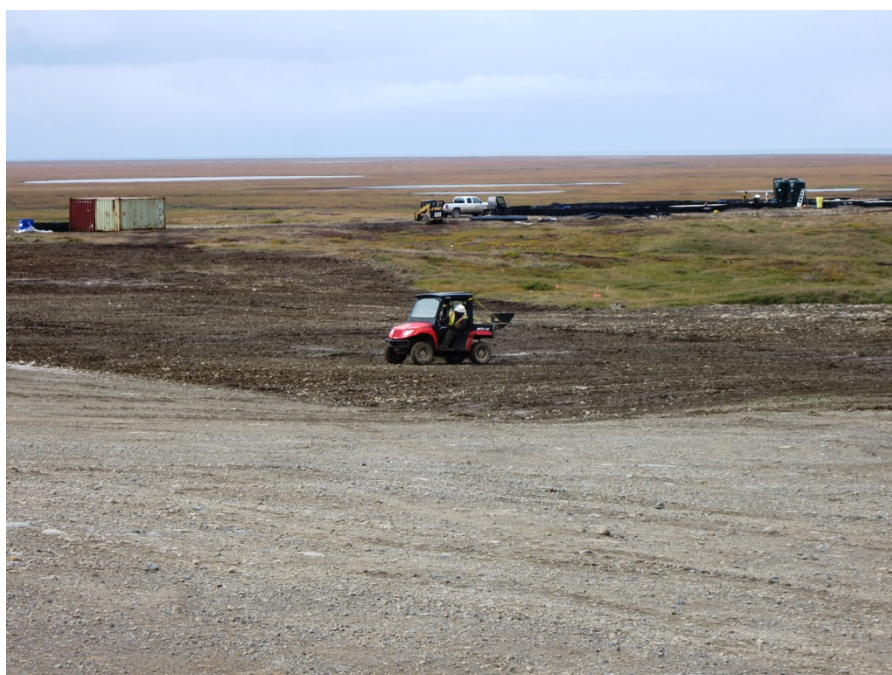
**Photo No. 62 – 14 September 2013
Seeding at Site 11. View facing north.**

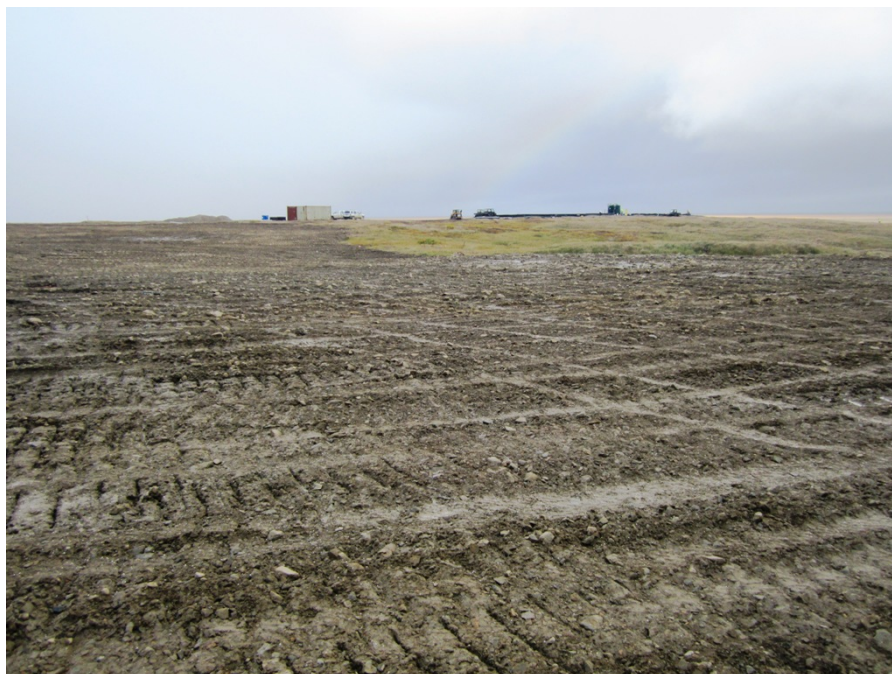
**Photo No. 63 – 15 September 2013
Overview of Site 13. View facing north.**

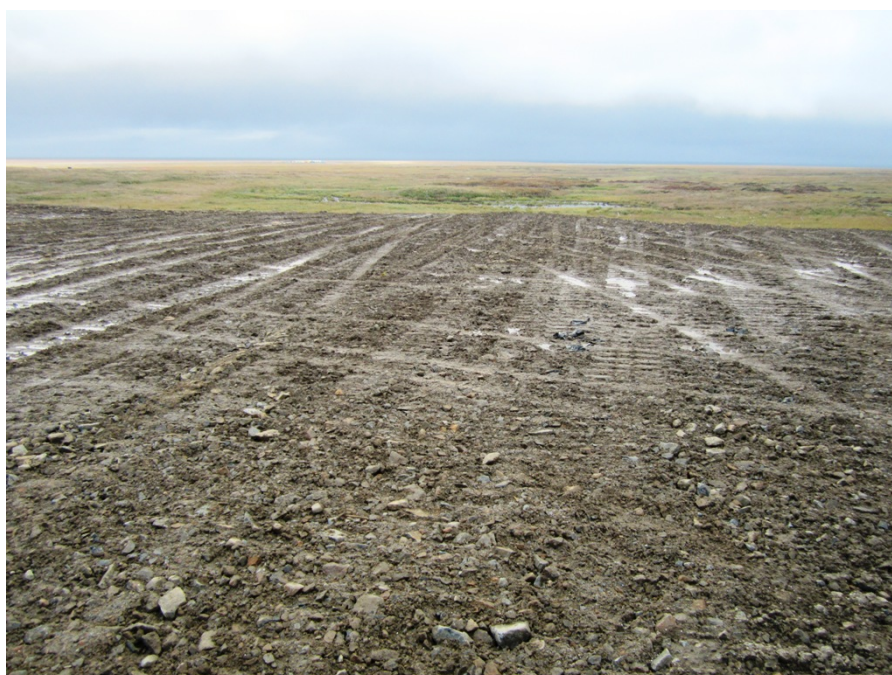
**Photo No. 64 – 15 September 2013
Overview of Site 15. View facing north.**

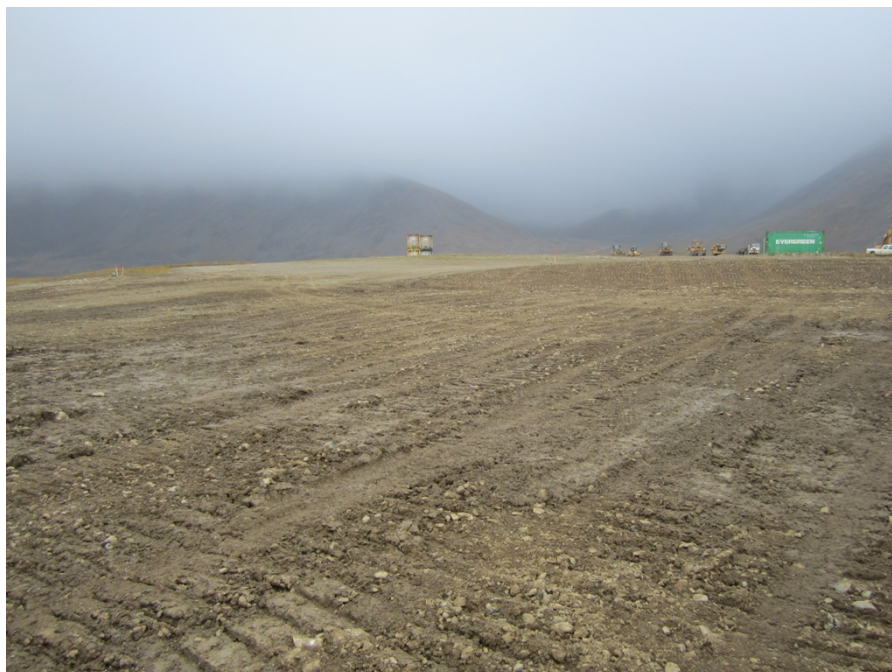
**Photo No. 65 – 15 September 2013
Overview of Site 15. View facing southeast.**

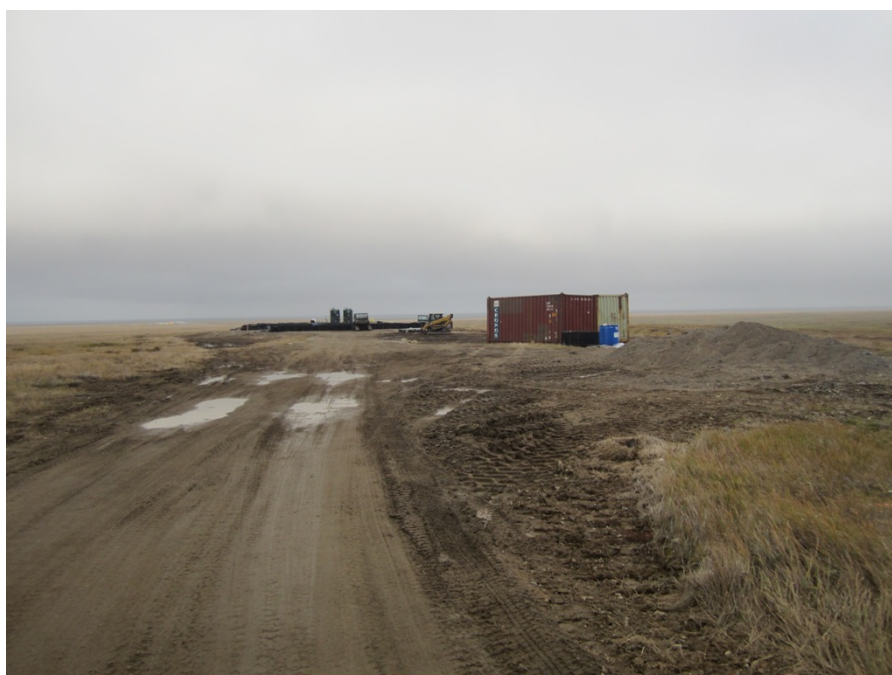
Site 16 was being used as an equipment storage area for ongoing remedial efforts as well as road access for Site 28 (Photo No. 66, Appendix D). The Paint and Dope Storage structure no longer remains onsite. The site had been partially graded to promote positive drainage. A stockpile with approximately 3 cubic yards of soil was observed. Two decommissioned monitoring wells were observed onsite (Photo Nos. 67, 70, and 71, Appendix D).

**Photo No. 66 – 15 September 2013
Overview of Site 16 and road access to Site 28. View facing north.**

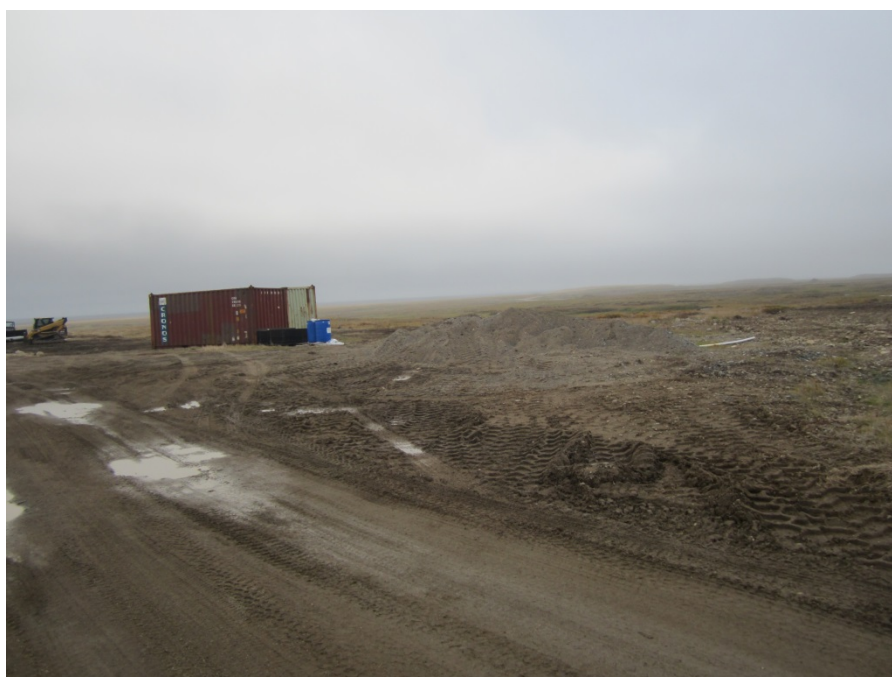
**Photo No. 68 – 15 September 2013
Overview of Site 16. View facing northeast.**

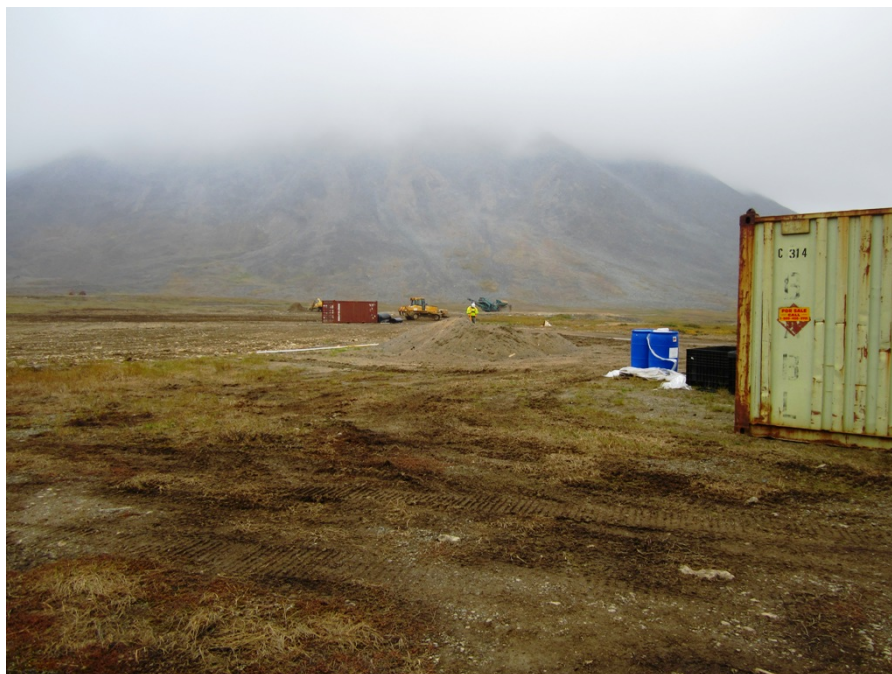
**Photo No. 69 – 15 September 2013
Overview of Site 16. View facing southwest.**

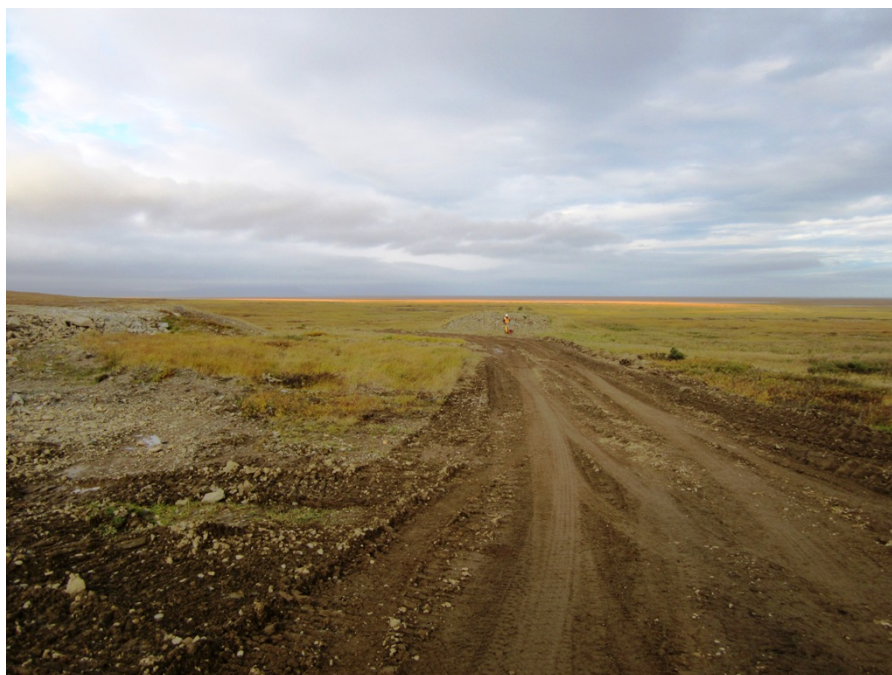
**Photo No. 74 – 15 September 2013
Road access to Site 21. View facing west.**

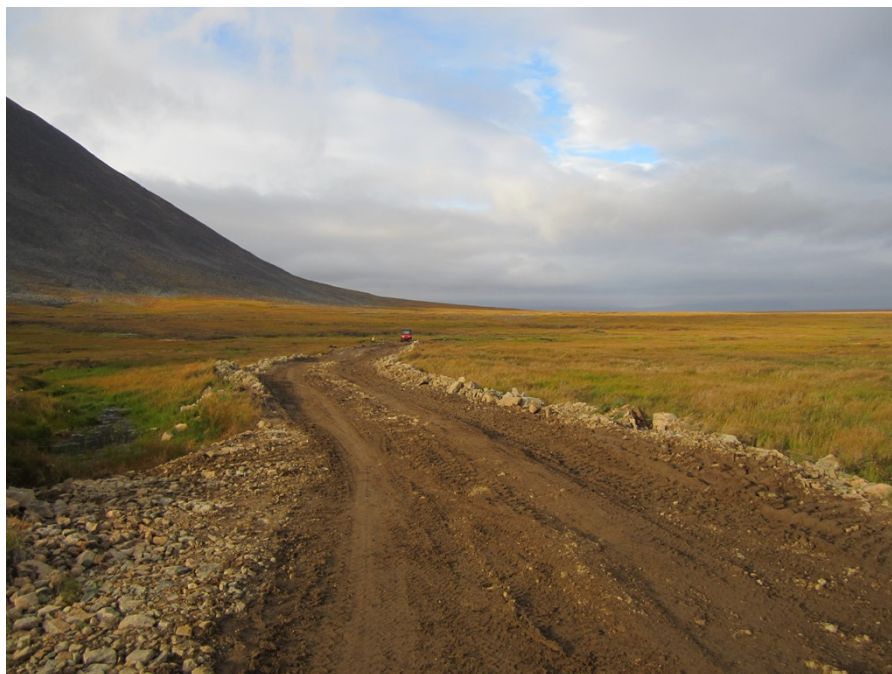
**Photo No. 75 – 15 September 2013
Road access to Site 21. View facing west.**

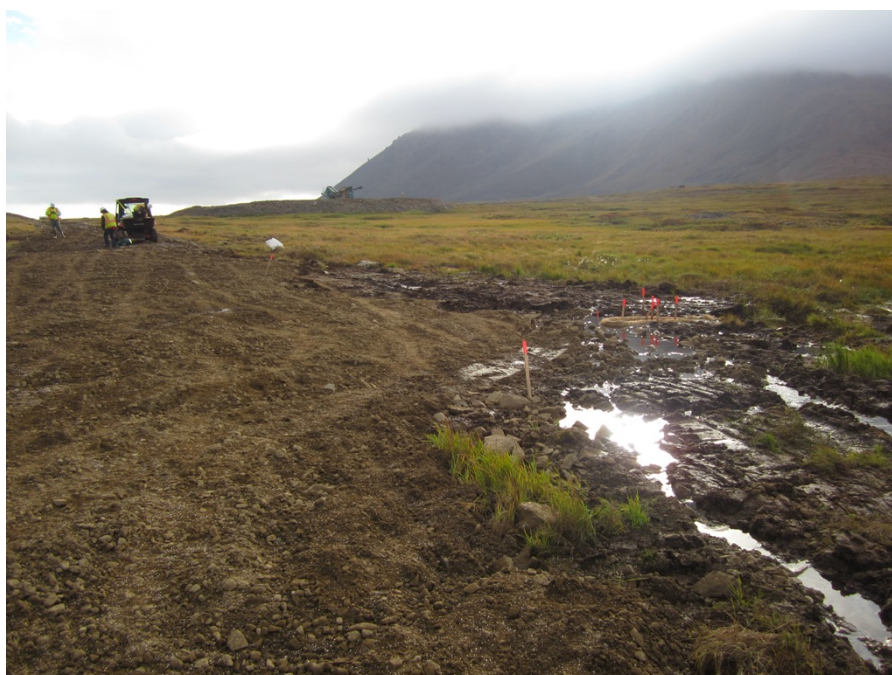
**Photo No. 76 – 15 September 2013
Backfill at Site 21. View facing southeast.**

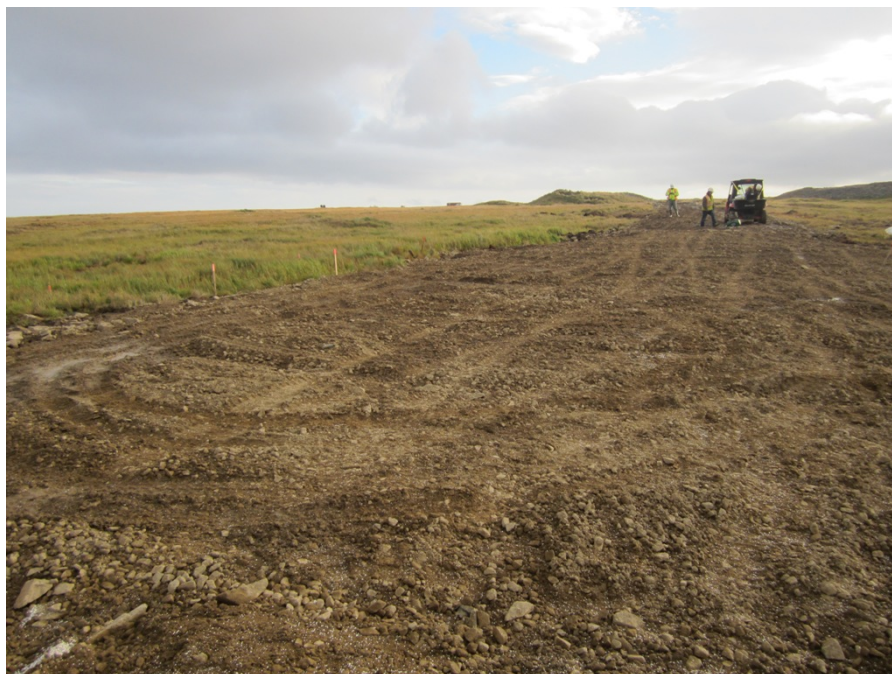
**Photo No. 77 – 15 September 2013
Backfill and grading at Site 21. View facing east.**

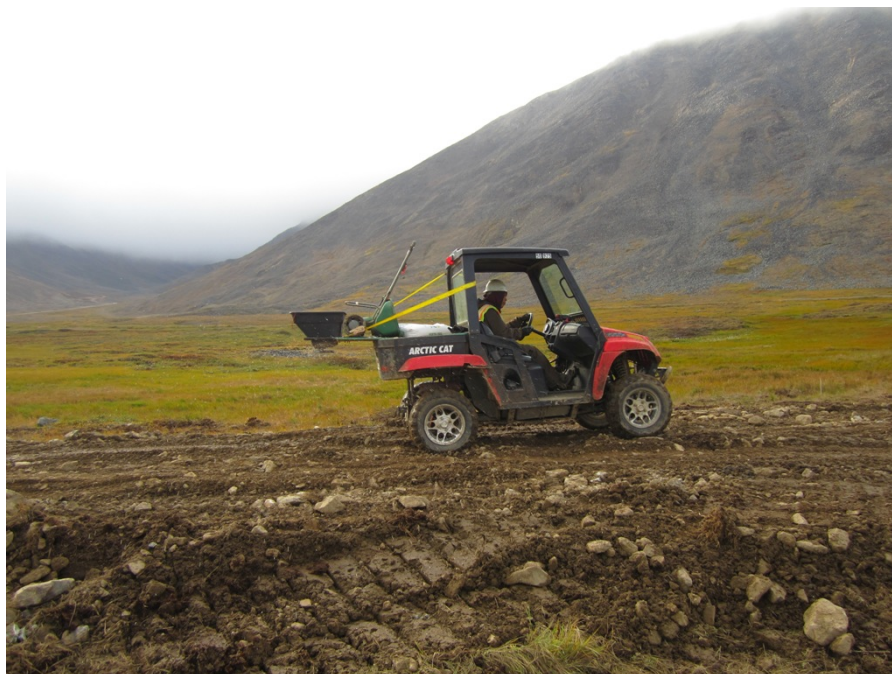
**Photo No. 79 – 15 September 2013
Seeding at Site 21. View facing south.**

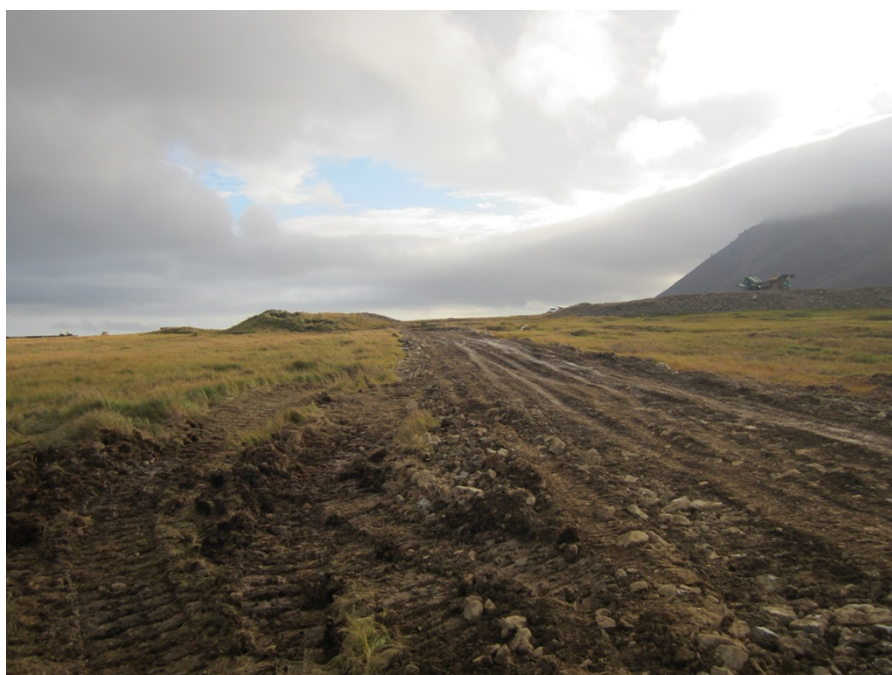
**Photo No. 80 – 15 September 2013
Road access to Site 21. View facing east.**

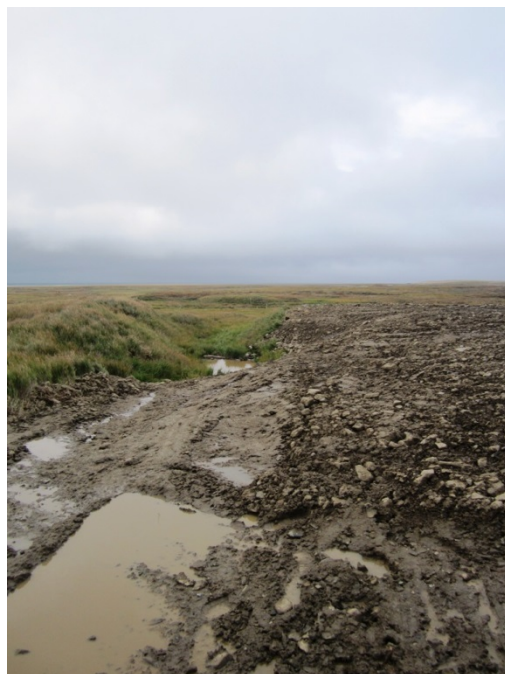
**Photo No. 81 – 15 September 2013
Drainage for Site 27. View facing north.**

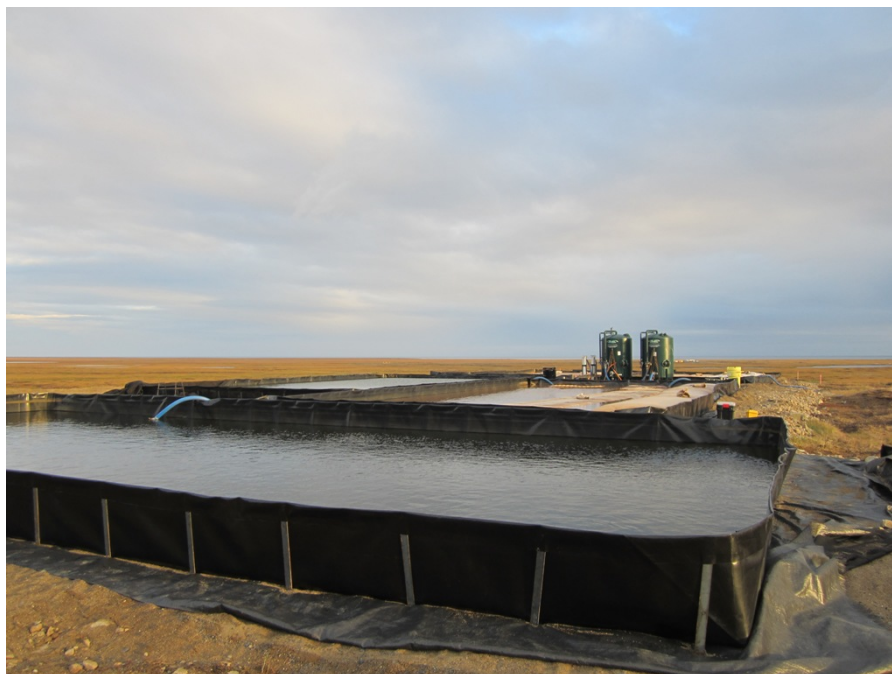
**Photo No. 83 – 15 September 2013
Sediment pond at Site 28. View facing north.**

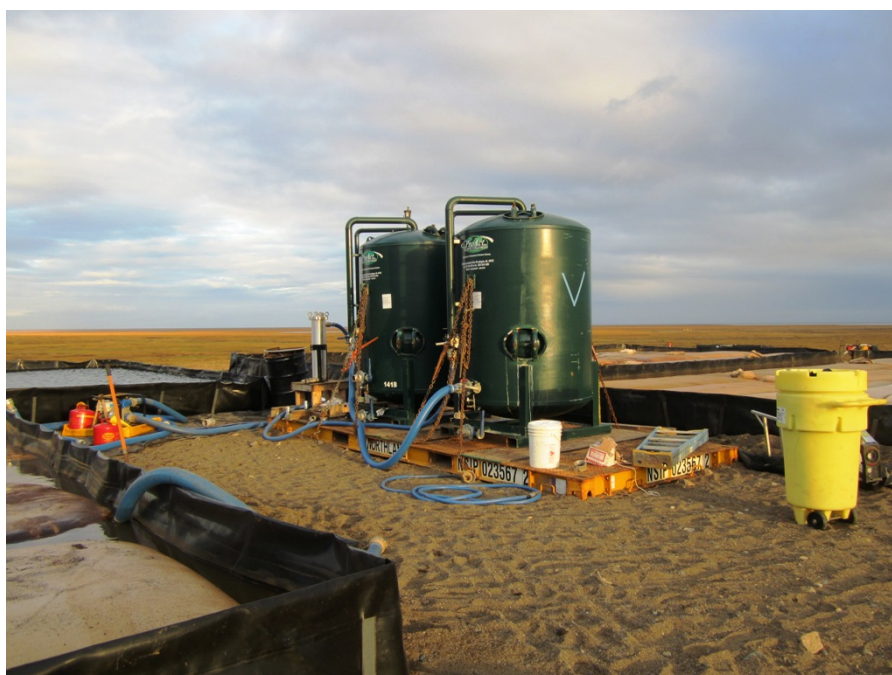
**Photo No. 84 – 15 September 2013
Water filters for remediation at Site 28. View facing northwest.**

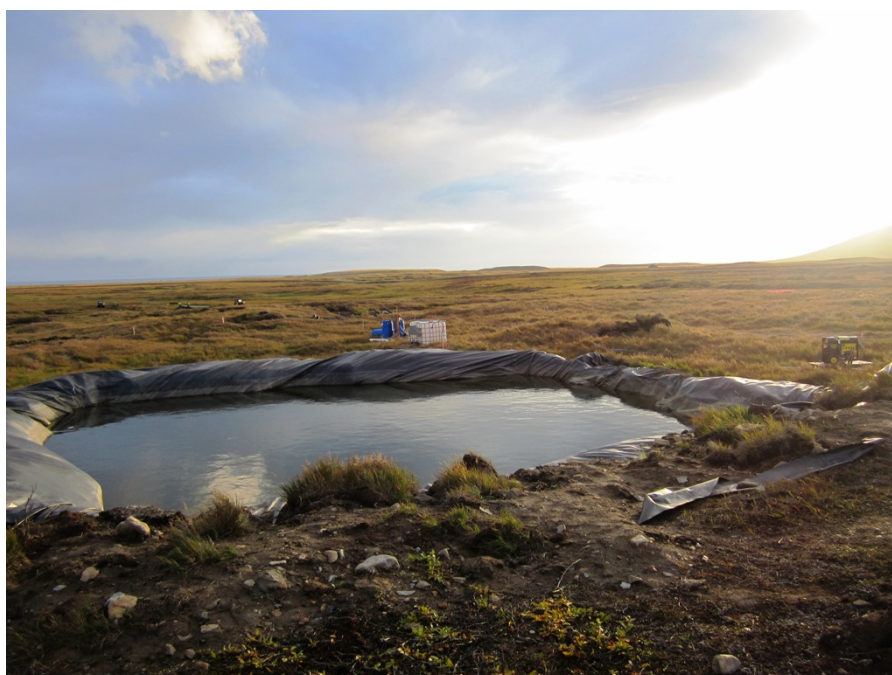
**Photo No. 86 – 15 September 2013
Intermediate pond for remediation at Site 28. View facing east.**

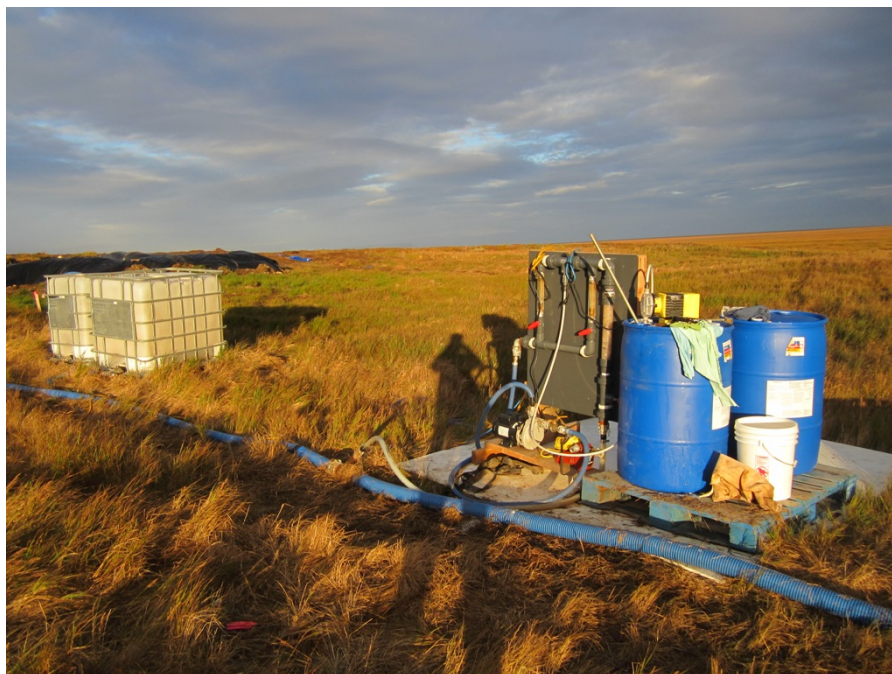
**Photo No. 87 – 15 September 2013
Flocculant station for remediation at Site 28. View facing north.**
