FIRST FIVE-YEAR REVIEW REPORT

NORTHEAST CAPE FUDS ST. LAWRENCE ISLAND, ALASKA

Formerly Used Defense Site No. F10AK0969-03

**FINAL
FEBRUARY 2015**

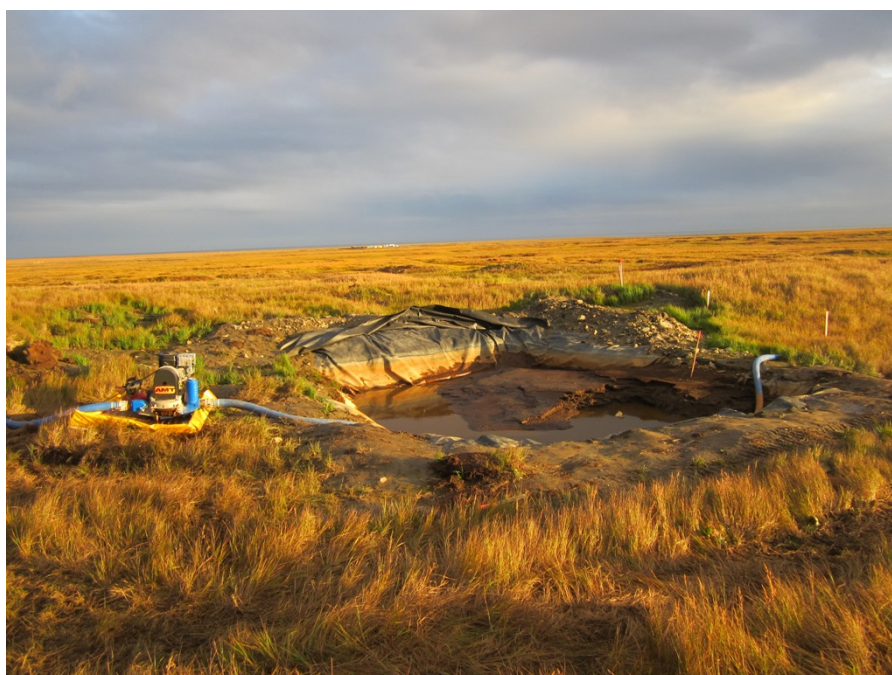
**Photo No. 88 – 15 September 2013
Intermediate pond for remediation at Site 28. View facing north.**

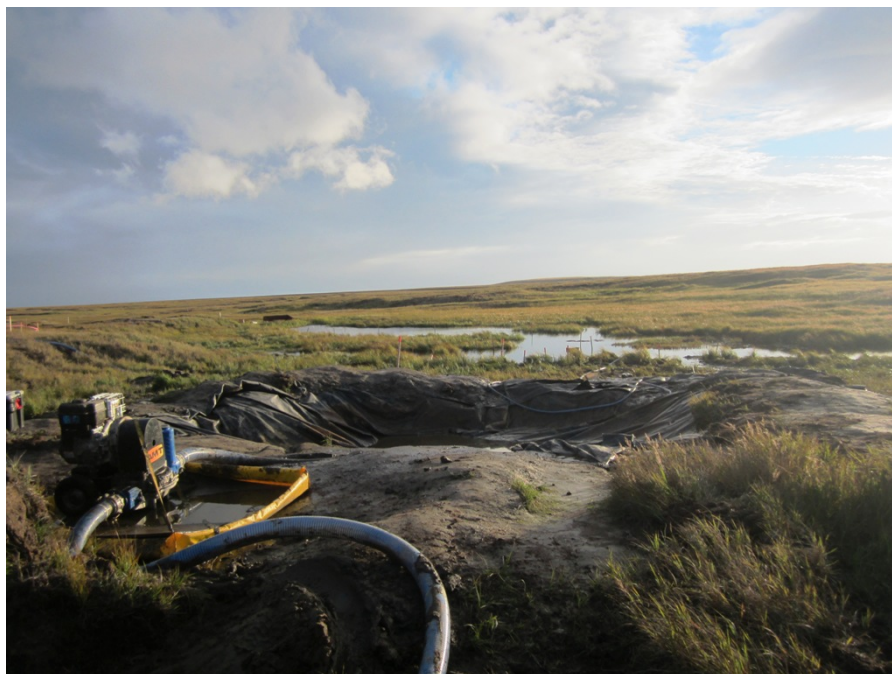
**Photo No. 92 – 15 September 2013
Sediment trap at Site 28. View facing east.**

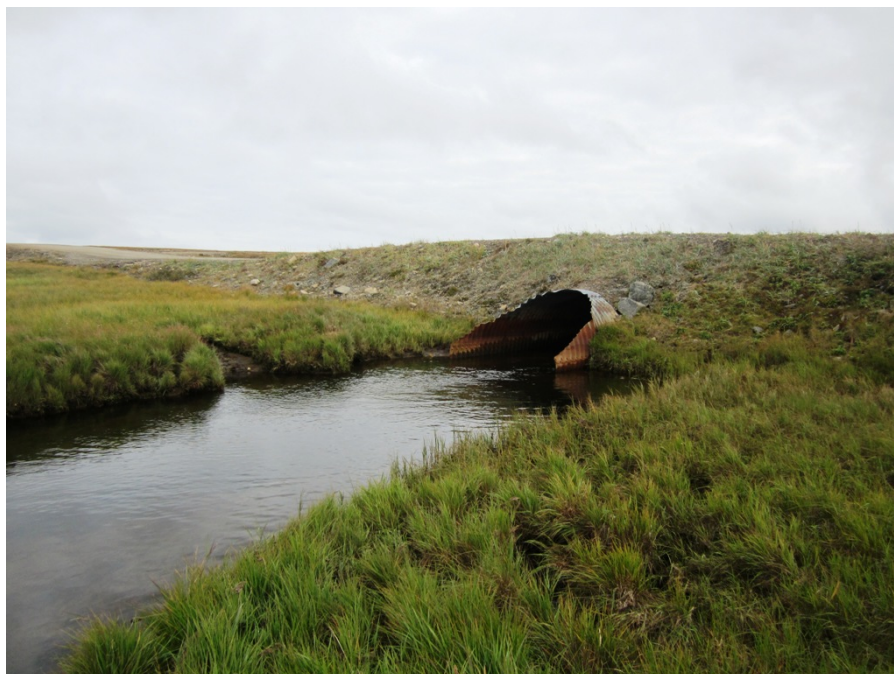
**Photo No. 103 – 14 September 2013
Culvert beneath the roadway at Site 29. View facing east.**

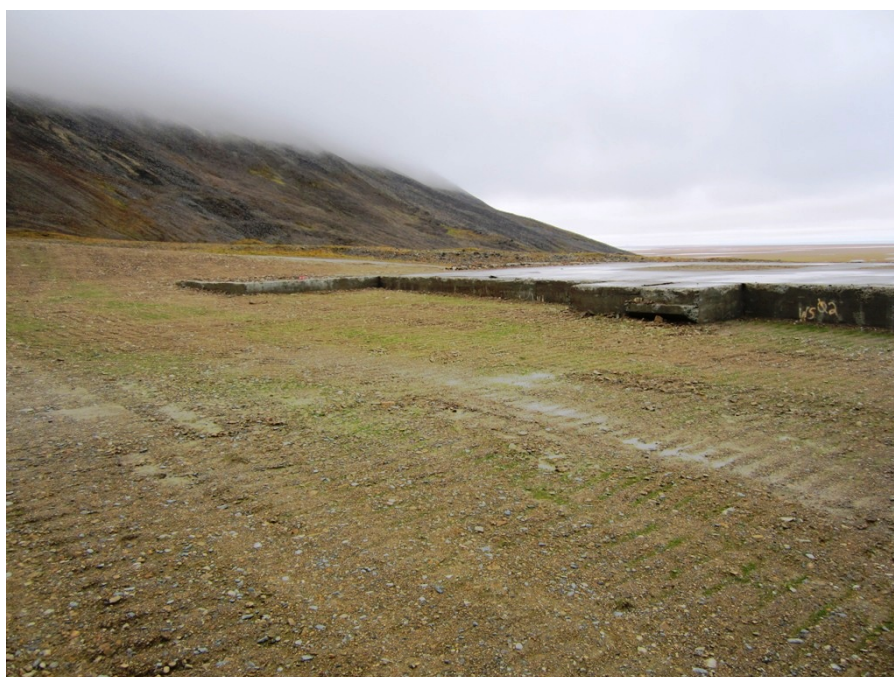
Photo No. 108 – 13 September 2013

Recent grading and seeding at Site 31. View facing west.

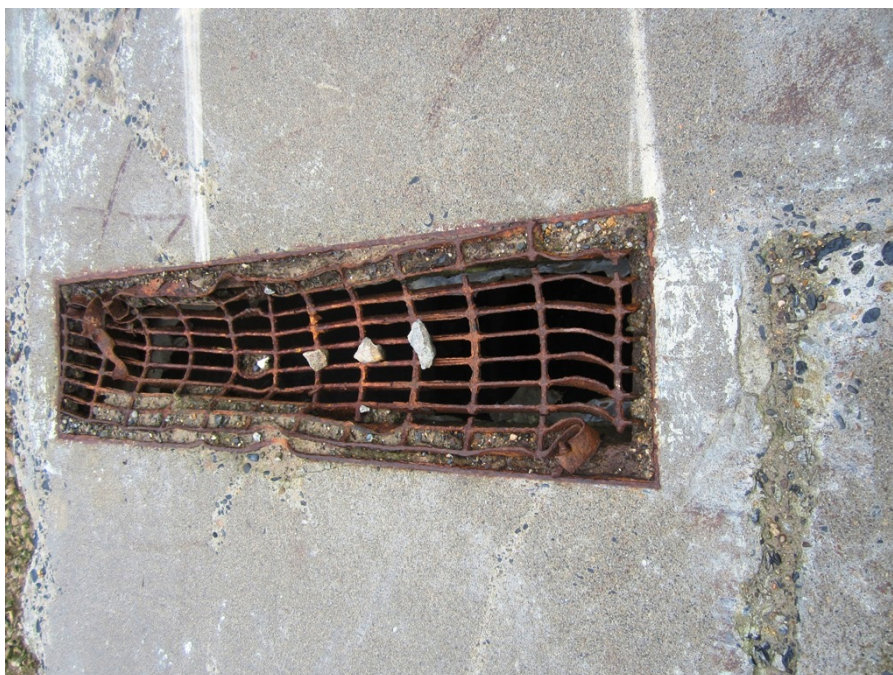
Four former antenna foundations and one building foundation were observed at Site 31. The building foundation contained an approximate 0.5-foot by 4-foot drain (Photo No. 112, Appendix D). The drain appeared to lead to an opening of approximately 5 feet by 9 feet by

**Photo No. 112 – 13 September 2013
Drain cover at Site 31.**

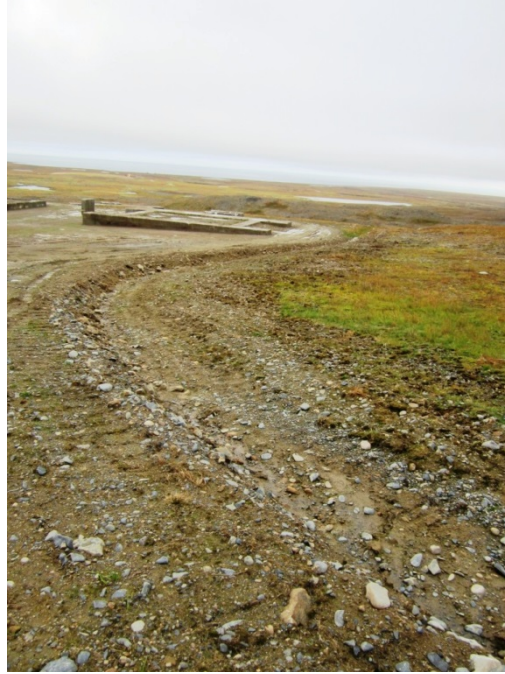
**Photo No. 113 – 13 September 2013
Constructed drainage at Site 31. View facing north.**

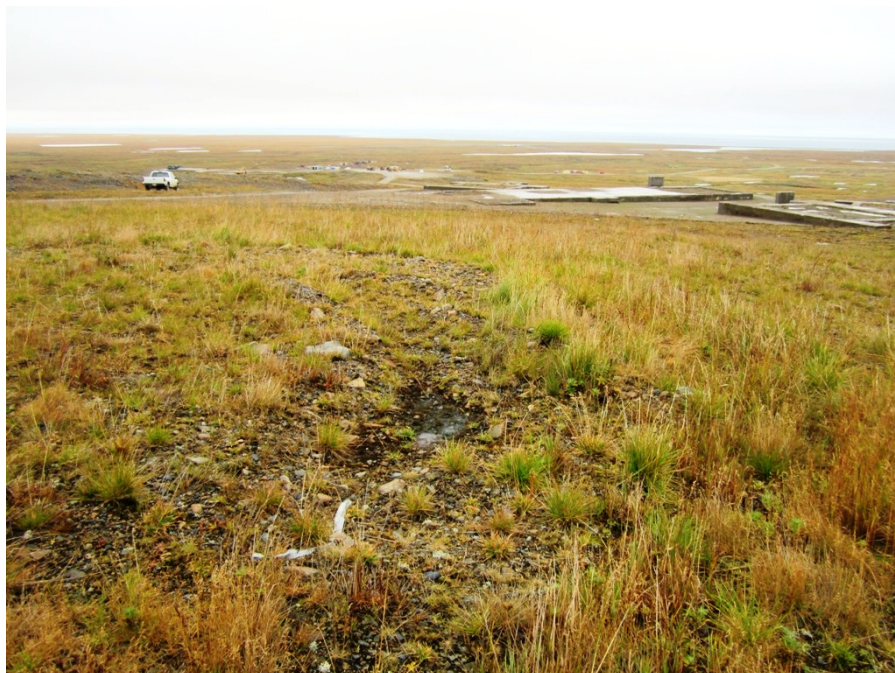
**Photo No. 114 – 13 September 2013
Slight depression at Site 31. View facing north.**

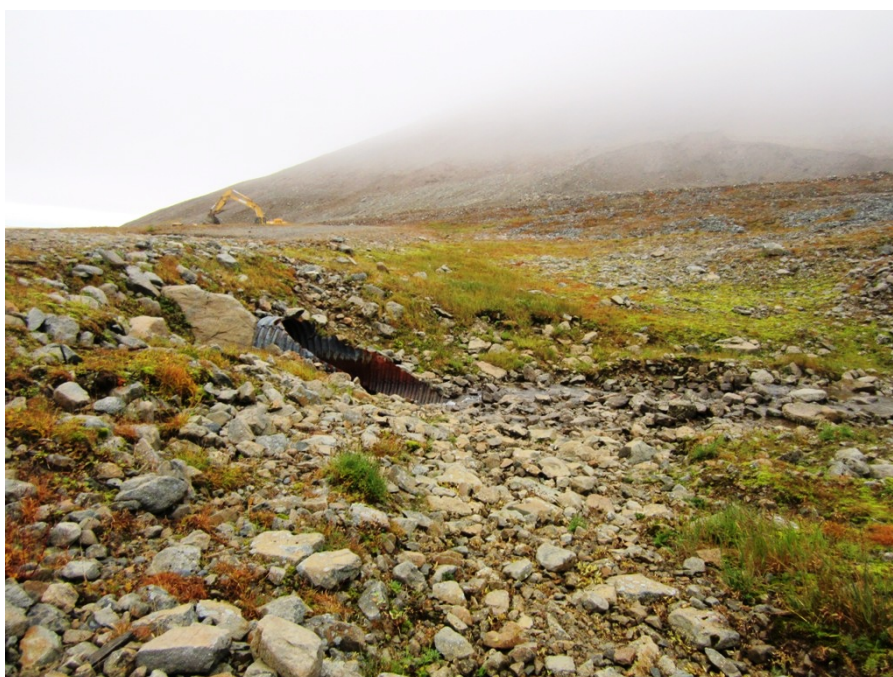
**Photo No. 122 – 13 September 2013
Culvert extending to the south below roadway at Site 32. View facing north.**

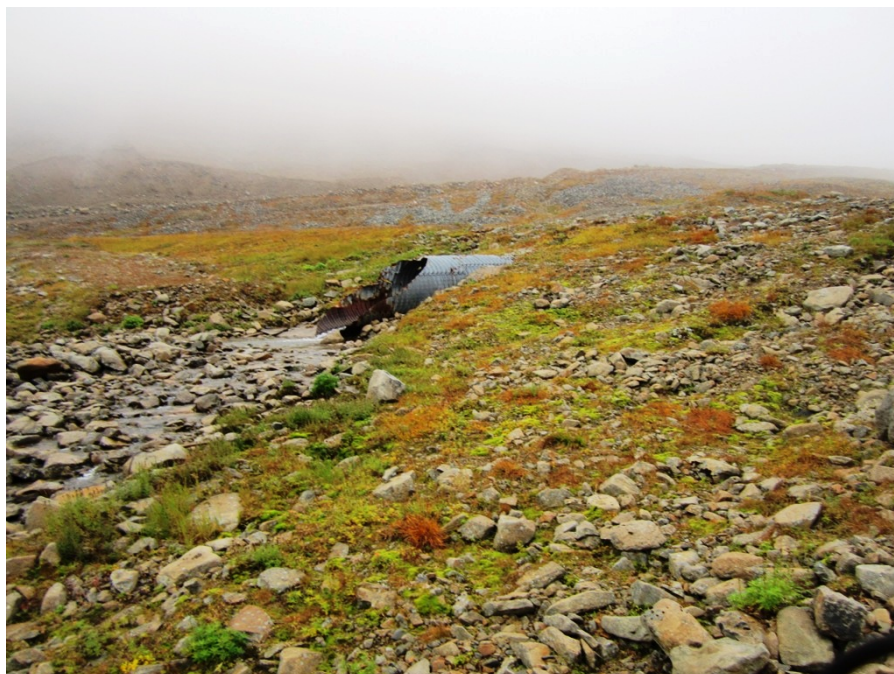
Photo No. 123 – 13 September 2013
Culvert extending to the north below the roadway at Site 32. View facing east.
