WORK PLAN ADDENDUM

2014 Northeast Cape HTRW Remedial Actions
Northeast Cape, St. Lawrence Island, Alaska

Contract No. W911KB-14-D-0006
Task Order 0002

August 2015

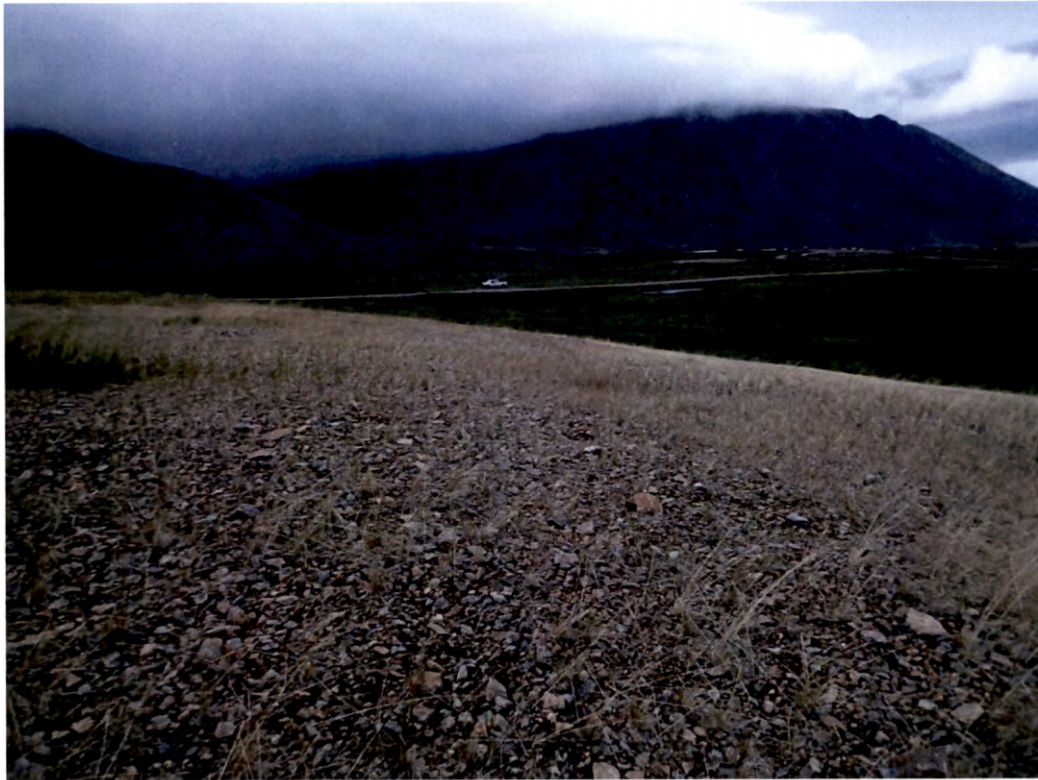
Photo 3: Site 7 Landfill - View of west side of landfill area, facing south.

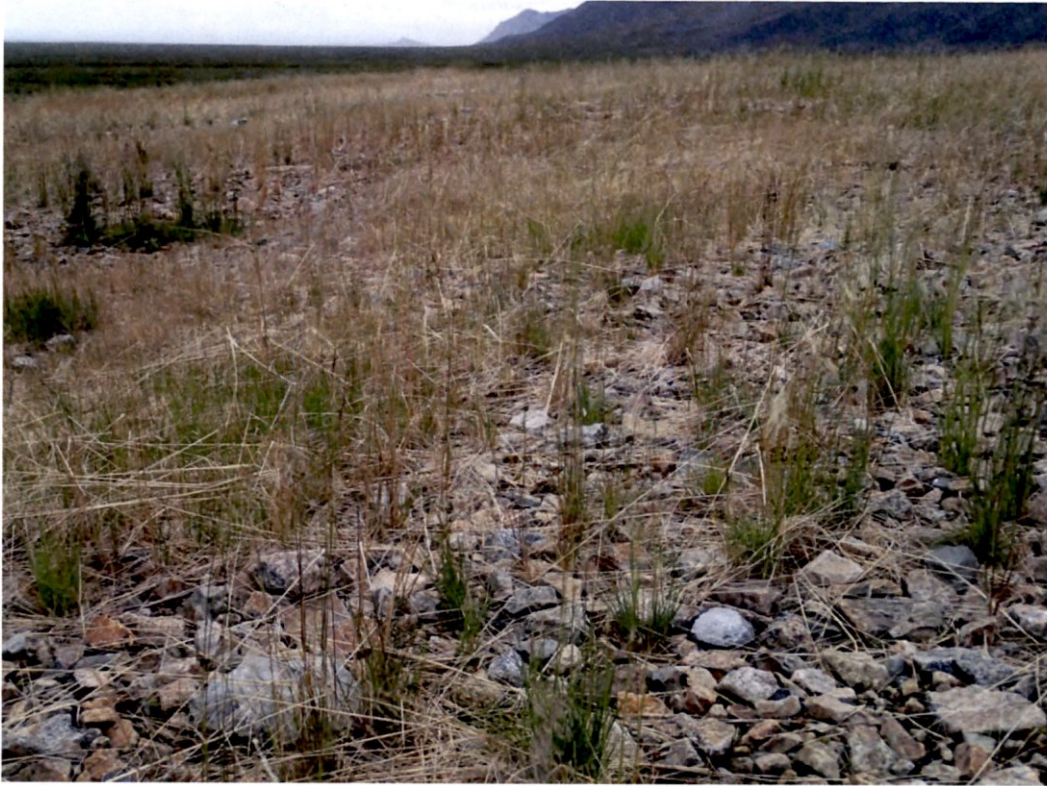
Photo 5: Site 7 Landfill – Surface of landfill, note both newer (green) and older (brown) grass tufts, facing east.

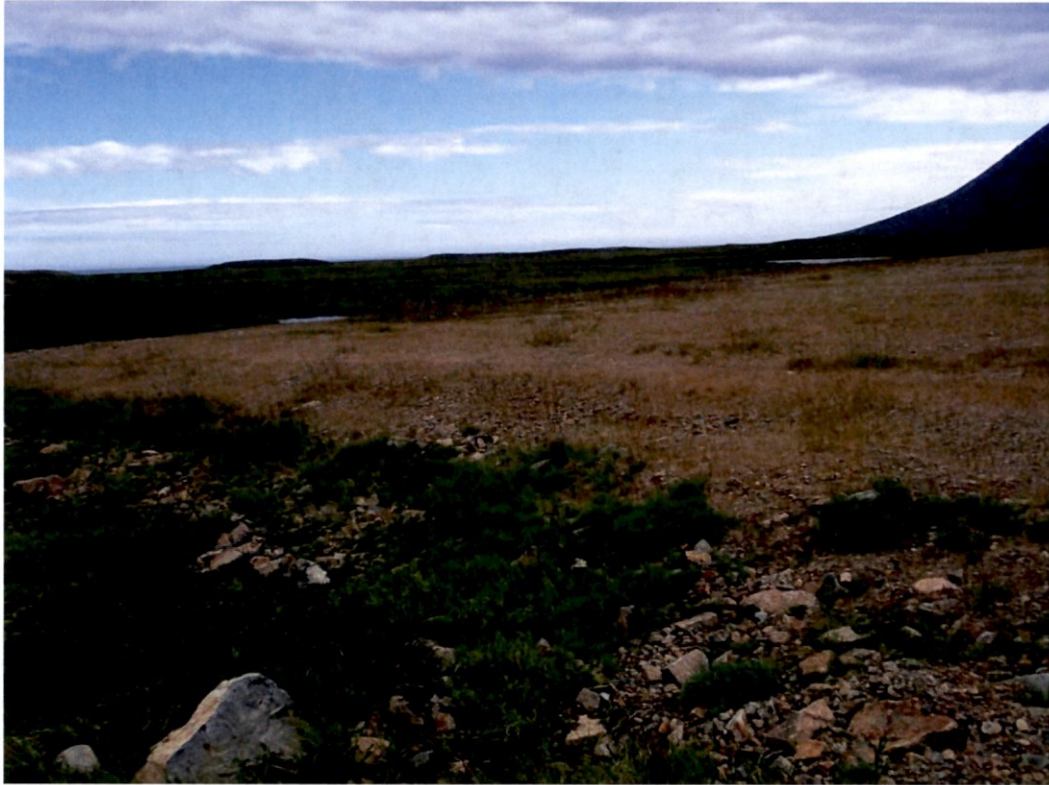
Photo 9: Site 9 Landfill – North end of landfill, facing NE.

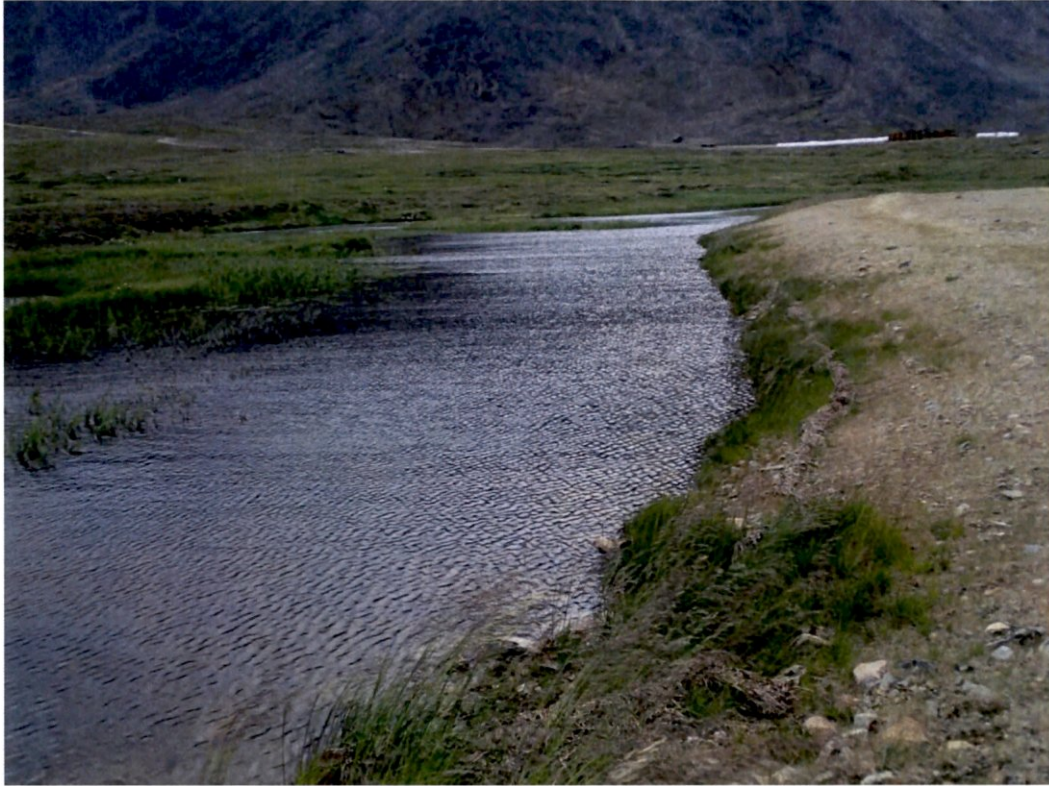
Photo 11: Site 9 Landfill – Pond along SE side of landfill, facing SW.

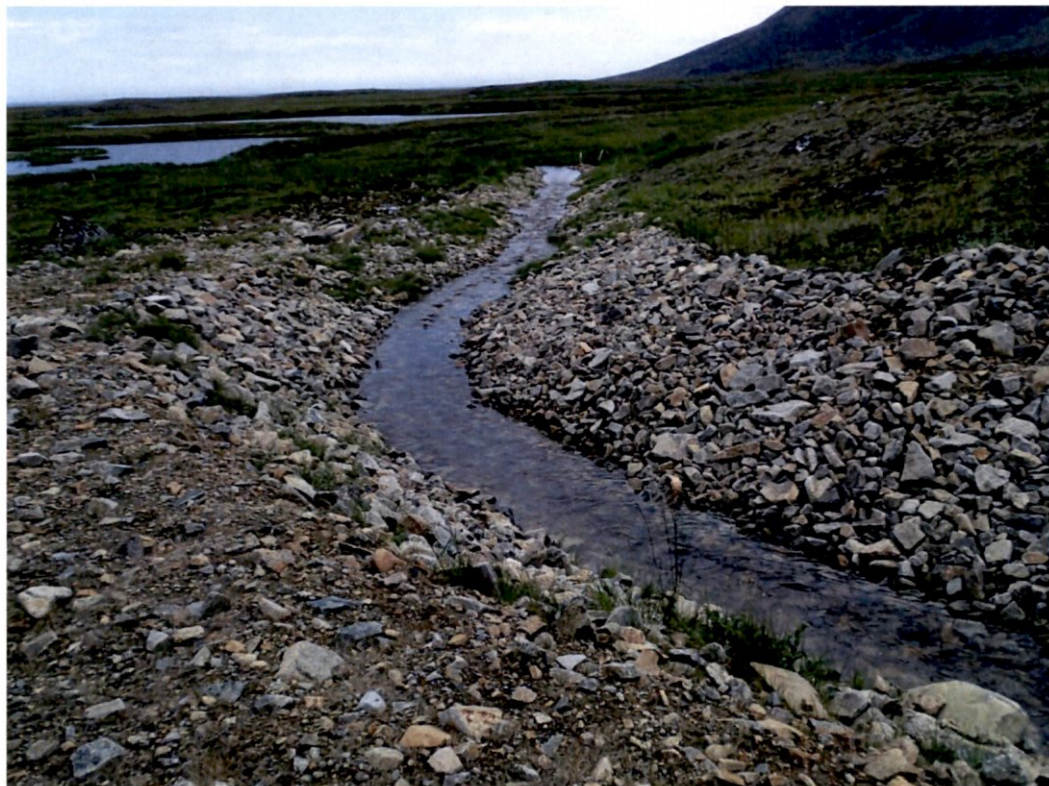
Photo 12: Site 9 Landfill – Diversion ditch that drain pond shown in Photo 11, operating sufficiently, facing NE.

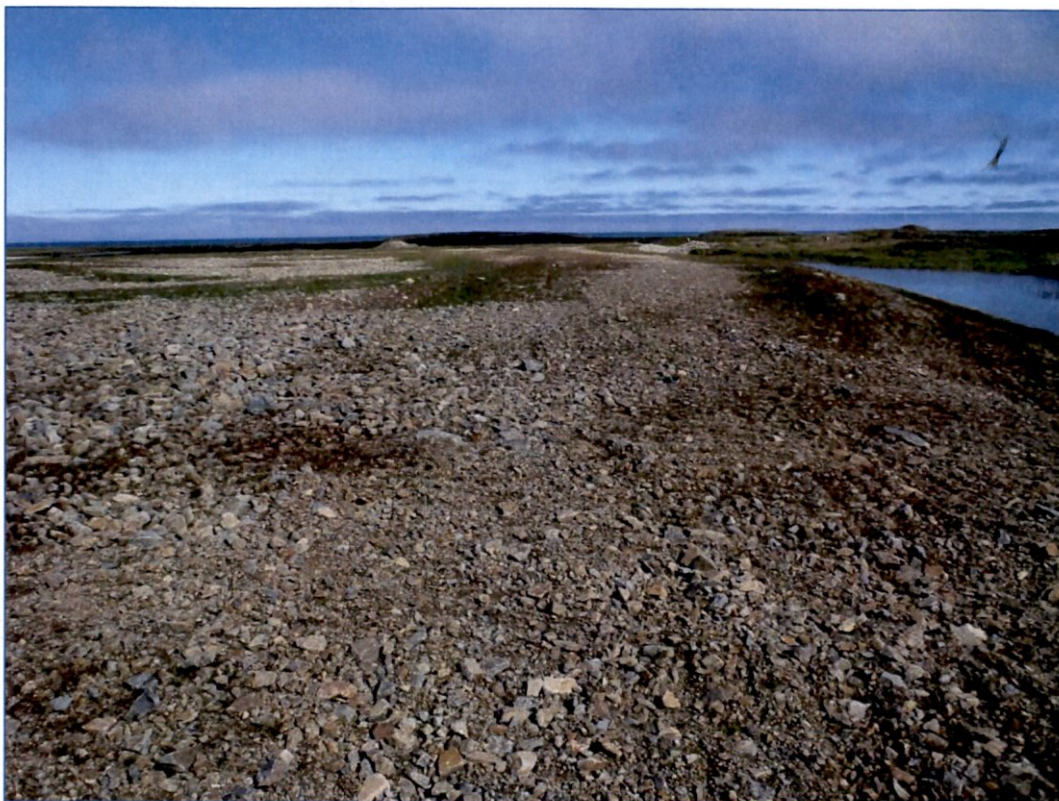
Photo 13: Site 9 Landfill – East side of landfill, facing north.

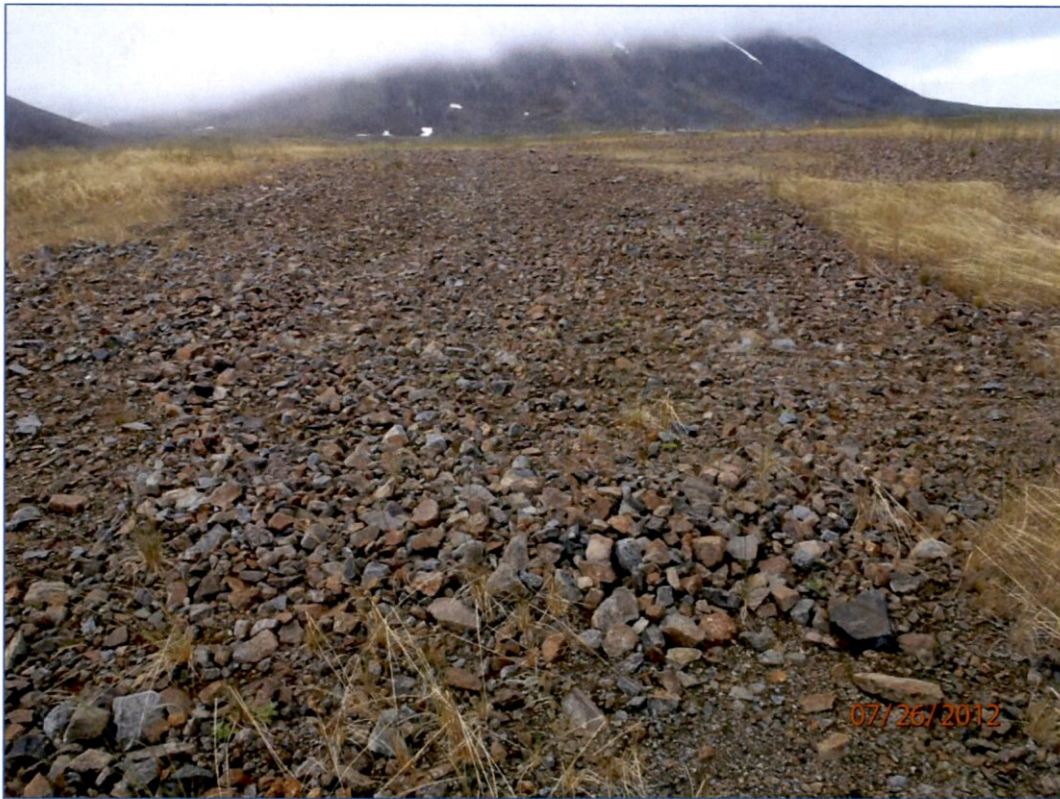
Photo 2: Site 7 Landfill – View of landfill cap from north side, facing southwest.

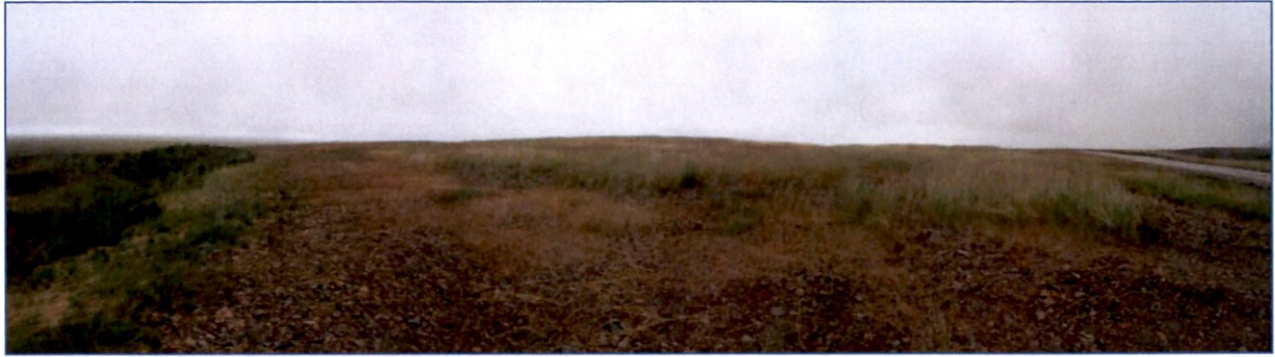
Photo 3: Site 7 Landfill – Panorama view from south side of landfill, facing north, road on right.

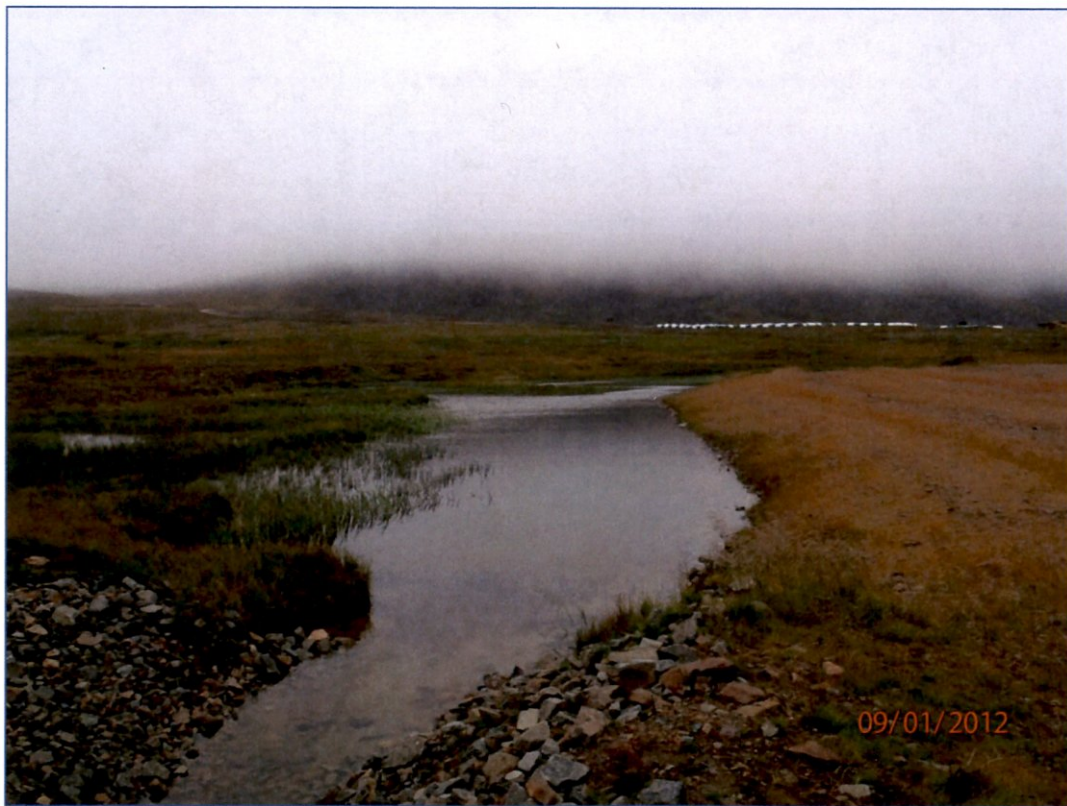
Photo 14: Site 9 Landfill – East side of landfill and adjacent pond, facing southwest.

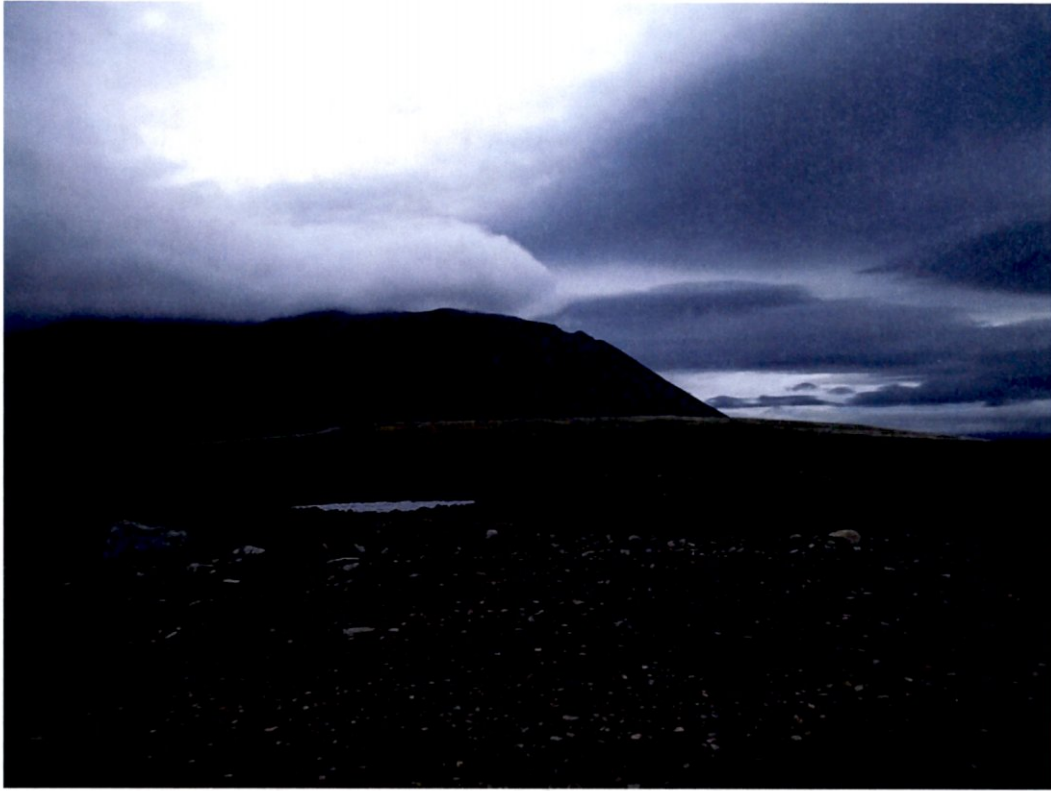
Photo 1: Site 7 Landfill - Overview of landfill area, facing SW.

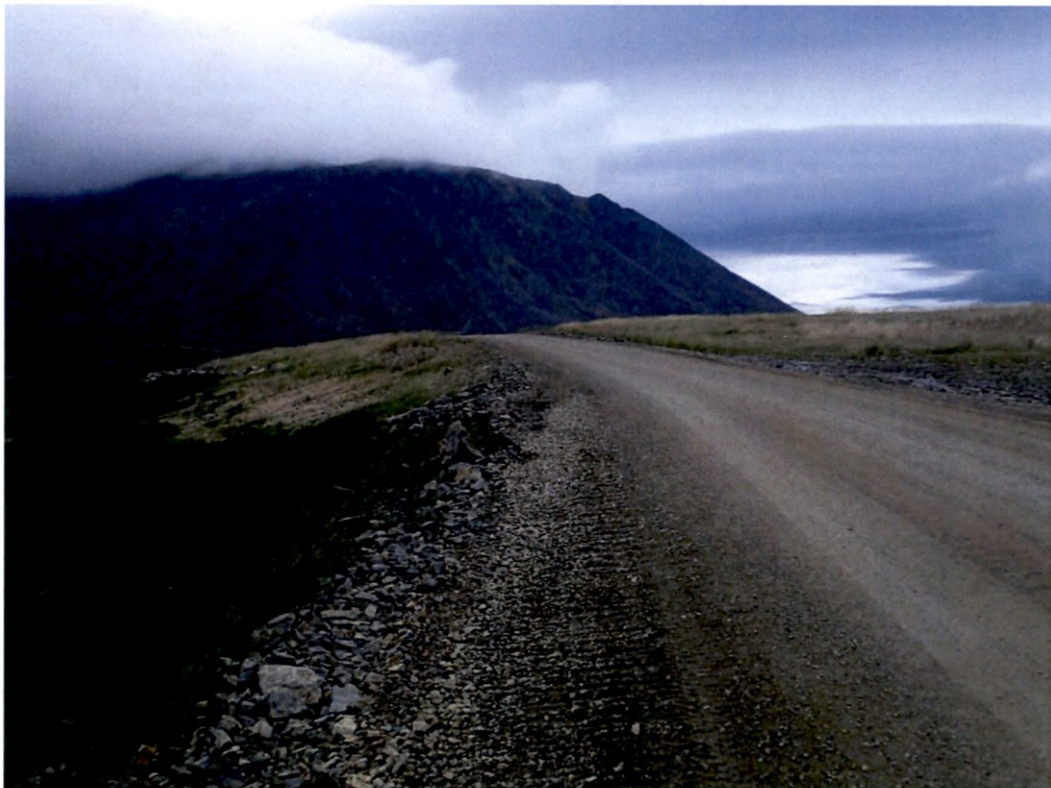
Photo 2: Site 7 Landfill - View of south side of landfill from Cargo Beach Road, facing SW.

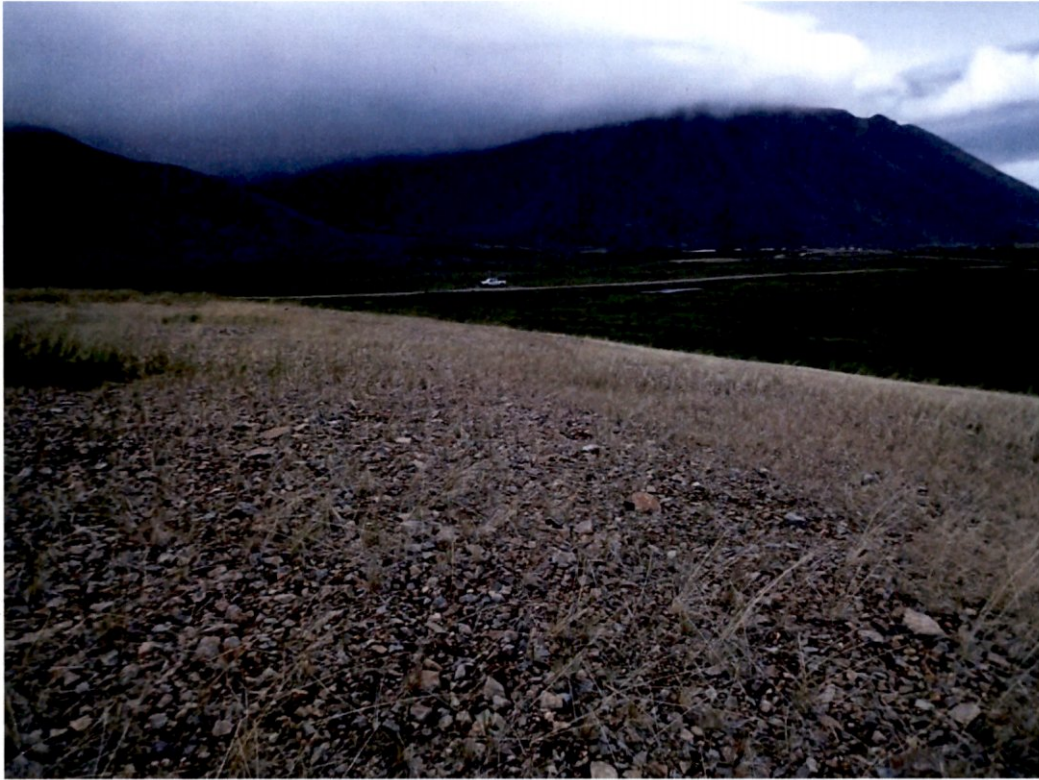
Photo 3: Site 7 Landfill - View of west side of landfill area, facing south.

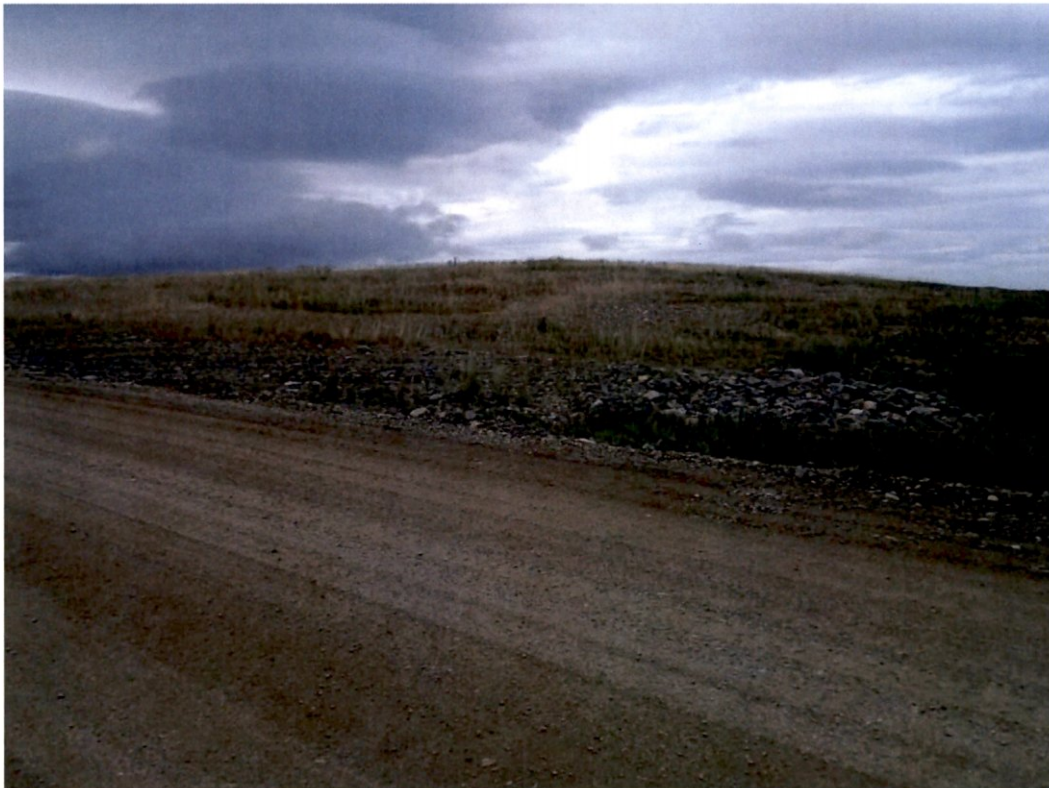
Photo 4: Site 7 Landfill – Southeast side of landfill from Cargo Beach Road, facing NW.

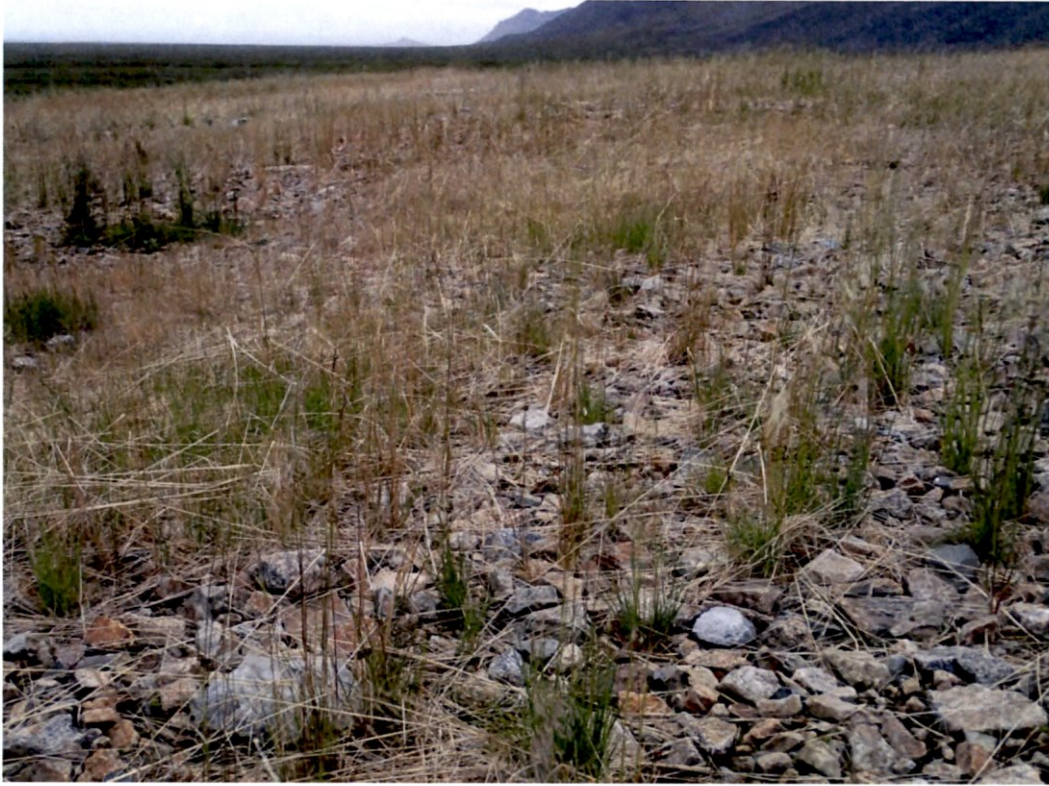
Photo 5: Site 7 Landfill – Surface of landfill, note both newer (green) and older (brown) grass tufts, facing east.

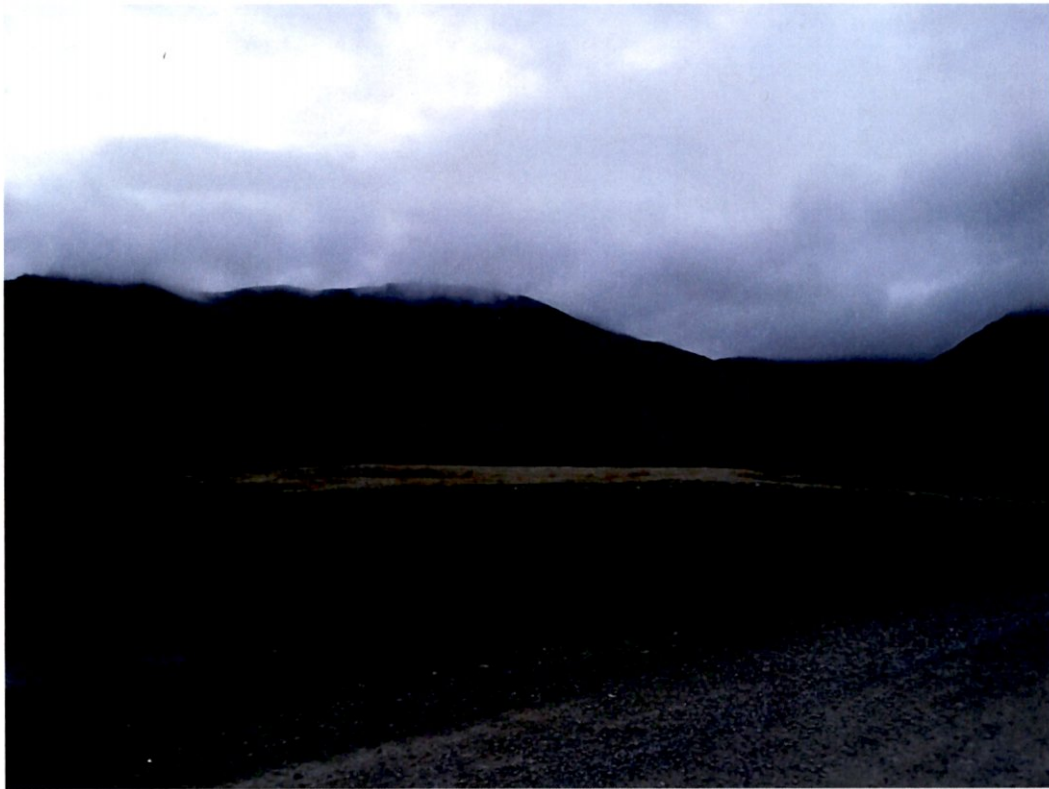
Photo 7: Site 9 Landfill – Overview of entire landfill area from site access road, facing south.

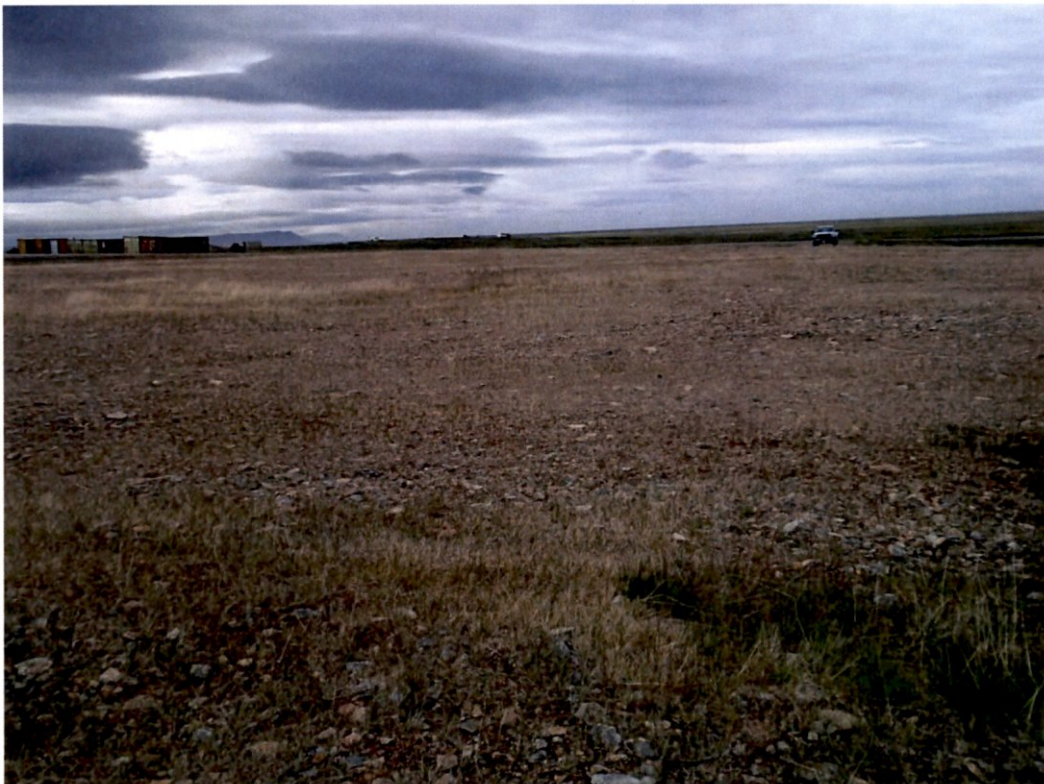
Photo 8: Site 9 Landfill – View of landfill facing west, MOC in background.

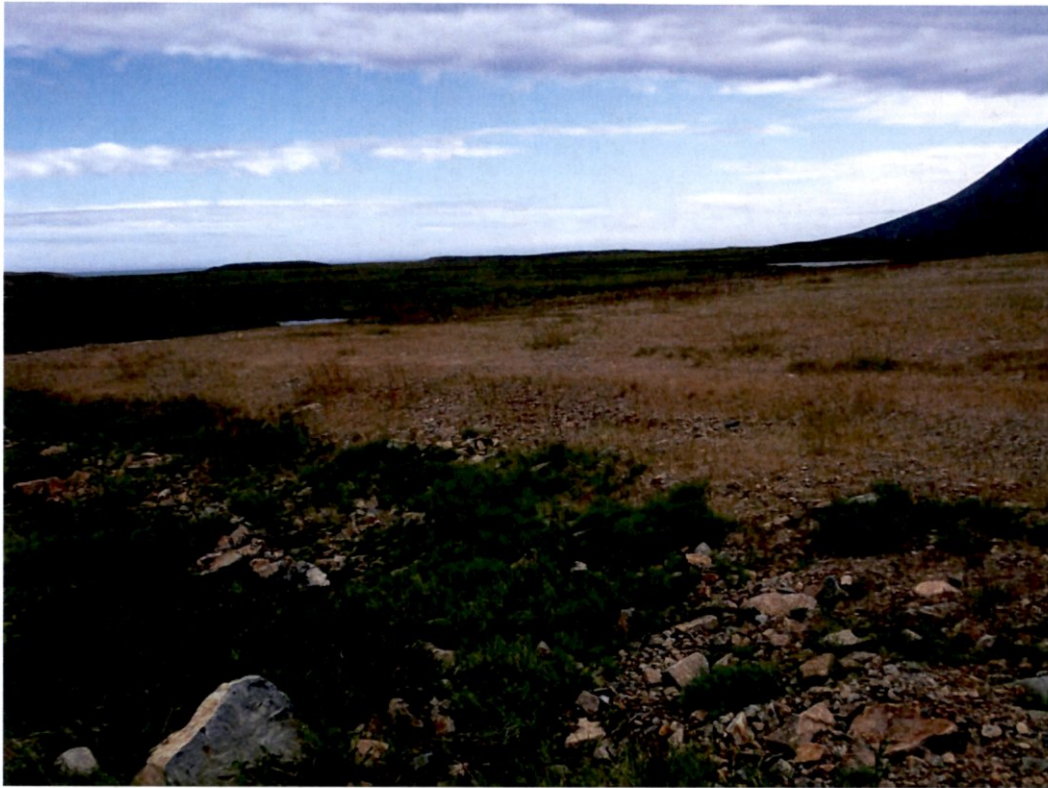
Photo 9: Site 9 Landfill – North end of landfill, facing NE.

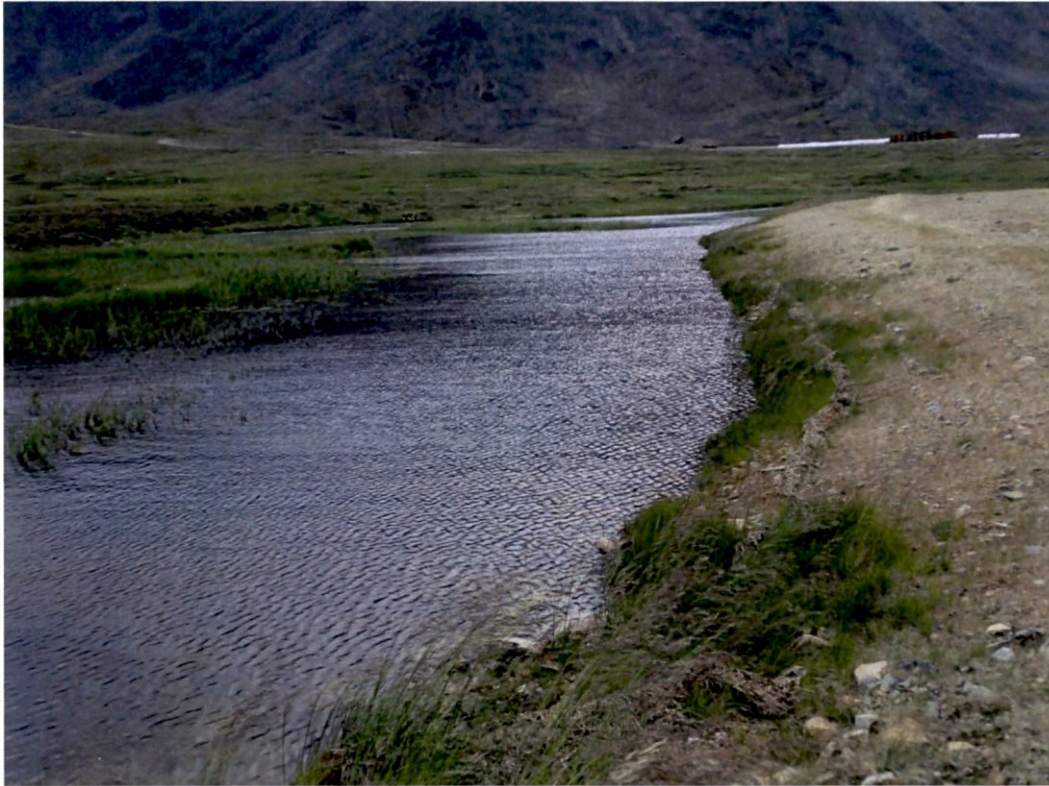
Photo 11: Site 9 Landfill – Pond along SE side of landfill, facing SW.

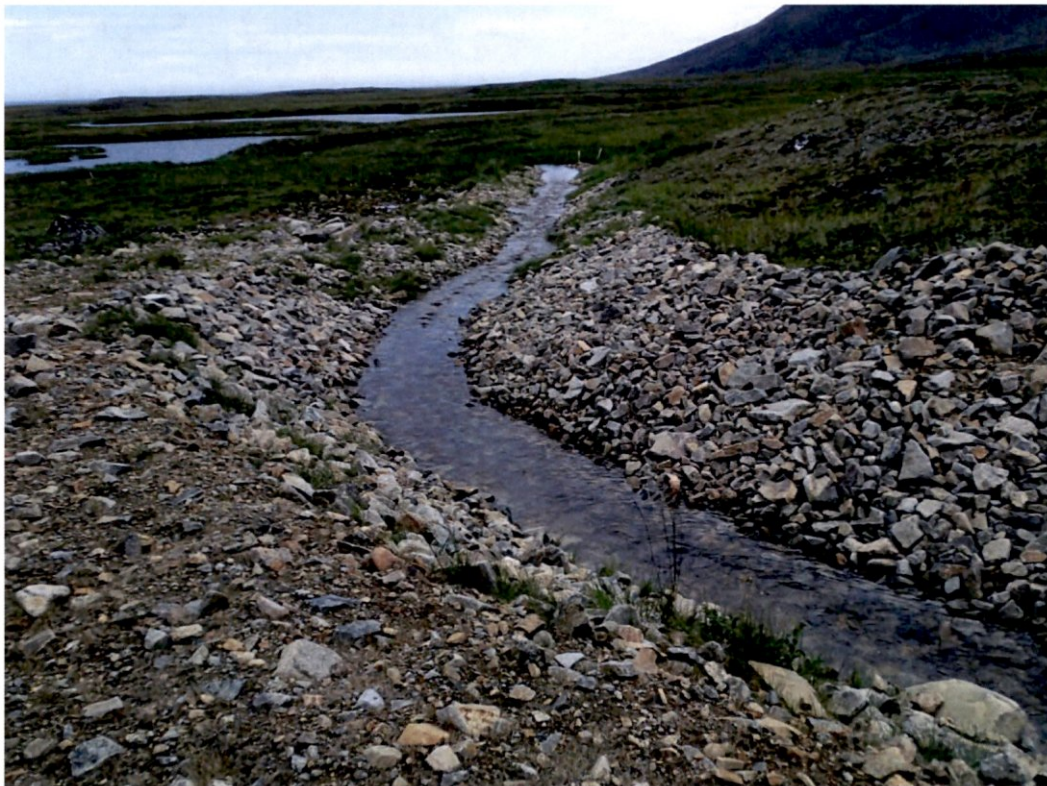
Photo 12: Site 9 Landfill – Diversion ditch that drain pond shown in Photo 11, operating sufficiently, facing NE.

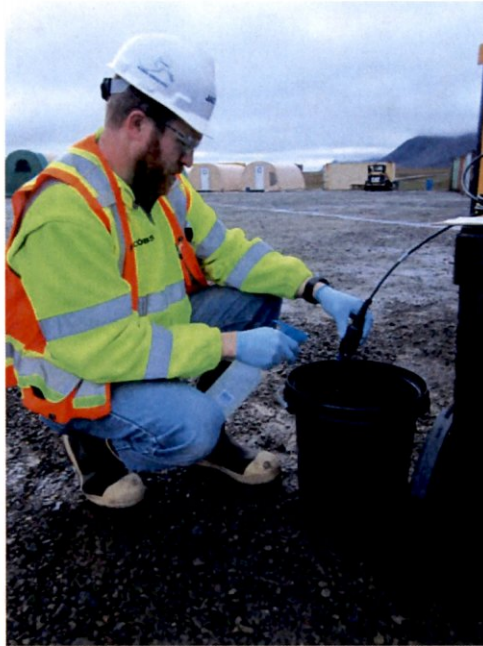
Photo No. 1 – 12 September 2013
Calibrating the YSI water quality meter. Facing south.

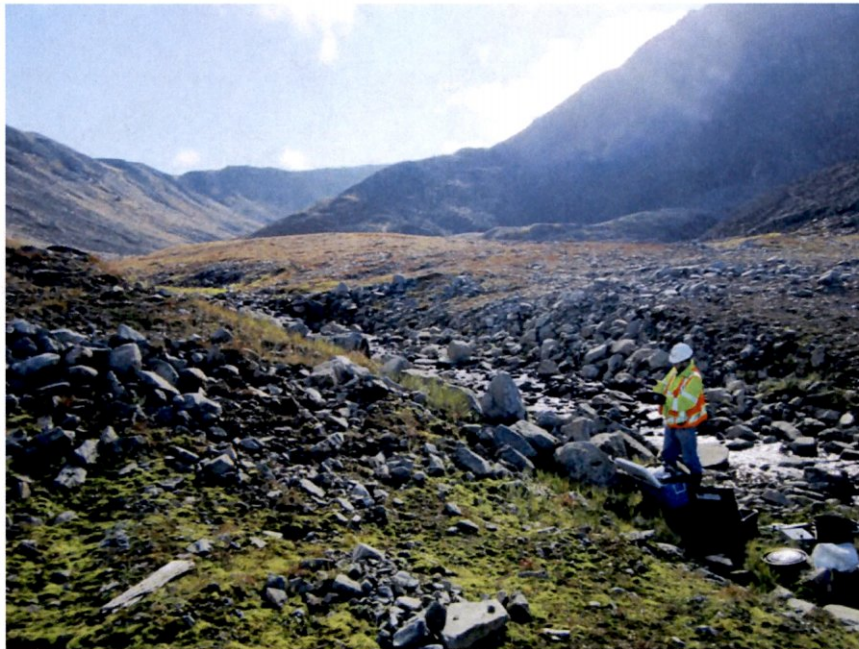
Photo No. 2 – 12 September 2013
Sampling at Kangukhsam Mountain Spring. Facing south.

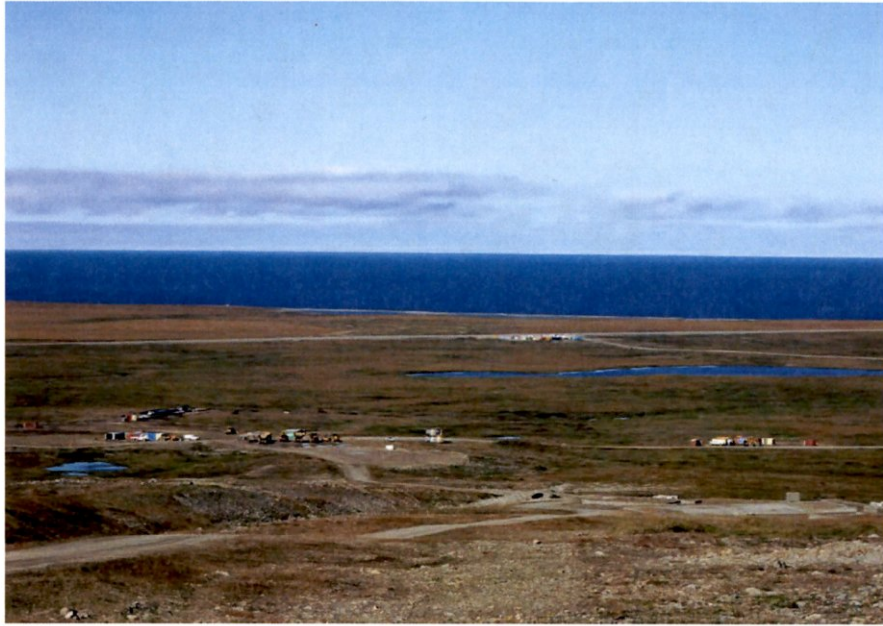
Photo No. 3 – 12 September 2013
Overview of Northeast Cape. Photograph taken facing north.

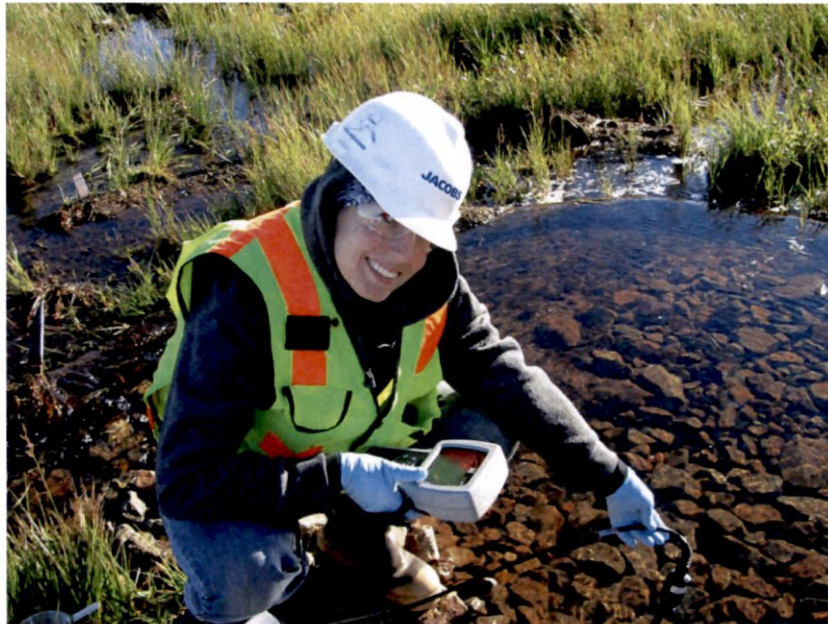
Photo No. 5 – 12 September 2013

Measuring surface water quality parameters prior to sampling at Site 9. Facing northeast.

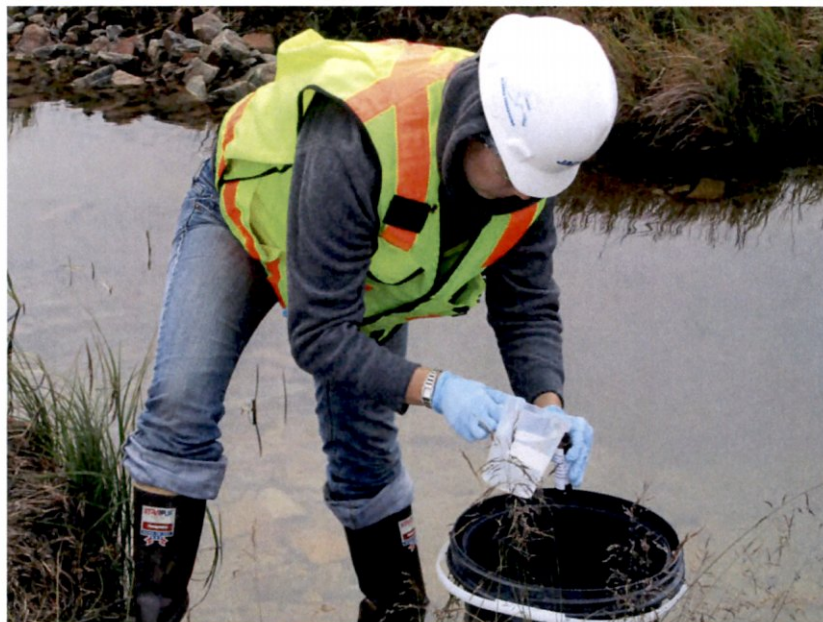
Photo No. 6 – 21 September 2013

Sampling surface water at Site 9. Facing northeast

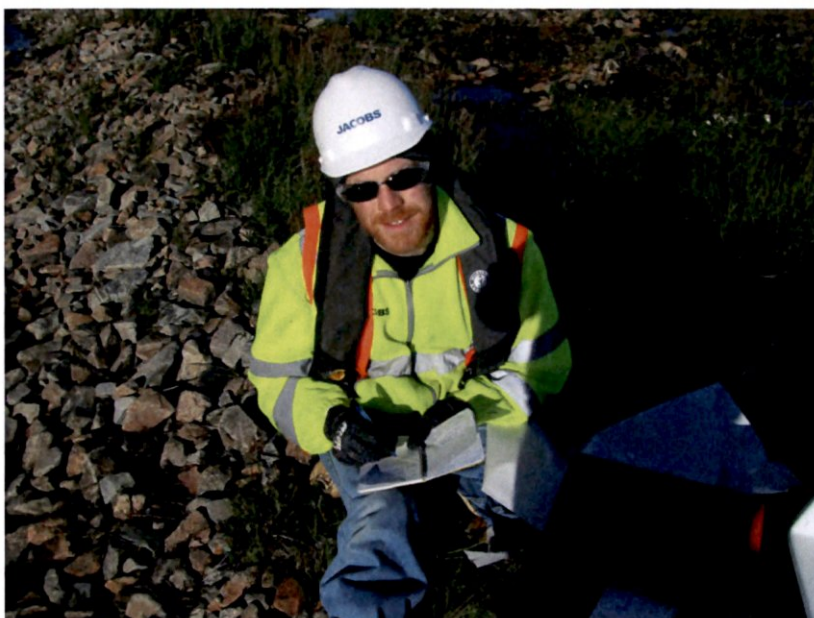
Photo No. 7 – 12 September 2013
Recording sampling efforts in the field logbook. Facing south.

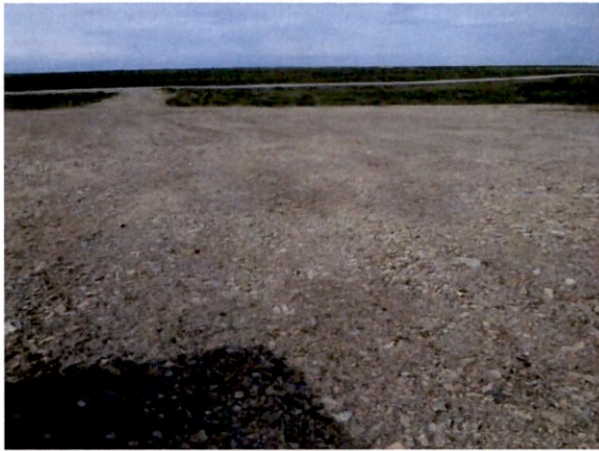
Photo 1: View of landfill cap surface looking toward road, facing NW.

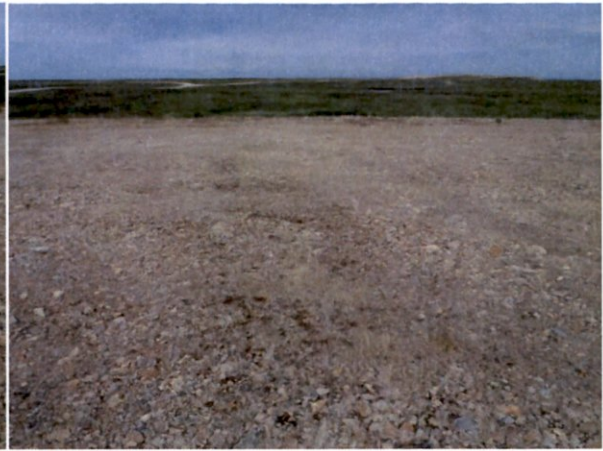
Photo 2: View of landfill cap surface, facing north toward Site 7 landfill (in background).

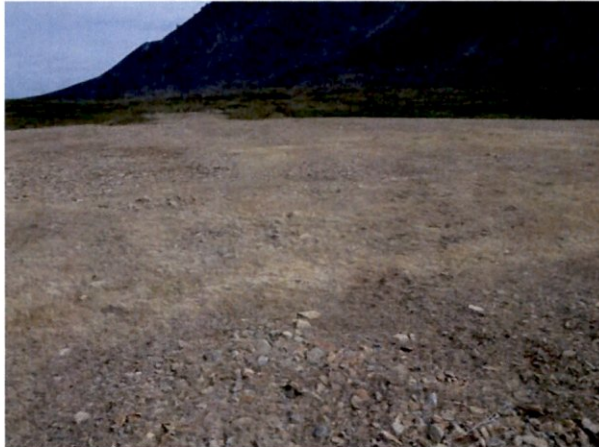
Photo 3: Surface of landfill cap, facing west.

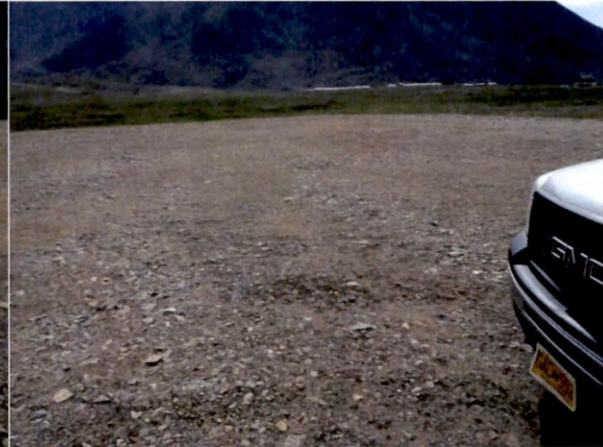
Photo 4: Surface of landfill cap, facing SW.

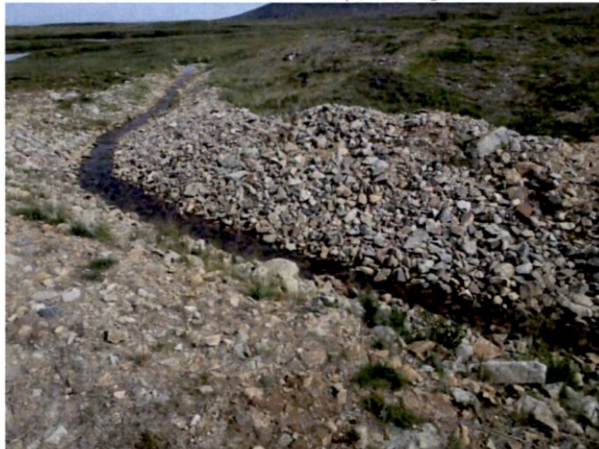
Photo 5: View of diversion ditch, functioning very well, facing NE.

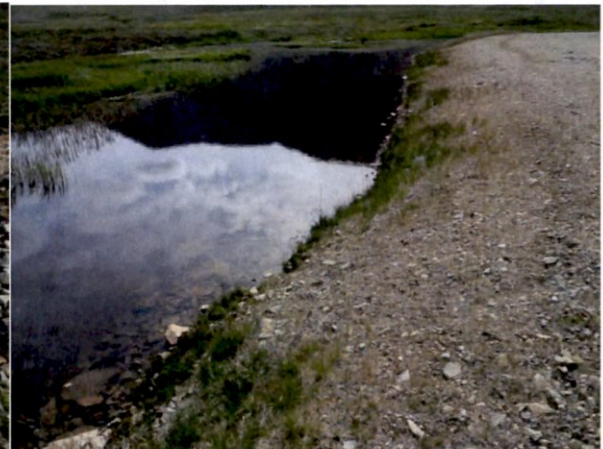
Photo 6: East side of landfill cap surface water pond, facing south.
