NATIVE VILLAGE OF NORTHEAST CAPE SITE INVESTIGATION REPORT REVISION 1

**Northeast Cape, St. Lawrence Island, Alaska
December 2009**

**Prepared for:
Native Village of Savoonga IRA Council
P.O. Box 120
Savoonga, Alaska 99769**

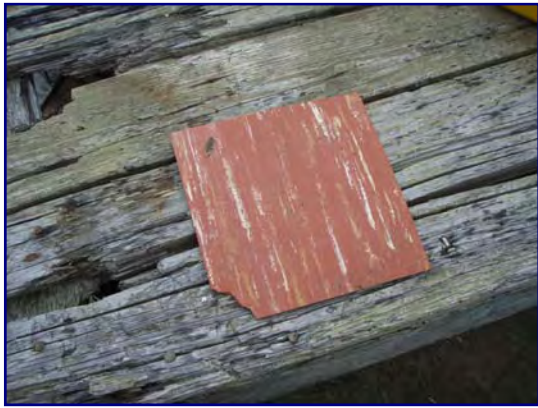
Red 9 X 9 Tile

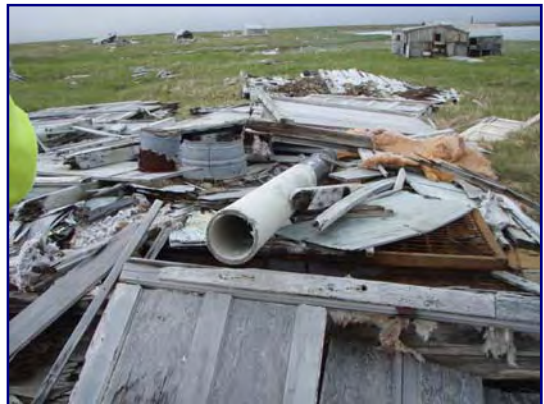
Transite pipe

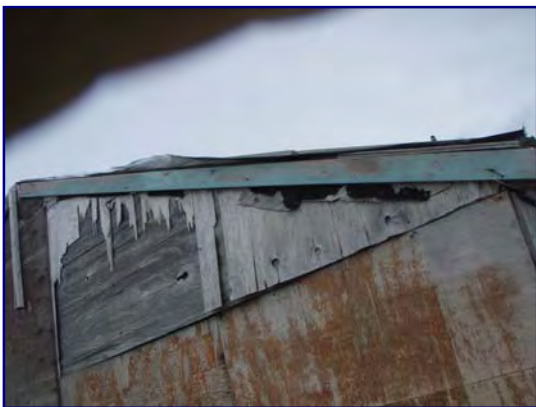
LBP on roof fascia board Building
#3

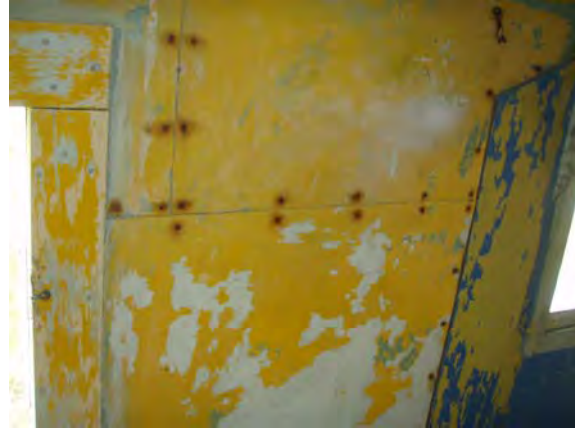
LBP on walls Building #6

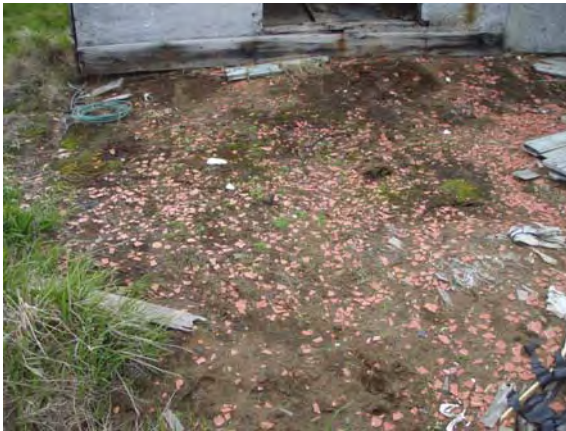
Red 9X 9 tiles on ground

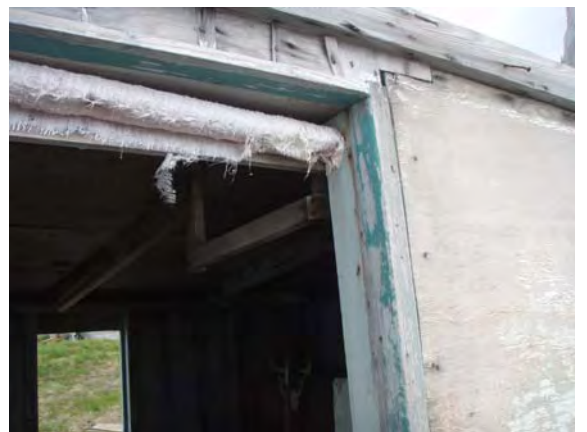
Exterior Door Cloth Building #2
Green LBP door frame

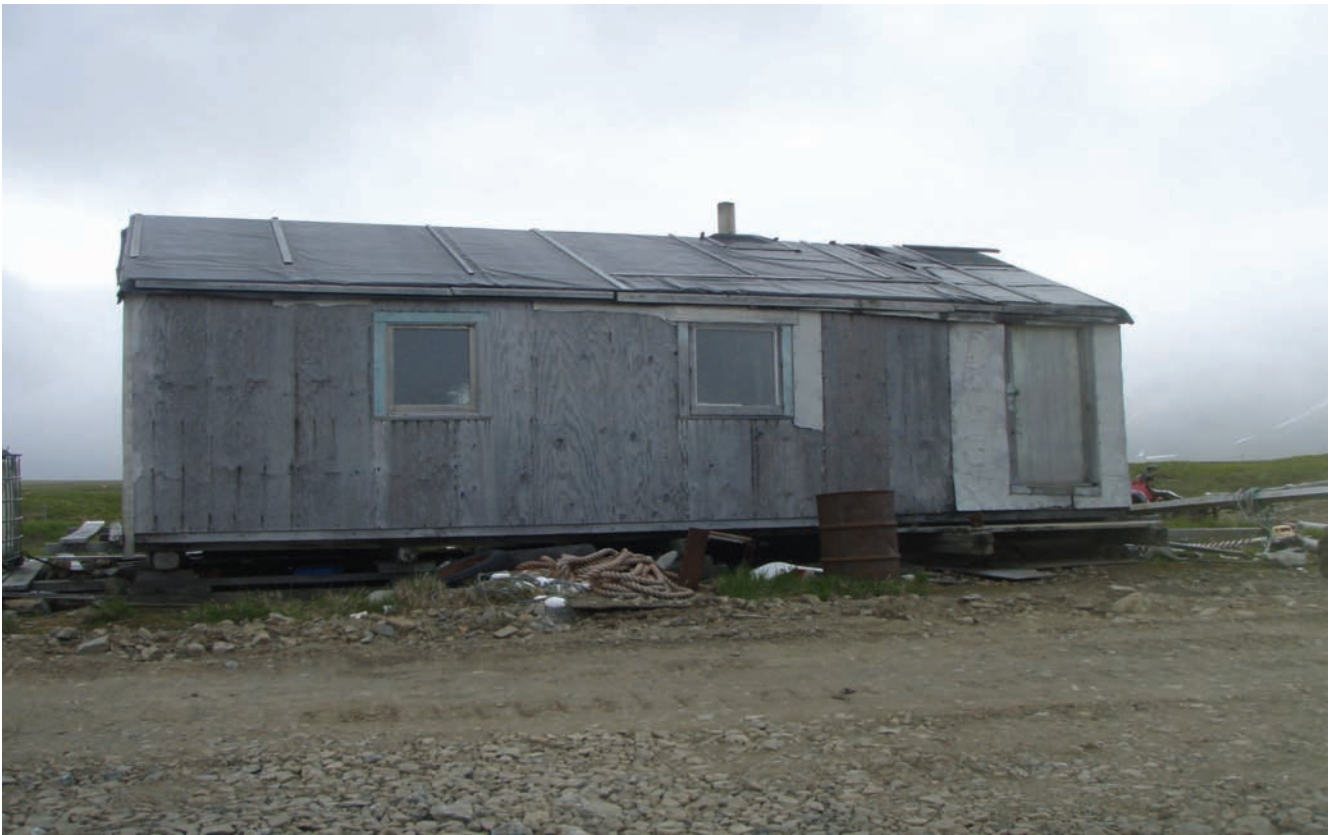
Photograph #3: Structure #1 Exterior
Direction: East

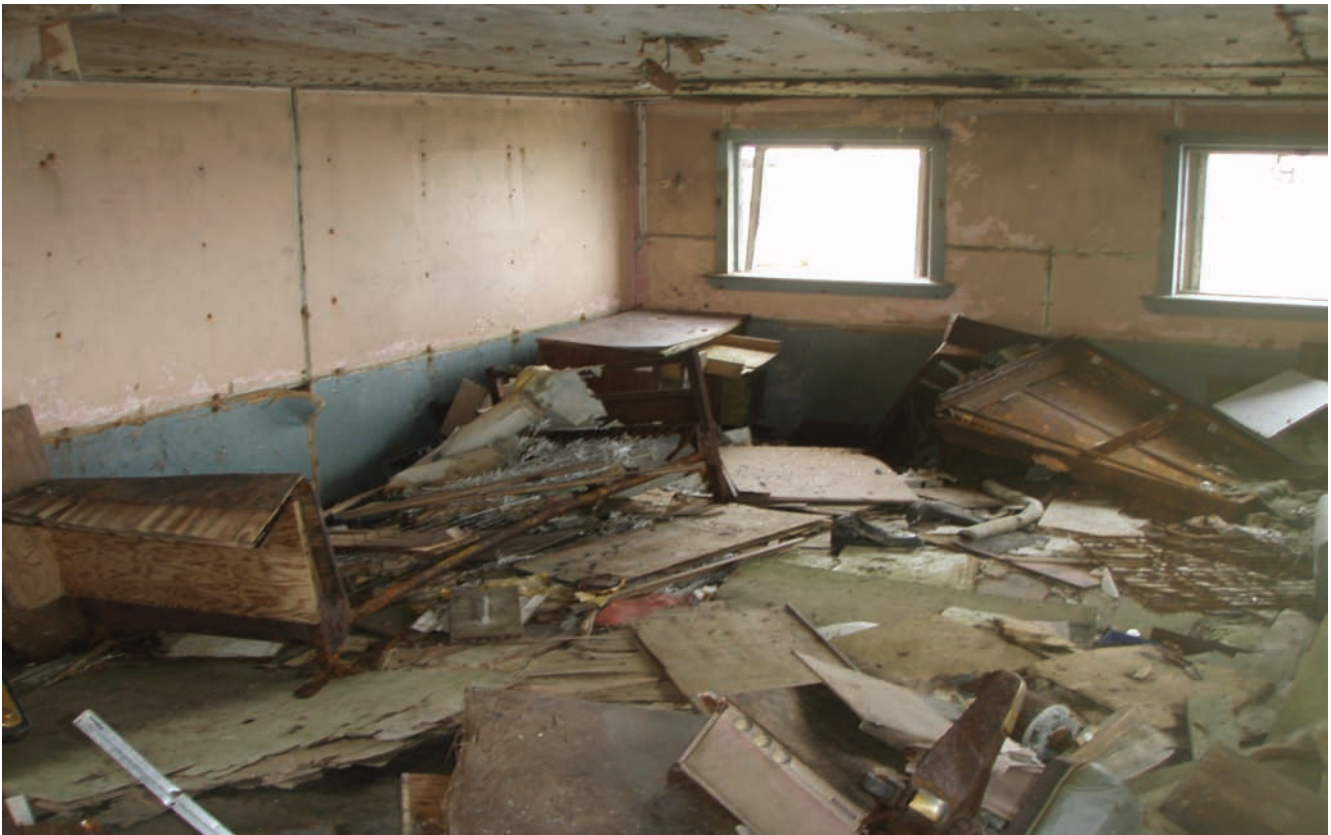
Photograph #5: Structure #2 Interior
Direction: West

Photo #5 - House #2 interior, poor condition facing NW (TE)

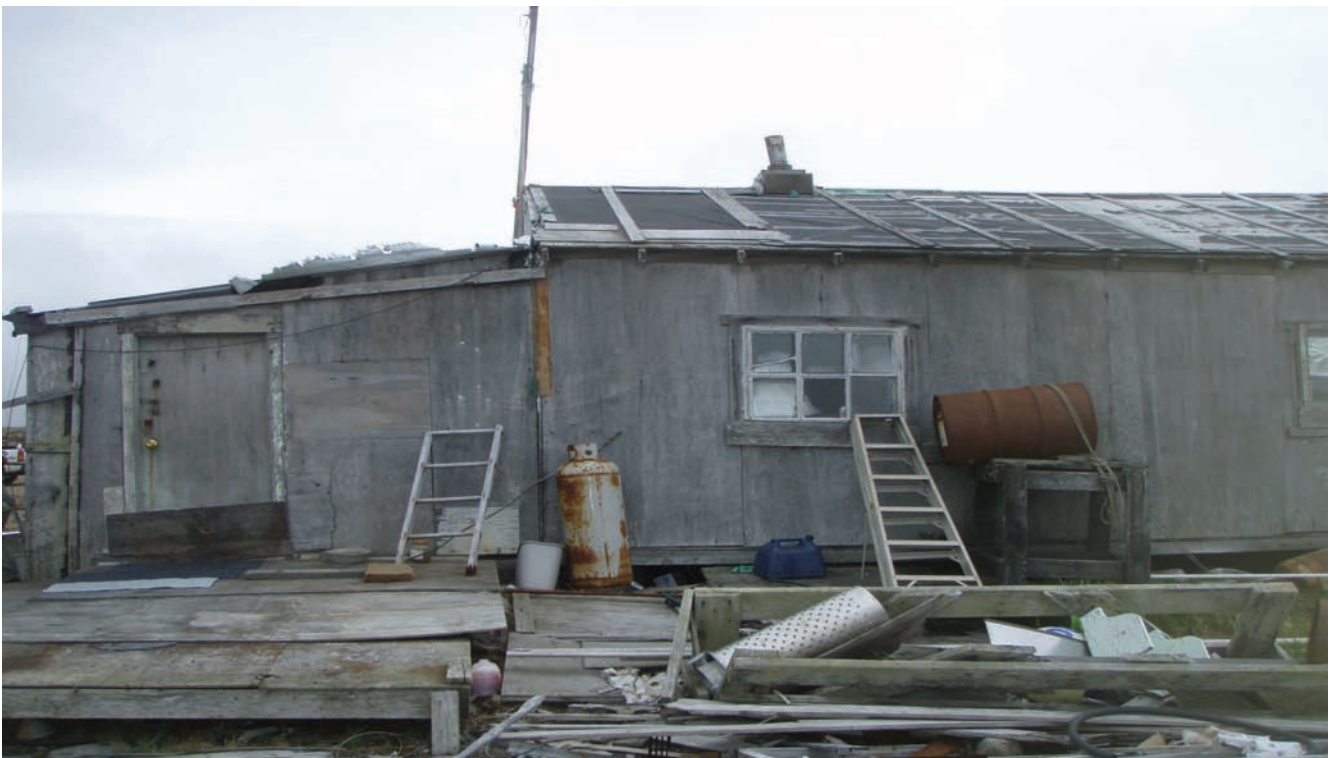
Photograph #8: Structure #3 Exterior
Direction: East

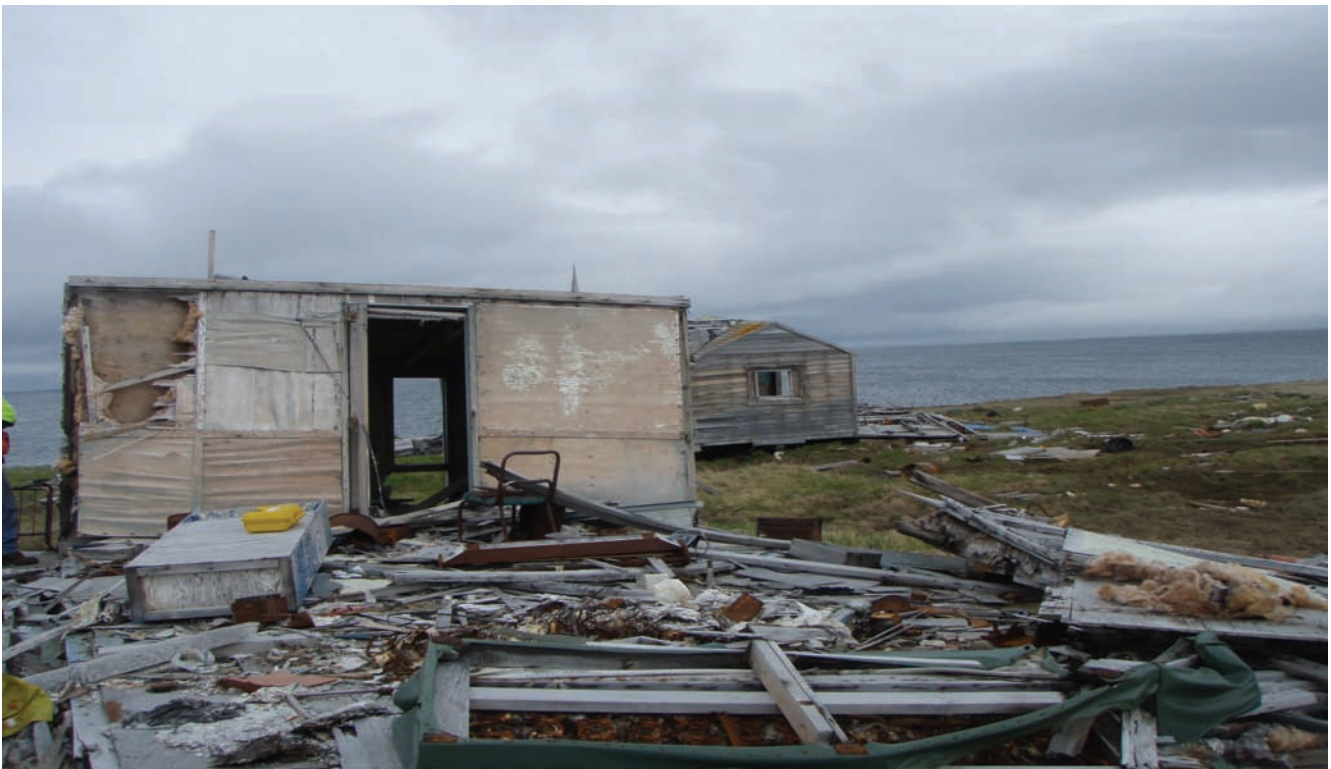
Photograph #14: Structure #4 and Debris Pile
Direction: North

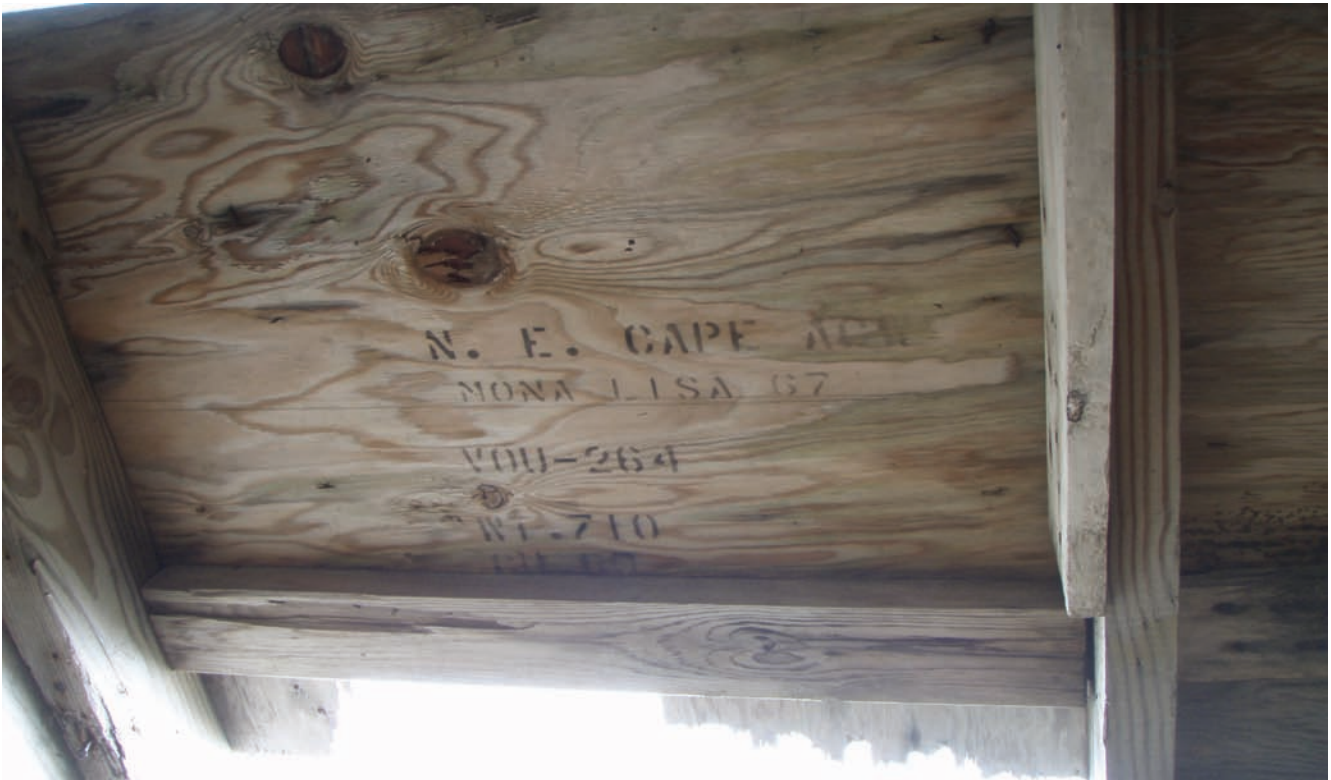
Photograph #26: Structure #8 Interior Ceiling
Direction: North

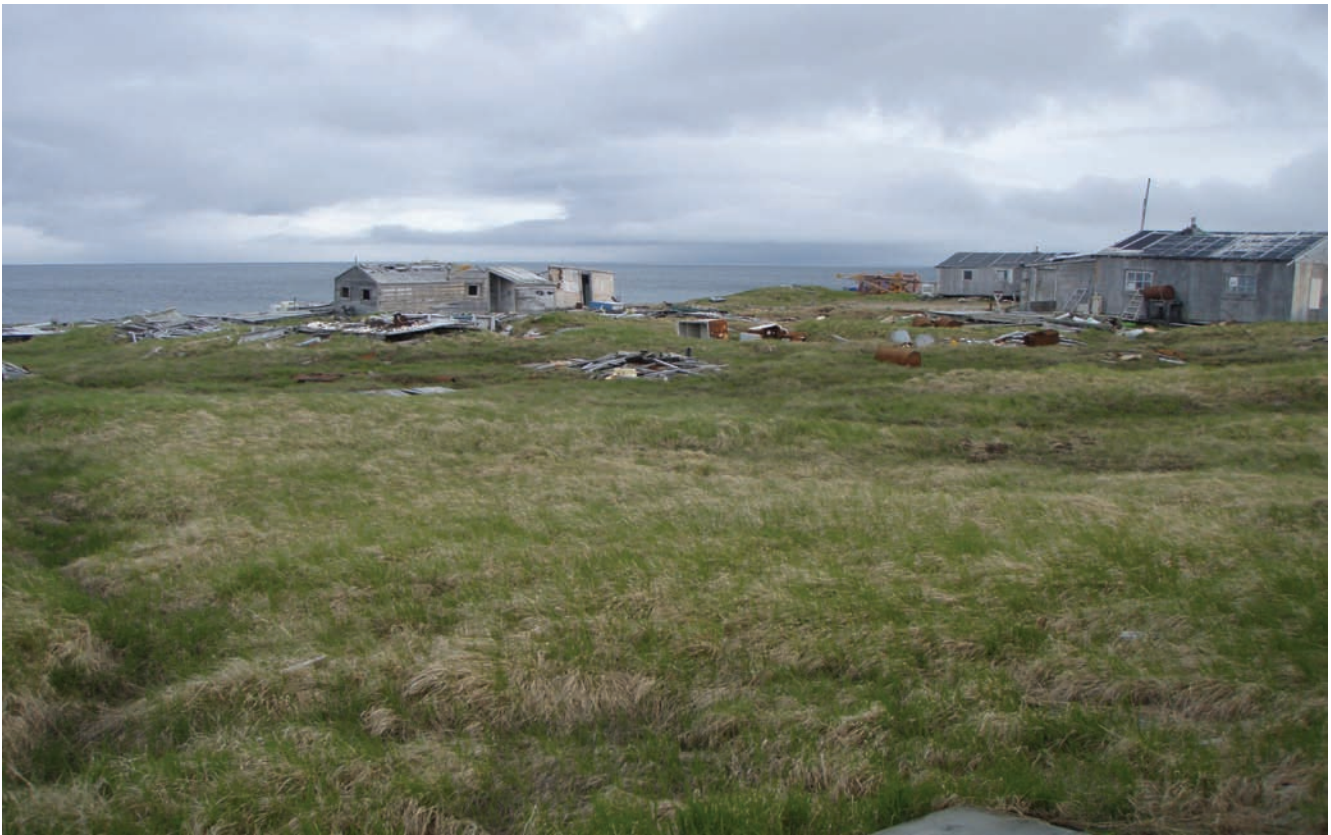
Photograph #27: NVNC Debris Piles Looking North from Structure #8 **Date: July 8, 2009**
Direction: North **Photographer: T. Ellingboe**

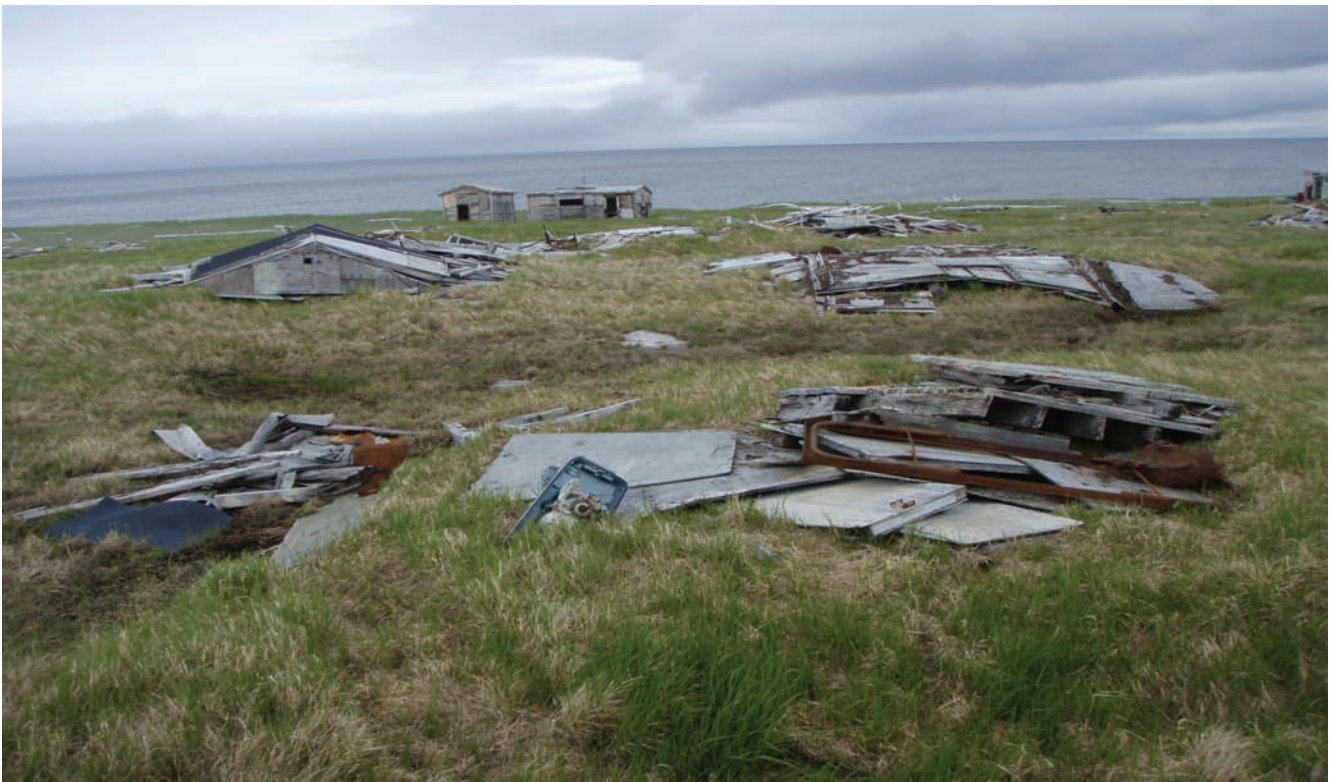
Photograph #28: NVNC Debris Piles Looking North from Structure #8 **Date: July 8, 2009**
Direction: North **Photographer: T. Ellingboe**

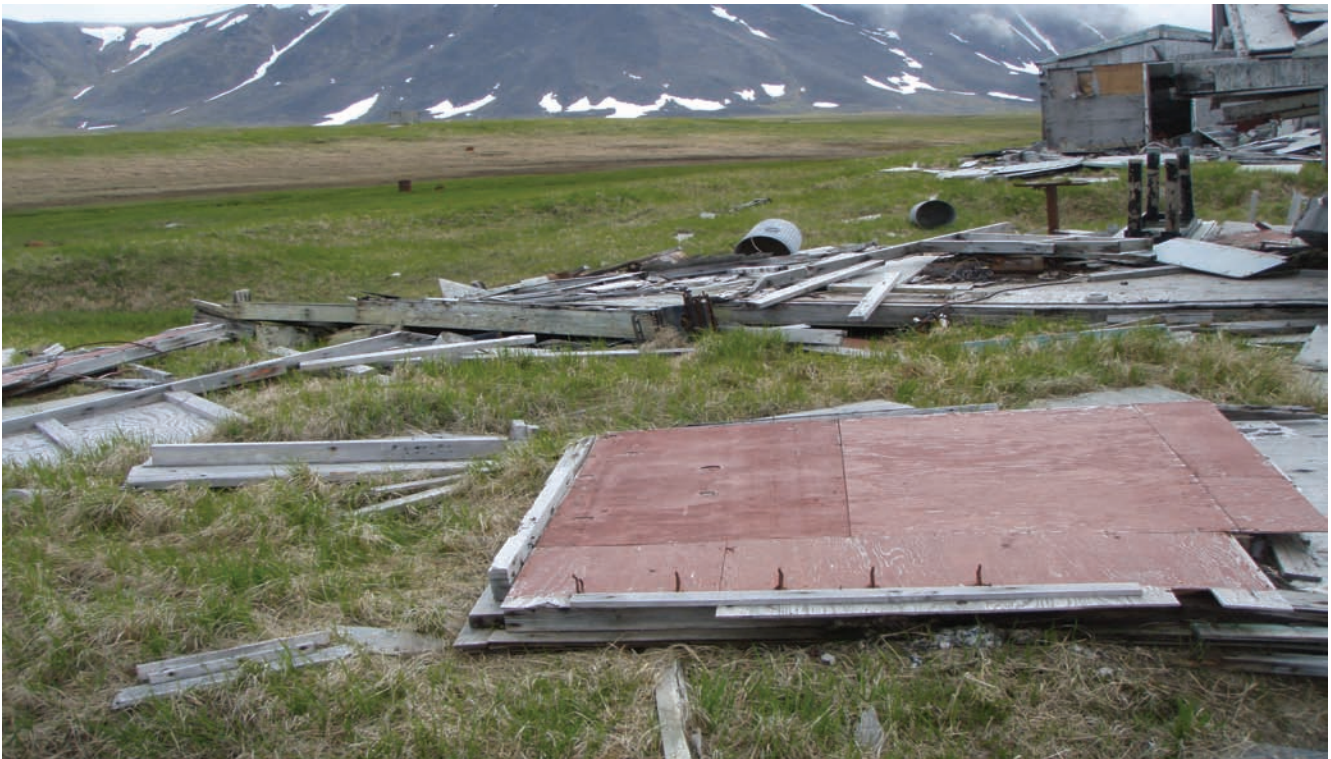
Photograph #40: NVNC Site Debris Piles
Direction: South

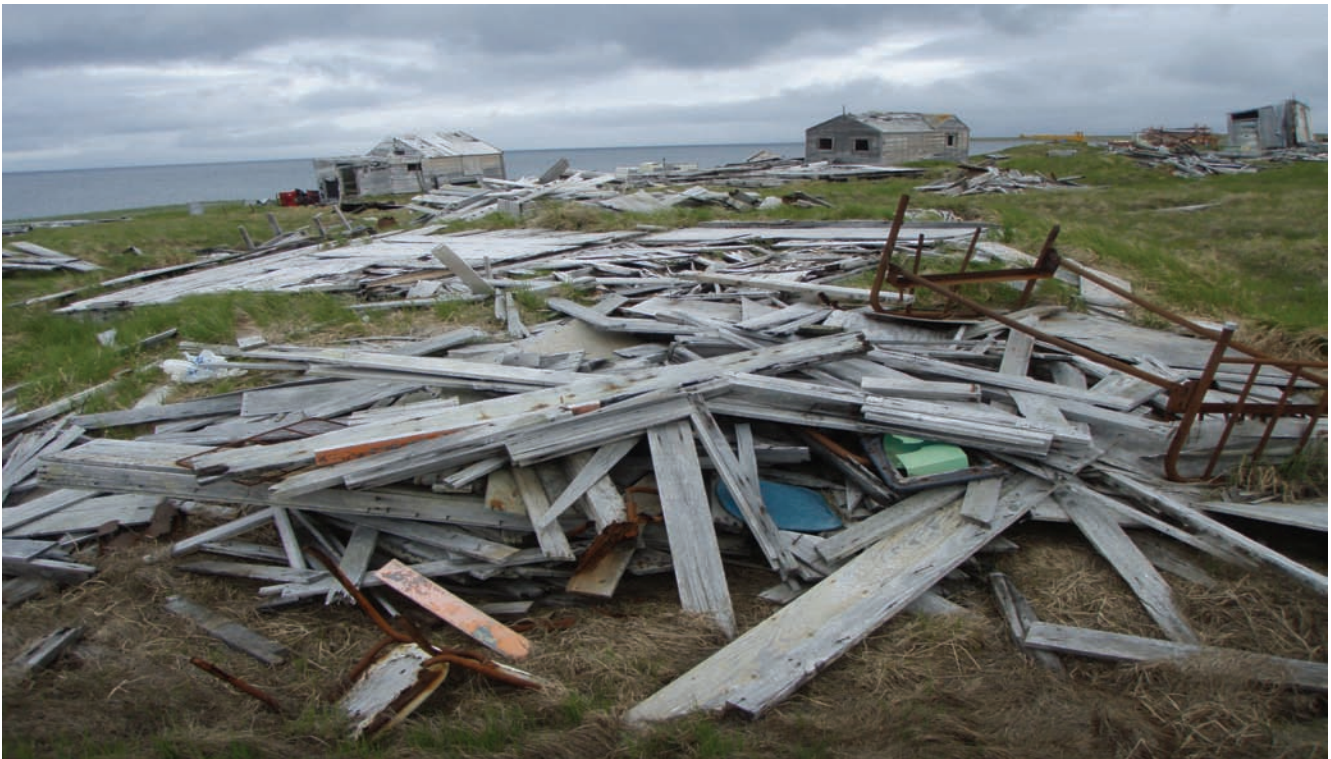
Photograph #41: NVNC Debris Pile
Direction: South

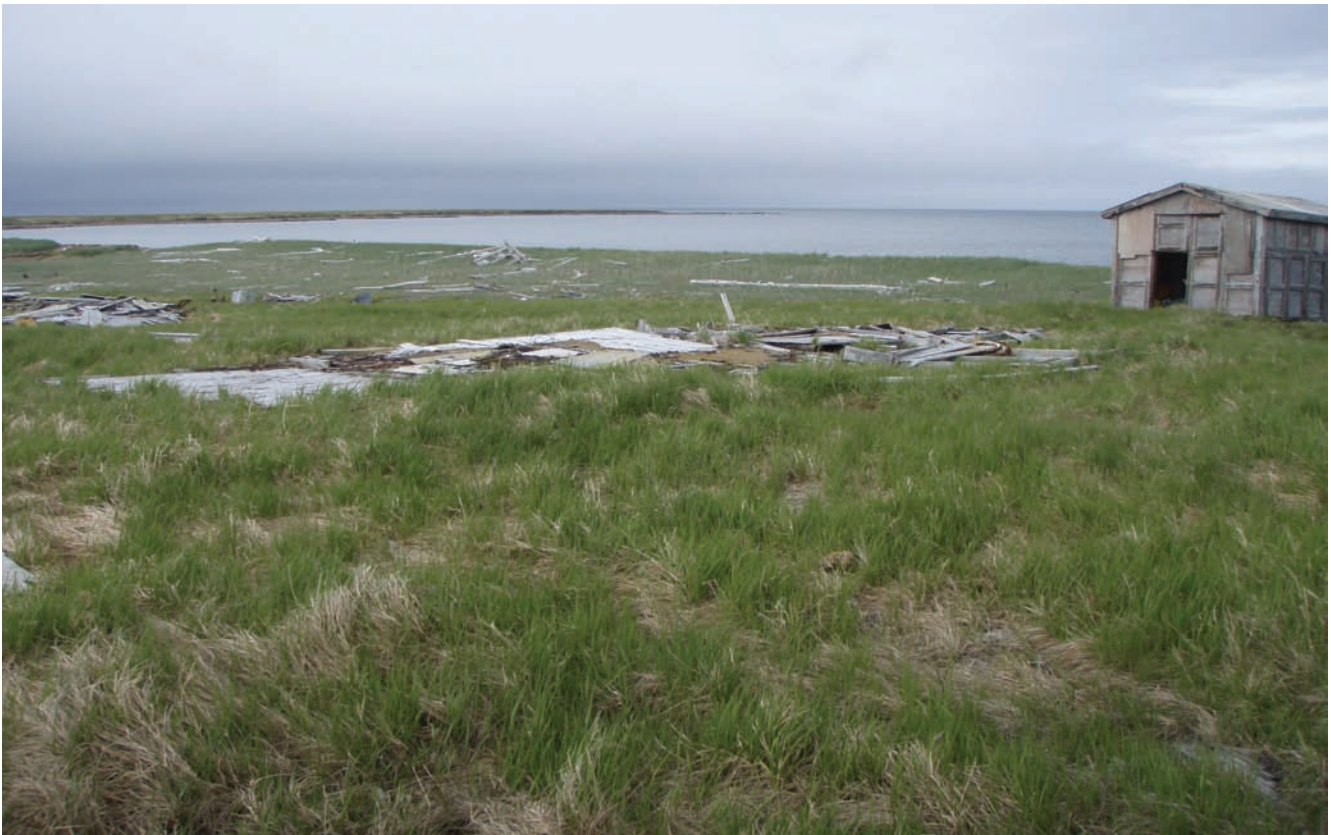
Photograph #42: NVNC Site Debris Piles
Direction: Northeast

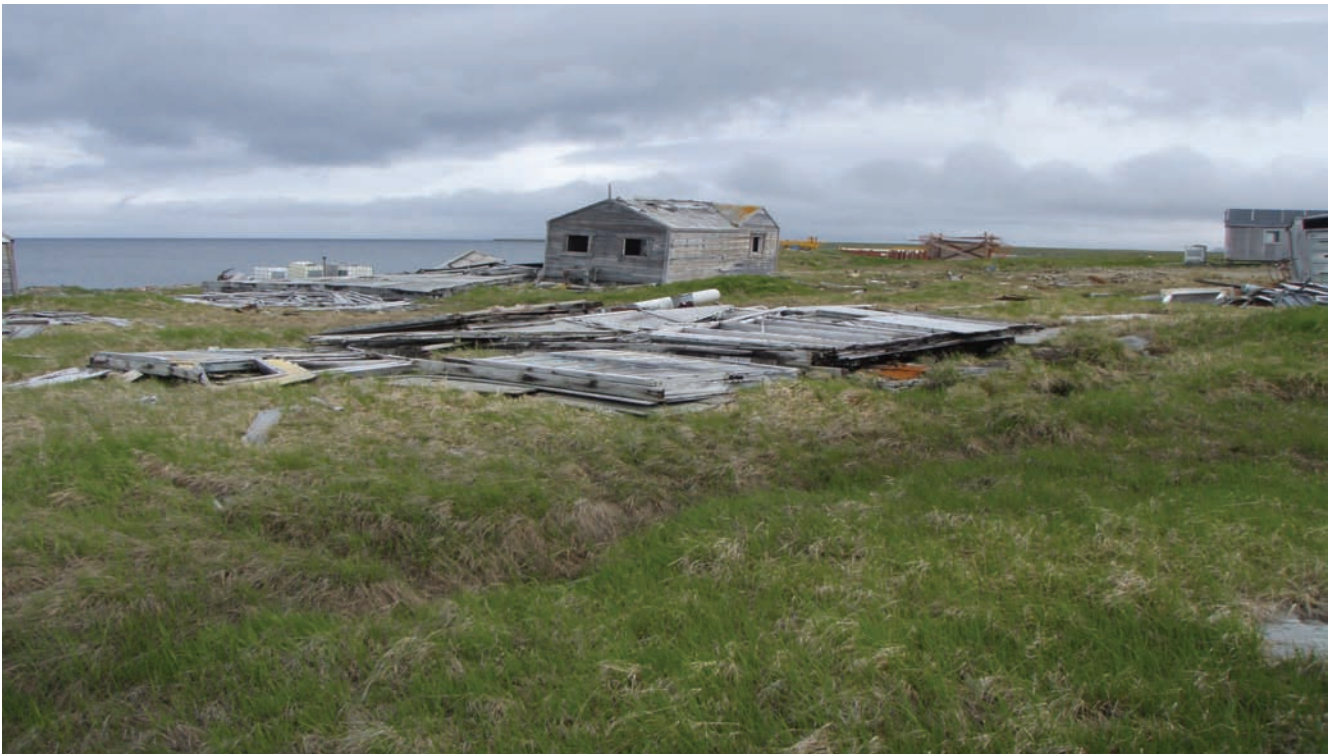
Photograph #43: NVNC Debris Pile/Former Structure Foundation
Direction: North

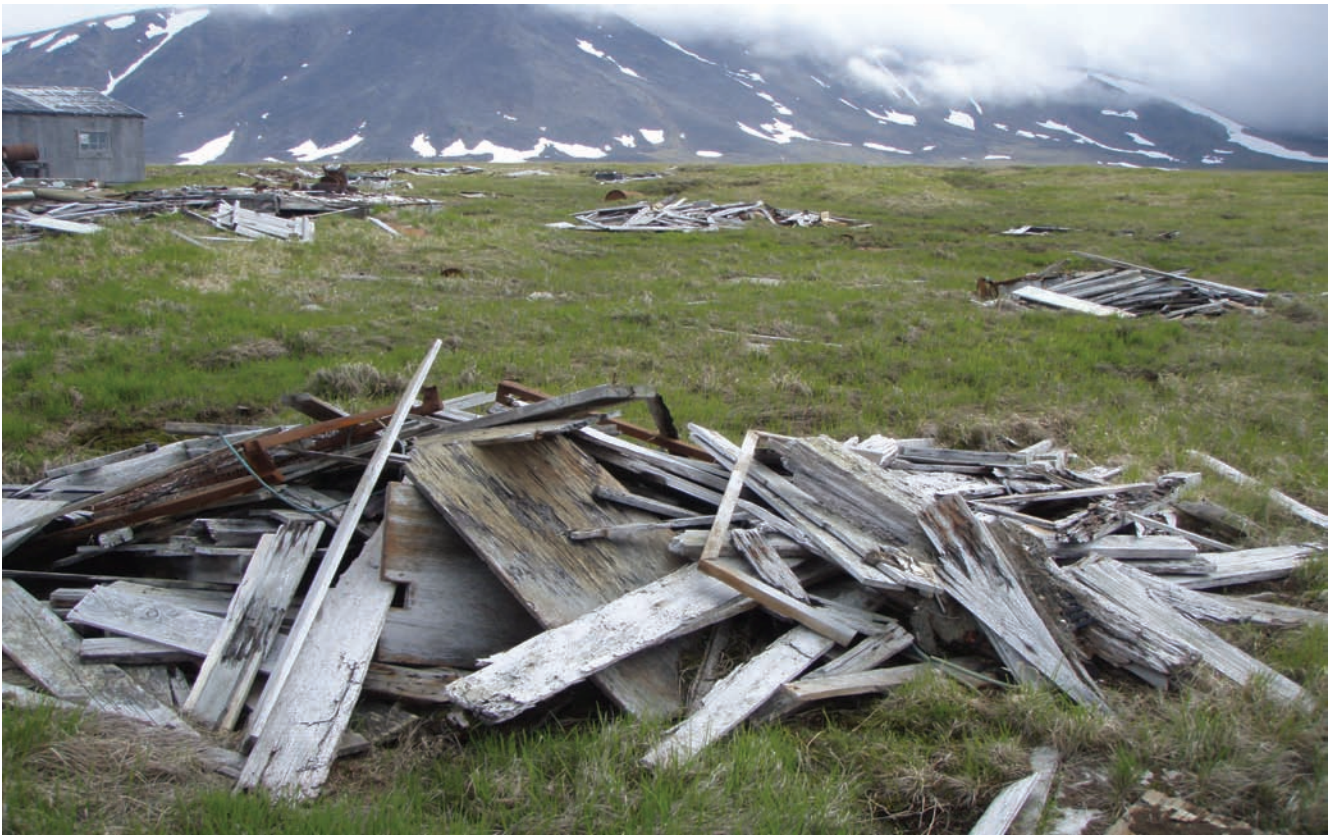
Photograph #44: NVNC Site Debris Piles/Former Structure Foundations
Direction: Northeast

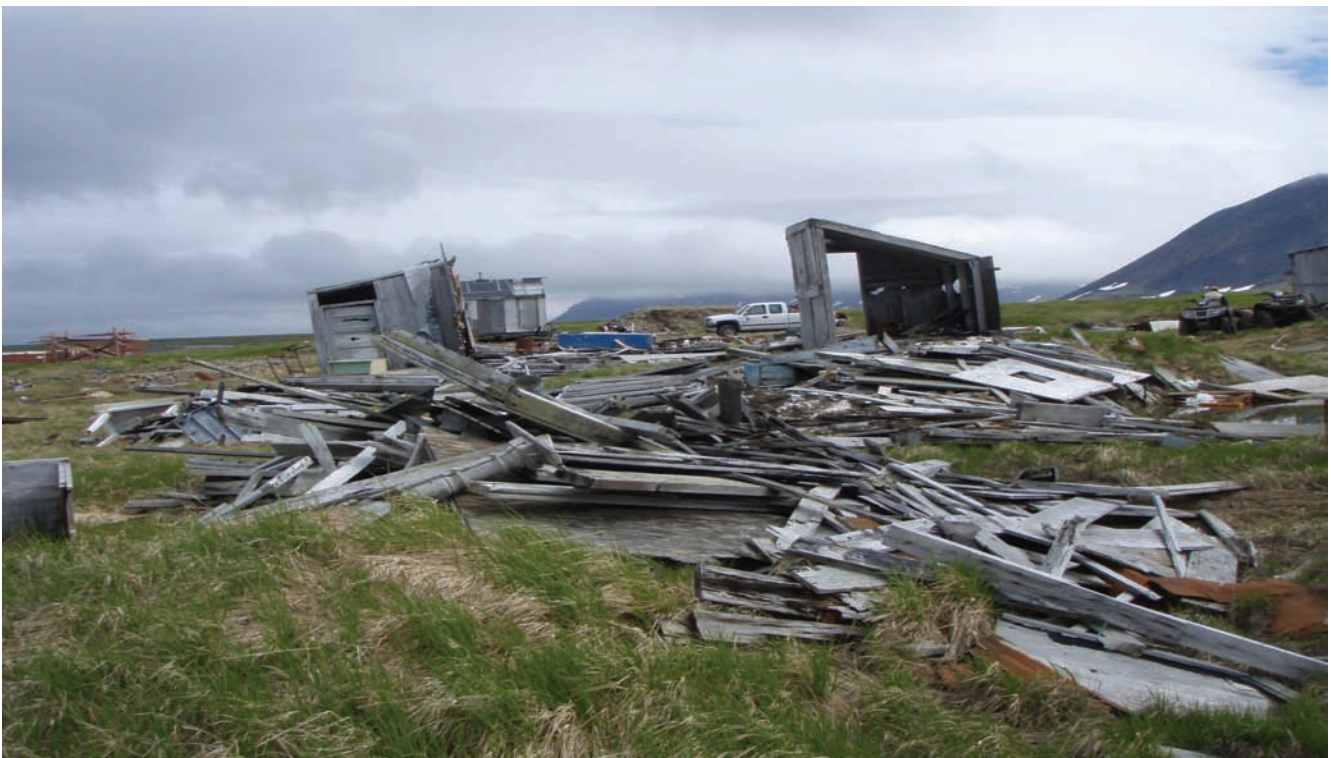
Photograph #45: NVNC Debris Piles
Direction: South

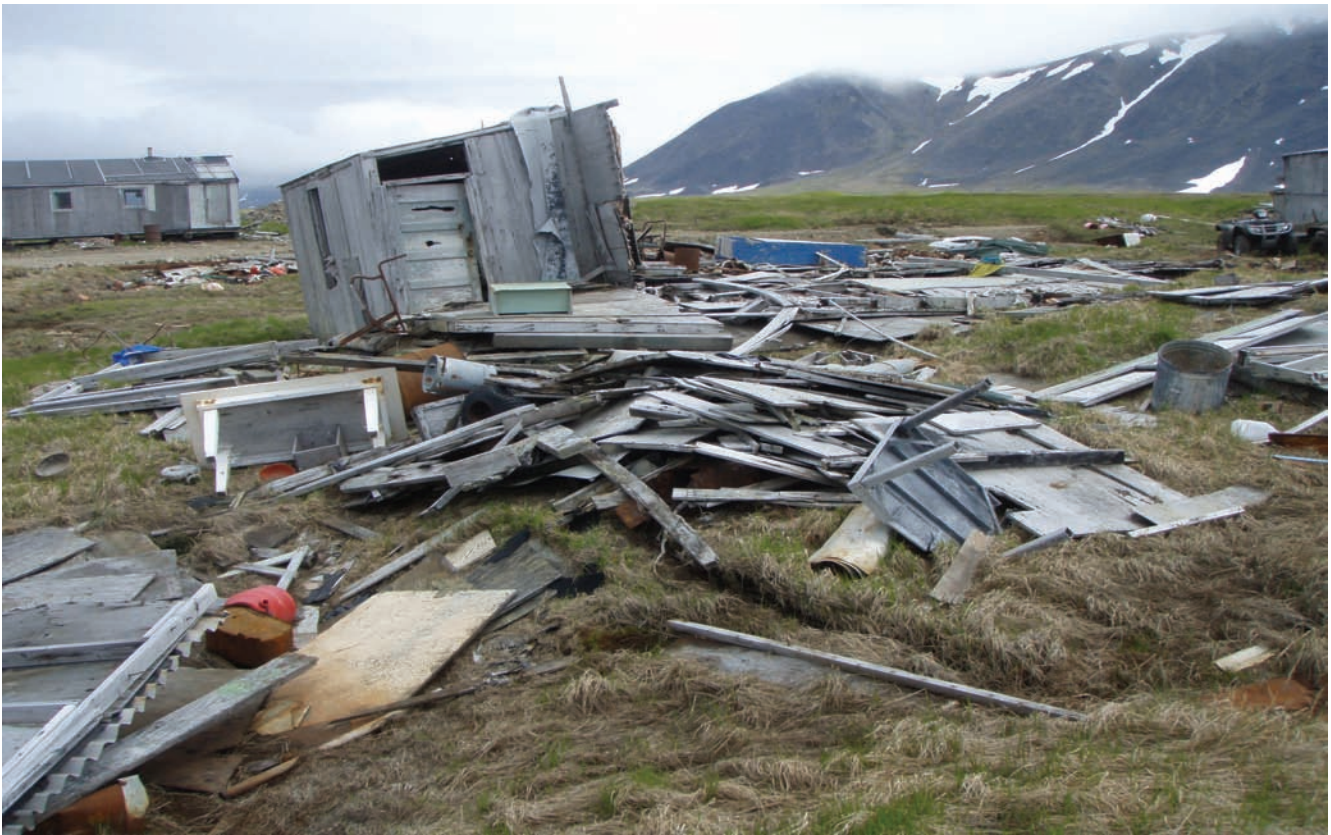
Photograph #46: NVNC Site Debris Piles
Direction: East

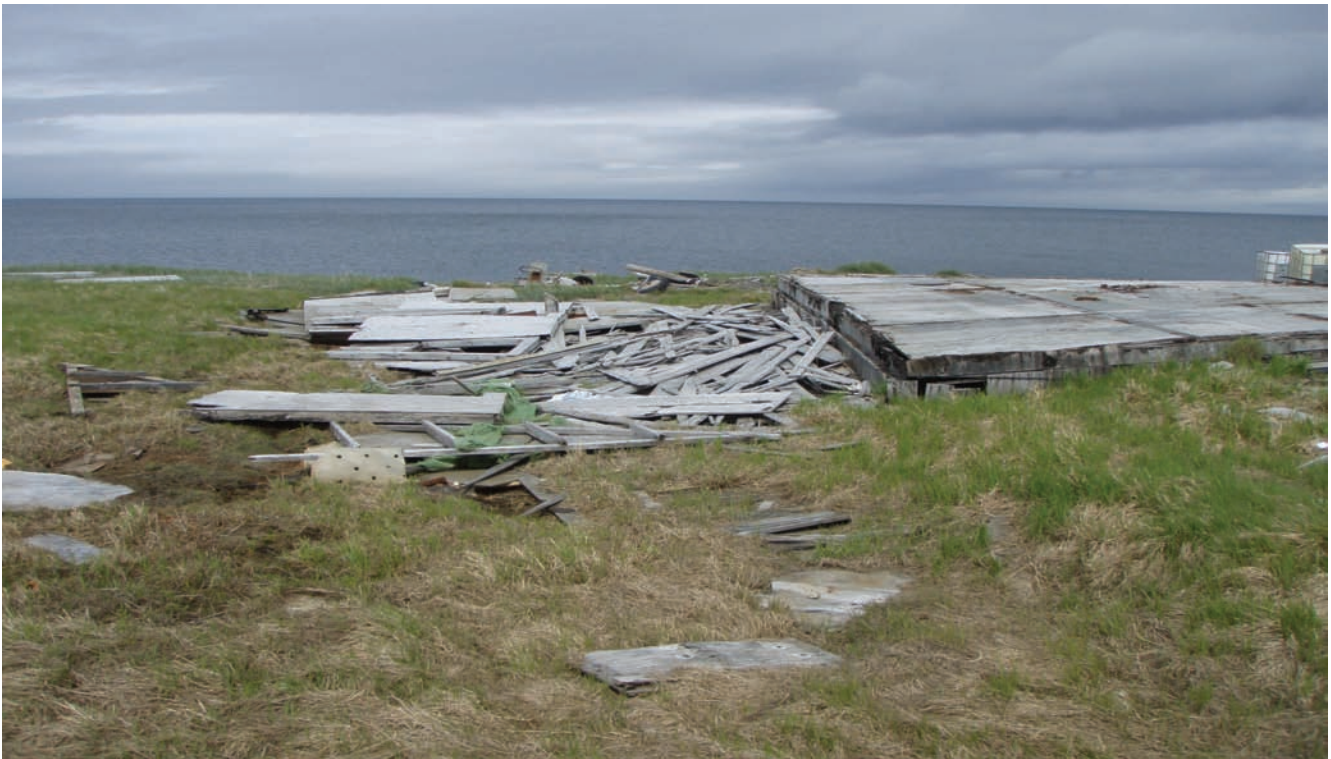
Photograph #47: NVNC Debris Piles
Direction: East

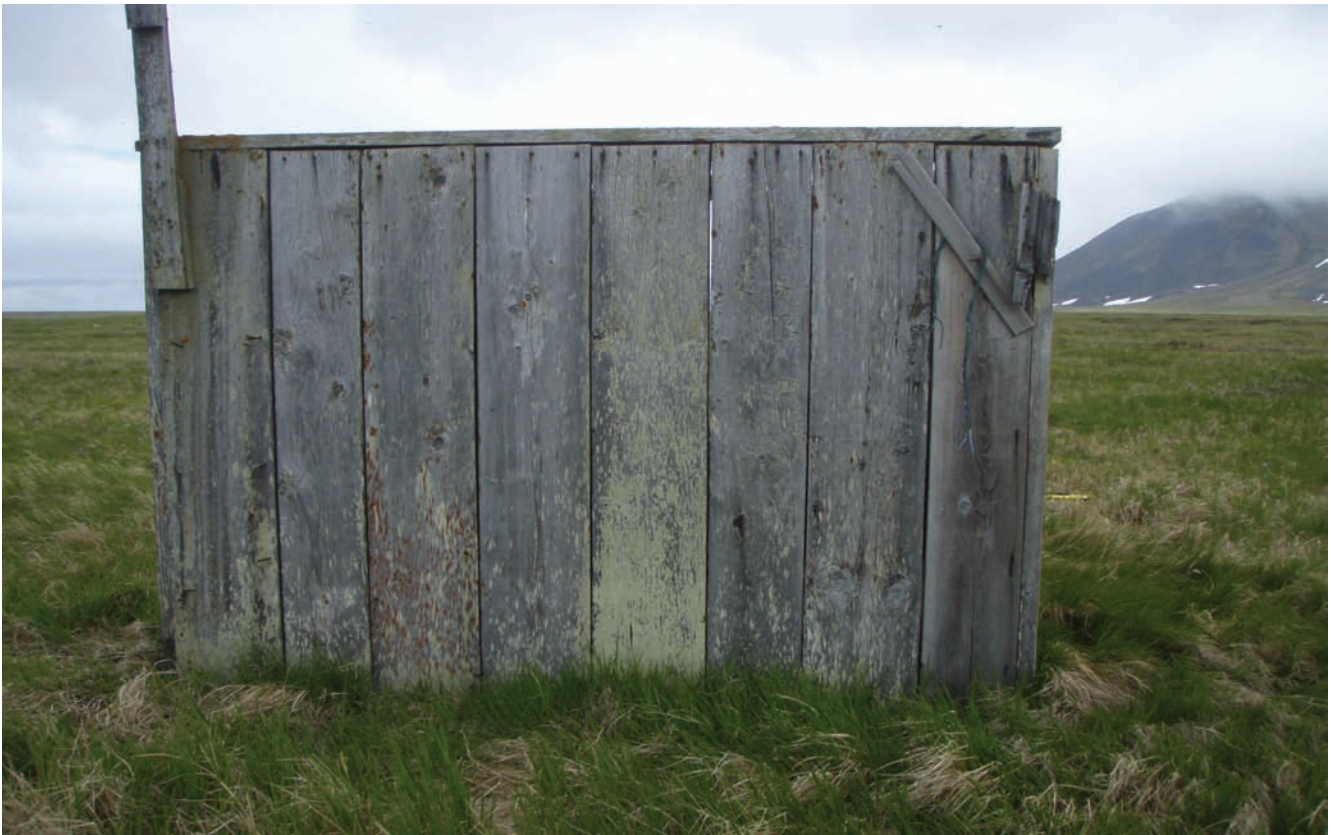
Photograph #48: NVNC Site Debris Piles/Former Structure Foundations
Direction: East
